Air-Ducted Hangar Foundations at Thule, Greenland

Kevin Bjella, P.E.

Cold Regions Research and Engineering Laboratory, Ft. Wainwright, Alaska, USA

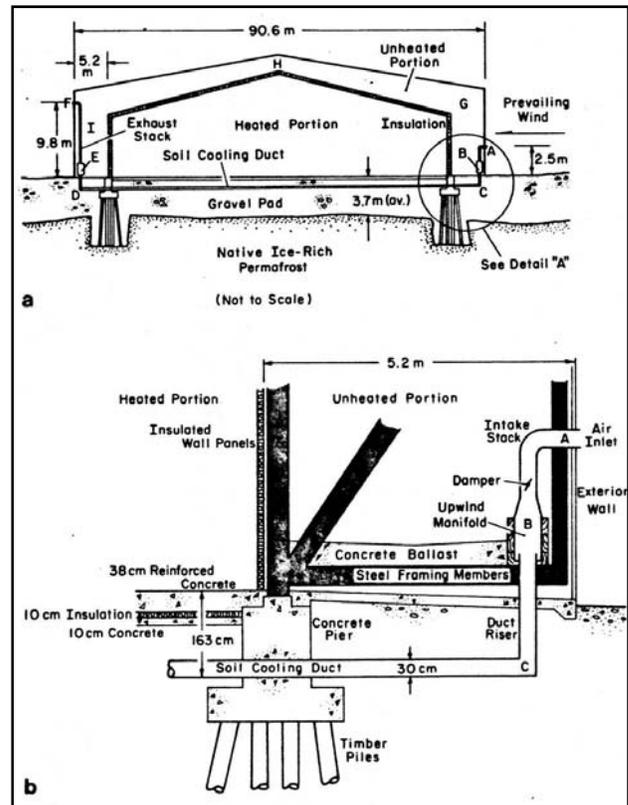
The air duct piping in these hangars are constructed of 28 cm diameter corrugated pipe separated from adjacent ducts by 60 cm, yielding approximately 64 rows and at a depth of 1.5 m below the floor surface. The ductwork runs from east to west emerging from the ground inside the unheated buttress areas on the east and west ends of the hangars into manifolds that group the ductwork into 9

stacks (Tobiasson 1970). The ductwork then runs vertically and penetrates through the buttress area walls to the outside (Figure 2b). Chimney draft is incorporated into the design and the air duct outlets (west) are approximately 7 m taller than the inlets on the upwind wall (east), and this is to induce a convective draft effect. All plenums are equipped with dampers located within easy reach, to shut the ductwork in the summer season preventing flow of warmer than freezing air.

Figure 2. a) Hangar Cross-section b) Detail of pile system and air duct system. (Tobiasson 1973)

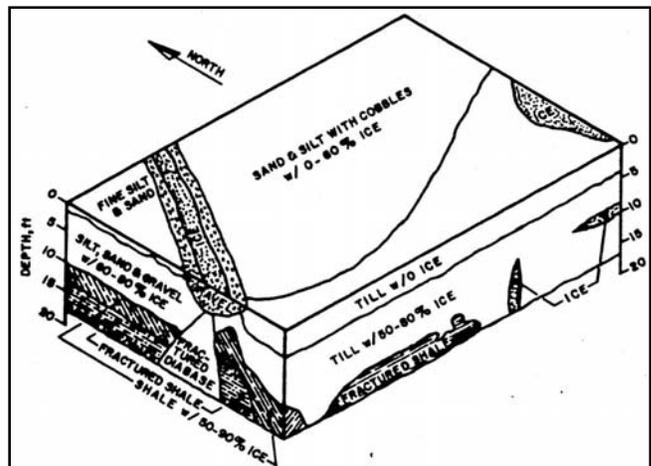
During the excavation of the pile trenches for Hangar 10, a detailed mapping was conducted of the underlying soil and ice conditions, and an isometric diagram of the conditions found, is shown in Figure 3. Bedrock was encountered in the western portion of the trench excavation. The bottom of massive ice, which is assumed to be ice wedge ice due to the linear nature, was located approximately 3 m above the bedrock. The full ice wedge extents are unknown

Figure 3. Isometric diagram of the soil conditions beneath Hangar 10. Note the massive ice in the northwest corner and bedrock at 3 m depth. Figure units in feet. (Tobiasson 1970).

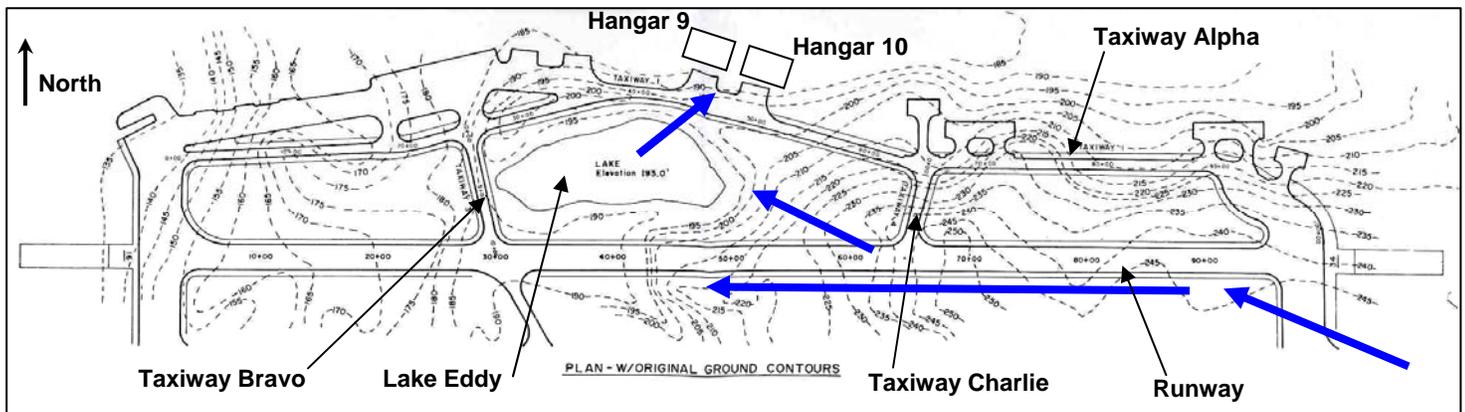
The previous drainage studies suggest that the runway and taxiway embankments act as conduits for the flow of water from the southeast, moving it north and westerly through the airfield, with some collection occurring in Lake Eddy and the remaining flow continuing under the runway embankment resulting in the noted seepages (Figure 4). These studies also suggest the water flow within the embankments is focused under the centerline, and this infers that a thaw bulb type basin exists under the embankment with the deepest thaw under the centerline. The concept of water flow under the embankments is not disputed, but finite element thermal modeling of the taxiway and runway embankments suggests that the deepest thaw would occur at the toe of the embankment shoulder due to a significant crown in the embankments, not under the centerline, where the permafrost table has been raised and nearly mirrors the topography of the embankment. The raised permafrost table is exacerbated by the 40 years of white painting of the runway and taxiways which decreases the depth of annual thaw by nearly 1.0 meter in comparison to natural black asphalt pavement. This subsurface permafrost topology would cause water transmission to occur under the shoulders, not the centerline, and this is validated by the seepage locations. Probable water flow pathways are shown in Figure 4.

Figure 4. Area map. Bold arrows indicate water flow paths. Preconstruction contours in feet.

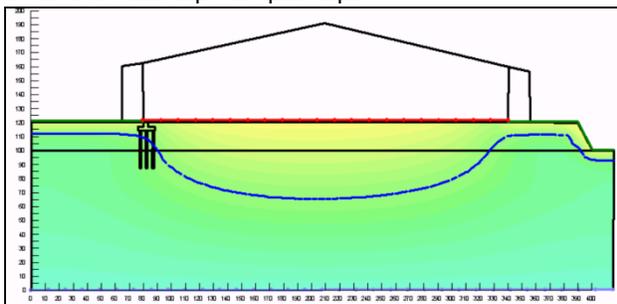
The results indicate that the thaw front will extend to a depth of 15 m below the center of the hangar floor, and the thaw front obtains a depth and lateral position that is approximately 3 to 4 m from impinging on the load bearing ends of the timber piles (Figure 5), and the thaw front does envelope the pile cap.

Figure 5. Thaw depth extent estimation utilizing Temp/W commercial software. 0°C isotherm after 25 years of heated hangar operation. Figure axes in feet
