INSPECTION REPORT
on the
LIARD HIGHWAY
MILE 0.0 to MILE 21.5

by
S. Hartwell
Environmental Protection Service
Yellowknife, N.W.T.

October, 1978

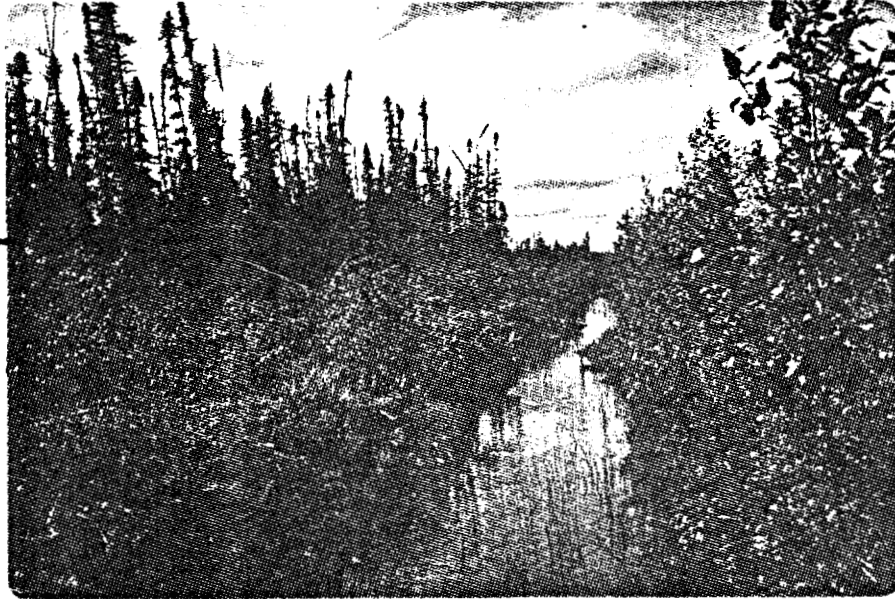
It was immediately obvious that the drainage and erosion control structures were in poor repair, and in some cases ill-planned. Although adequate drainage ditches are present parallel to the highway (plate), and energy dissipating ditch blocks have been constructed, stilling basins are in some cases clogged with silt, causing pooling and flooding of water. Ditch blocks and culvert outlets are often not protected with lining or rip-rap, so that erosion and/or clogging of culvert outlets is also a problem.

Plate 1: Drainage ditches parallel to Liard Highway

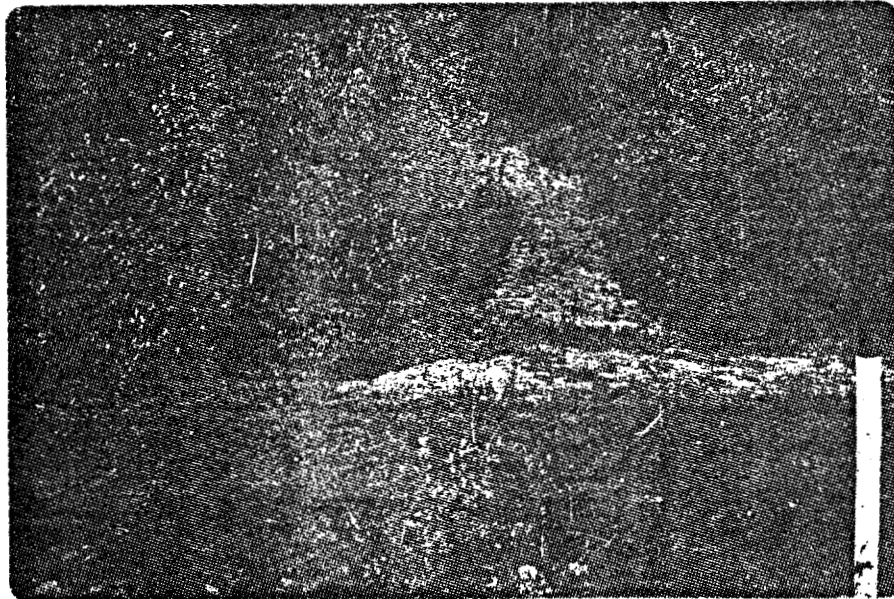
Cross drainage structures, in the form of offtake berms and ditches (plates 2, 3) are frequently present to direct water flow through culverts. While the culverts themselves appear to have been well placed, the offtake

Plate 2: Offtake ditch. Note build-up of sediment in foreground, at Culvert outlet. Such heavy sedimentation may be due to improperly placed ditch blocks (plate 3).

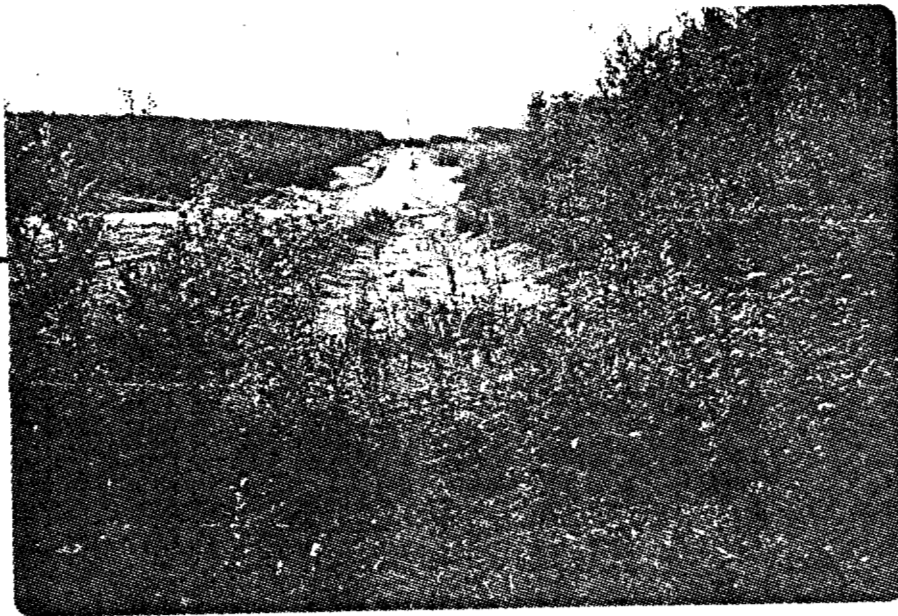
Plate 3: Ditch block to direct water into cross drainage culvert, and offtake ditch. This ditch block has apparently been placed incorrectly, resulting in clogging of the culvert (plate 4).

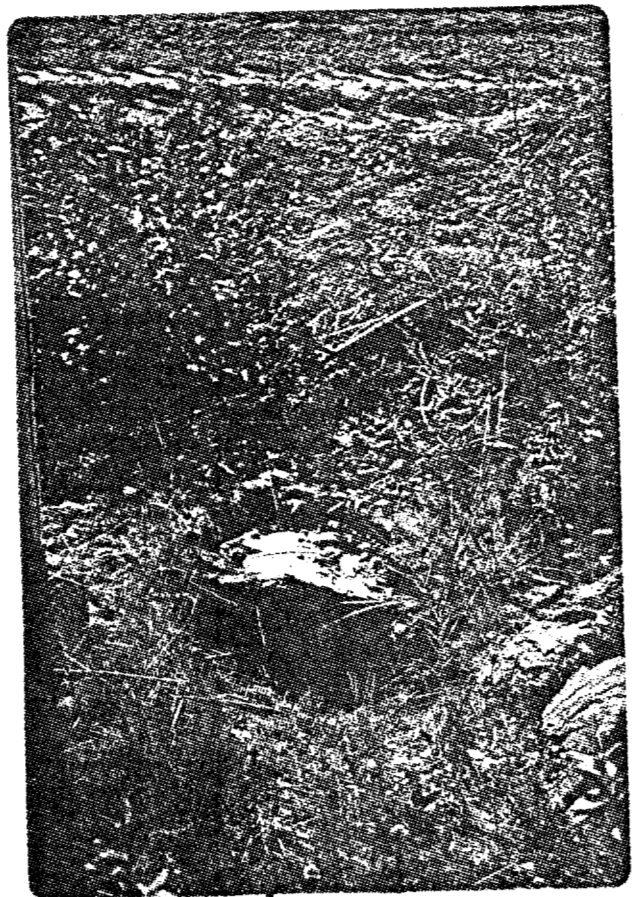
berms and ditches are sometimes incorrectly positioned in relation to the culverts. This has resulted in heavy sedimentation in the immediate vicinity of the culvert, and subsequent clogging of the intake (plate 4), a condition aggravated by lack of rip-rap to protect the intake. The problem has been recognized, but repairs appear to have been limited to a cursory shovelling out of the area immediately adjacent to the culvert, rather than full scale dredging, or relocation of the offtake ditch.

Plate 4: Clogged culvert. Cleaning has been perfunctory - relocation of ditch block and protection with rip-rap is necessary for a more permanent solution.

Minor oversights such as failure to place rip-rap at culvert outlets or over ditch blocks should be easily handled during routine maintenance. More major errors (e.g. incorrect placement of offtake ditches) will require careful diagnosis and greater expenditures of time and money. As DPW currently has no funds scheduled for such a capital project, but is planning to upgrade drainage structures in 1981 (personal communication, R. Rollefson, DIAND), perhaps it will not be possible for them to complete these repairs until then. Prompting is nevertheless suggested, as a survey of necessary repair work could be conducted in the interim.

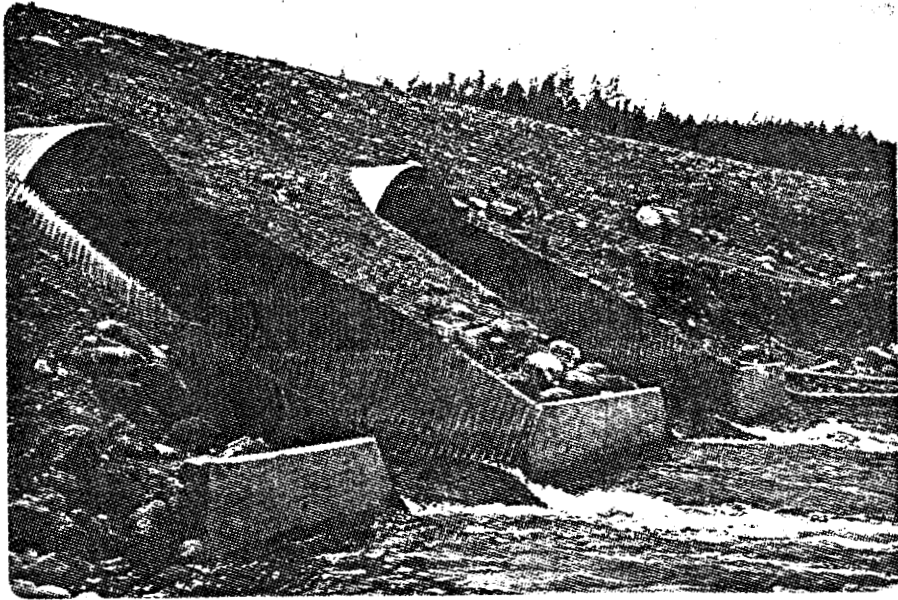
The Poplar River culverts, contentious since their initial design, obviously obstruct upstream fish movement with their rapid water flow and elevated outlets (plate 5). A new factor to emerge, however, was the presence of a stone weir on the upstream side of the culverts (plate 6). This weir, apparently built as a temporary measure at some time in the past, stretches over two-thirds of the width of the Poplar River, and does not appear to be in current use. It is an obvious obstruction to fish movement.

Plate 5: Poplar River culverts: rapid water flow and elevated outlets obstruct fish passage.

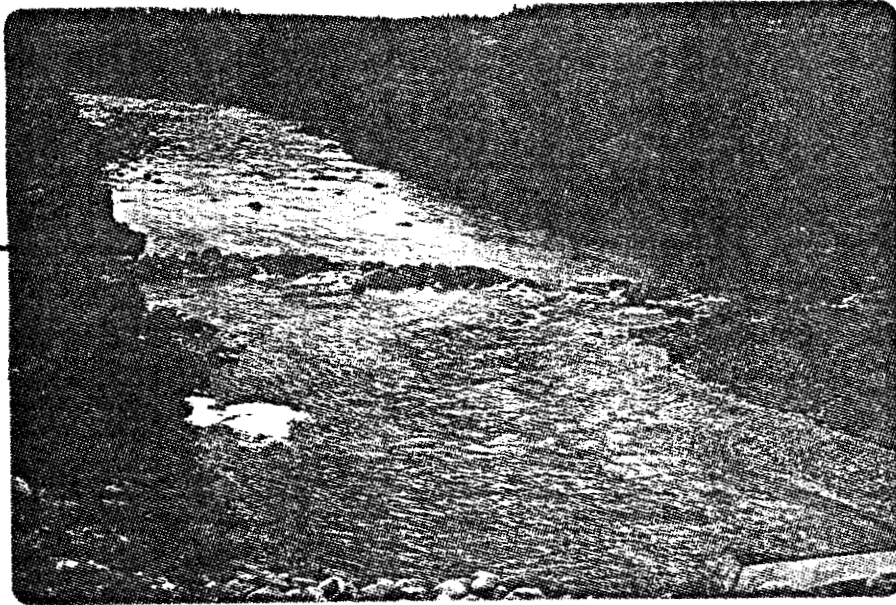
Plate 6: "Temporary" weir upstream of Poplar River crossing: more than two thirds of the channel is obstructed.

The rock weir upstream of the Poplar River crossing should be removed as soon as possible; such obstruction of fish passage is contrary to sections 24 and 27 of the Fisheries Act. Parties obtaining water authorizations for stream crossings under the Northern Inland Waters Act are normally required to remove all debris and temporary structures from the stream bed as soon as construction of the permanent crossing is complete. One would expect government departments to exhibit exemplary rather than recalcitrant behavior in such matters.
