INSPECTION REPORT
on the
LIARD HIGHWAY
MILE 0.0 to MILE 21.5

by
S. Hartwell
Environmental Protection Service
Yellowknife, N.W.T.

October, 1978

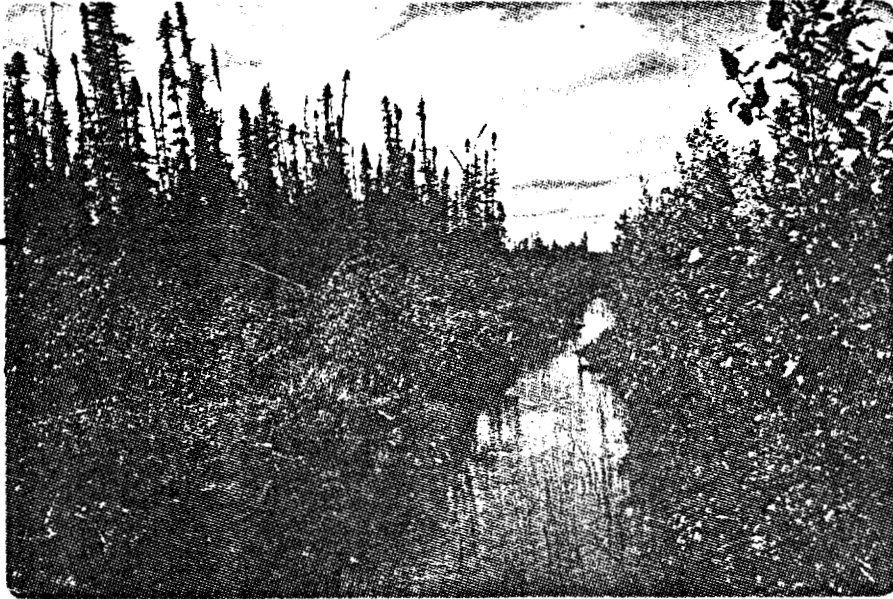
Plate 1: Drainage ditches parallel to Liard Highway

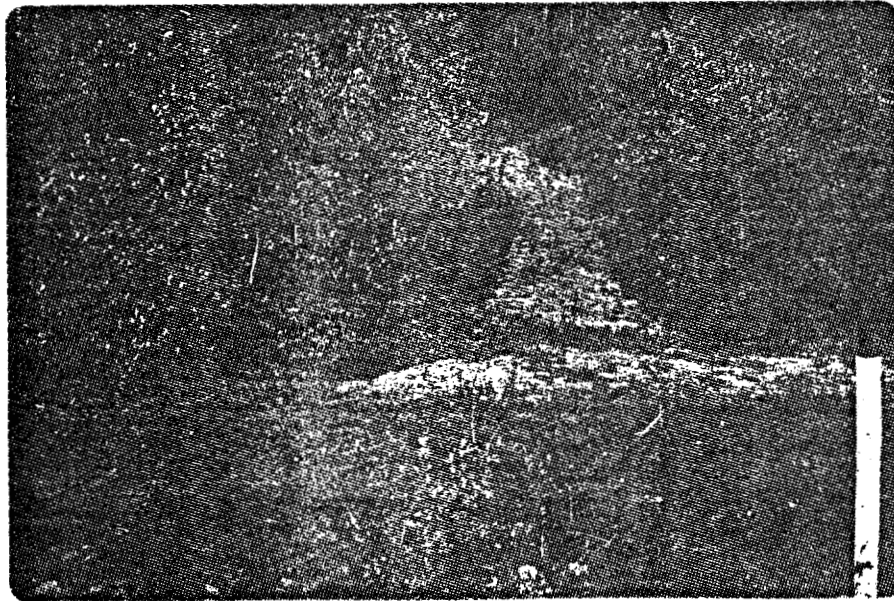
Cross drainage structures, in the form of offtake berms and ditches (plates 2, 3) are frequently present to direct water flow through culverts. While the culverts themselves appear to have been well placed, the offtake

Plate 2: Offtake ditch. Note build-up of sediment in foreground, at Culvert outlet. Such heavy sedimentation may be due to improperly placed ditch blocks (plate 3).
