III. 4. FOUNDATION PROBLEMS AT FORT McPHERSON, N.W.T.

R. Harding

During the period from July 1956 to December 1958, the Department of Public Works was responsible for the construction of several buildings at Fort McPherson, N.W.T. The construction of these buildings was complicated by the presence of permafrost throughout the entire area covered by the project. This paper deals with the problems encountered in placing the foundations for these structures.

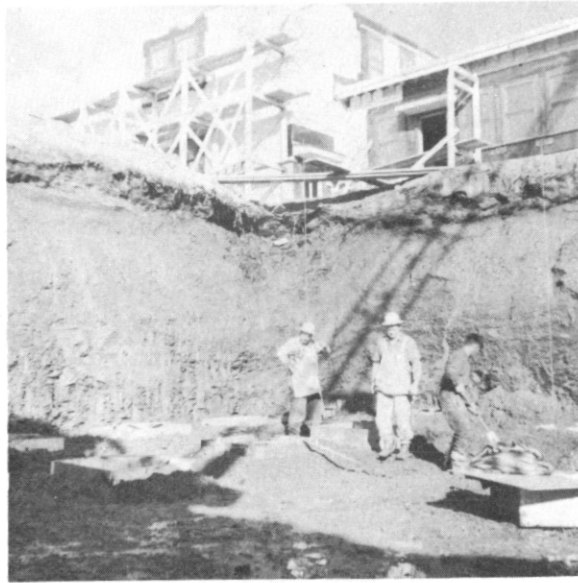
The third method of excavation, the open pit method, is discussed in more detail because the problems were considerably different from the smaller holes. It was decided to use the open pit excavation for the boiler room piers because the pier spacing for this portion of the building was too close for individual hole excavation. Pier spacing was 7 feet 6 inches in the east-west direction and 6 feet 7 inches in the north-south direction. The total excavation covered an area of approximately 68 feet by 45 feet and was 16 feet in depth. This meant approximately 1,800 cubic yards of material were removed. The area was first stripped of its moss cover by the dragline down to permafrost. The jack hammers were then used to break out the frozen material and the pieces thus chipped out were gathered together and removed by the dragline. Severe thawing was experienced on the vertical surfaces exposed by the excavation, particularly on the north face which was exposed directly to the sun. The bottom of the excavation was channelled so that water flowed to one corner and was removed by continuous pumping. Solid shale was encountered at approximately 16 feet below the surface. The total excavation, forming of the piers, beams, and floor slab took exactly one month, from August 13 to September 14. As soon as the excavation was completed, 3 foot by 3 foot pier footings were placed and poured. The piers were formed in place in two 8 foot sections, the upper 8 foot section being placed approximately a week after the lower. The boiler house slab and beams were poured monolithically with the piers. Incorporated into the boiler house slab was a water tank enclosure. This structure was similar to a basement with the difference that the floor slab was supported on piers which went down to the hard shale. To date, no leaks have shown in this water tank enclosure. Figures 1 and 2 show details of the boiler house foundation and Figure 3 shows the completed hostel.

Fig. 1 View towards the northwest corner of the excavation for the boiler room piers. Note the depth of excavation - approximately 16 ft. below grade. August 29, 1957.

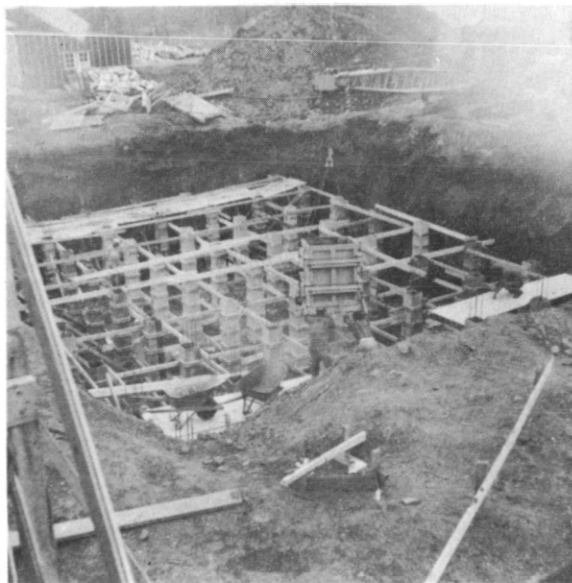
Fig. 2 Pouring first lift of boiler room piers. Note crane holding concrete hopper. August 30, 1957.

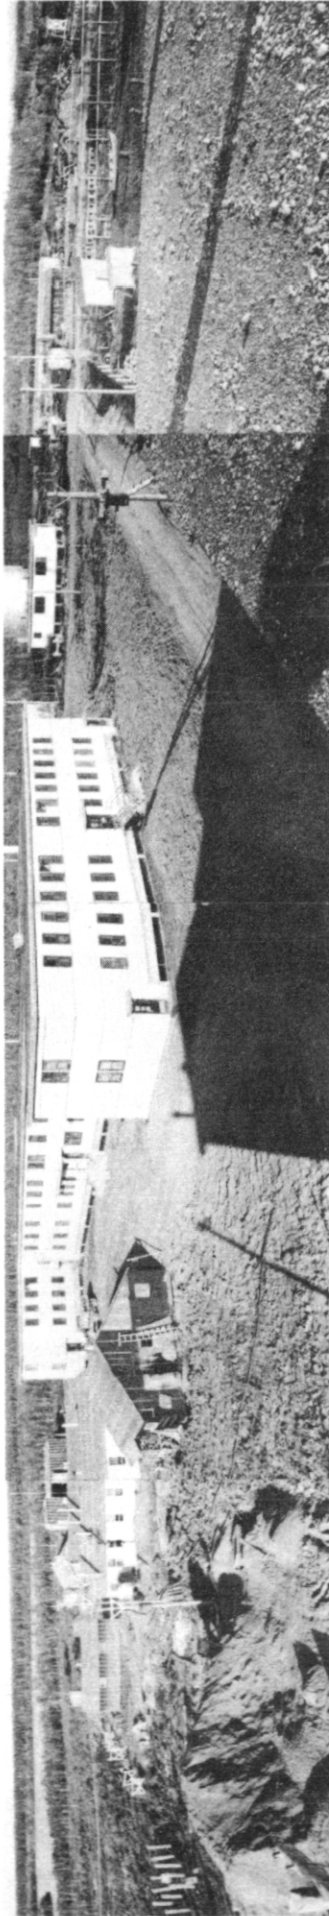
Fig. 3 View southeast showing front elevation of completed hostel. Note teacherage in background (center-right). June 1958.
