## Management of groundwater discharge for the solution of icing problems in the Yukon

R.O. VAN EVERDINGEN

Proc. 4th Can. Permafrost Conf. (1982)

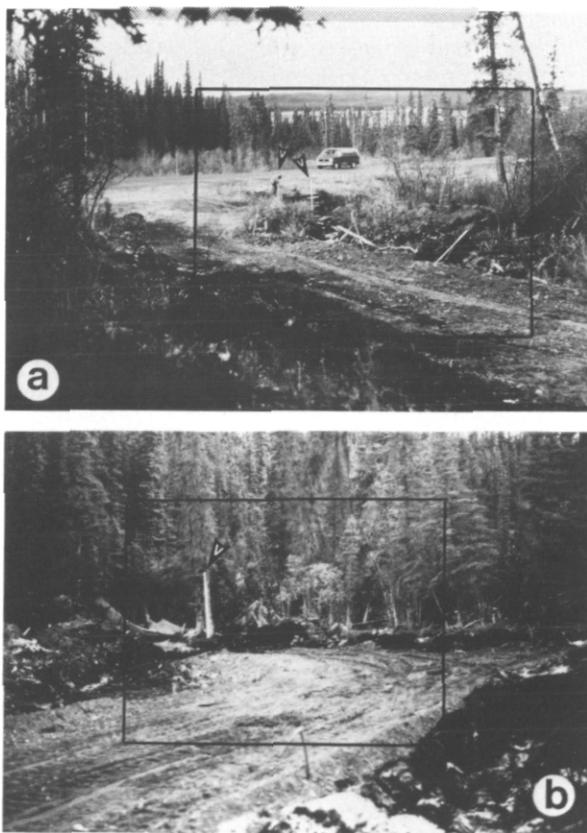
time-lapse camera systems of the type described by Banner and van Everdingen (1979) were installed at the site on October 2 and 3, 1979 (see Figure 10 for locations). The cameras were set to expose three frames once a day, at solar noon. Staff gauges were installed as reference points and scales for measurement of ice build-up (two gauges, 2.5 m long, at the culvert, shown in Figure 6a; one gauge, 3 m long, against a tree at the edge of the forest about 100 m upstream from the culvert, shown in Figure 6b).

FIGURE 6. Staff gauges at **a** the Burlap creek culvert, and **b** the edge of the forest, October 2, 1979. Frame lines indicate areas photographed by the time-lapse cameras.

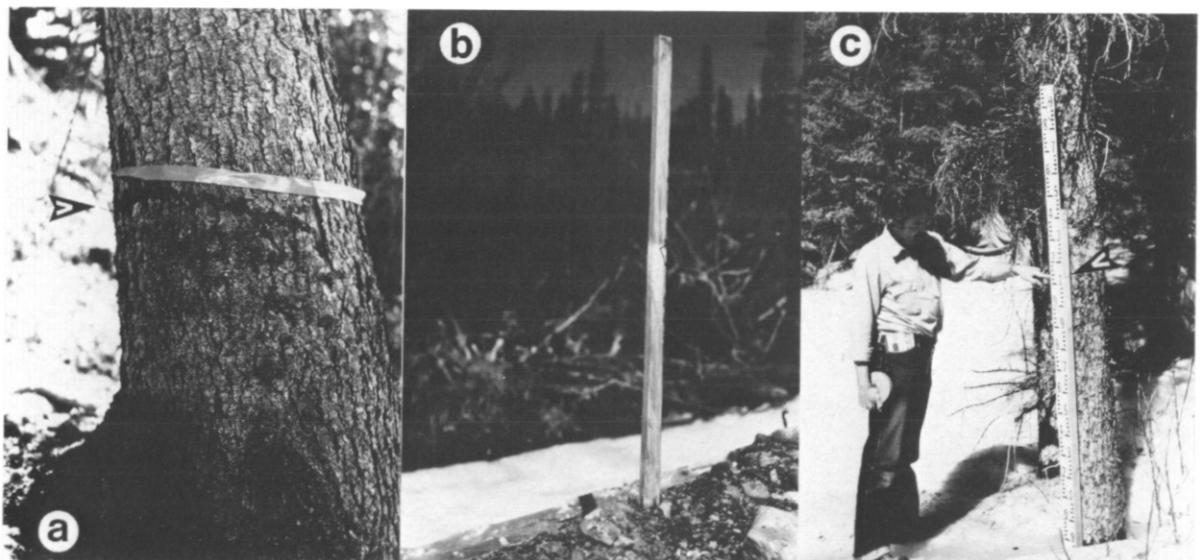
During visits to the site on March 26 and 27, 1980, nails were driven into a number of trees and posts, at the level of the surface of the icing, to enable measurements of ice thickness to be made after melting of the ice. The trees thus marked were identified with flagging tape (Figure 9a).

The ice thicknesses of March 26 and 27, represented by the nails, were measured on September 9, 1980. At that time it was found that some of the trees showed "scars" at the maximum ice level (see arrow in Figure 9a), presumably as a result of vertical movements of the ice caused by build-up of

FIGURE 9. Ice level markers: a flagged nail in tree with icing scar; b nail in post of burlap fence showing discolouration of wood at maximum ice level; c staff gauge with discolouration of support showing maximum ice level.

groundwater pressures. Evidence of maximum ice levels was also discernible on the posts and on the lumber used as supports for the three staff gauges installed in October 1979 (light discoloration just above the nail in the post shown in Figure 9b and on the support of the staff gauge in Figure 9c, at a level of 2.14 m on the gauge).

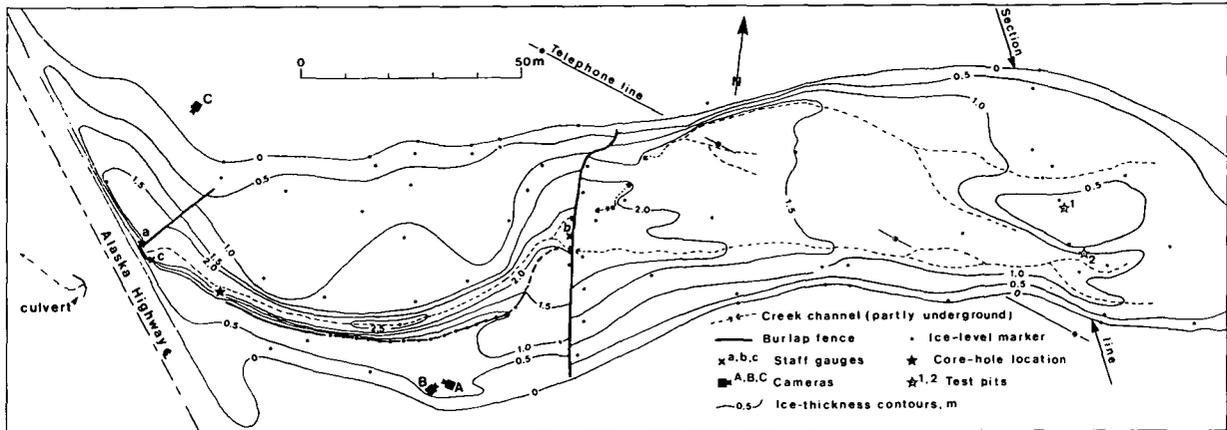
FIGURE 10. Contour map of thickness of the Burlap creek icing, from survey on March 26 and 27, 1980. Section see Figure 13.

Highway maintenance personnel from Destruction Bay have indicated that the icing build-up at Burlap creek during the 1979/1980 winter was not the largest observed at this site. The approximate volume of the icing (see Figure 10) was 14,000 m<sup>3</sup>. This volume accumulated over a period of approxi-

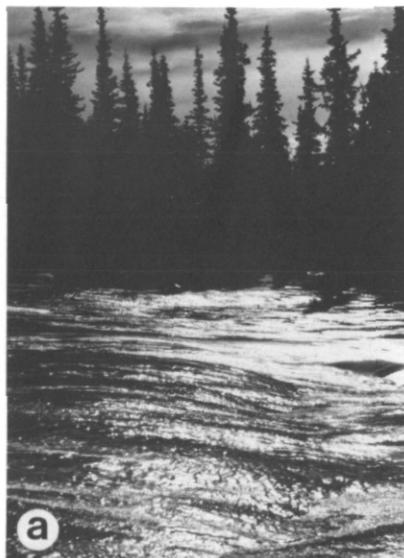
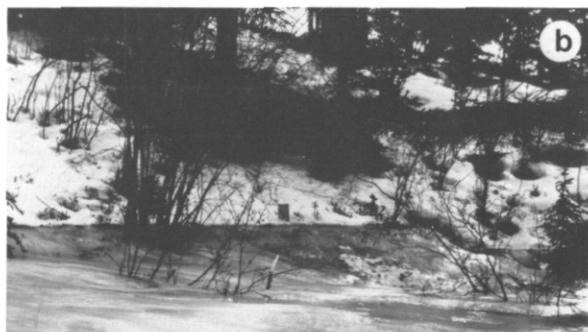
During late night and early morning little or no water was flowing over the surface of the icing. The limited flow that did take place appeared to move primarily through openings between the upper layers of the icing; water that emerged onto the surface froze quickly, within a short distance of its point of emergence. By the end of the morning, widespread flow over the icing gradually became established (Figure 11a). It was found that much of this flow reached the surface of the icing through fractures in icing mounds and along the stems of shrubs and bushes. This phenomenon, described earlier by Johnson and Esch (1977, p. 119), was also

FIGURE 11. Observations of icing activity, March 26, 1980: a water flowing over ice; b elevated ice formed in snow along lateral edge of icing.

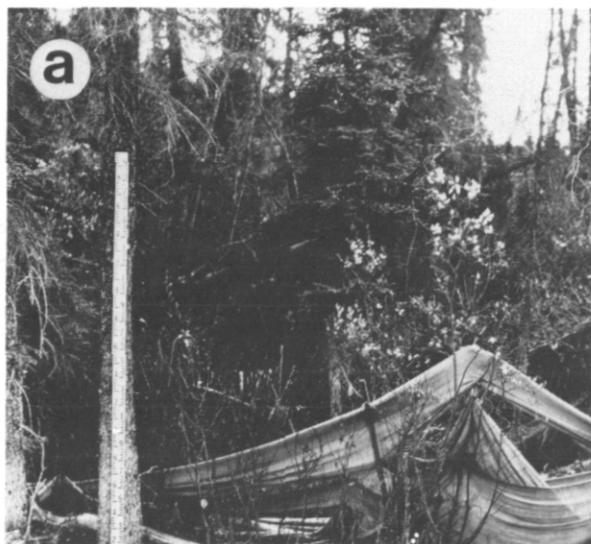
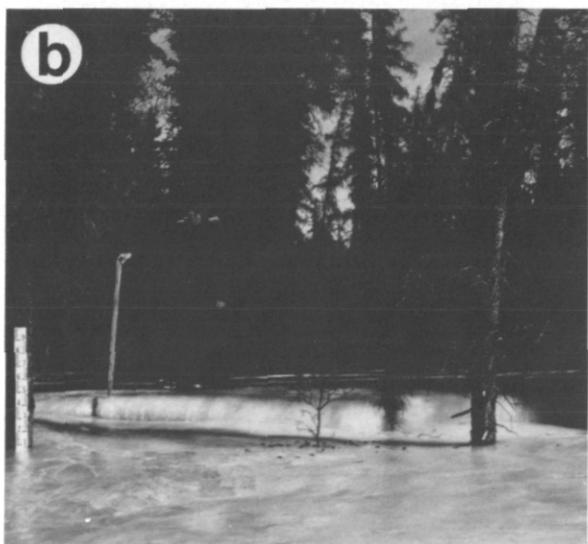
FIGURE 12. Effect of burlap fence: a staff gauge b with old burlap fence in background (Oct. 2, 1979); b frozen “fall” over buried burlap fence behind staff gauge b (March 26, 1980).

The effect of the main burlap fence across Burlap creek (Figure 12a) could still be seen on March 26, although the time-lapse photography indicated that the fence had been overtopped by ice on February 7. A frozen "fall", 40 cm high, was found slightly downhill from the position of the buried fence behind staff gauge b (Figure 12b). After all the ice had melted, the March 27 ice-level markers revealed that the ice in front of the fence had been 2.0 m thick, whereas that behind the fence was slightly over 2.4 m thick. The frozen fall had gradually been displaced in a downhill direction from the location of the fence, as ice accumulated above, on the front of, and below the fence. If icing activity had continued longer, the fall would eventually have been eliminated by the more rapid accumulation of ice at its base.

Present methods of icing control have a number of drawbacks that vary in significance, depending on local conditions. Calcium chloride, used during the early part of the icing season, and diesel fuel leaking from thaw-barrel installations both contaminate the lower reaches of the streams on which they are used. In some icing areas the vegetation is extensively damaged by seasonal drowning, by vertical movements of the icing ice, and through trimming during ice-removal operations. Some sites are littered by the remains of burlap fences (see Figure 12a).

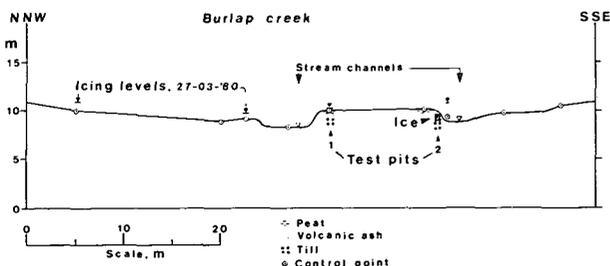
Test pit No. 1 penetrated 25 cm of peat, 25 cm of mixed peat and volcanic ash, 2 cm of clean ice, and 15 cm of water-saturated mixed silt and volcanic ash; it was terminated 15 cm into a layer of saturated sandy gravel ("washed" till?). Test pit No. 2 penetrated 30 cm of peat, 40 cm of mixed peat and volcanic ash (with thin ice lenses in the lower 5 cm), and 75 cm of clean ice; it was terminated in saturated sandy gravel ("washed" till?). The grain-size distribution in a sample of the sandy gravel was presented earlier (see Figure 2). The mixing of peat and volcanic ash observed in the test pits is post-deposi-

A low cavity (4 to 6 cm high) was found to extend horizontally between the ice and the underlying sandy gravel in test pit No. 2. This cavity could have been formed by slow melting of the base of the ice by heat from the water moving through the sandy gravel, or it could be a remnant of the cavity of a frost blister. The positions of the March 27 ice-level markers, relative to each other and relative to the ground surface along the section (see Figure 13), appear to indicate that a large, low frost blister may have existed here during the 1979/1980 winter. Such a frost blister was described by Eager and Pryor (1945, p. 64) from another icing area along the Alaska Highway. Diagnostic criteria for the recognition of frost blisters, as well as a description of their seasonal development have been published by van Everdingen (1978).

FIGURE 13. Section across Burlap creek about 215 m upstream from the highway culvert, showing ice levels on March 27, 1980 and subsurface data from two test pits.

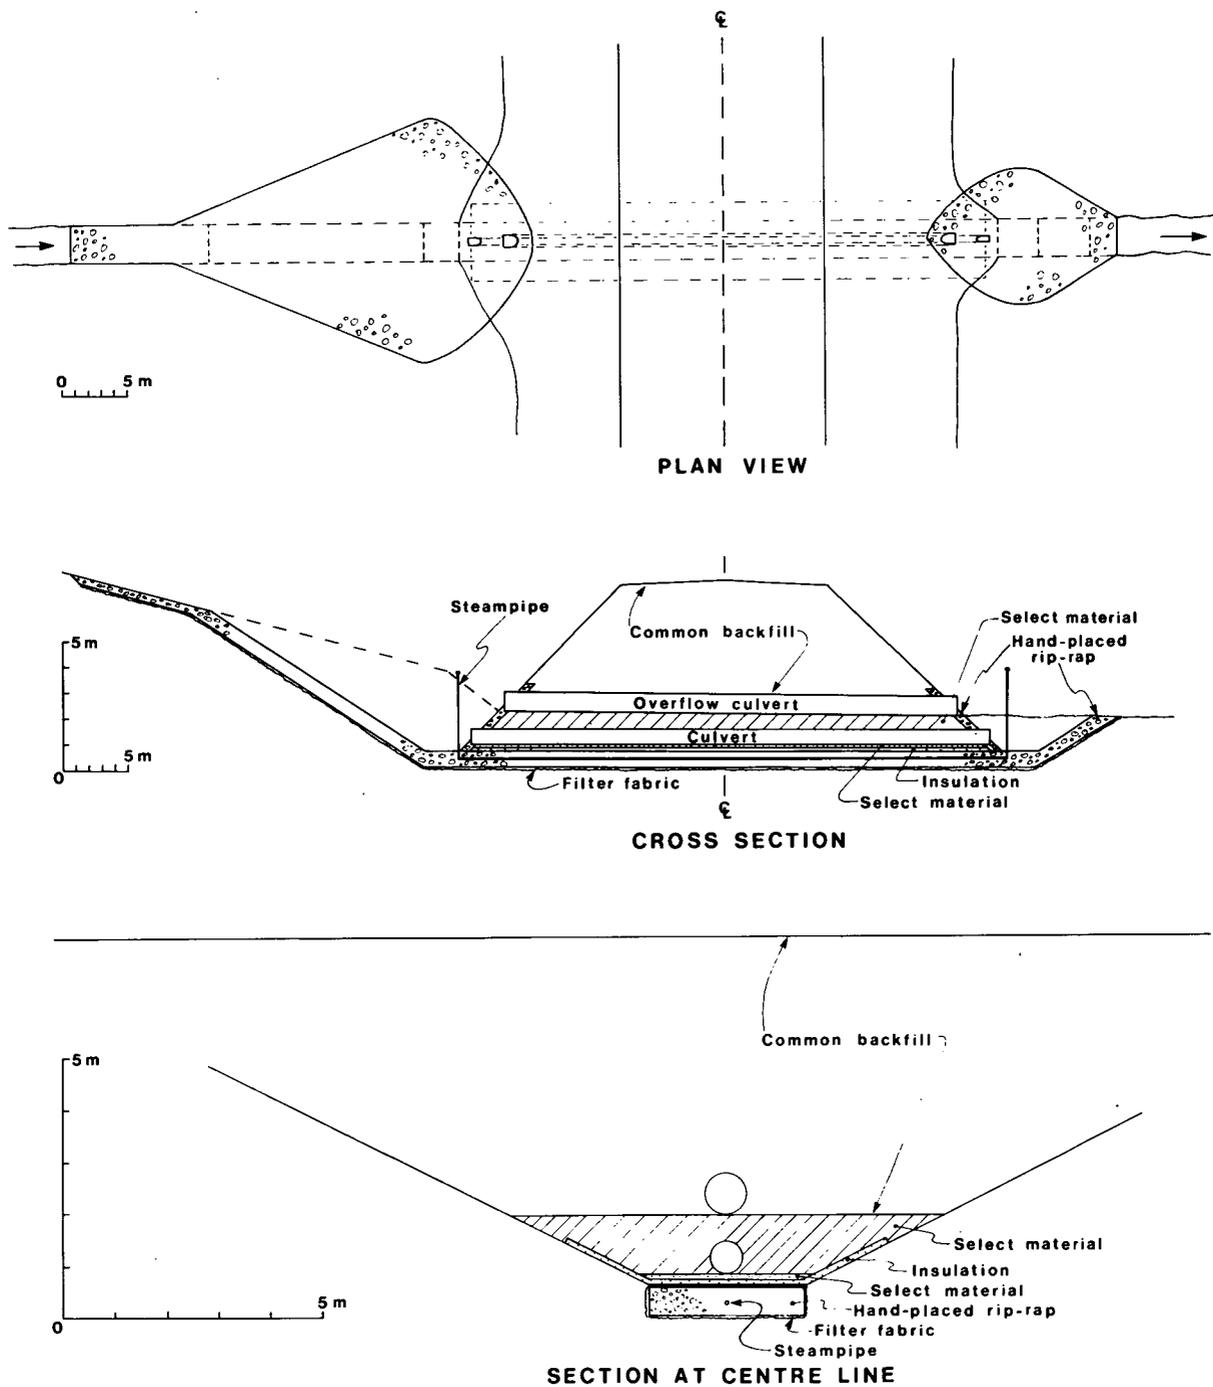
FIGURE 14. Subdrain and culvert installation for groundwater-fed icing sites, modified from a design used on the Haines Road about 3 km south of Haines Junction (modified after Public Works Canada).

In view of the existing plans for the reconstruction of portions of the Alaska Highway, a more practical choice for the solution of icing problems at sites like km 1817.5 could be the installation of subdrains. For this method to be effective, springs and diffuse groundwater seepage would have to be intercepted close to their source, with lateral subdrains installed below the level of seasonal frost if possible (Johnson and Esch 1977, p. 124).

short rock-filled subdrain below the base of the highway embankment with small ponding basins at both ends to prevent freezing of either inlet or outlet (Figure 14), was recently installed in a tenacious icing area on the Haines Road, about 3 km south of Haines Junction. This system performed well during the 1979/1980 and 1980/1981 icing seasons. It could be an attractive alternative for some icing sites where the installation of a complete system of subdrains and laterals, such as suggested by Johnson and Esch (1977), or the provision of an "ice-storage" area are impractical.
