## Solution to frost heave of ice arenas

C.E. LEONOFF AND R.C. LO

Proc. 4th Can. Permafrost Conf. (1982)

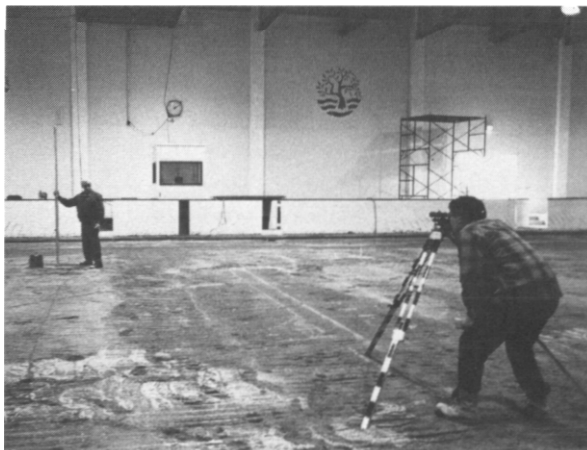
The ice surface was first removed by melting. The investigation consisted of a levelling survey of the surface of the sand bedding (Figure 1) and the digging of test pits through the sand and gravel base courses into the native subsoils.

FIGURE 1. Levelling survey for determining frost heave.

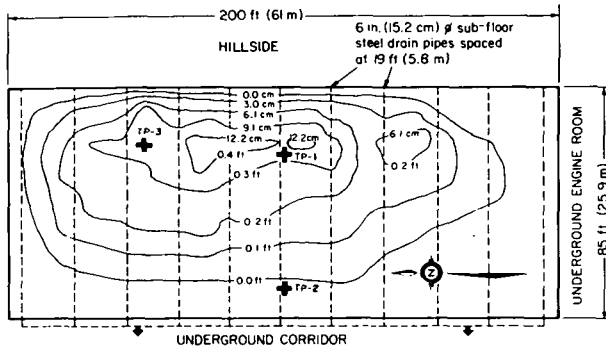
NOTES: Heave contours are interpolated between survey points spaced at 10 ft (3 m) intervals and are expressed in feet and centimeters.

TP-1, TP-2, and TP-3 are locations of test pits.

FIGURE 2. Skating rink — contours of heave.

The contours of the heaved surface as surveyed in April 1974 are shown (Figure 2). The heaved area located in the north-east portion covered slightly over 50 per cent of the total rink. Heat from an underground corridor and engine room had kept an L-shaped area in the south-west portion free of frost heaving. The heaved surface assumed the shape of a gentle ridge, high at the peaks and feathering out at the edges; it was approximately elliptical with dimensions of 150 ft (45.7 m) by 60 ft (18.3 m). The measured heave averaged about 3 in. (7.6 cm) but reached a maximum of 5.5 in. (14 cm) at the peak area. Since an additional 2.5-in. (6.4-cm) thick sand layer had been removed from the peak of the heaved area during the previous maintenance, the maximum heave was in the order of 8 in. (20.3 cm).

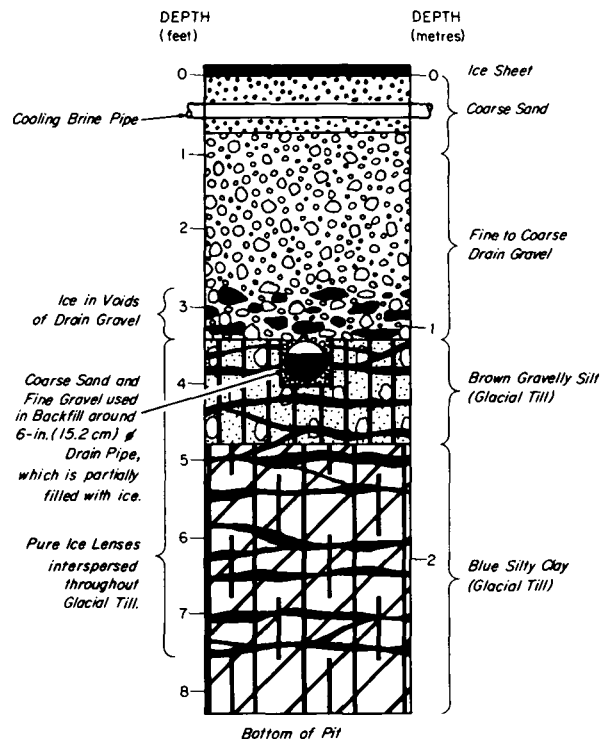
The typical subsoil section, as revealed in test pit TP-1 (Figure 3), consisted of a surface layer of 6- to 8-in. (15.2- to 20.3-cm) thick, coarse sand bedding overlying a layer of 3- to 4-ft (0.9- to 1.2-m) thick, fine-to-coarse drain gravel. The natural subsoil

beneath the base course ranged from brown gravelly silt to brown and blue silty clay. The free-draining sand and gravel base course was relatively ice free, although ice had formed from back-up water where drainage was impeded by inadequate backfill. However, the top 4 ft (1.2 m) of natural subsoil contained reticular pure ice lenses embedded within the subsoil, which were the source of the heave.

FIGURE 3. Subsurface section of frost-damaged ice rink.

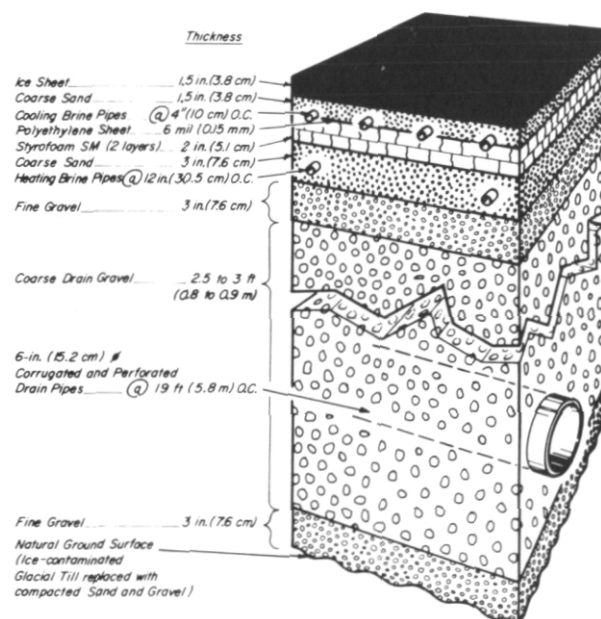
FIGURE 4. Perspective through reconstructed ice rink

In general, the remedial measures involved excavating and wasting the full depth of the frozen soil and replacing it with granular backfill under careful control of the grain-size and density. Where existing base course material and piping could be used suitably in the reconstruction, it was removed and stockpiled temporarily inside and outside the rink. The corrective action (Figure 4) included the following steps:

3. To eliminate future heave, a thermal barrier were placed at foundation level to prevent passage of the frost from the cooling pipes through to the subsoil. This involved installing an insulating medium plus an active heating system. Heating systems considered for the project included mineral-insulated electrical heating cables, warm air, and warm brine. Based on a heat-transfer analysis of the problem and practical considerations, the authors designed a heating system, involving the circulation of warm brine through plastic pipes embedded in a sand layer under the rink. The brine is warmed by drawing waste heat from the refrigeration plant. Studies showed this system to be safer and far more economical in operating costs than a conventional heating system using electrical cables. A warm-air system was ruled out because of insufficient space in this rink for air ducts and/or a raised floor.

4. Two layers of styrofoam SM insulation were placed above the heating system to thermally separate it from the ice-making system above, which consisted of conventional plastic cooling pipes containing cold brine within a sand layer below ice level.

The heating and cooling brine pipes were embedded within suitably graded sand courses with sandwiched insulation layers separating the two systems (see Figure 4). The entire installation was placed within the top 9.5 in. (24.1 cm) of subsurface profile. The heating brine pipes were installed on the prepared sand surface (Figure 6) at intervals of 1 ft (0.3 m) on centre and connected to header pipes located at the south end of the rink near the engine

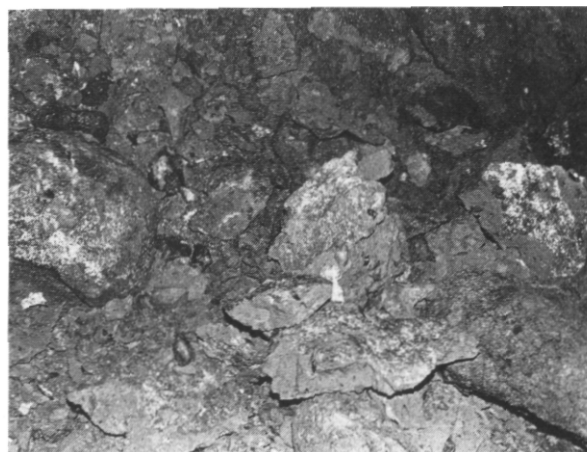
FIGURE 5. Ice lenses in subsoil.

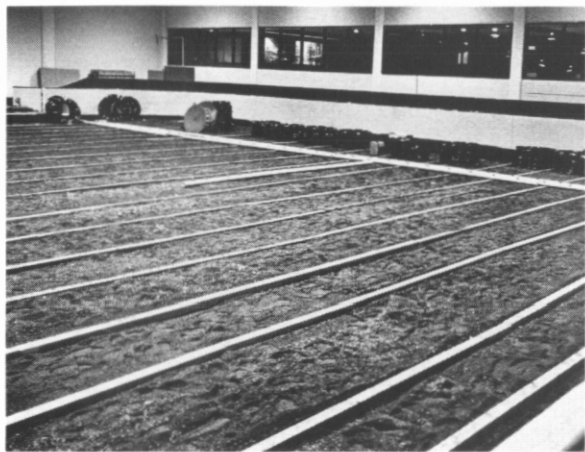
FIGURE 6. Sand surface ready for placing heating brine pipes.

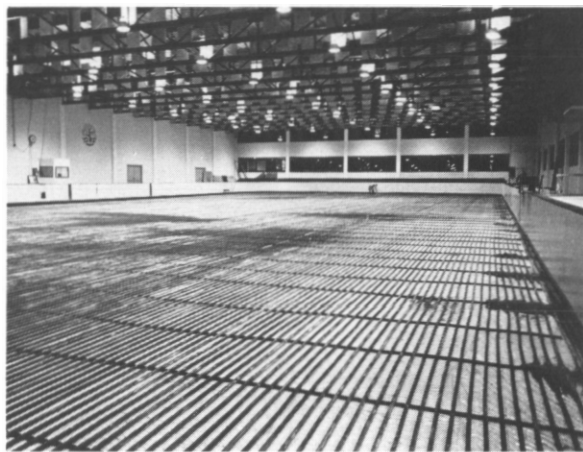
FIGURE 7. Cooling brine pipes placed over polyethylene sheet.

The cooling brine pipes were, in turn, placed directly over the polyethylene sheet (Figure 7). To save replacement costs in the order of \$10,000 for this 10-mile (16-km) long system of pipes spaced at 4 in. (10.2 cm) on centre, a decision was made to re-use the cooling pipes rather than to replace them. However, this decision resulted in some additional construction and maintenance problems. While the problems were annoying, the cost to repair was much less than to install completely new pipes. These plastic pipes were becoming brittle with age so that the inevitable bends and kinks during handling and storage in a limited work area caused weakness and breaks. Any pipe containing a visible defect was replaced by a new section. When the whole system was in place, it was tested at 60 psi (413.7 kPa) pressure instead of the normal operating pressure of 33 psi (227.5 kPa). In those few instances where major leaks occurred a geyser-like spring developed which although quickly repaired, contaminated an area of sand with salt water. The contaminated sand had to be completely re-

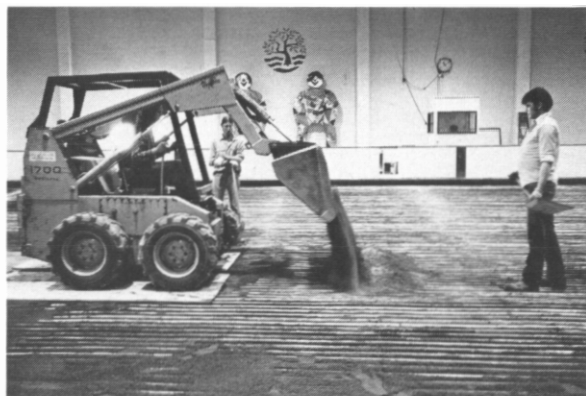
FIGURE 8. Placing sand over cooling brine pipes.

After the cooling pipes were installed and pressure tested, the sand topping layer was carefully placed by a rubber-tired front-end loader (Figure 8). To prevent damage, the weight of the loader was distributed over the pipes using plywood boards. The final sand surface was screeded by hand and the ice sheet was formed over this smooth and level sand surface.
