The Trans-Alaska Pipeline System workpad — an evaluation of present conditions

Proc. 4th Can. Permafrost Conf. (1982)

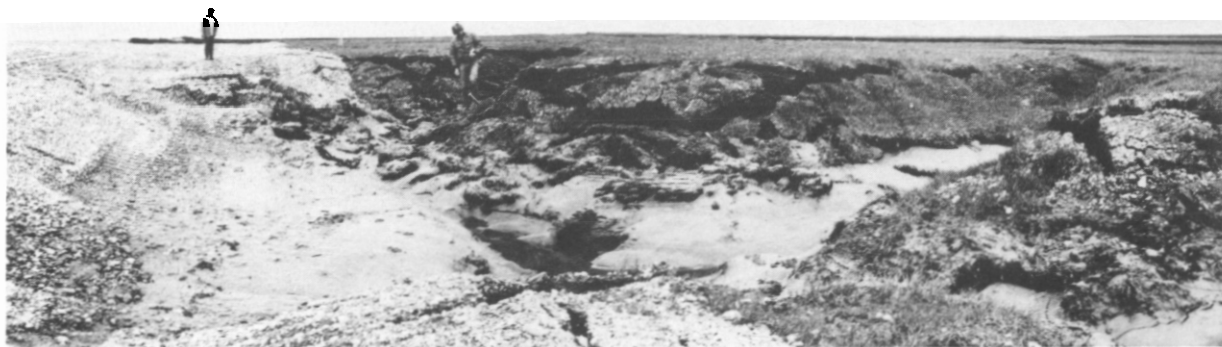
FIGURE 1. Massive sinkhole adjacent to the buried pipeline. This is a polygonal ground area where the workpad and pipeline intersect ice wedge.

create what appears to be a continuous thermokarst feature across the entire workpad and pipe trench area (see Figure 1).

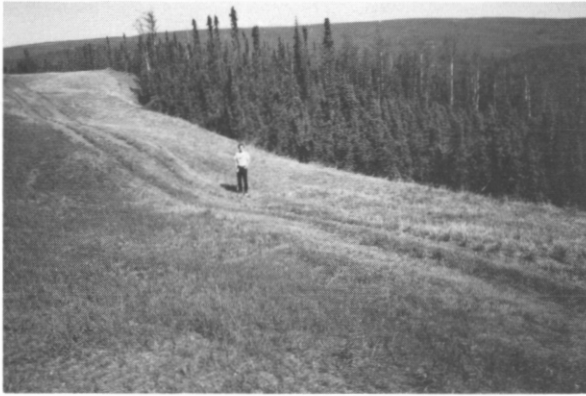
FIGURE 2. Thermokarst depression encompassing the travel lane of the workpad.

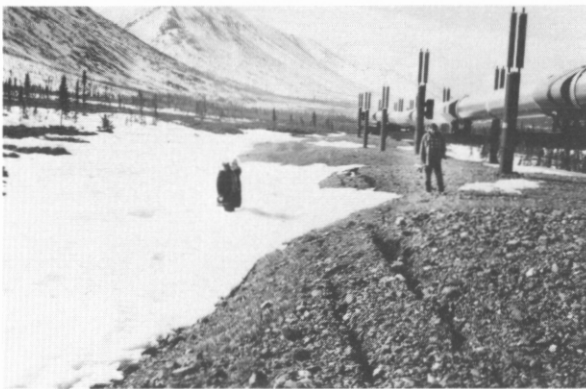
FIGURE 3. Differential settlement of the workpad in an elevated pipeline segment.

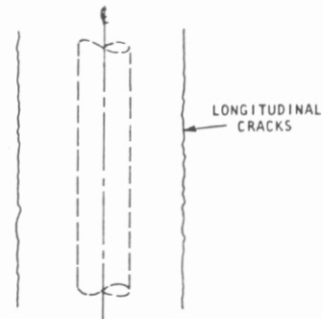
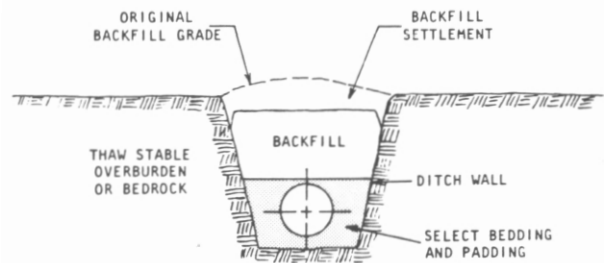
When the ditch backfill material adjacent to the workpad has settled below the adjacent native soils, longitudinal cracks develop at the edges of the former trench (Figure 4). The settlement is typically due to poor compaction of the ditch backfill or thawing of a backfill material which was placed in a frozen state (Figure 5). Although this type of distress does not materially affect the trafficability of the workpad, it can aggravate drainage and erosion problems proximate to the pad. When ice-rich overburden soils thaw and settle adjacent to a ditch backfilled with granular material, a mounding condition over the buried pipe is observed with longitudinal cracks at both the edge of the former trench and the limits of the thaw bulb. Longitudinal tension cracks may also be present over pipe centreline due to loss of backfill side support (Figure 6). Typically the pipe is founded in an

FIGURE 4. Settlement of ditch backfill material

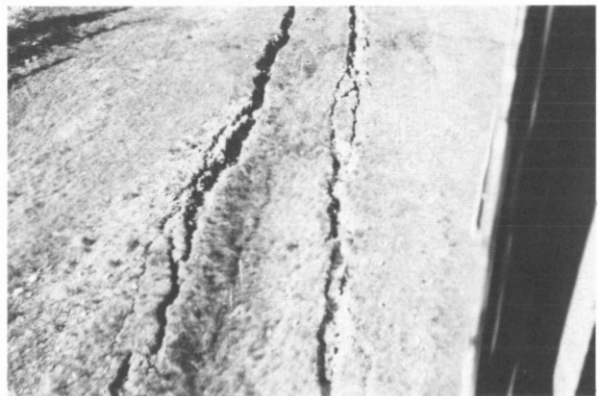
FIGURE 5. Cracking adjacent to a buried pipeline with a depressed area over pipe centerline.

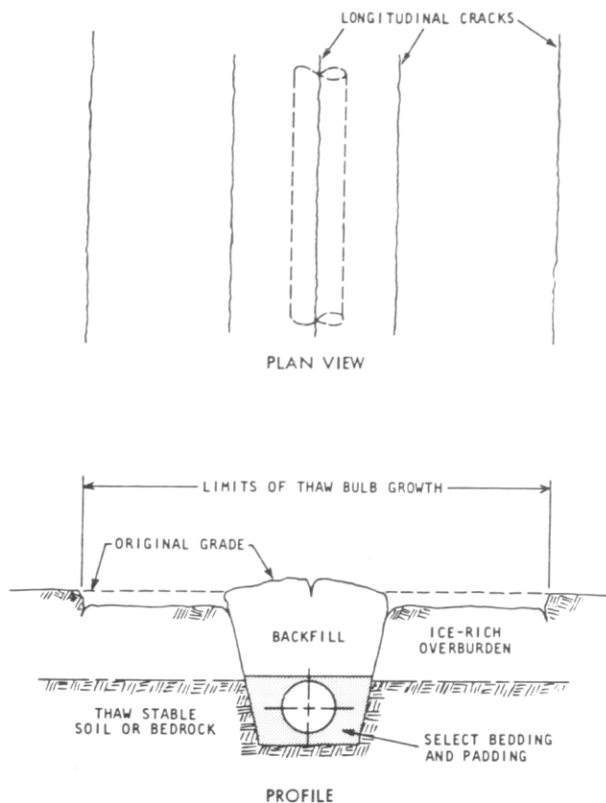
underlying stratum of thaw-stable soil or bedrock and the observed differential settlement is due to the thaw bulb advancing through the ice-rich overburden (Figure 7). Continued growth of the thaw bulb in these ice-rich overburden areas results in almost complete loss of trafficability of the workpad.

FIGURE 6. Thaw settlement of ice-rich overburden.

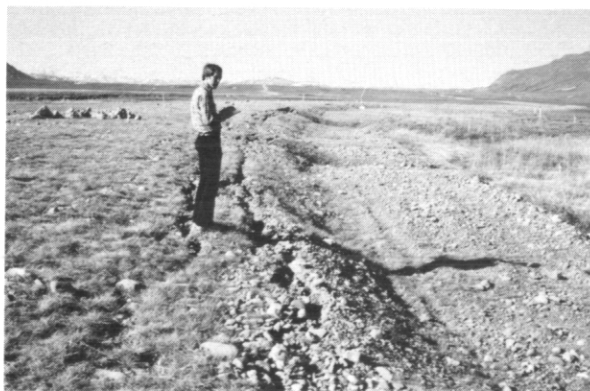
FIGURE 7. Cracking adjacent to a buried pipeline with mounding over pipe centreline.

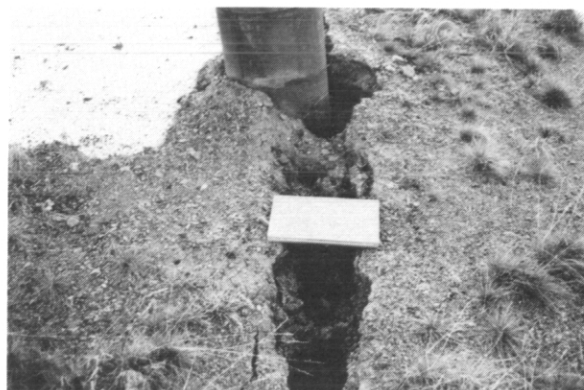
Lateral movement of the workpad was observed on cross-sloping ground. This was evidenced by longitudinal cracking and mounding on the uphill side of the vertical support members (Figure 8). This distress occurred where frozen fine-grained soils with high moisture content were thawing below the workpad embankment.

FIGURE 8. Lateral workpad movement on a cross slope with resulting mounding on the uphill side of the vertical support member and a gap on the downhill side.

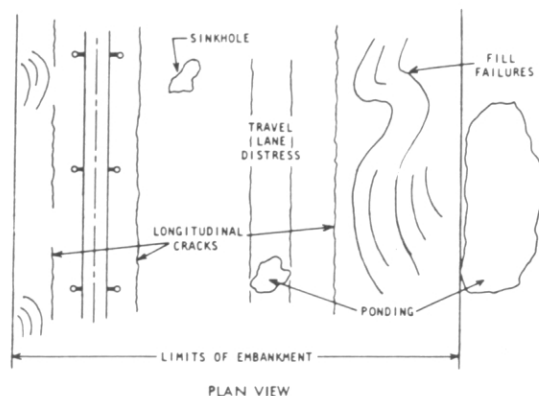
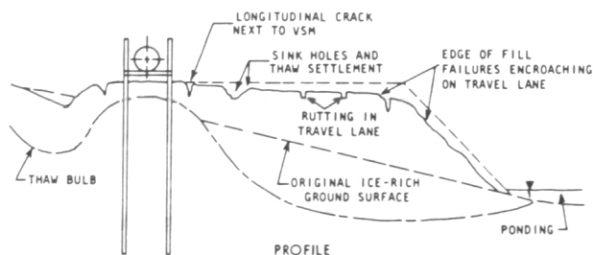
FIGURE 9. Differential thaw settlement and fill failures.

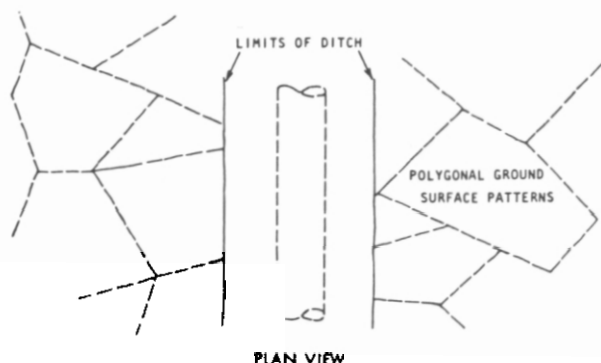
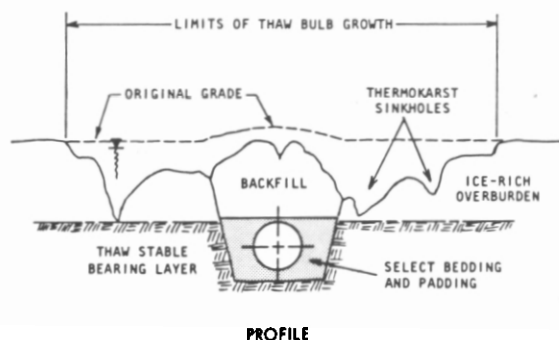
FIGURE 10. Melting of massive ice wedges in overburden.

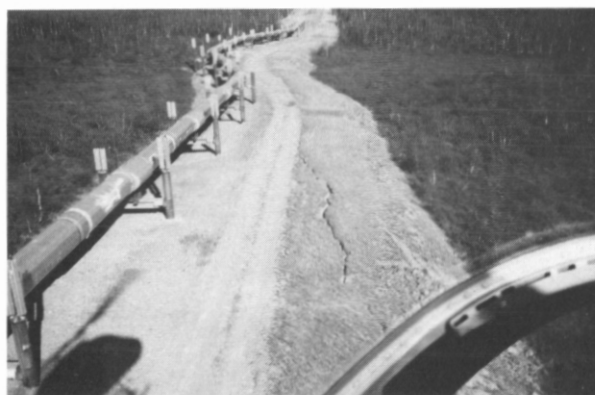
Tension cracks were observed in both buried and elevated segments of the alignment. In areas of buried pipeline, the cracks were either adjacent to a depression over the pipeline or adjacent to mounding over the pipeline. In elevated segments, the cracking was observed at various locations on the workpad but

FIGURE 11. Longitudinal tension cracks on the workpad in an elevated segment of the pipeline.

predominantly in the longitudinal direction (Figure 11).

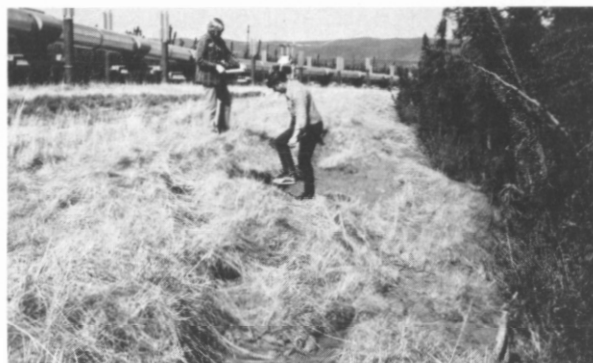
Edge of workpad failures in the form of ravelling fill slopes, minor rotational slumping of fill slopes, and mudflows on saturated pad material were inspected. These minor failures were encroaching on the travel lane of the workpad at several locations. Figure 12 illustrates an edge of workpad mudflow.

FIGURE 12. Edge of workpad mudflow failures. Saturated fine-grained workpad material.

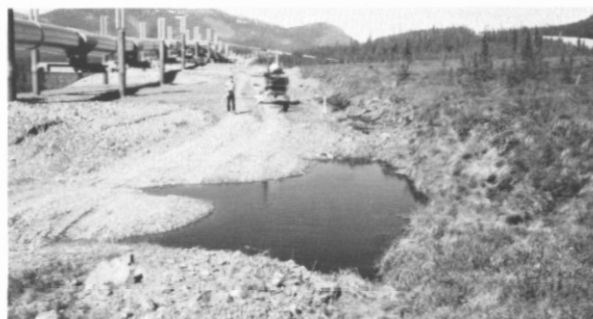
FIGURE 13. Ponding on, and adjacent to, the workpad in an elevated pipeline segment.

served at many locations (Figure 13). Saturation of the workpad, especially in areas of ponding and workpad subsidence, have reduced trafficability even for light, wheel load vehicles (Figure 14).

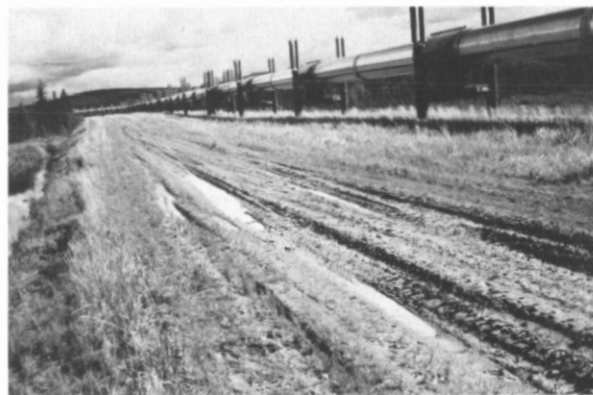
FIGURE 14. Soft, saturated, and badly rutted workpad.
