Impact of groundwater flow on permafrost degradation: implications for transportation infrastructures

I. de Grandpré^{1,2}, D. Fortier^{1,2,3} and E. Stephani^{2,3,4}

¹ *Département de Géographie, Université de Montréal, Québec, Canada*

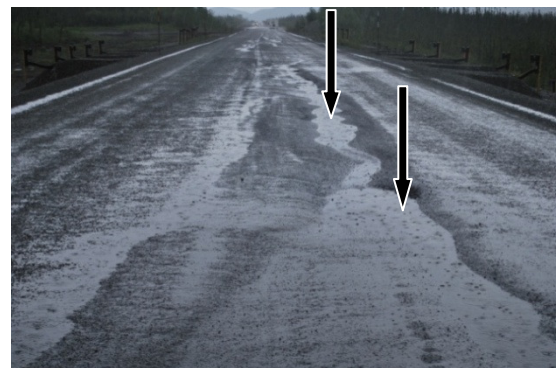
When the ground is ice-rich, thawing of permafrost usually induces thaw-settlement, ground subsidence, surface disturbance and changes in drainage conditions. Transportation infrastructures built on permafrost are particularly sensitive to permafrost stability (Allard et al. 2007). Melting of ground ice and consolidation of thawed soil promote road embankment subsidence and the development of cracks, potholes and depressions in the road pavement (Figure 1) (Qingbai et al. 2002).

Figure 1. Depressions in the road (black arrows) at the study site are outlined by water accumulation during a rain event. The road is 15 m wide.

During the summer 2008 and 2009, measurements of depressions on the road surface indicate that road subsidence was in the order of 30 cm each summer.

Repetition of groundwater flow under the road over the years increases permafrost degradation and explains the important depressions and cracks observed in the road surface at the study site. Observations of water flow in October 2009 when the upper portion of the active layer was frozen suggest that this process remains active for extensive periods of the year.

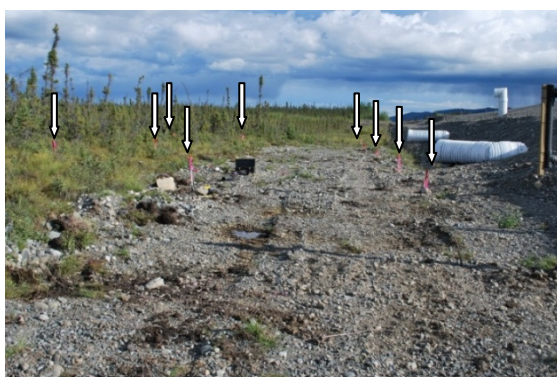
Figure 3. Piezometer network (wooden stakes under arrows) on the northern side of the road. The white horizontal and vertical pipes in the background are mitigation measures to control permafrost degradation (see Fortier et al. for details in these proceedings)

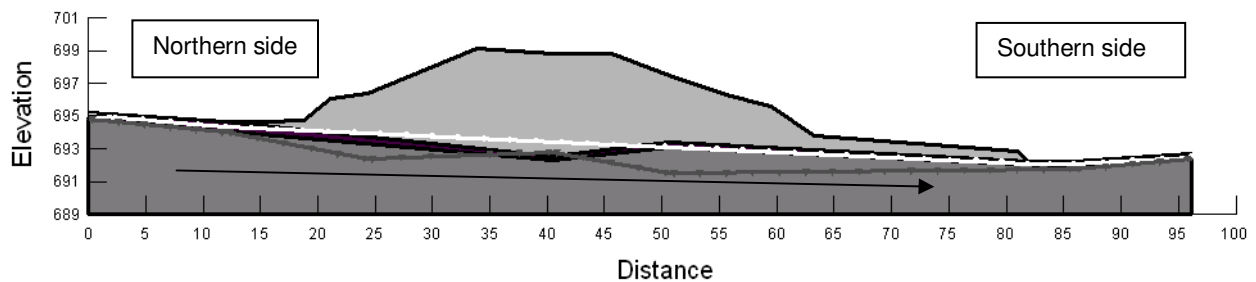
Figure 5 shows a schematic cross-section of the road and underlying natural ground at the study site. As a result of permafrost degradation, the road embankment has subsided in the thawed natural ground (peat and silt) and the embankment material is now located under the natural ground surface and therefore intersects the water table and groundwater flow paths.

Figure 5. Cross-sectional transect of the road embankment and the underlying natural ground. Light grey: embankment material, black: peat, dark grey: silt. The upper dotted line represents an interpolation of water table and the lower one is an interpolation of the permafrost table. The arrow shows the general direction of groundwater flow.

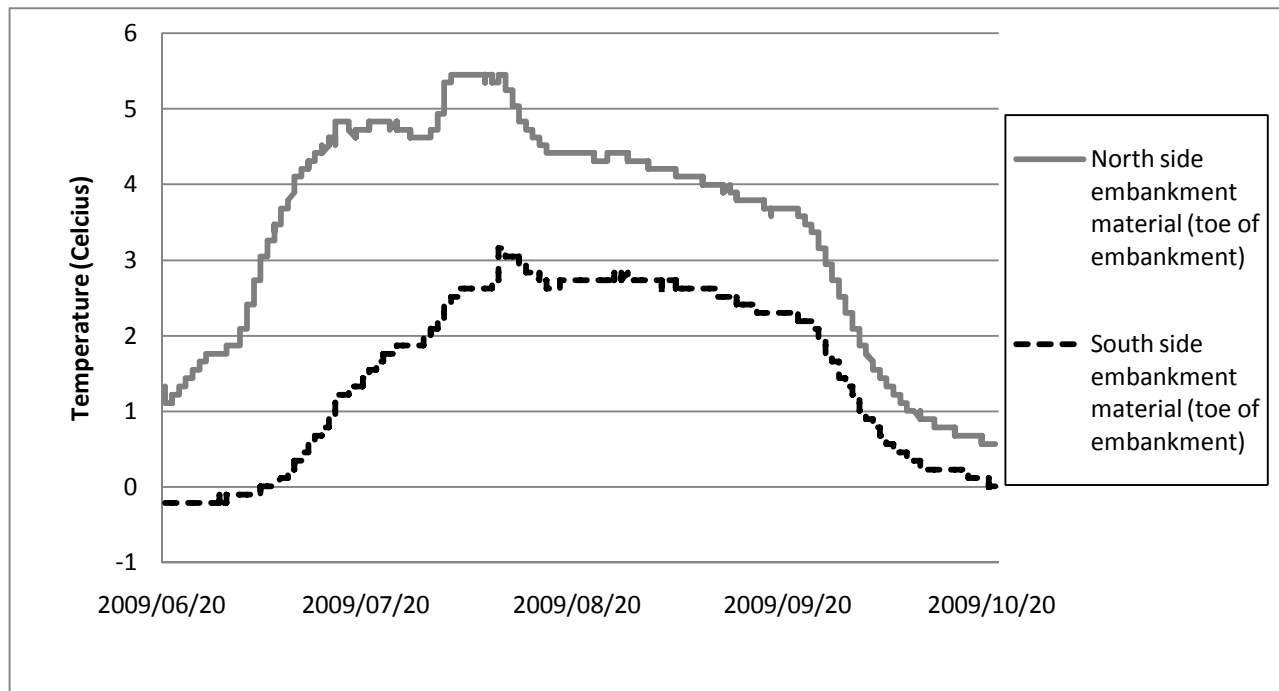
Figure 6 shows temperature data recorded by pore water pressure and temperature sensors from June to October 2009 on both side of the road and under the road side slopes along a transect. Water temperatures on the northern side of the road are higher than on the southern side by 2 to 4 °C.

Figure 6. Water temperature profiles along transect 3 (Figure 4) between June and August 2009. Note the difference of water temperature between the northern and southern sides of the road, indicating that water is transferring heat to the surrounding ground as it flows under the embankment.

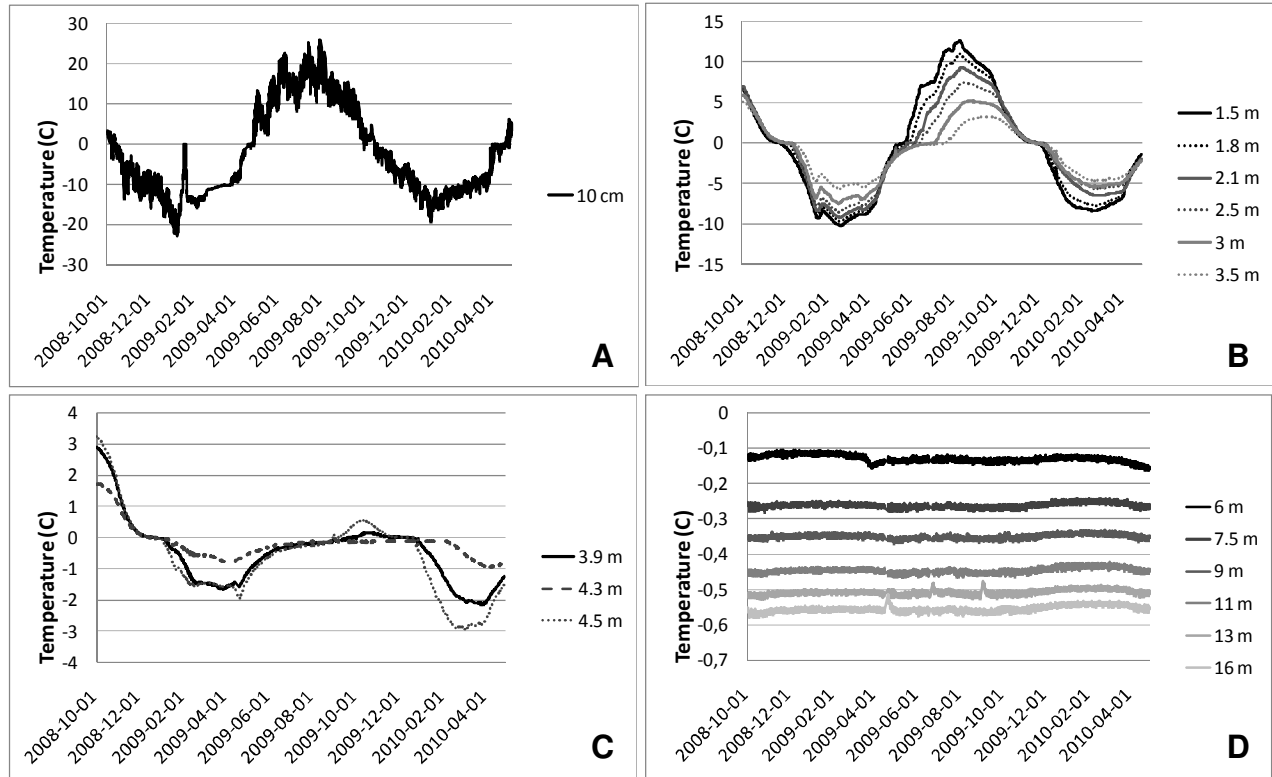
Temperature data from thermistor cables between 0.1 m and 3.5 m show very concordant trends (Figure 7A, B). Temperatures profiles at depths of 3.9 and 4.5 m are

similar and stay in isothermal condition very close to 0 °C from June 2009 to January 2010. Temperature profile at depth of 4.3 m has less amplitude and stays in isothermal condition around 0 °C for four months longer. Temperatures at a depth of 6m and lower remained under 0 °C all year (7D). Note that temperatures in the depth interval 6 to 16 m are decreasing with depth.

Figure 7. Temperatures recorded by thermistors cable at various depths between October 2008 and April 2010. A: Depth of 0.1m. B: Embankment (1.5 to 3.5 m). C: Interface embankment-natural ground (3.9 to 4.5 m). D: natural ground (6 to 16 m).
