**THURBER CONSULTANTS LTD.**

RE: GRANULAR RESOURCES MANAGEMENT STUDY  
SOUTH SLAVE REGION (DSS FILE: 38ST.A0632-6-5023)

In accordance with the contract for the above study, we are pleased to submit this photo album for your information. It provides documentation of the granular sources visited during the recent field reconnaissance.

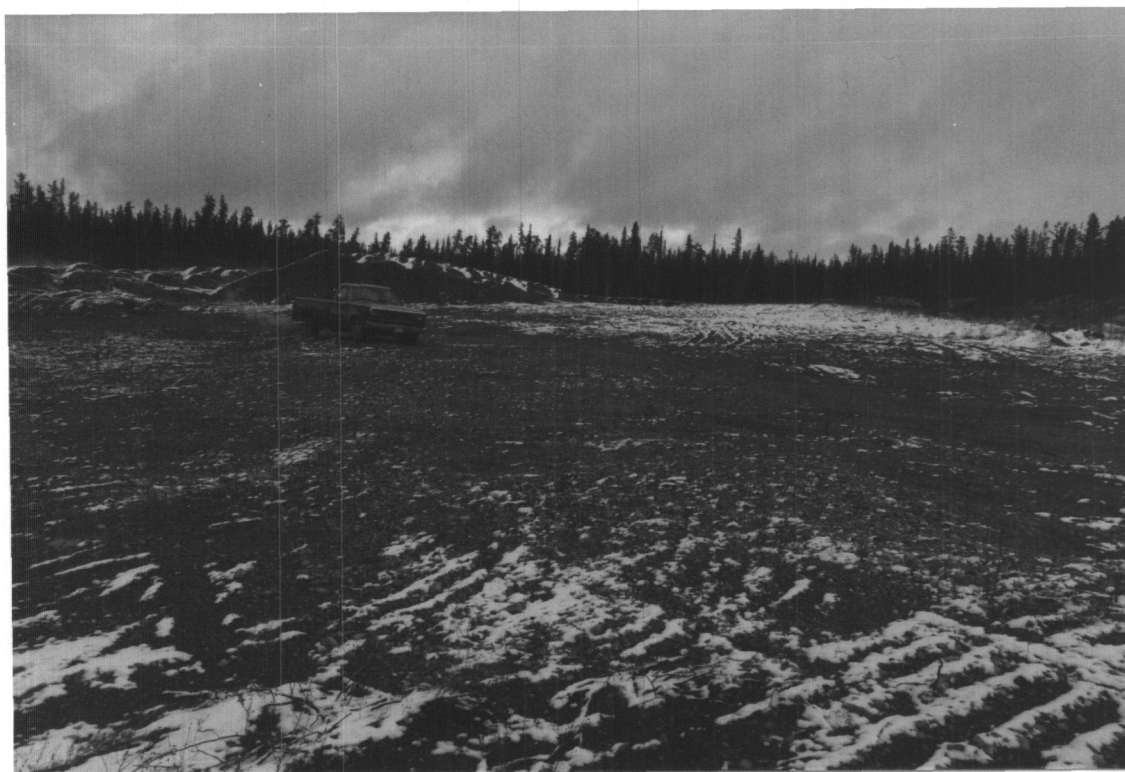
PHOTO 1: Foxhole South (Bertons') Pit Deposit 5-69. View to northeast along axis of pit, showing stockpiles of sandy gravel on left and windrows of restoration materials on right.

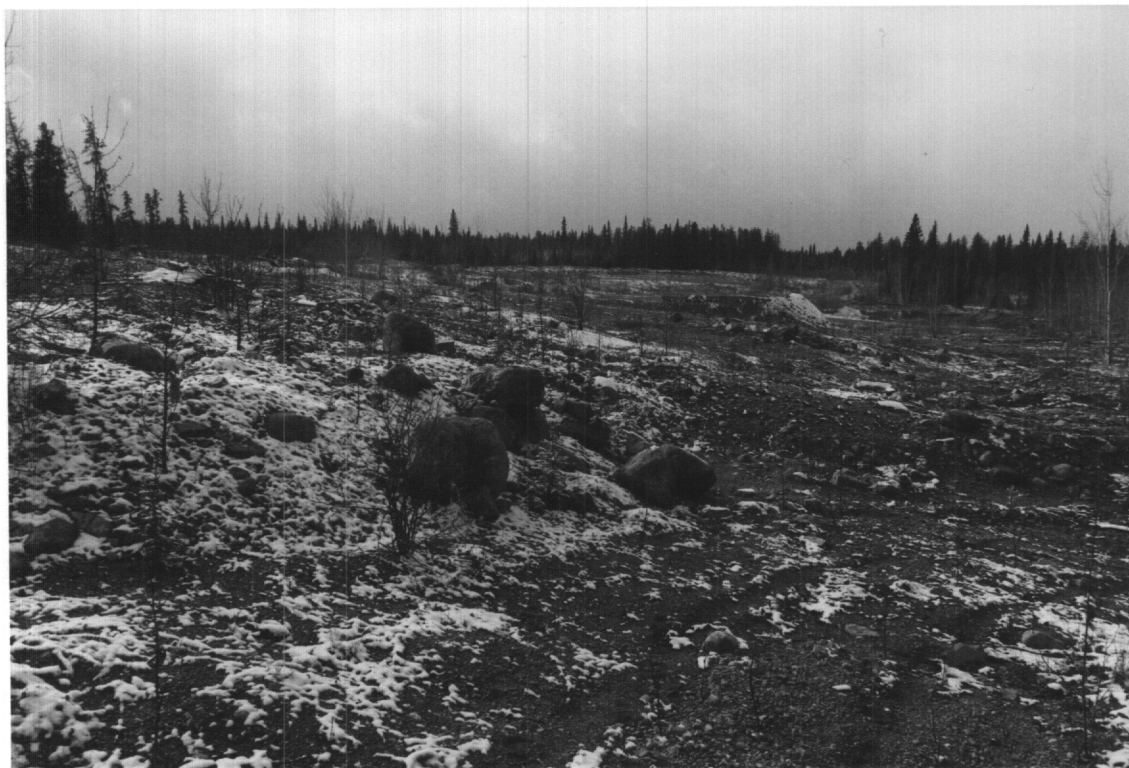
PHOTO 3: Foxhole North Pit, Deposit 5-69. View to west across depleted pit area. Much of remaining material is of variable composition and/or shallow.

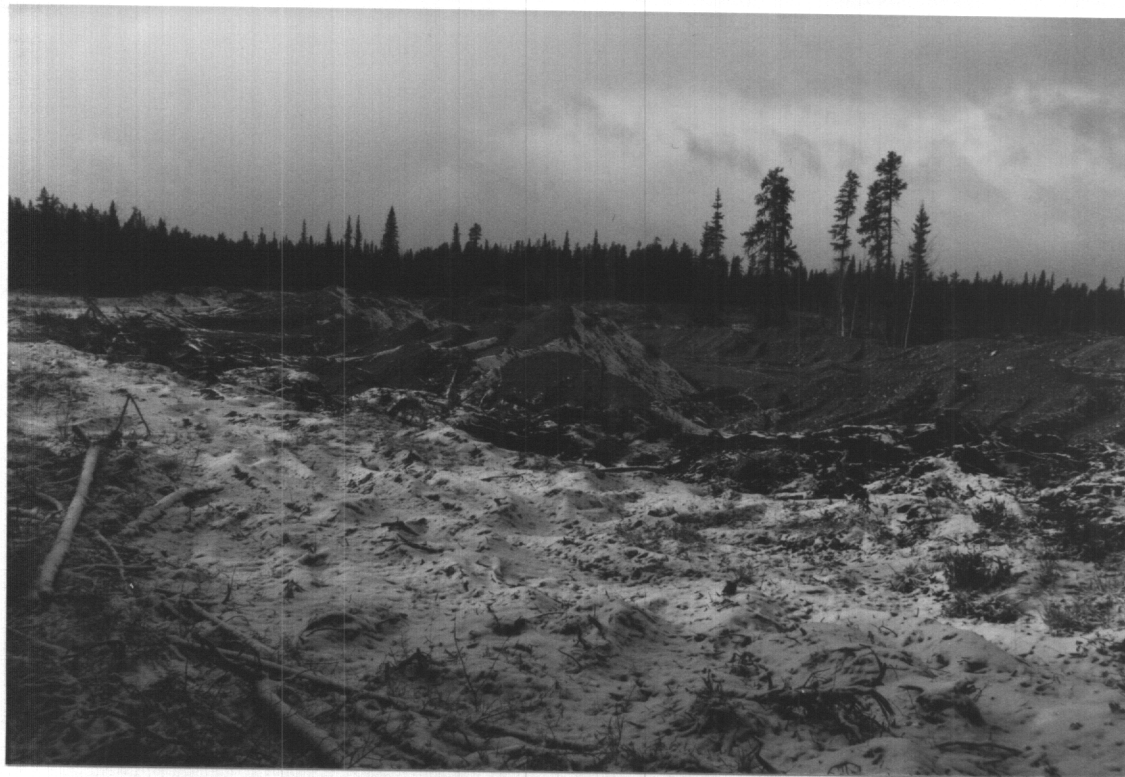
PHOTO 4: Foxhole North Pit, Deposit 5-69. Reserves of gravelly sand (Class 4) material remain in southeast part of pit area.

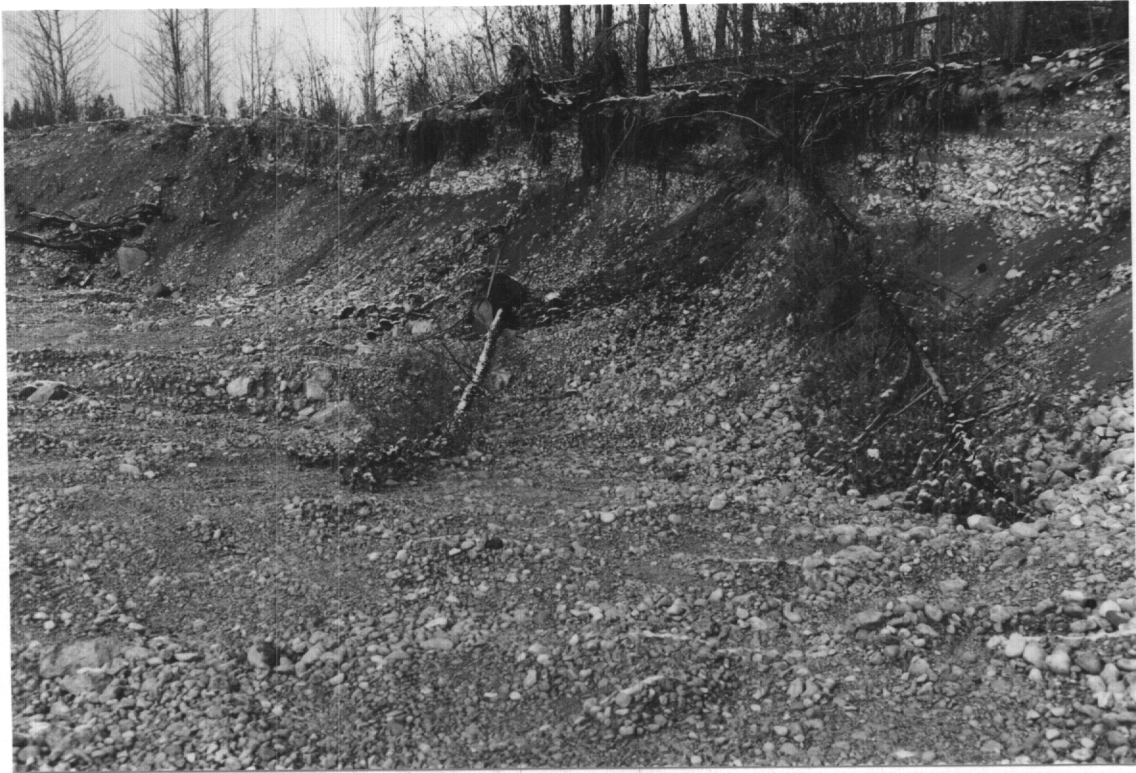
PHOTO 5: Salt Mountain South Pit, Deposit 5-69. Coarse, gap graded, sand and cobble material is exposed along east wall of pit.

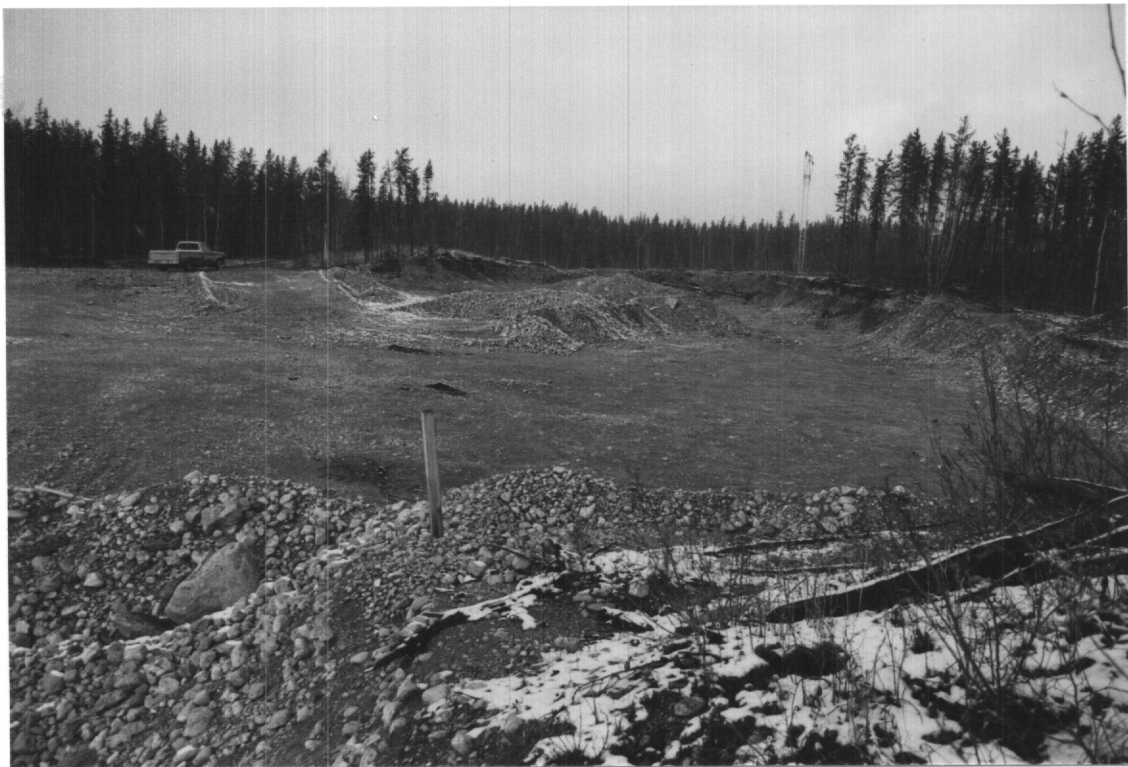
PHOTO 6: Salt Mountain South Pit, Deposit 5-69. General view to north across pit area towards Highway 5 and the powerline right-of-way.

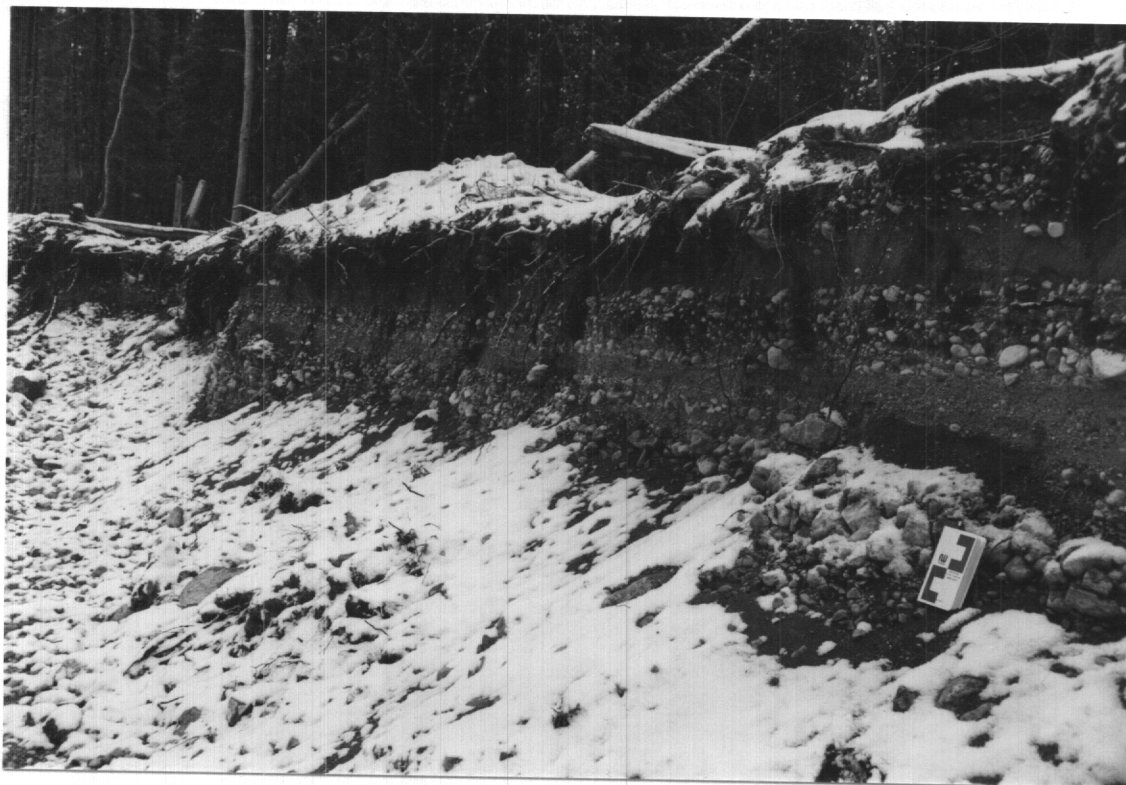
PHOTO 7: Salt Mountain North Pit, Deposit 5-69. Aggregate of variable composition and up to 2 m thick is exposed along northeast wall of pit.

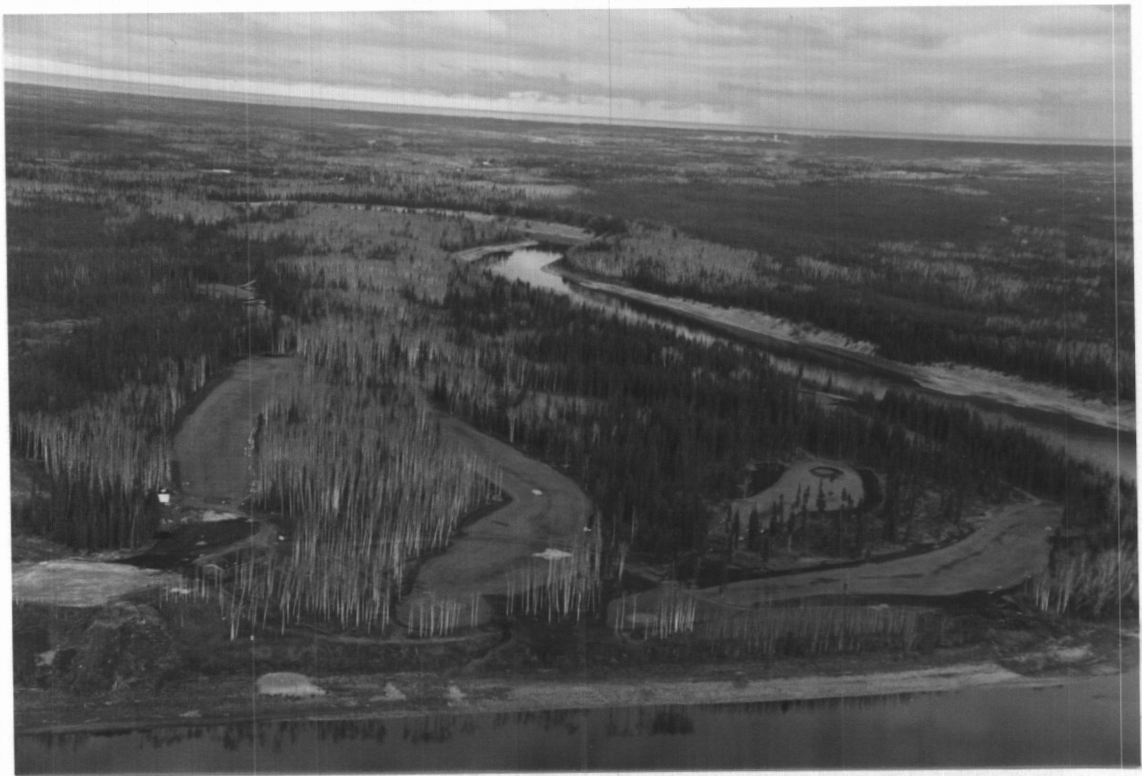
PHOTO 12: Deposit 2-8. View to north across depleted and rehabilitated source, now developed as golf course.

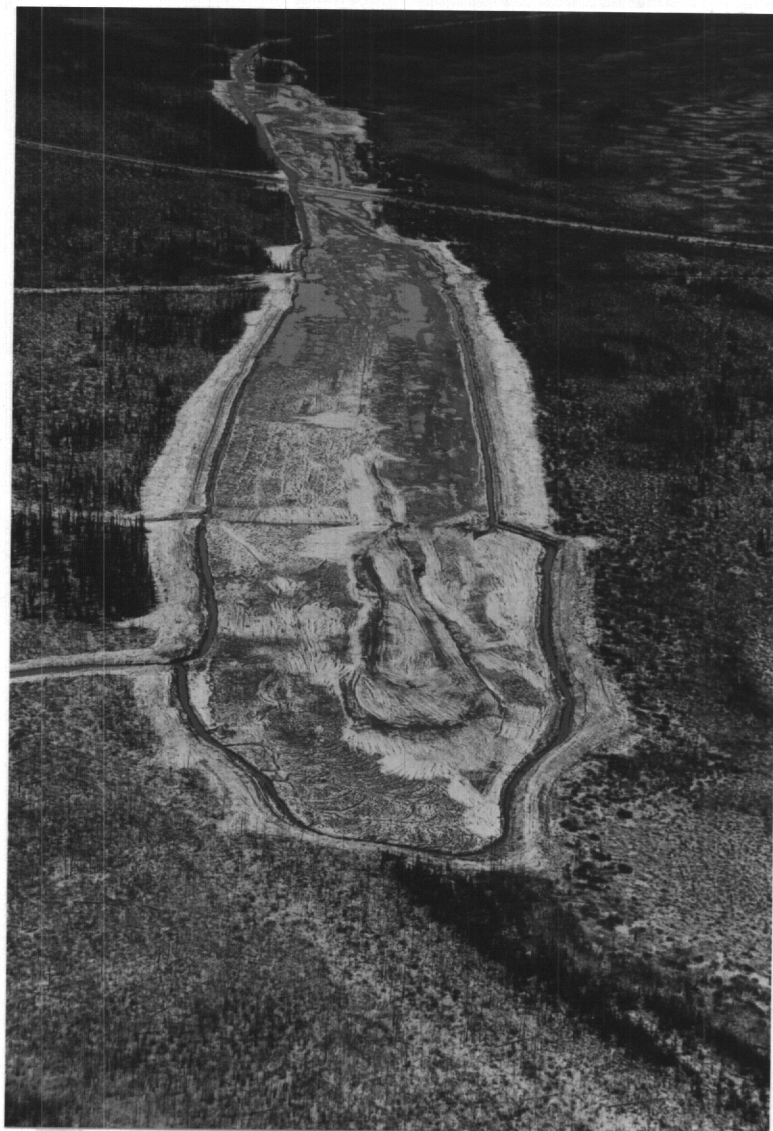
PHOTO 13: View to east along axis of depleted portion of Deposit 2-3 (HR-116). Aggregate has been extracted down to the groundwater table. Ditches have been constructed to improve surface drainage.

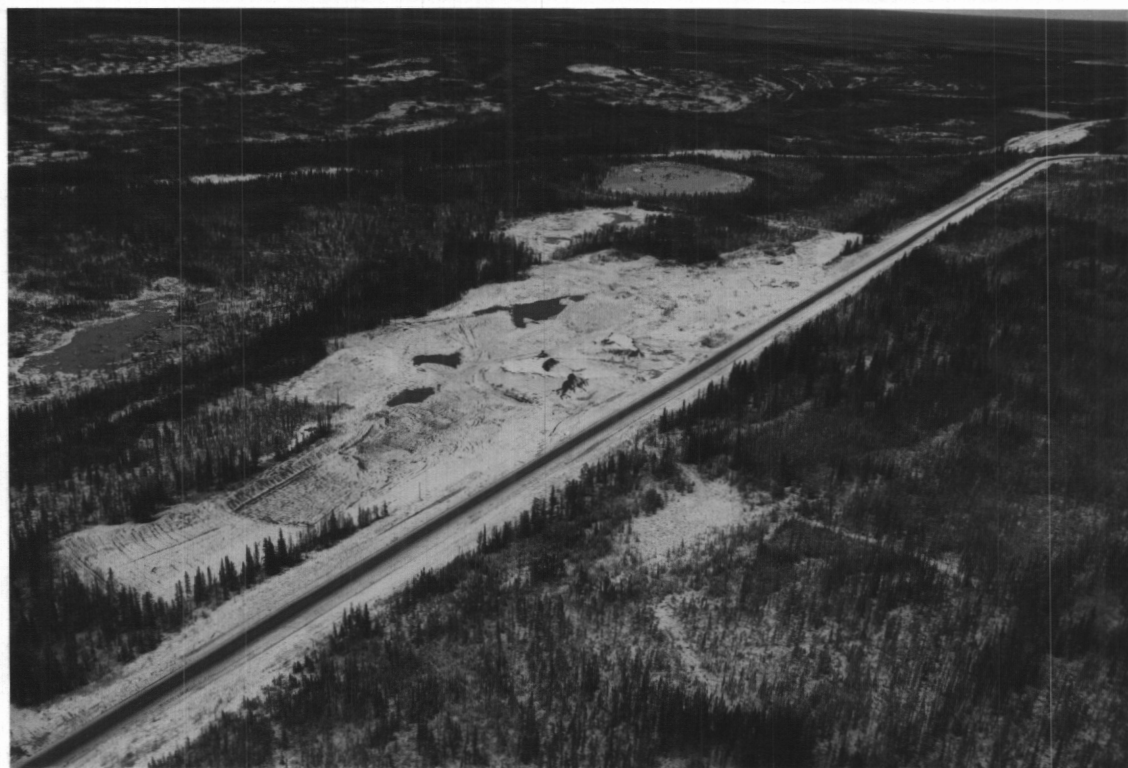
PHOTO 14: Deposit 1-18. Depleted pit area, now used as crushing and stockpile site, along Highway 1 west of Enterprise.

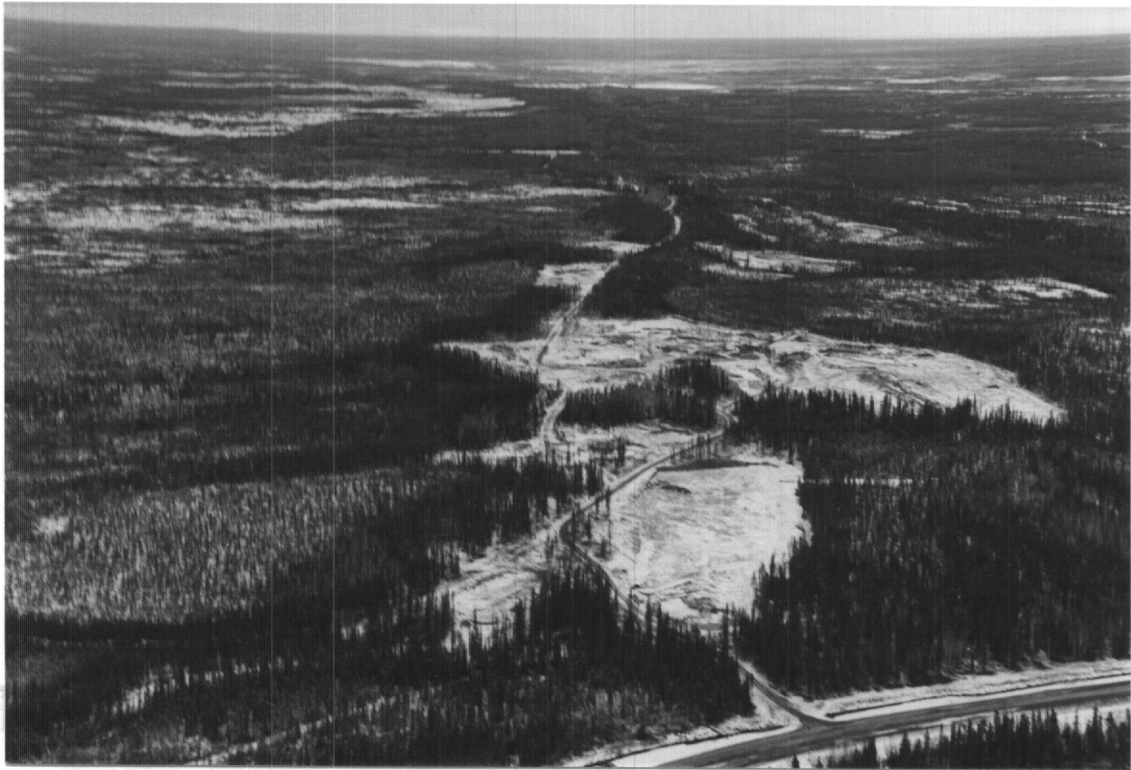
PHOTO 15: Deposit 2-1. View to west along axis of deposit (now largely depleted), showing former pit areas. Large pit area in middle distance is used as Enterprise nuisance grounds.

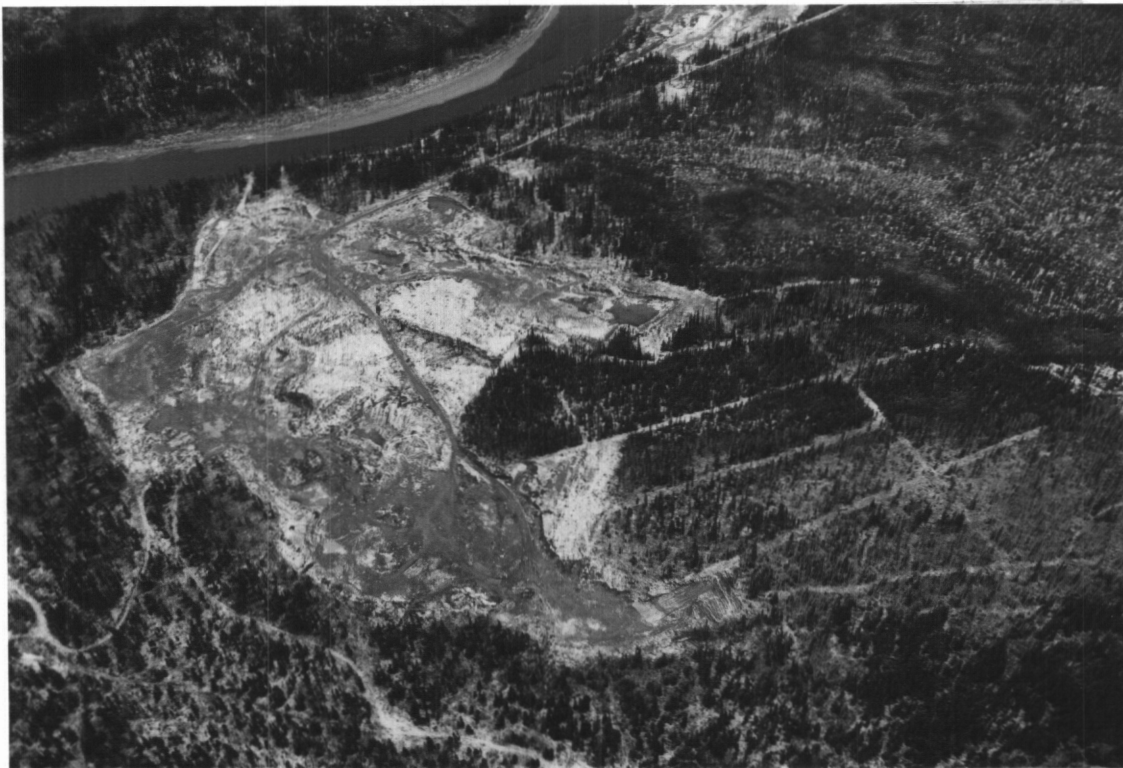
PHOTO 17: Depleted alluvial terrace pit, Deposit 2-5. Restoration and rehabilitation is recommended.

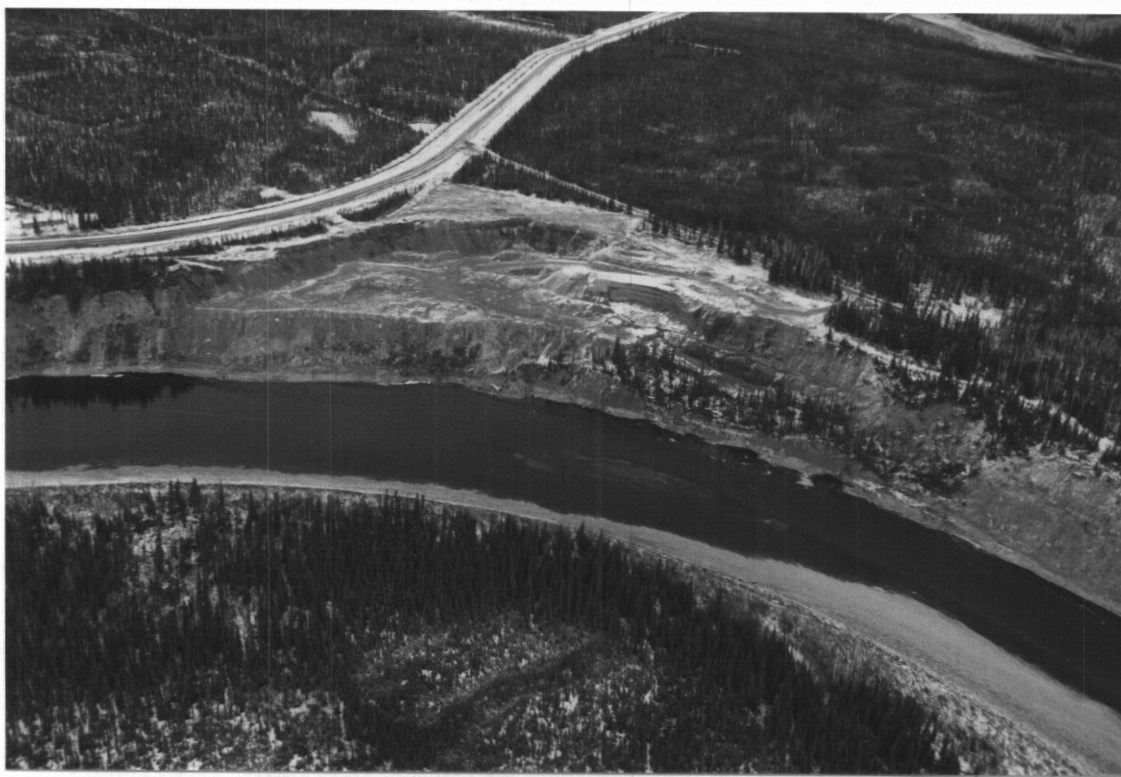
PHOTO 18: Limestone bedrock quarry, Deposit 2-5. It is understood that this area was abandoned due to environmental concerns (primarily proximity to the river valley).

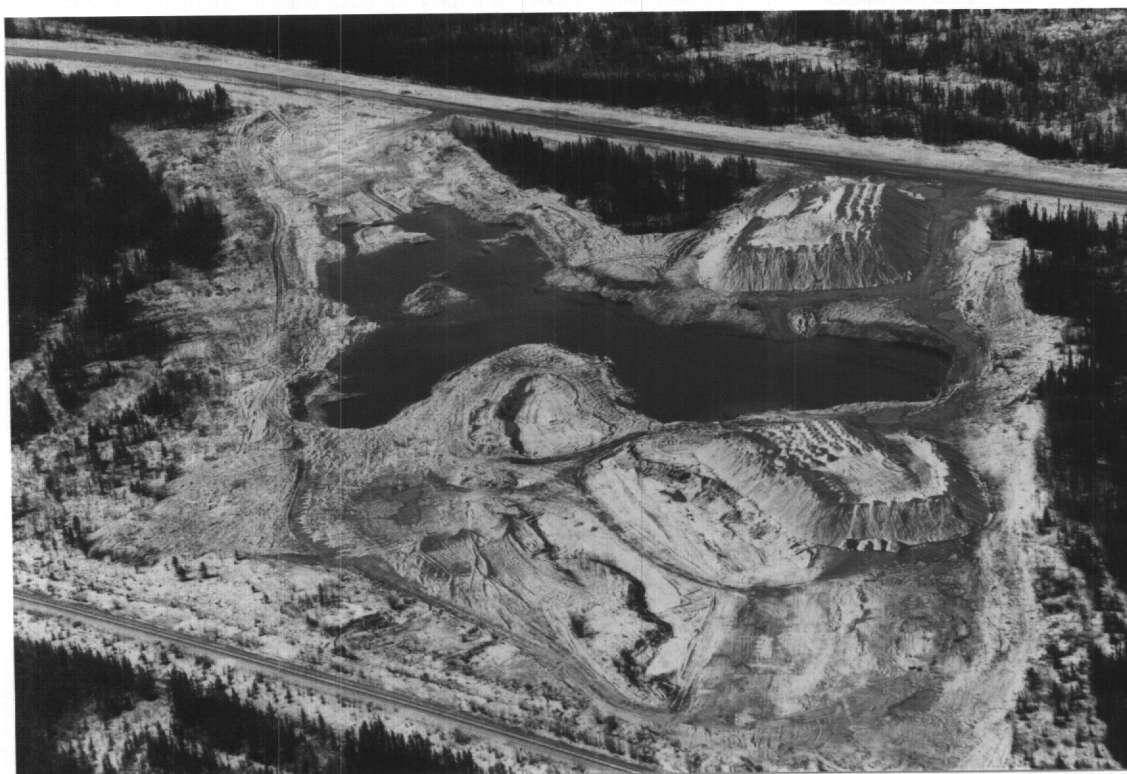
PHOTO 20: Deposit 1-15 (DPW km 66.6) is the source of limestone bedrock for crushing and blending with sand from Deposit 1-16.

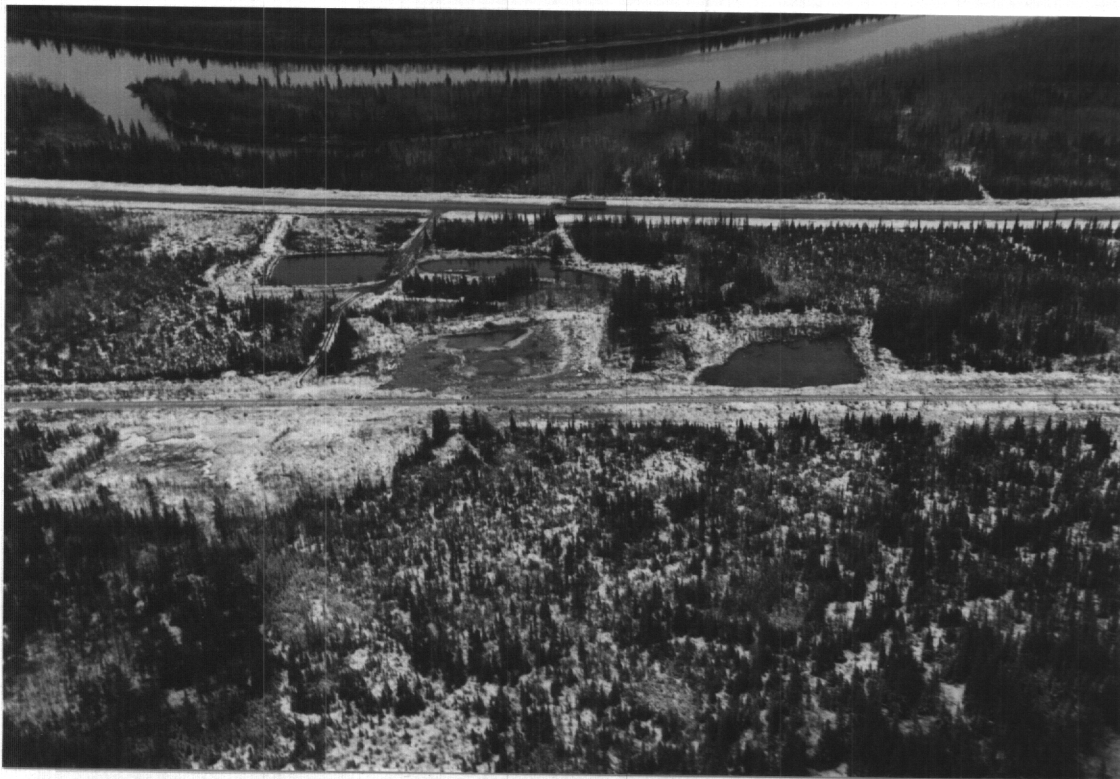
PHOTO 21: Small sand pits, now abandoned, between the highway and CN Rail, within Deposit 1-13.

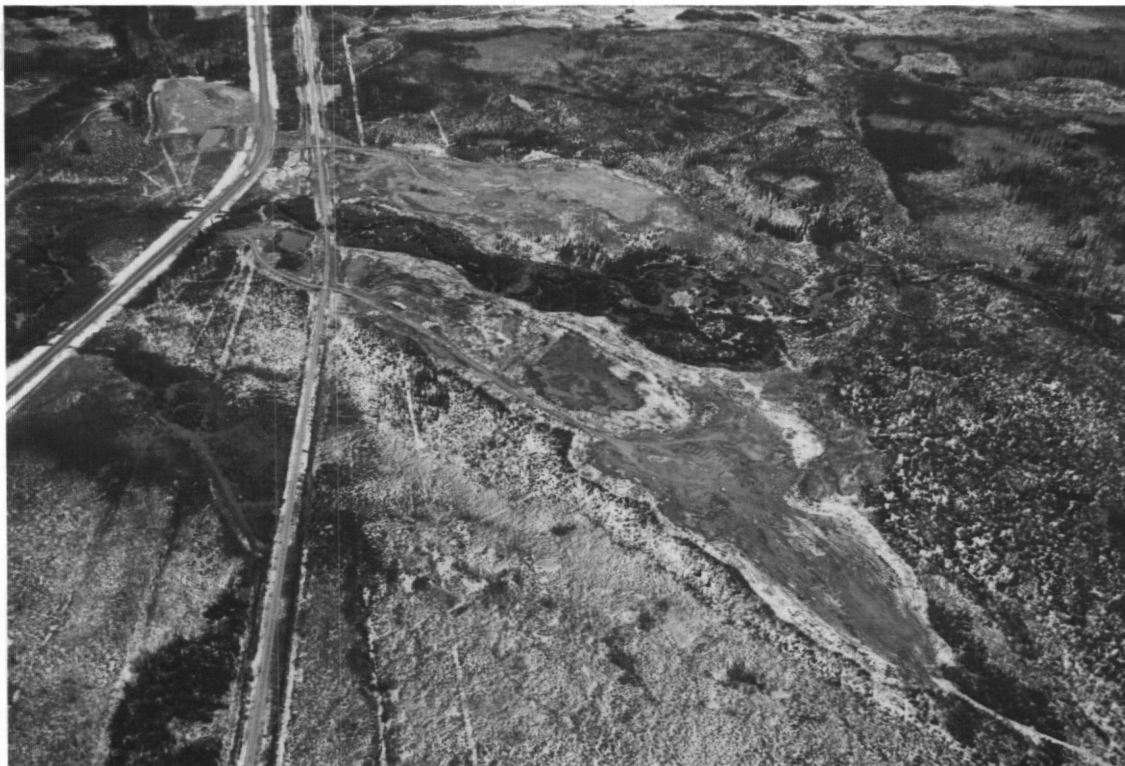
PHOTO 23: Depleted Deposit 1-18, situated to the north and south of Swede Creek. Restoration and rehabilitation is now recommended.

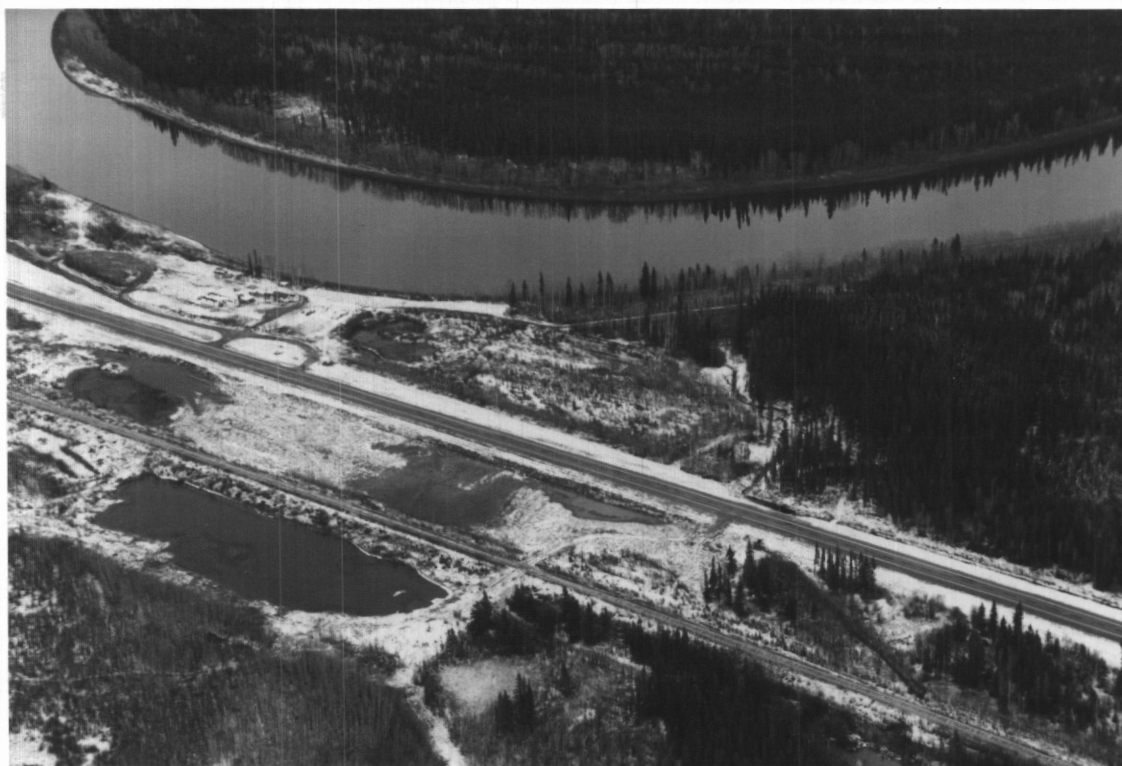
PHOTO 24: View to east across long depleted Deposit 1-4 at Grumbler. Natural revegetation is now well advanced, and additional rehabilitation work is not recommended.

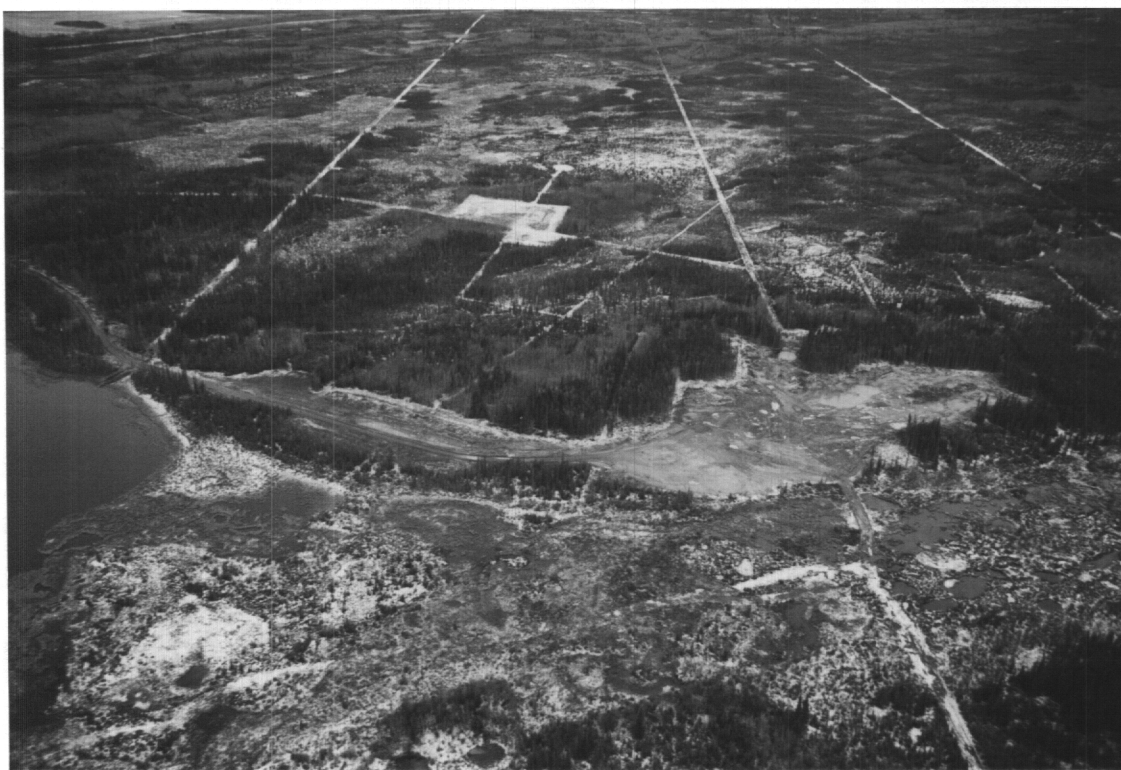
PHOTO 25: Depleted Deposit 1-2 in the southern part of Management Area I. Restoration and rehabilitation of the pit area is recommended.

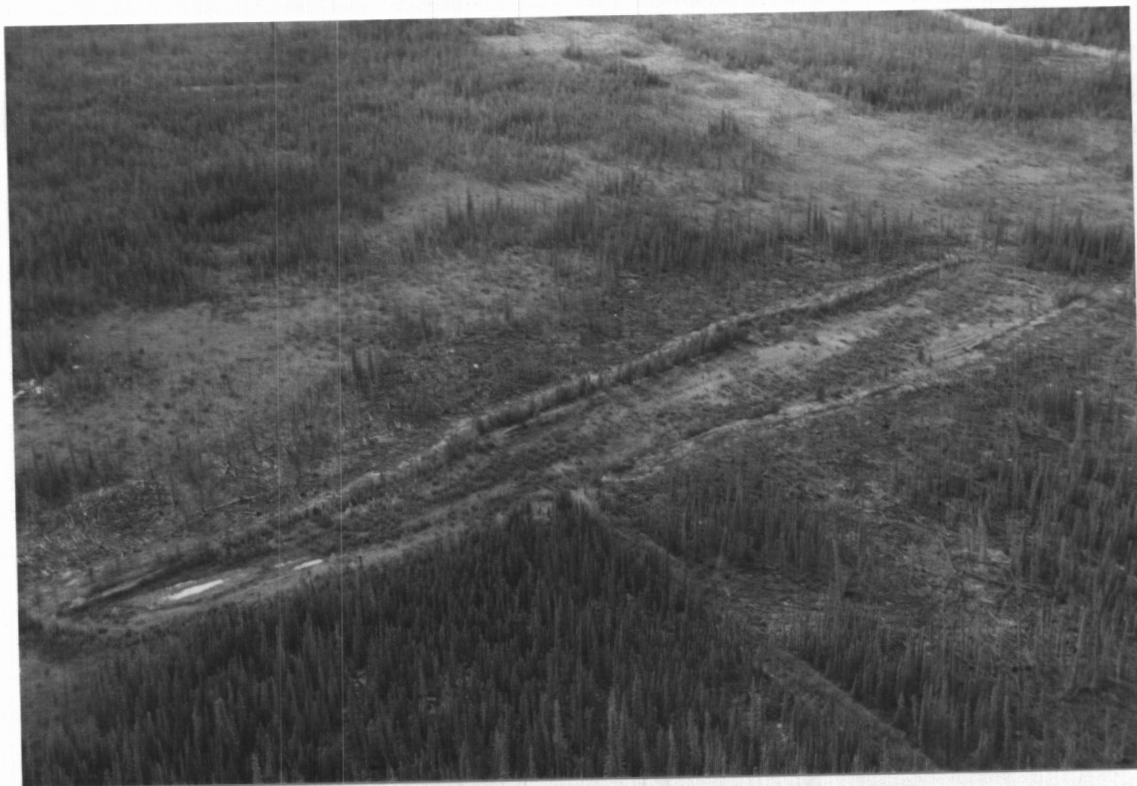
PHOTO 26: Long-depleted Deposit 5-1, situated south of Highway 5 about 8 km from Hay River. Natural revegetation is well advanced.

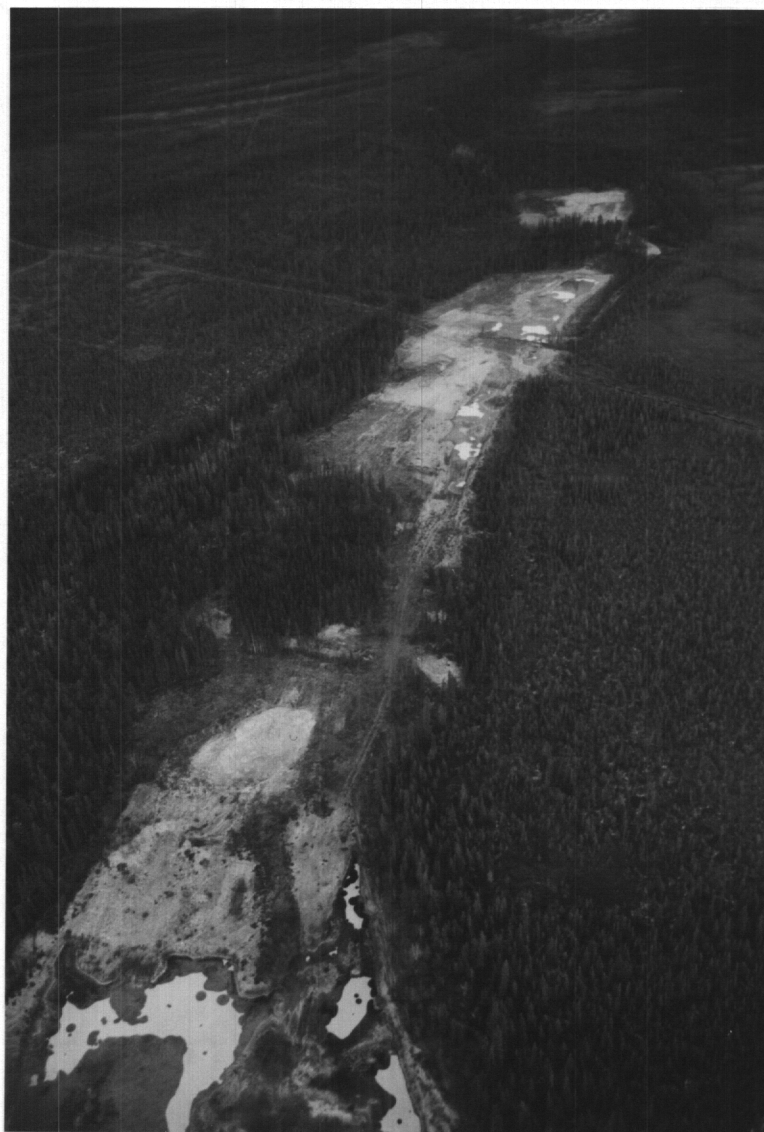
PHOTO 28: View along axis of Deposit 5-6 (HR-109A) towards the east. The initial (CN Rail) pit area is in the foreground, with more recently developed pits along and to the east of the old Fort Smith winter road alignment visible in background.

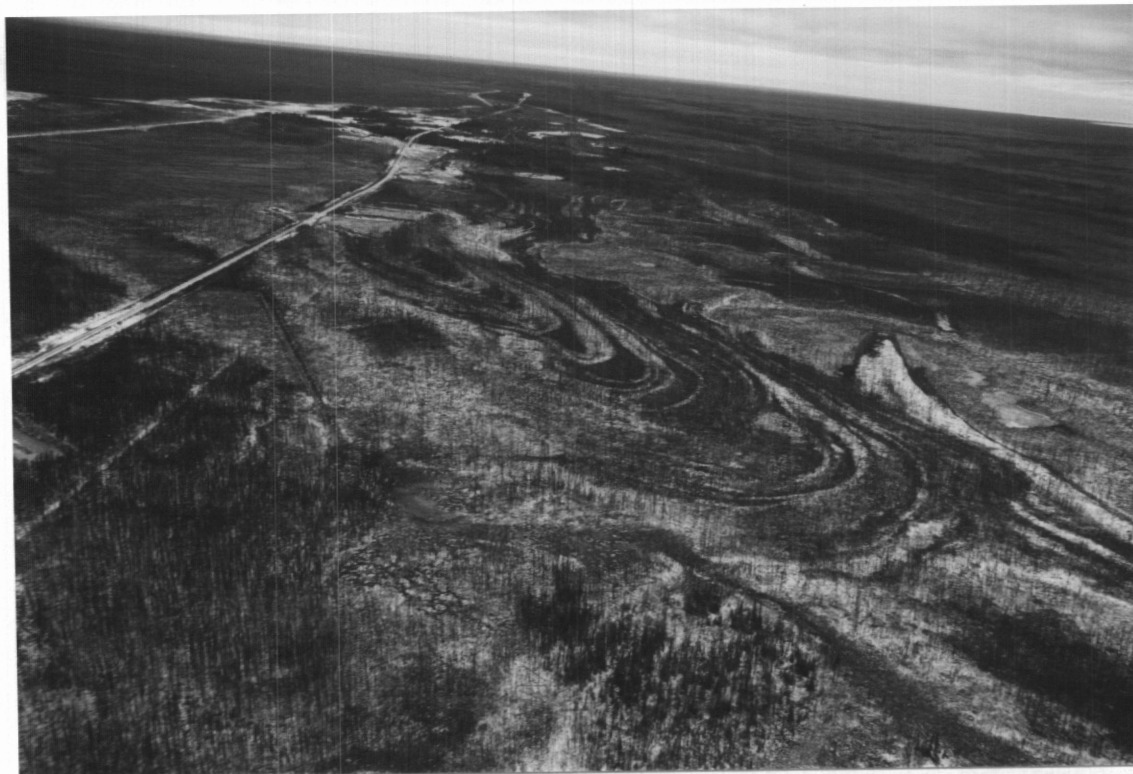
PHOTO 30: View to east along axis of Deposit 5-19 (HR-119, 121 and 122; Mile 21). Note prominent beach ridges, and depleted areas adjacent to C.N.R.

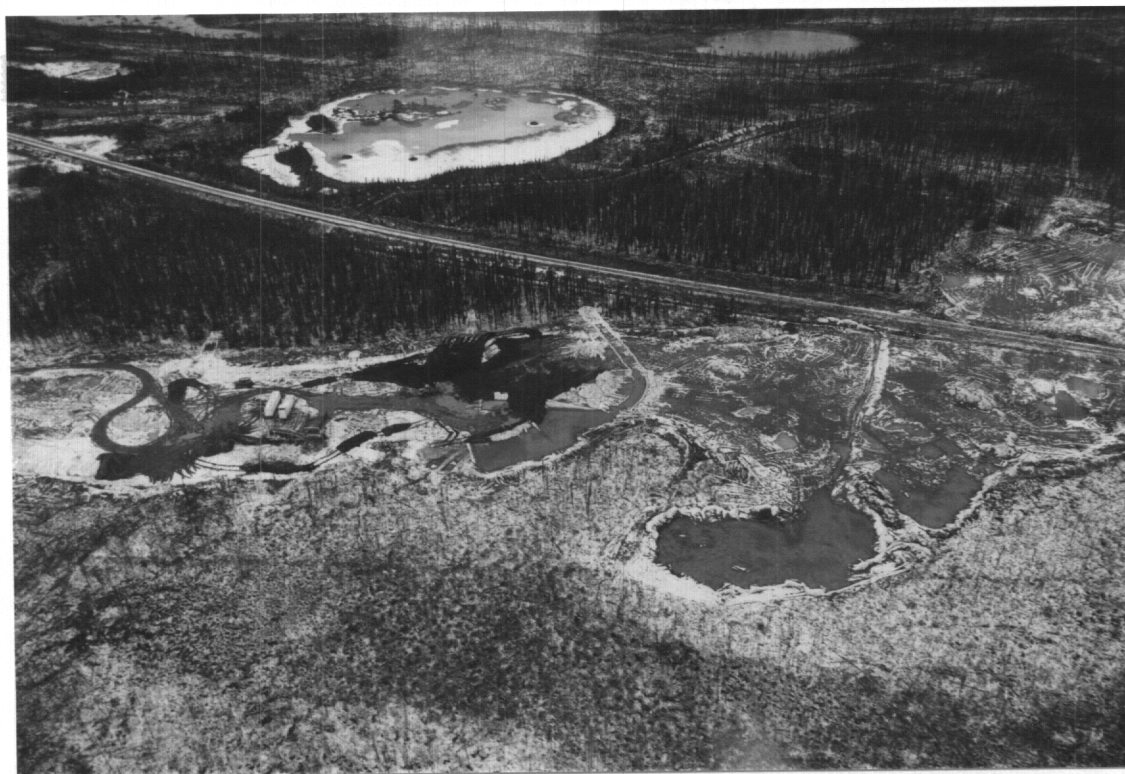
PHOTO 32: Deposit 5-19. The main area of current extraction activity is in central part of deposit.

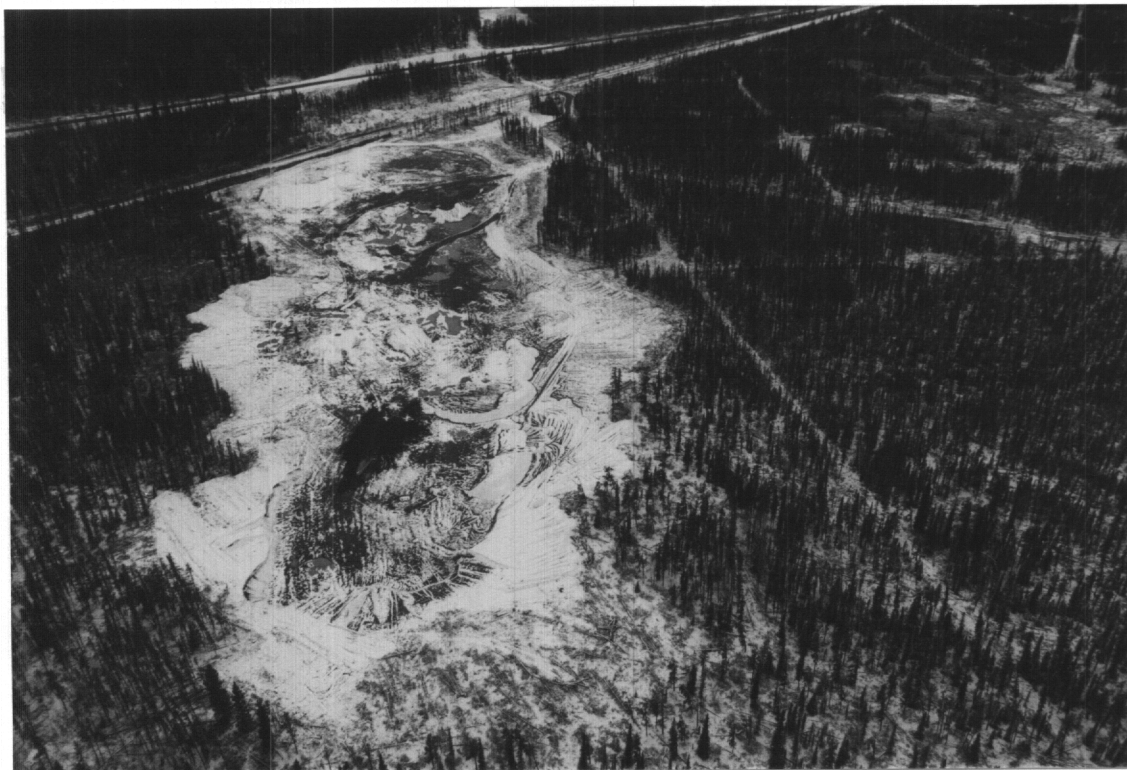
PHOTO 33: Deposit 5-23 (Mile 26). Note that access has recently been developed across the C.N.R. into the pit.

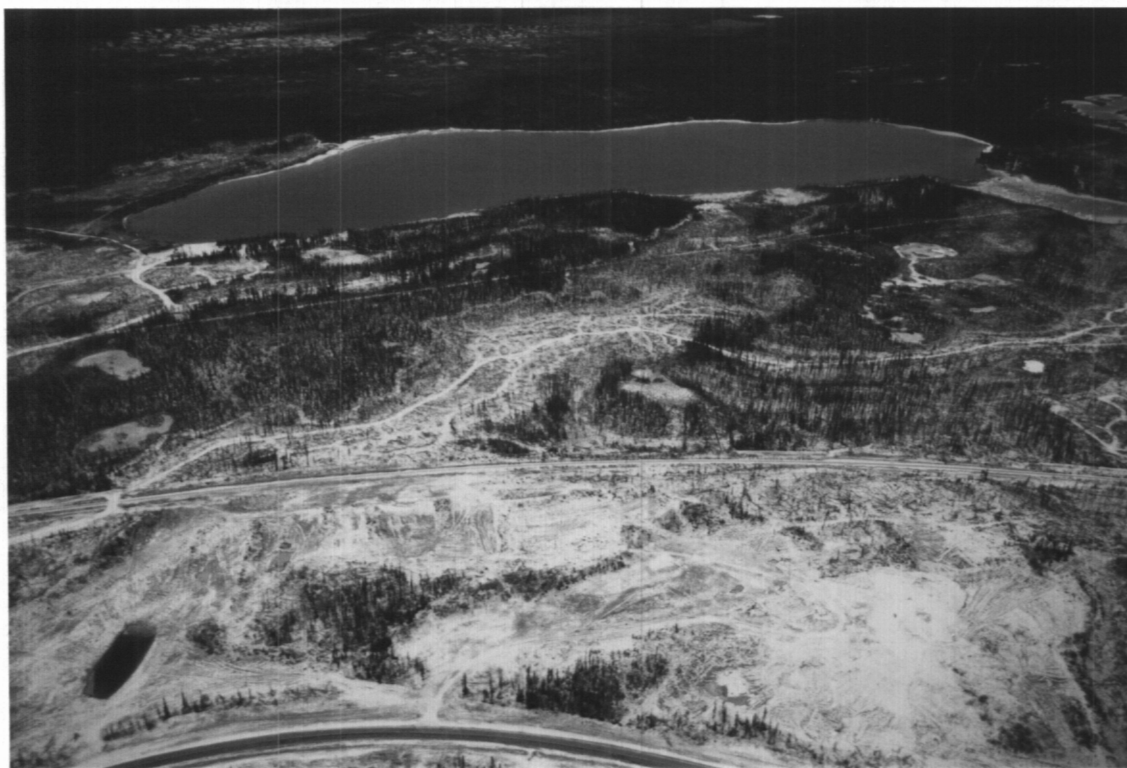
PHOTO 36: Deposit 5-29. View north to Polar Lake, showing essentially depleted area between Highway 5 and the C.N.R.

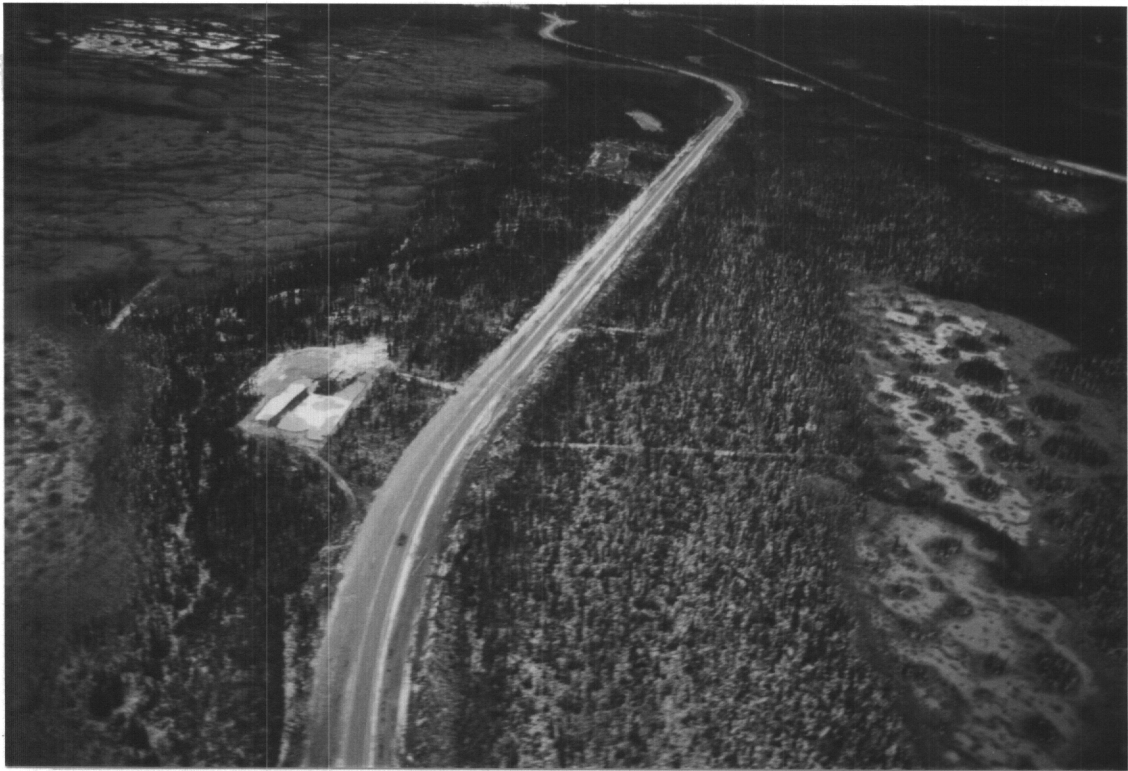
PHOTO 37: Deposit 5-33, view to west. Material from the pit in the foreground was sampled during the October 1987 field program.

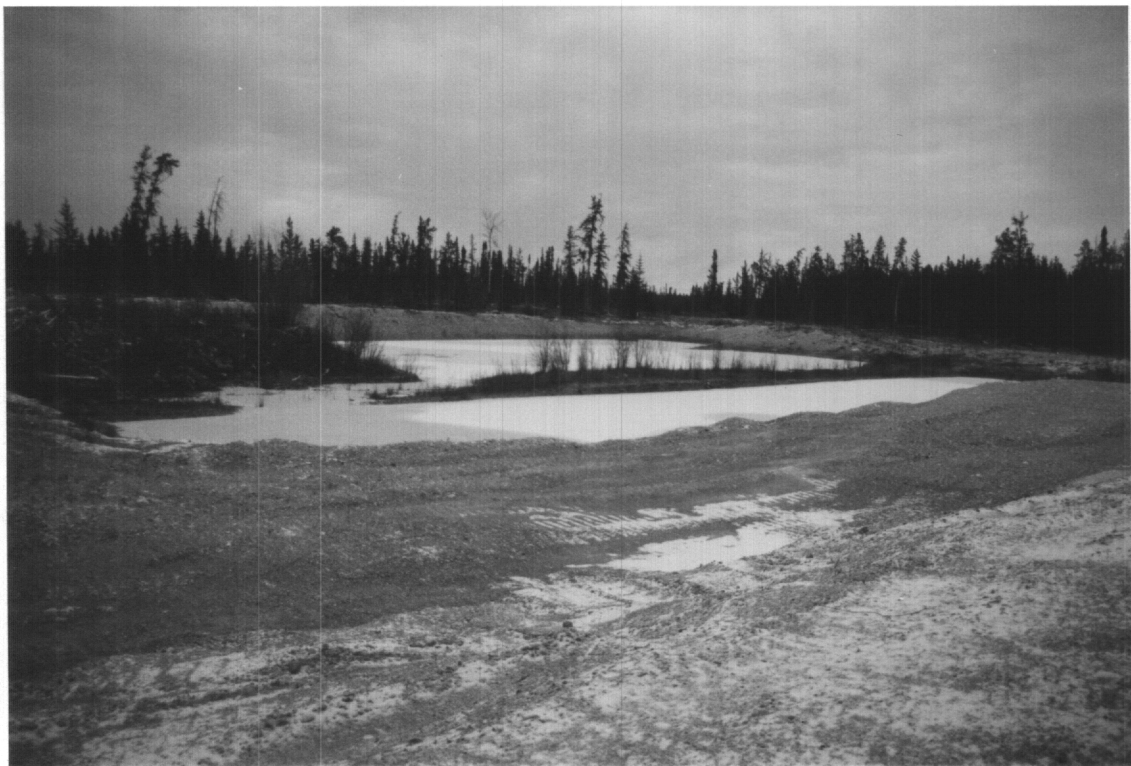
PHOTO 38: Pit area, Deposit 5-33. Note that material thickness above the water table is only about 1 m. It is understood that aggregate is extracted from below the water table for use in concrete.
