**THURBER CONSULTANTS LTD.**

RE: GRANULAR RESOURCES MANAGEMENT STUDY  
SOUTH SLAVE REGION (DSS FILE: 38ST.A0632-6-5023)

In accordance with the contract for the above study, we are pleased to submit this photo album for your information. It provides documentation of the granular sources visited during the recent field reconnaissance.

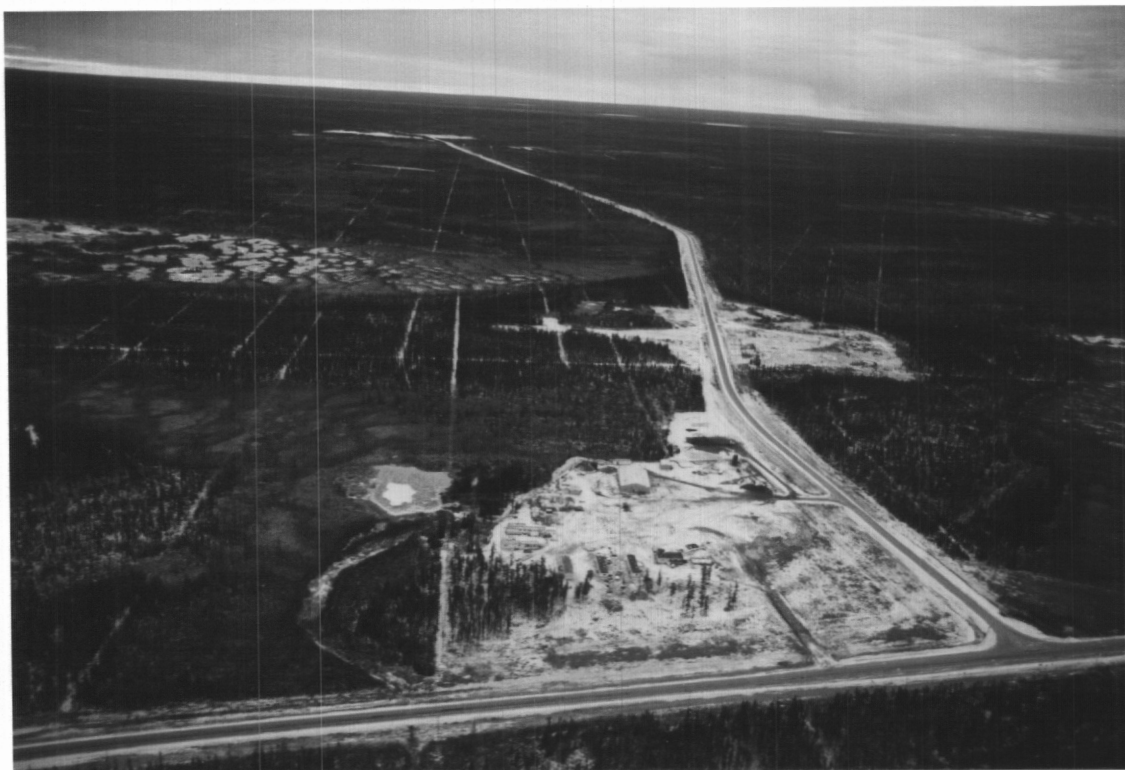
PHOTO 39: DPW camp area at junction of Highways 5 and 6. The camp is developed on a portion of Deposit 5-34. Source 5-35 is visible, as a low ridge, in the left middle distance.

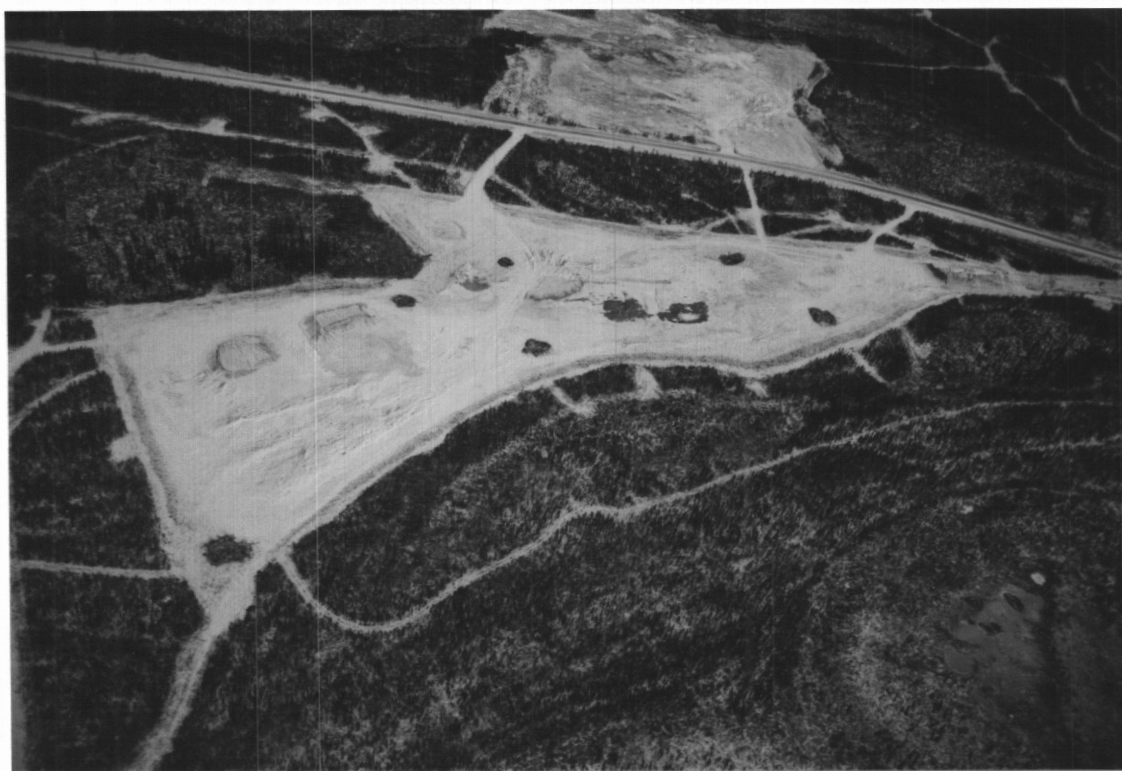
PHOTO 40: DPW km 64.5 pit in Deposit 5-40. Depleted pit is visible to west of Highway 5, while pit opened up in winter 1986-1987 is in foreground.

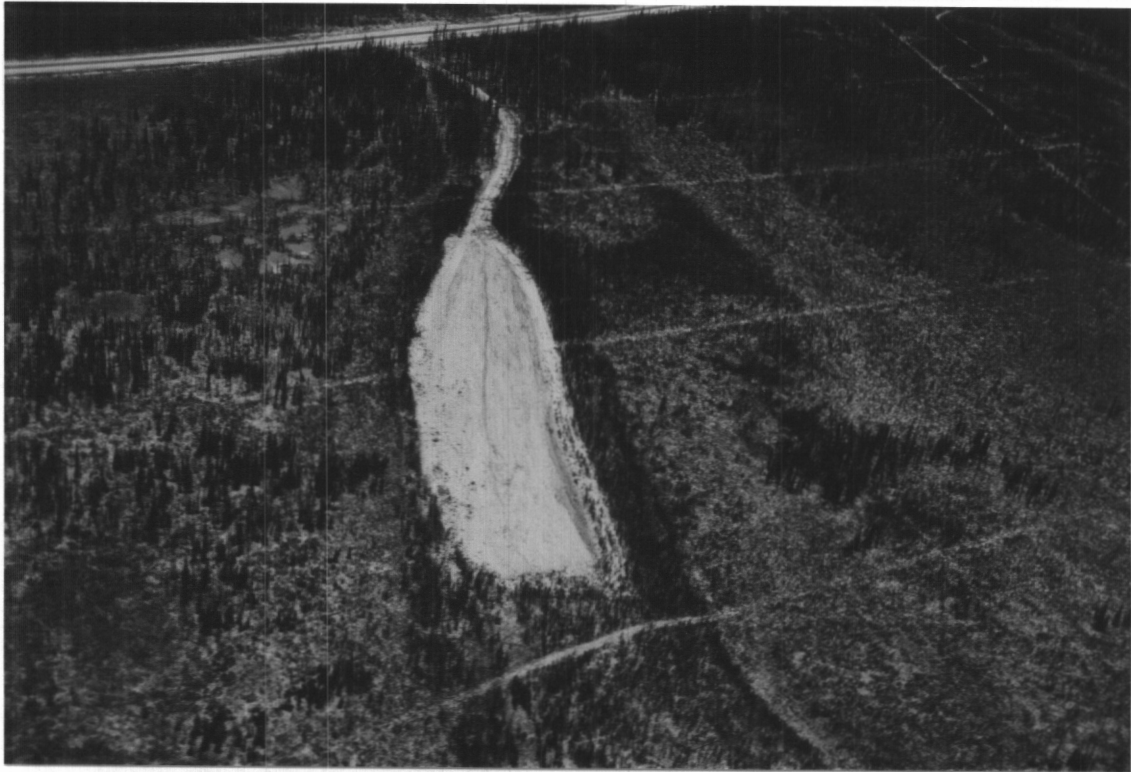
PHOTO 41: Abandoned pit area, Deposit 5-39. Existing pit appears to be depleted; however, considerable material remains further to the east.

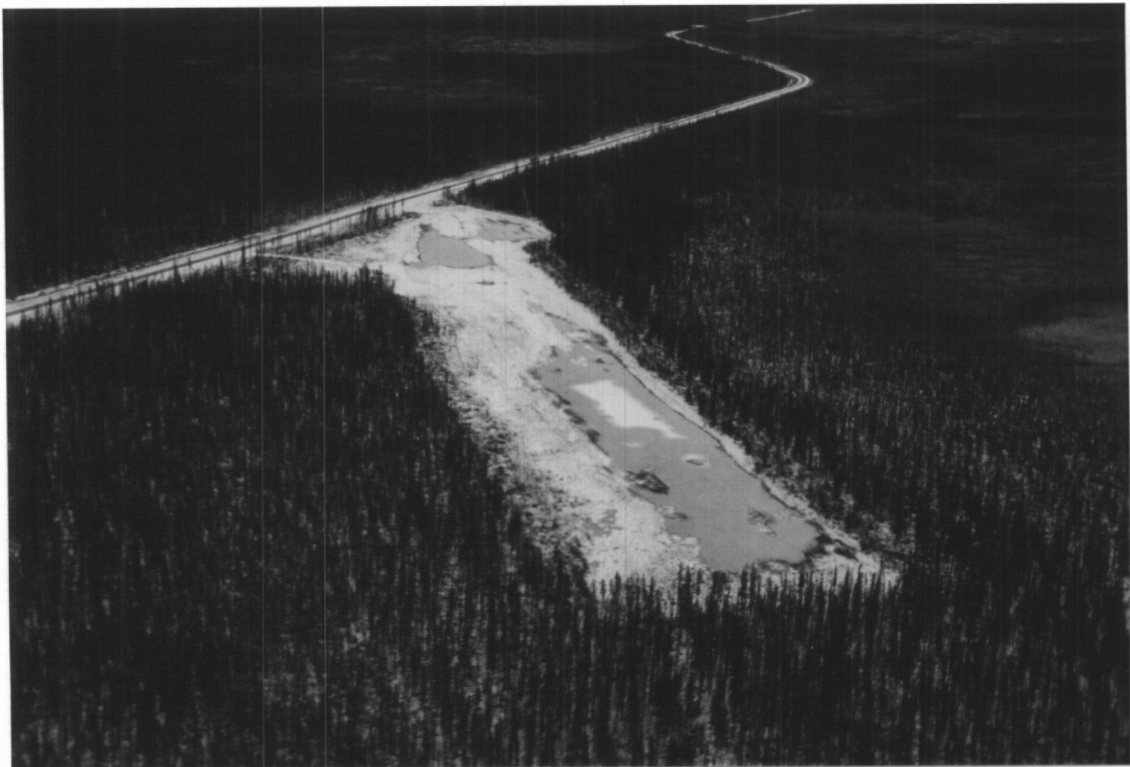
PHOTO 42: Abandoned/depleted pit area, Deposit 5-42.

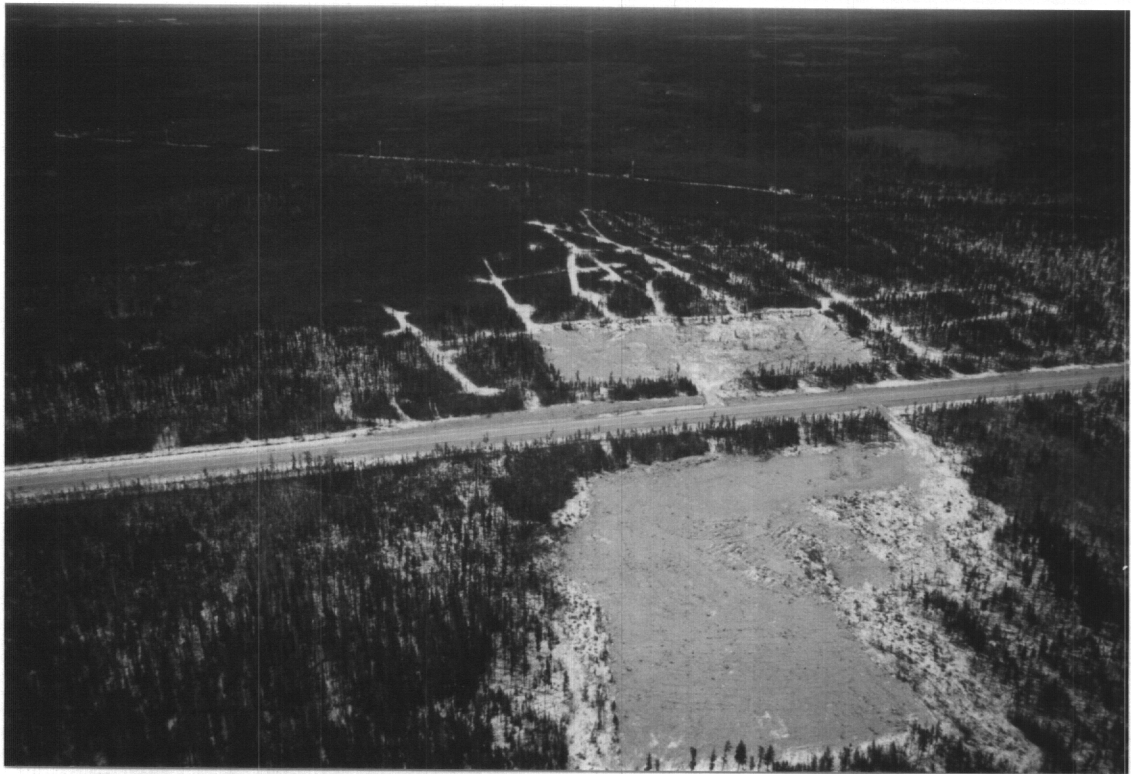
PHOTO 43: Deposit 5-45 (DPW km 83.5), showing recent exploration access trails on east side of highway and power line right of way.

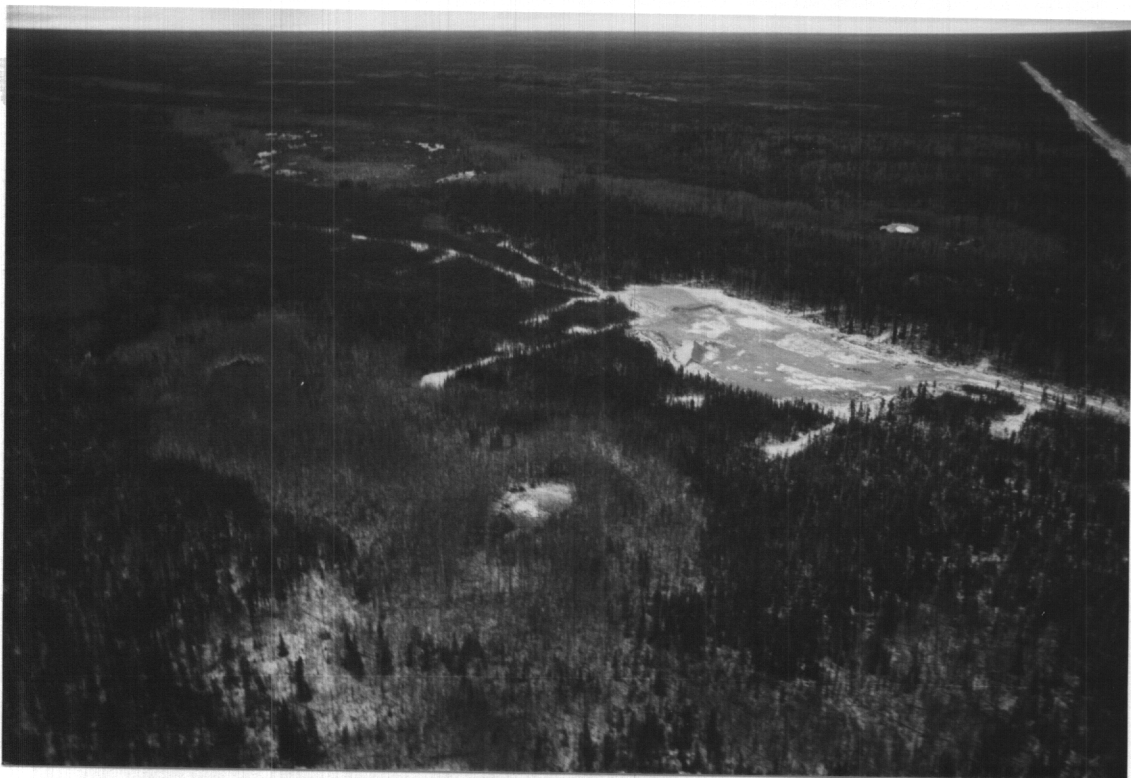
PHOTO 44: Deposit 5-47 (DPW km 89.1). Trails developed during recent (Underhill Engineering) field testing program are visible to left.

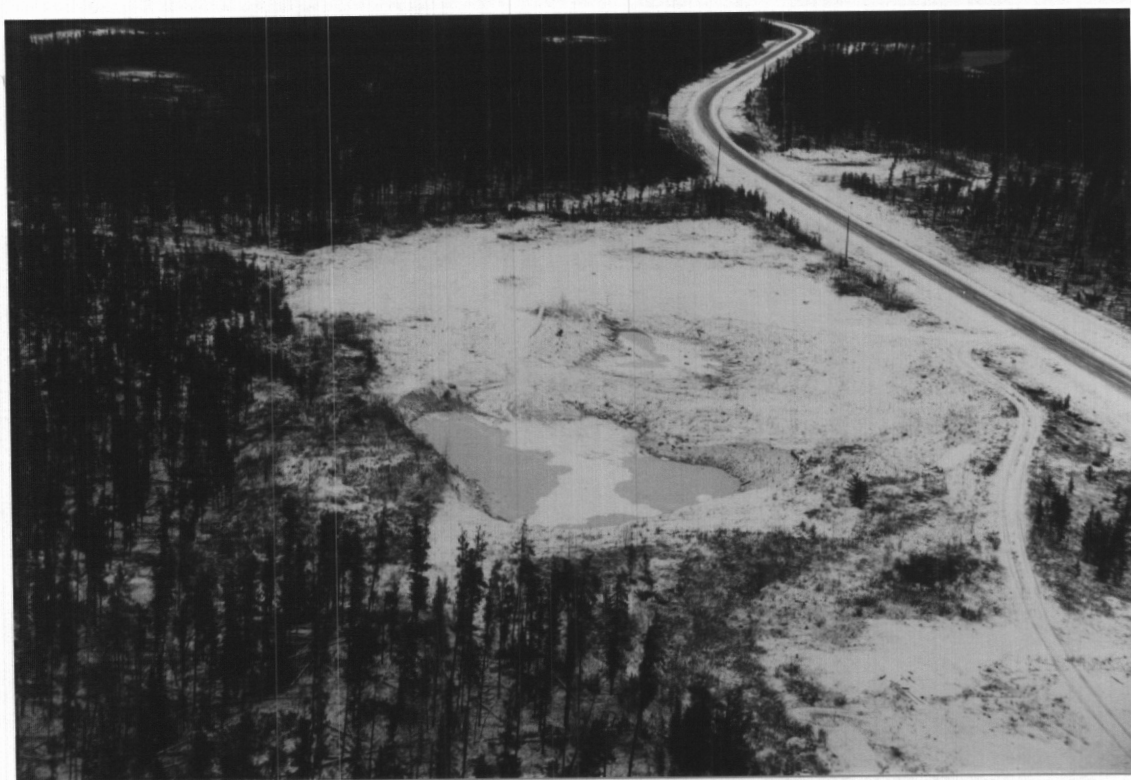
PHOTO 45: Small road side pit, Deposit 6-3. The snow cover and frozen material precluded sampling at this location.

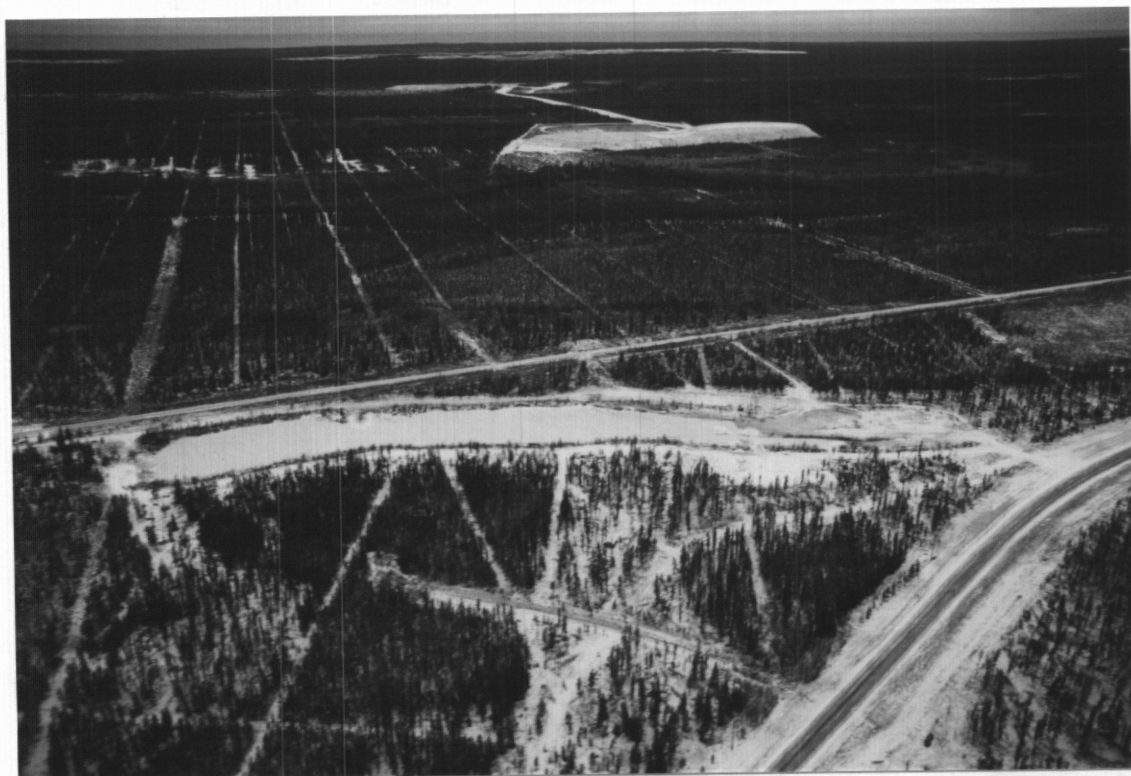
PHOTO 46: Roadside borrow pit at east end of Deposit 6-3. A mine waste dump (possible future source of Class 5 aggregate) is visible in background.

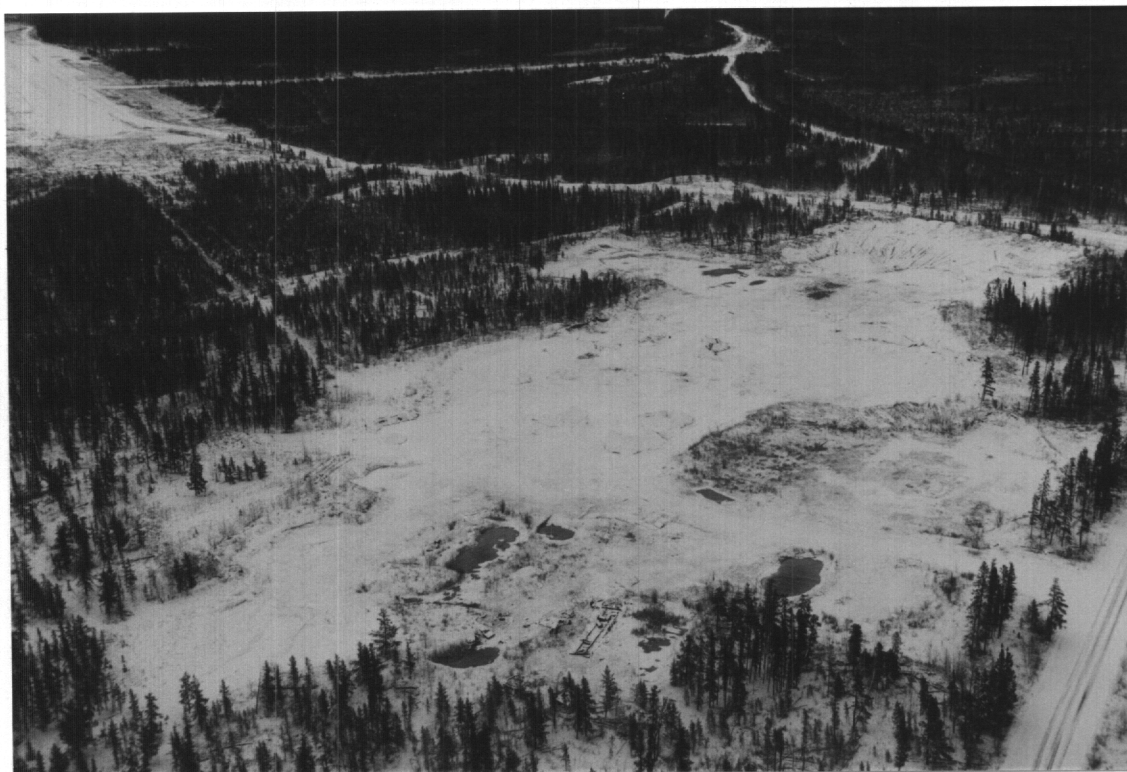
PHOTO 49: Active pit area in Deposit 6-11, located south of Pine Point airstrip. A coarse aggregate sample was obtained during the October 1987 field reconnaissance.

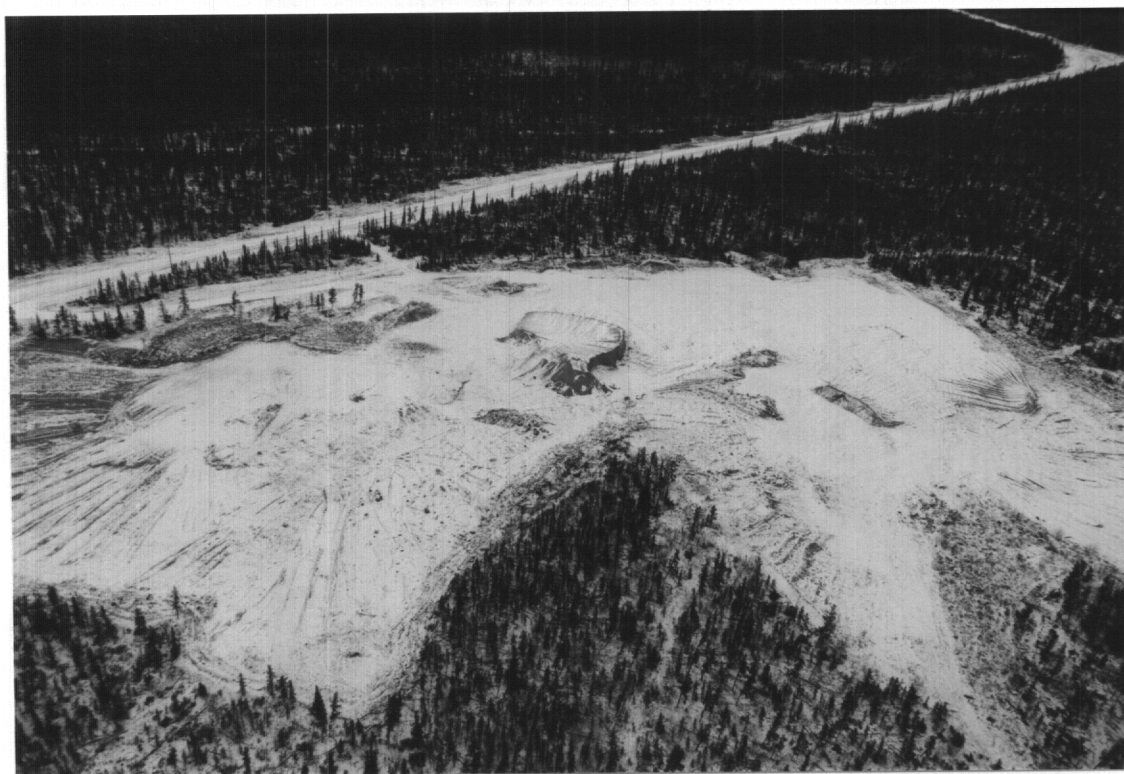
PHOTO 50: Bedrock quarry, with crushed material stockpiles, Deposit 6-18 (DPW km 62.4).

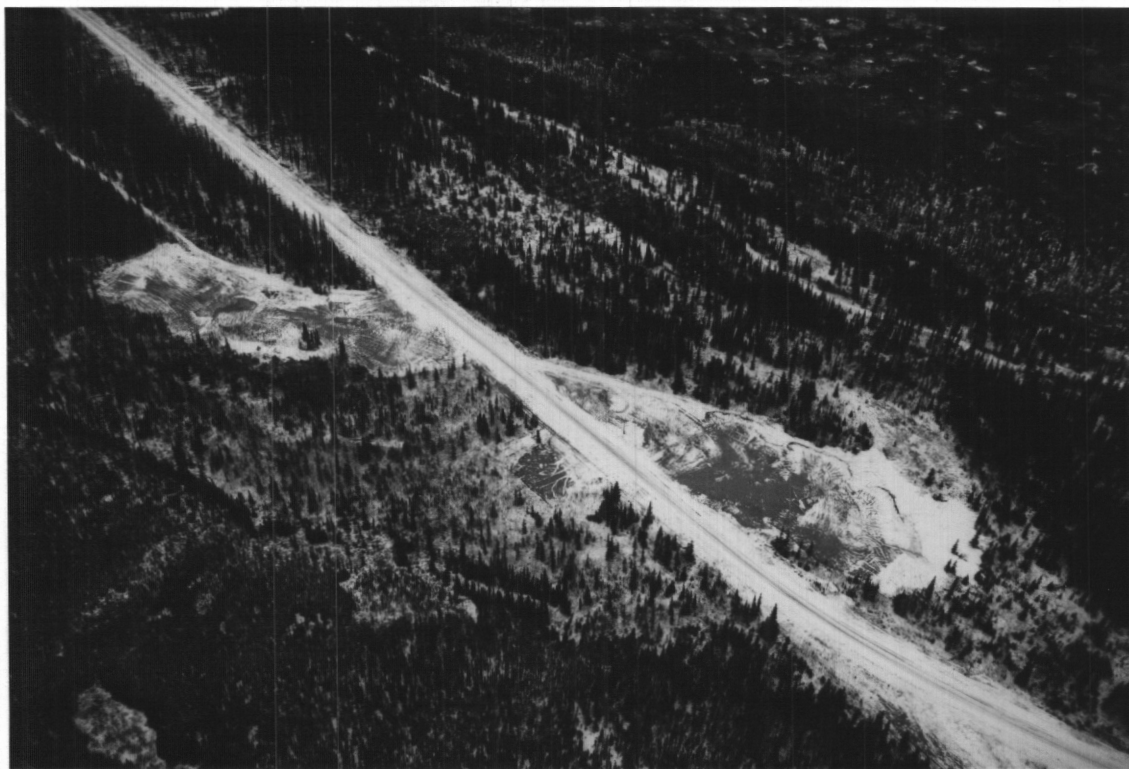
PHOTO 51: Deposit 6-19, showing small gravel pits developed to the north and south of Highway 6.

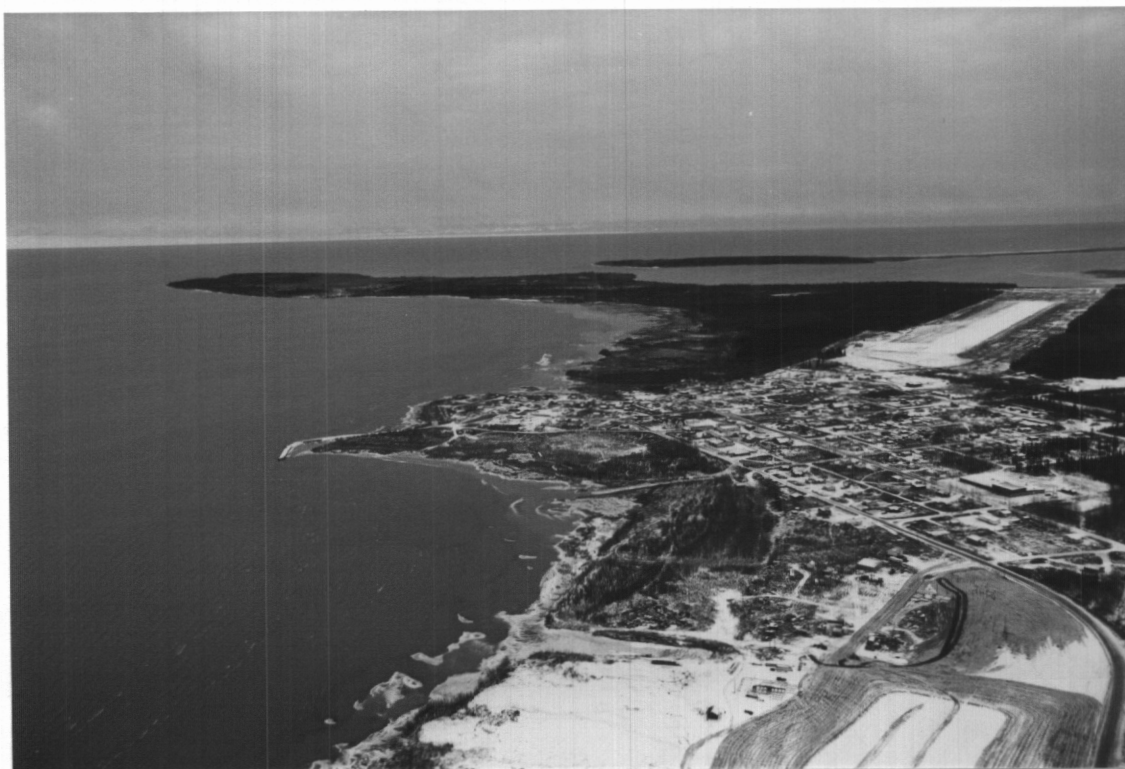
PHOTO 54: Fort Resolution. Mission Island (Deposit 6-23) is visible on left and the airstrip on the right.

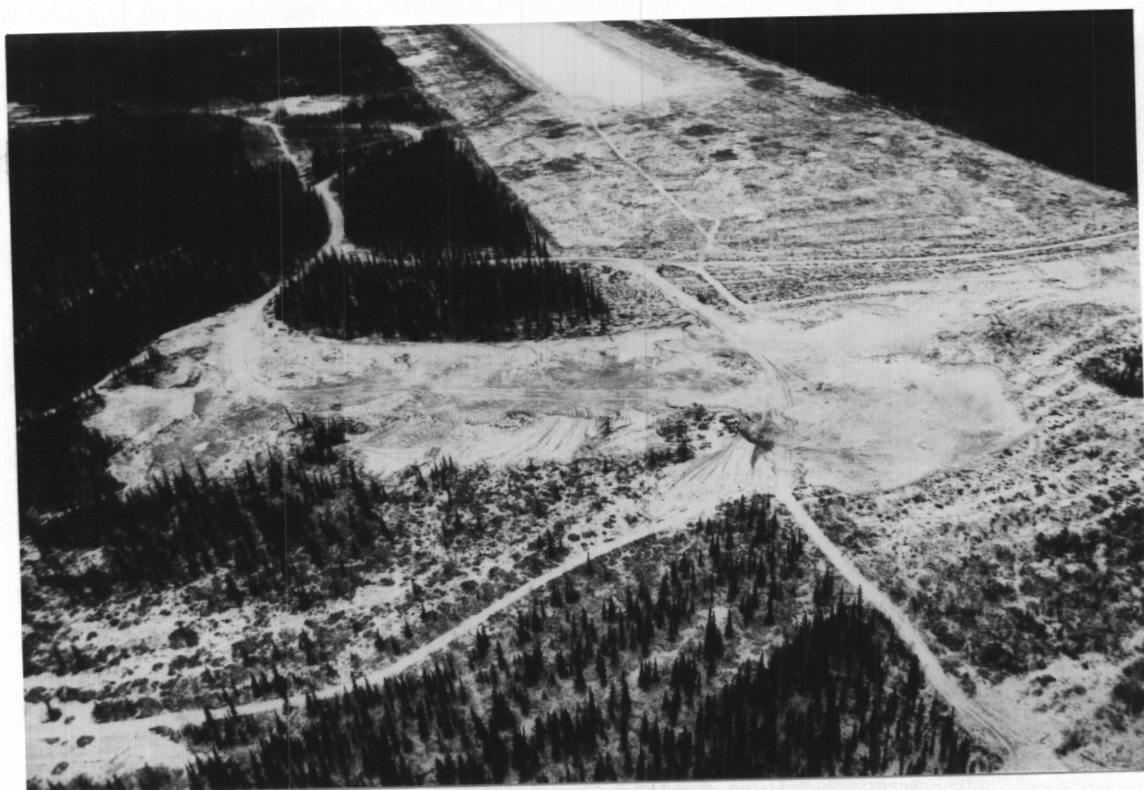
PHOTO 55: Deposit 6-22, comprising lag gravel deposits on bedrock high, is located at north end of Fort Resolution airstrip.

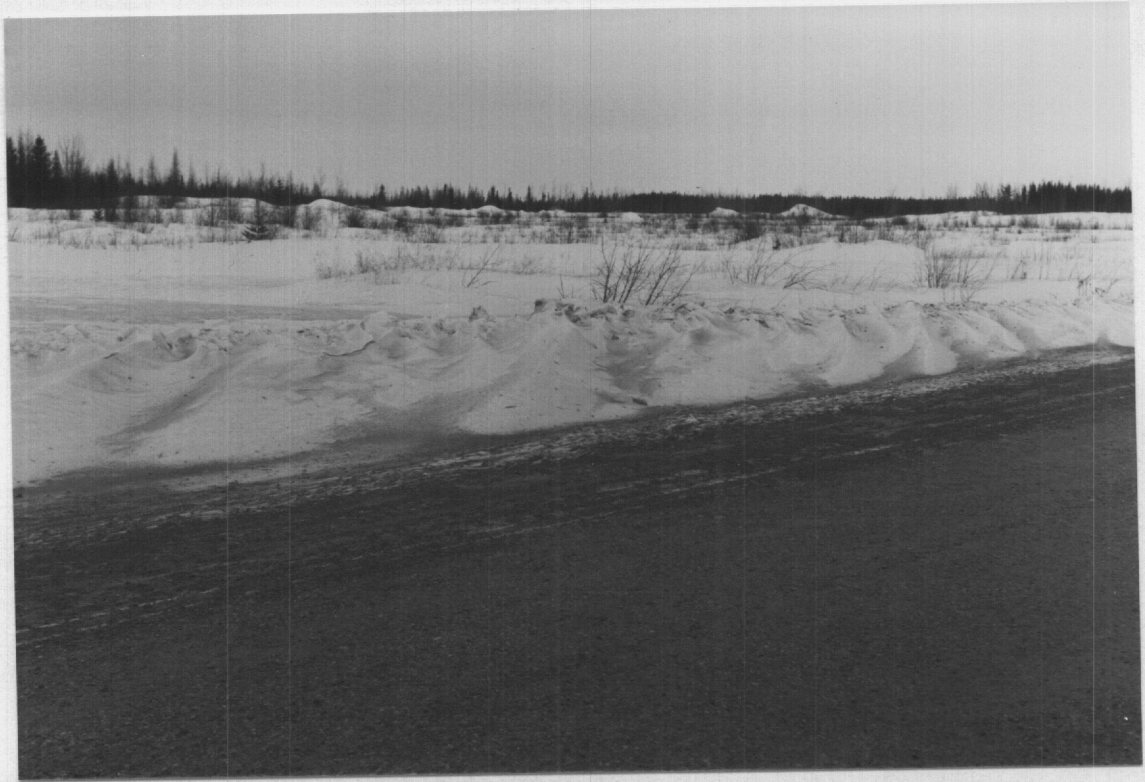
1. Deposit 1-10: View west from Highway 1. This source is essentially depleted, and in need of rehabilitation.

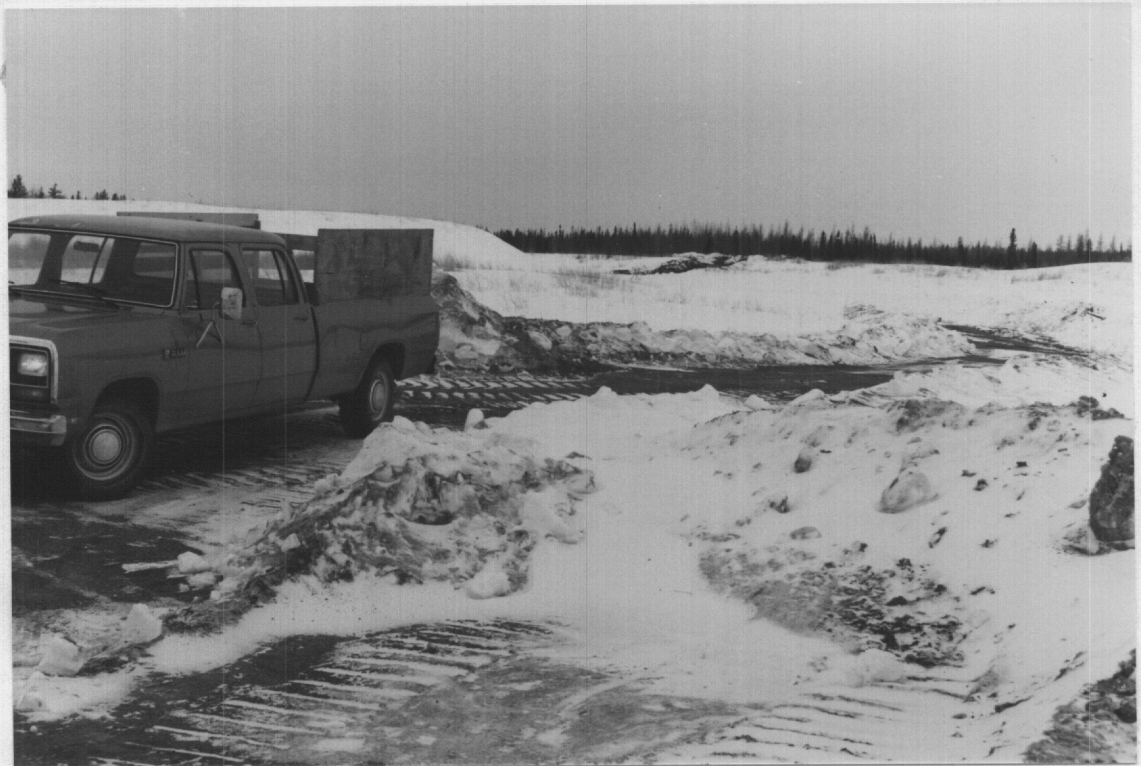
2. Deposit 1-11: View towards south over depleted pit area. A Highways Department crushed material stock pile is visible in the background.

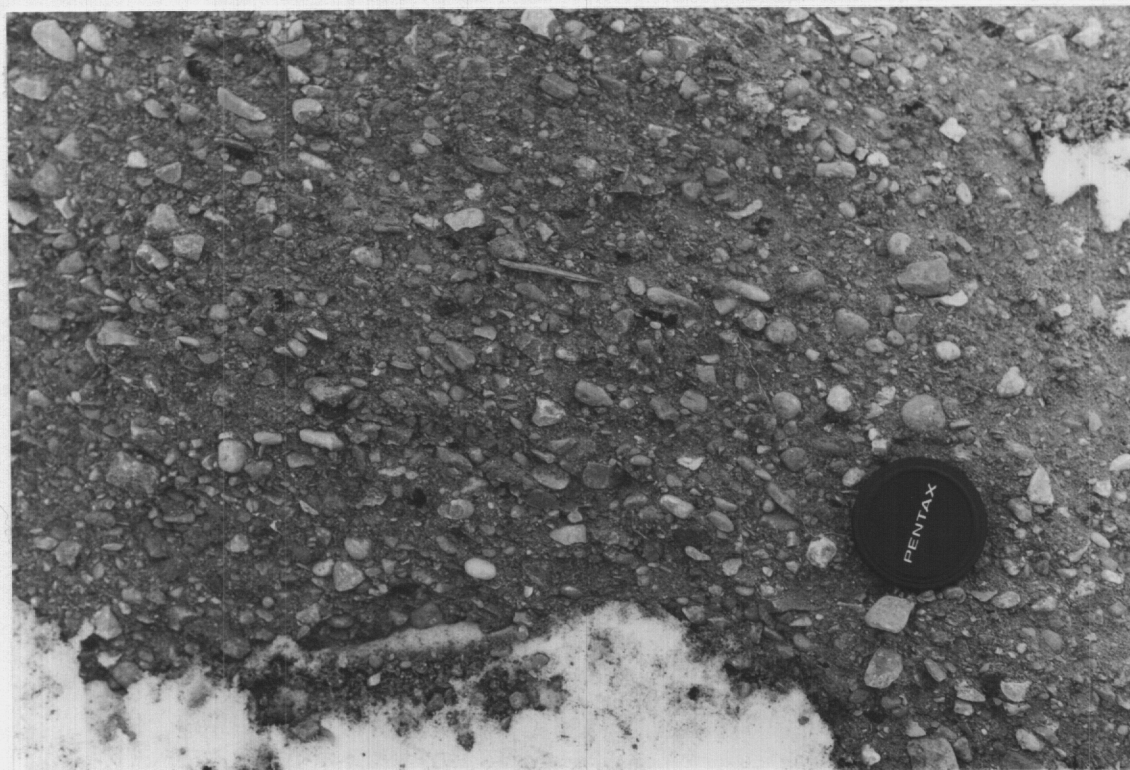
3. Deposit 1-11: Close-up of crushed material in Highways Department stockpile.

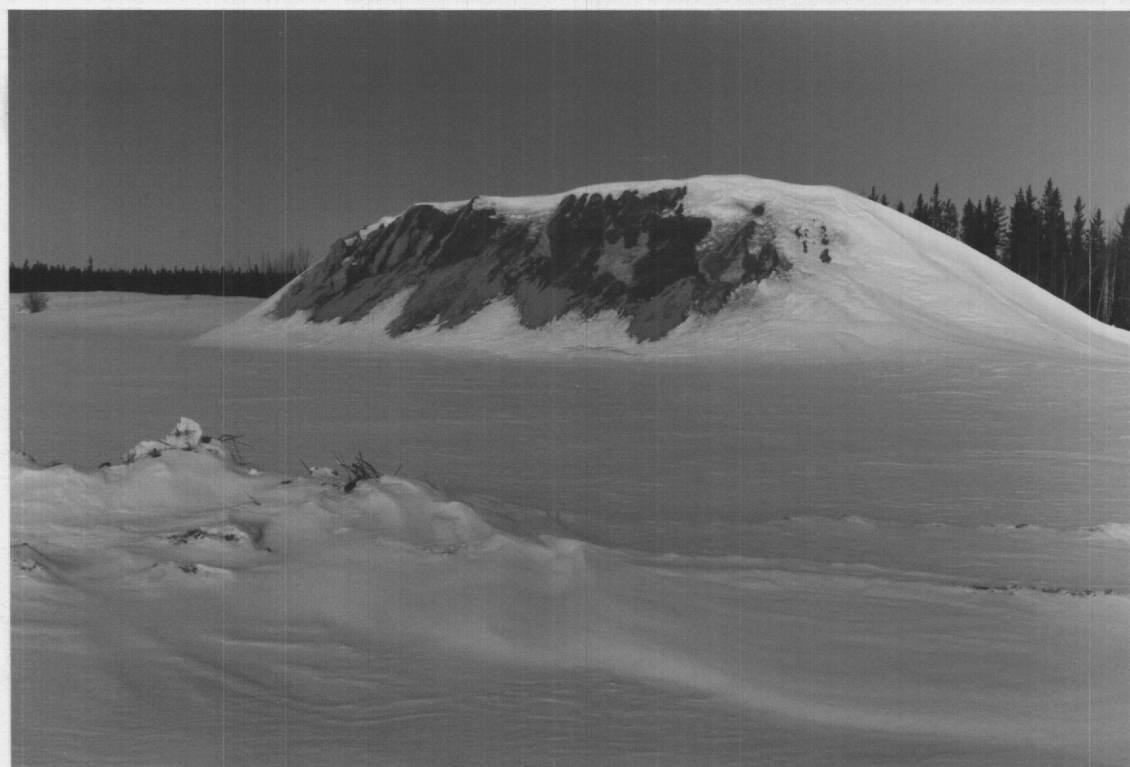
4. Deposit 1-15: View to west from Highway 1 (km 66.6) to Highways Department stockpile, consisting of crushed limestone bedrock blended with sand from Deposit 1-15 (km 77.2).

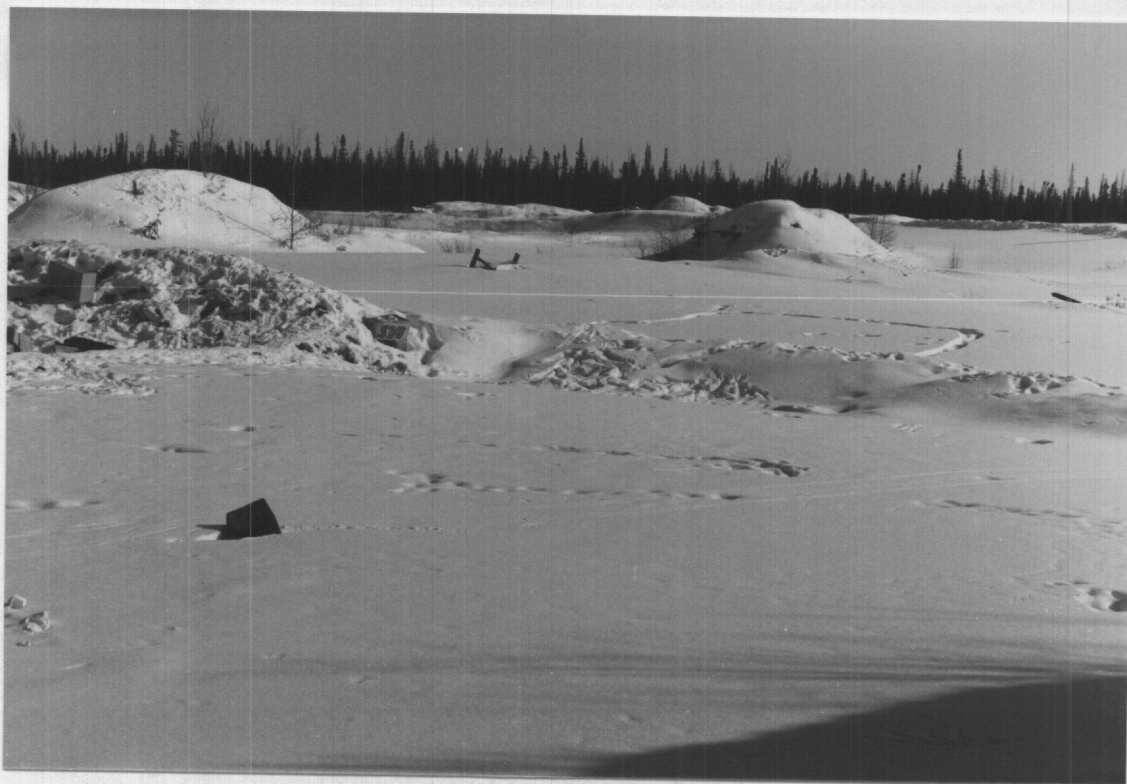
6. Deposit 2-1 (HR-100): View to north across Enterprise nuisance grounds in depleted portion of deposit. Overburden stockpiles and poorly drained depressions on pit floor should be noted.

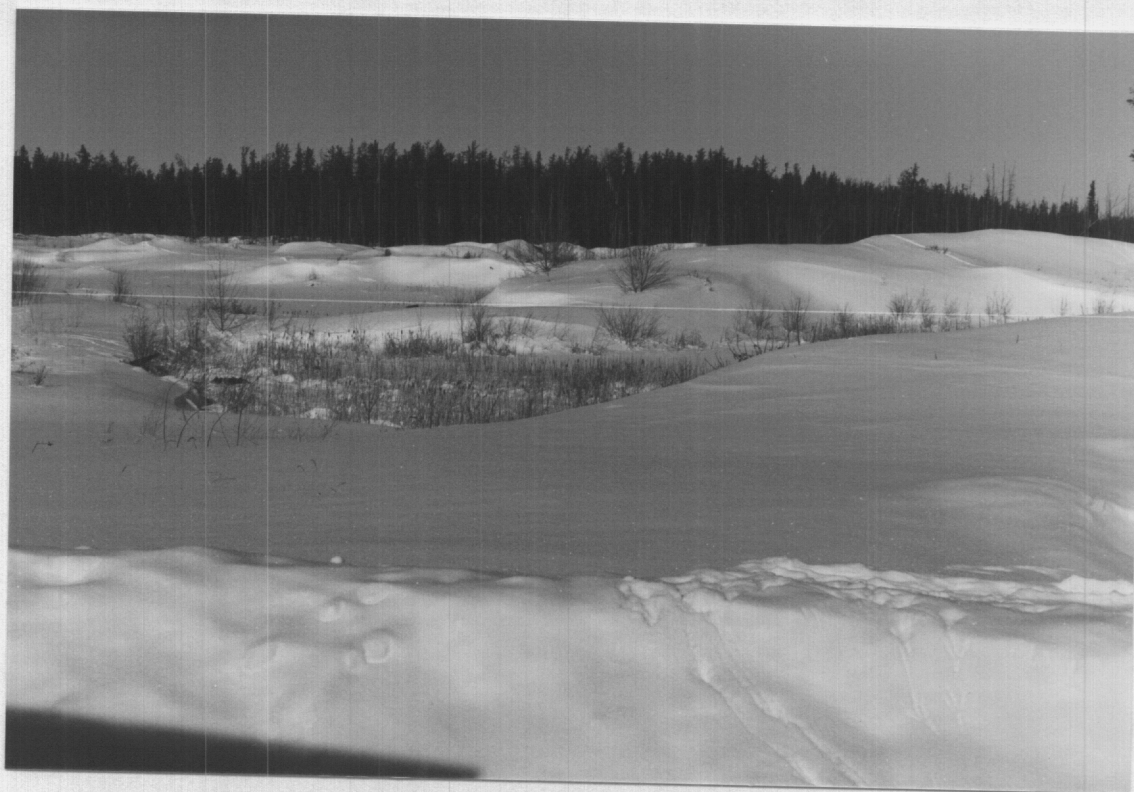
7. Deposit 2-1 (HR-100): Close-up view of poorly drained depression on pit floor. Rehabilitation of areas excavated below the water table is difficult.

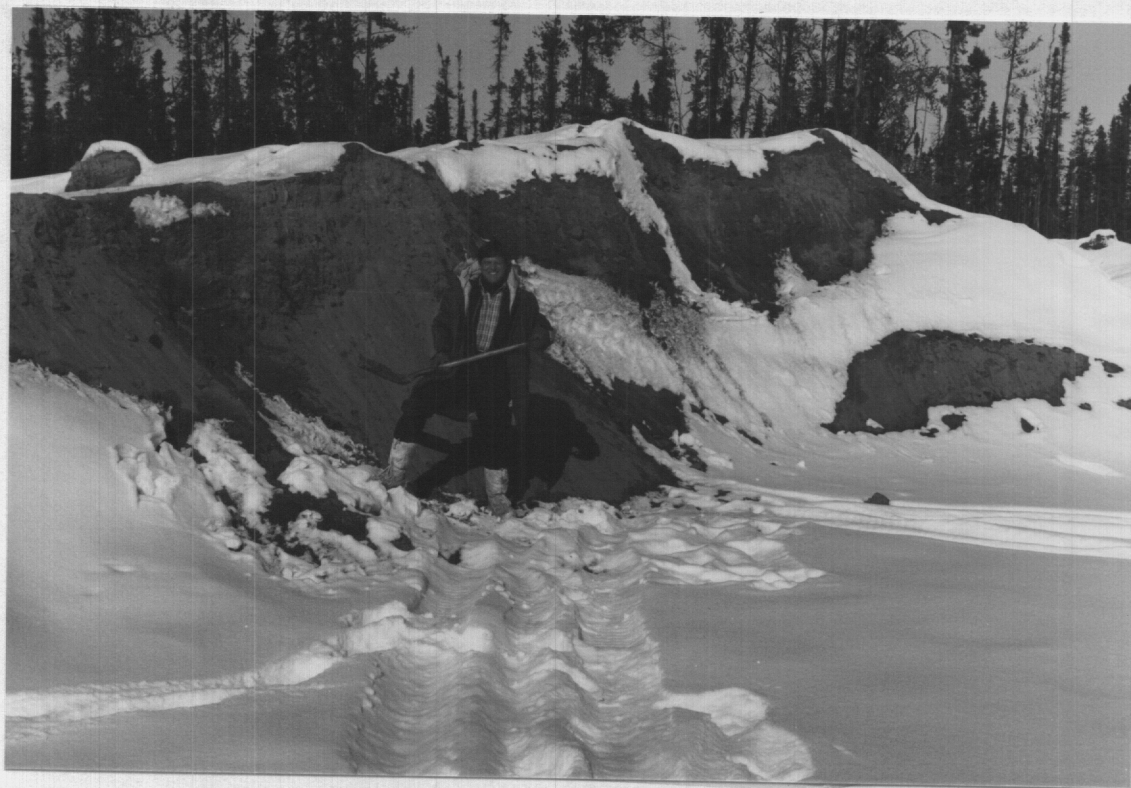
8. Deposit 2-11 (HR-105): View to east of Town of Hay River sand pit. Clean fine sand has been pushed up; original material thickness (above water table) is about 1 m maximum.

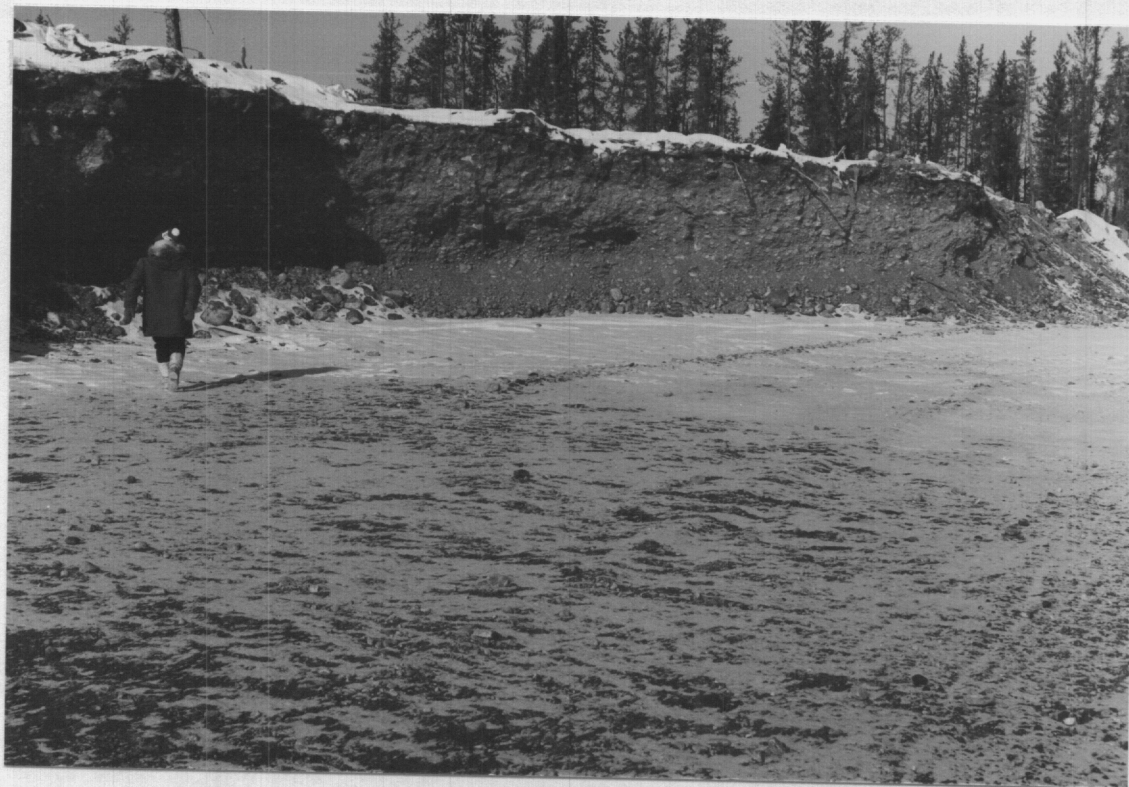
9. Deposit 5-6 (HR-109A): View of west end of pit, recently excavated adjacent to Fort Smith winter road alignment in eastern section.

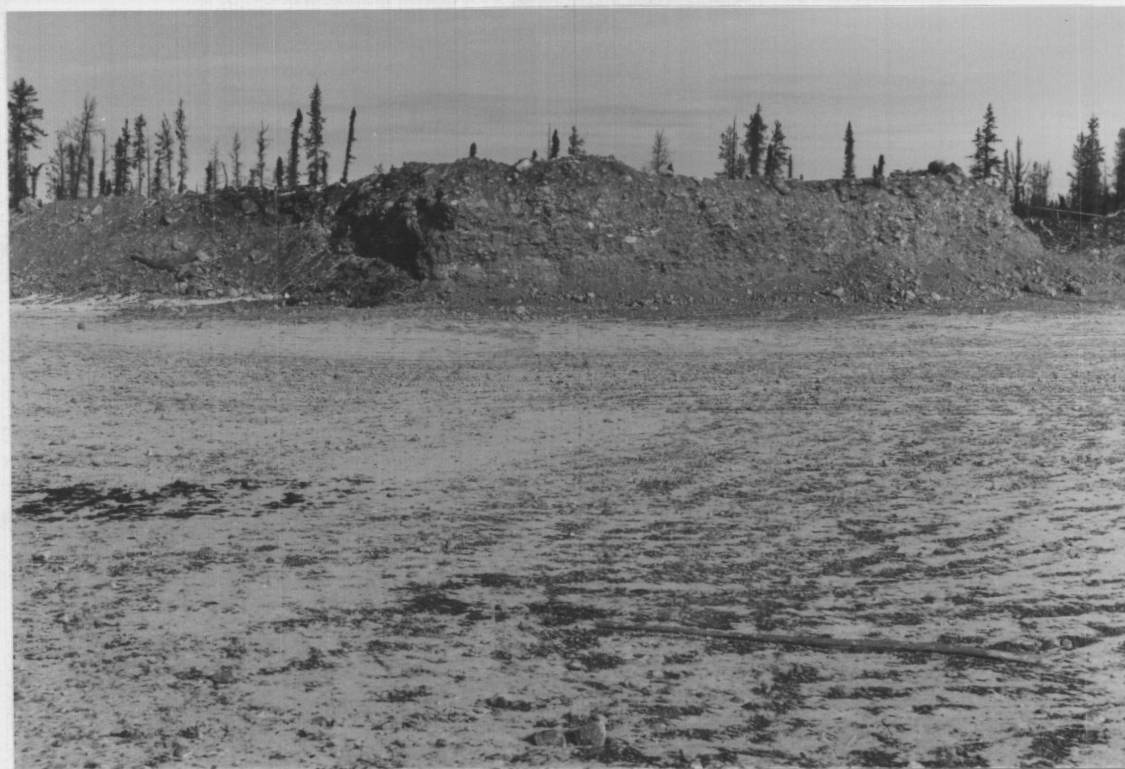
11. Deposit 5-6 (HR-109A): View of north side of recently-excavated pit, showing cobbly, relatively poorly graded, aggregate in upper section of deposit.

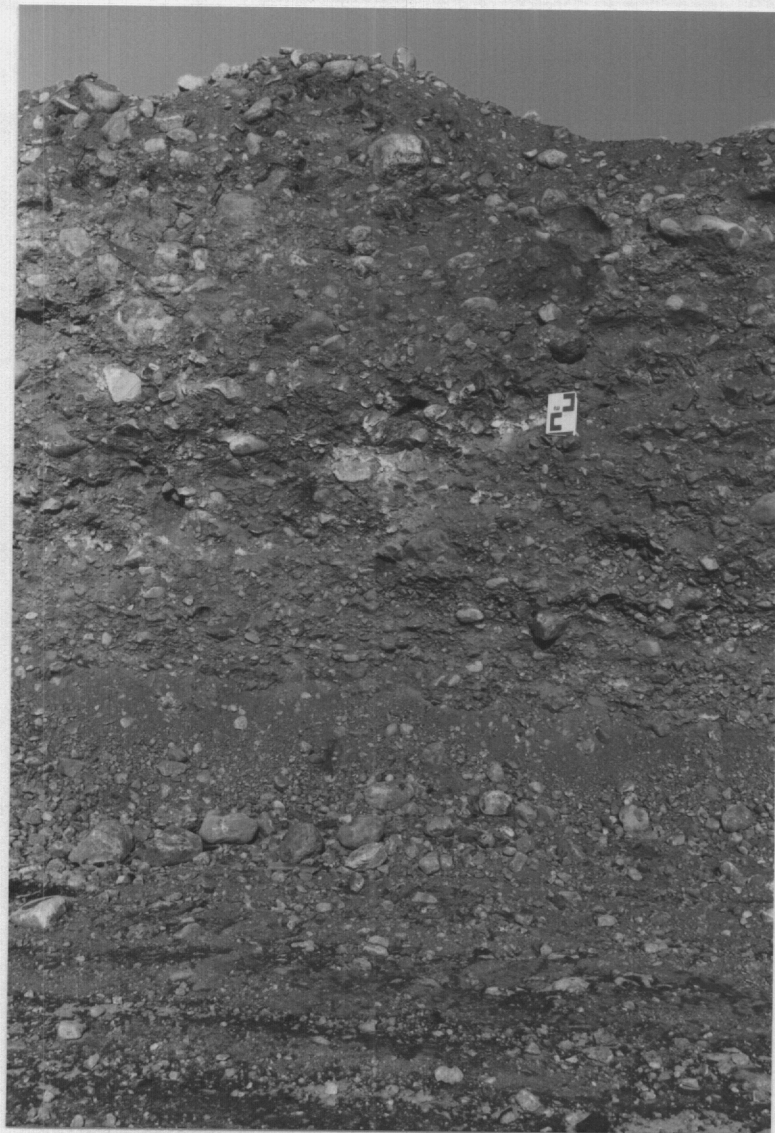
12. Deposit 5-6 (HR-109A): Close-up of poorly-graded and cobbly near-surface material exposed along north side of new pit at east end of deposit.

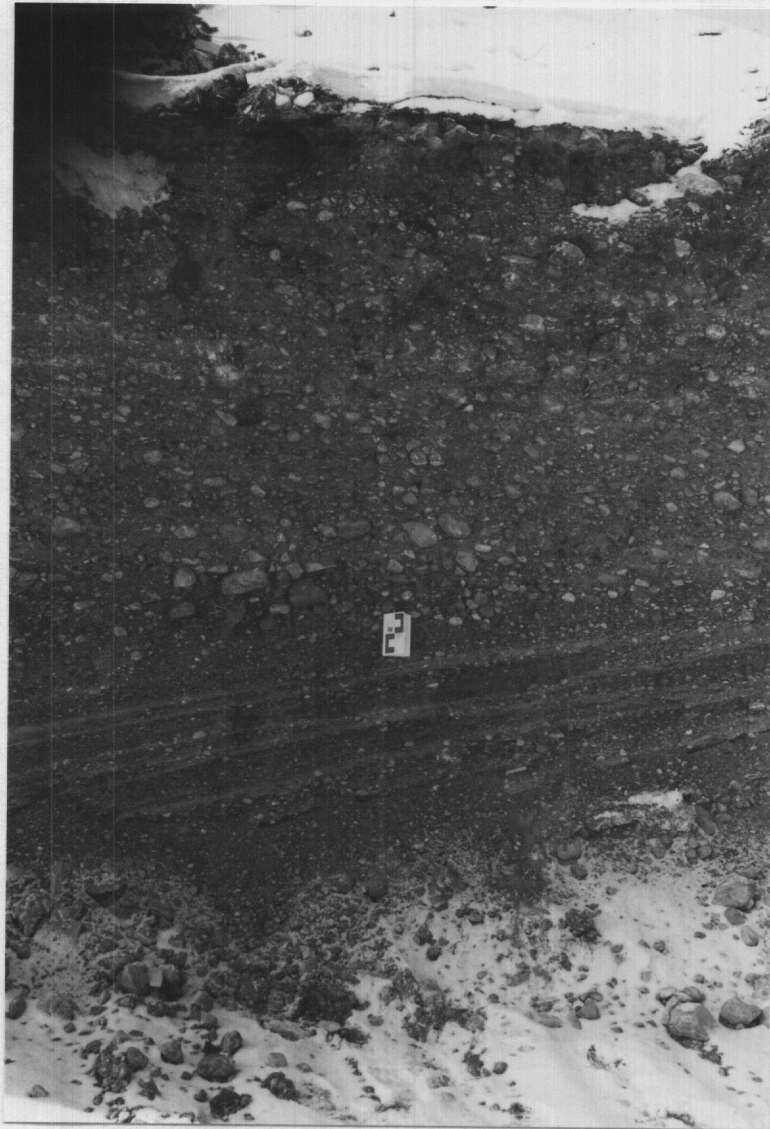
13. Deposit 5-6 (HR-109A): Close-up of east end of new pit, showing poorly-graded nearsurface aggregate overlying well graded fine sandy gravel.

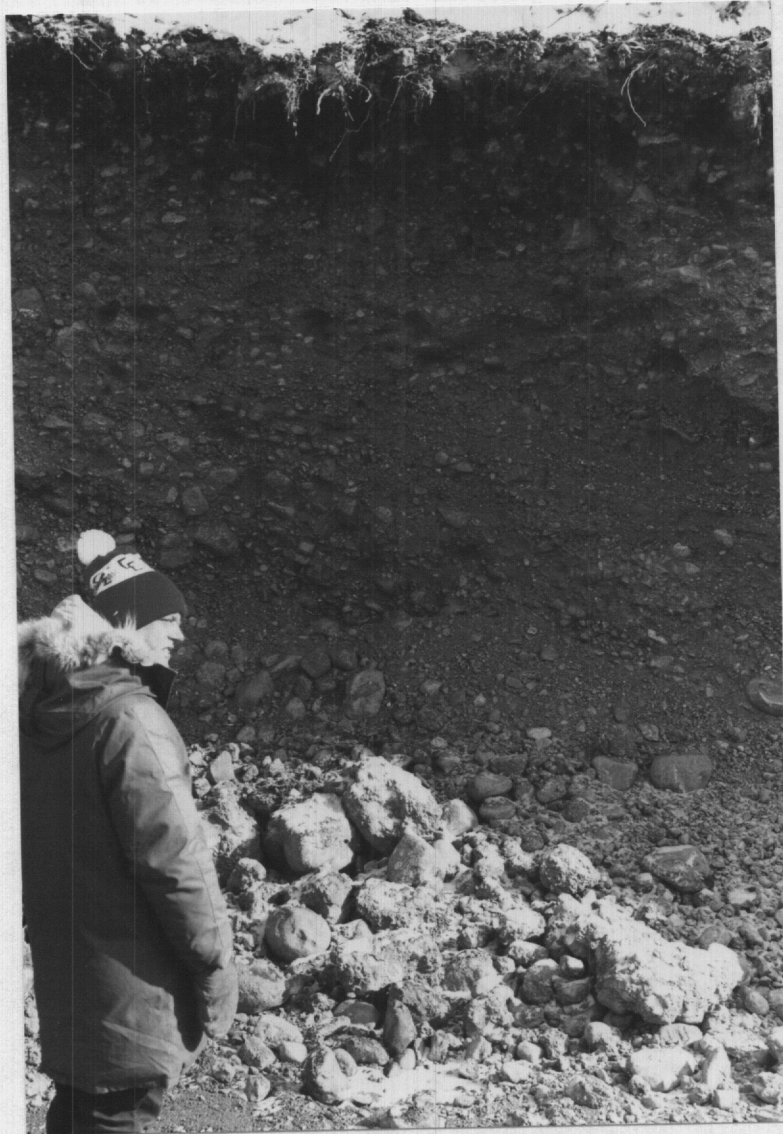
14. Deposit 5-6 (HR-109A): View of east end of newly developed pit, showing 3 m high face developed in cobbly moderately to poorly graded Class 3 material.
