**THURBER CONSULTANTS LTD.**

RE: GRANULAR RESOURCES MANAGEMENT STUDY  
SOUTH SLAVE REGION (DSS FILE: 38ST.A0632-6-5023)

In accordance with the contract for the above study, we are pleased to submit this photo album for your information. It provides documentation of the granular sources visited during the recent field reconnaissance.

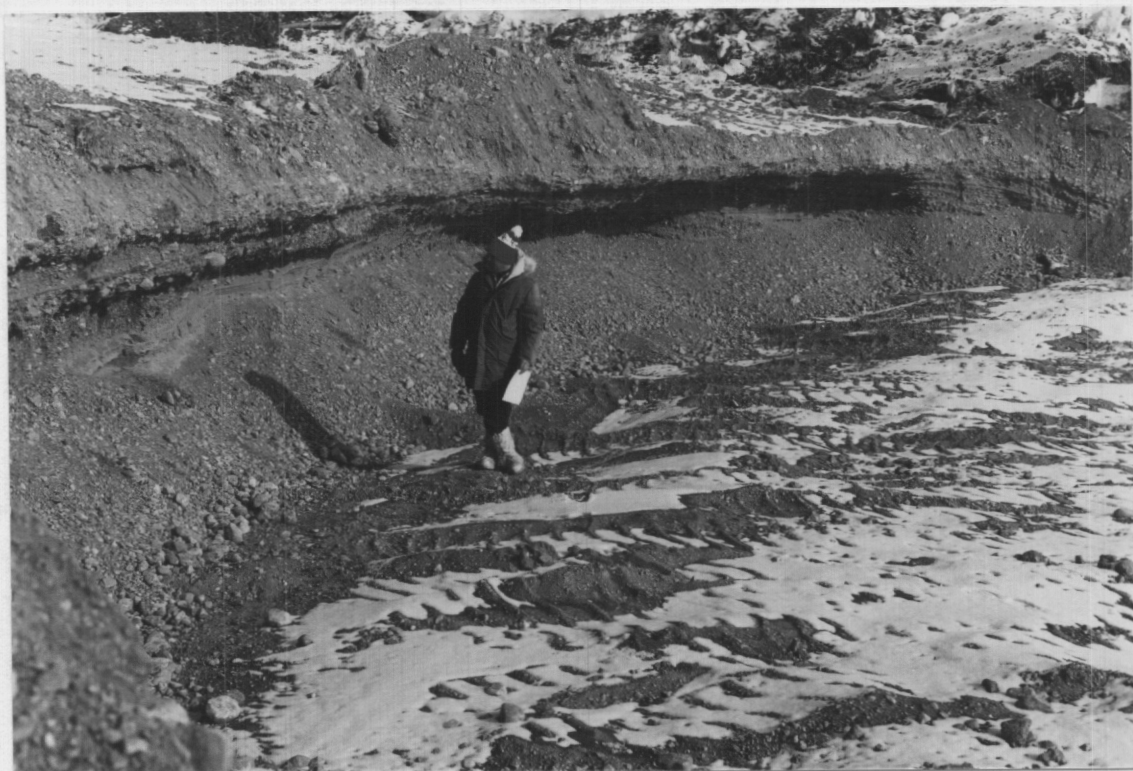
15. Deposit 5-6 (HR-109A): Small pit developed, adjacent to Fort Smith winter road alignment, by J. Pope of Hay River in well graded Class 1 or 2 aggregate.

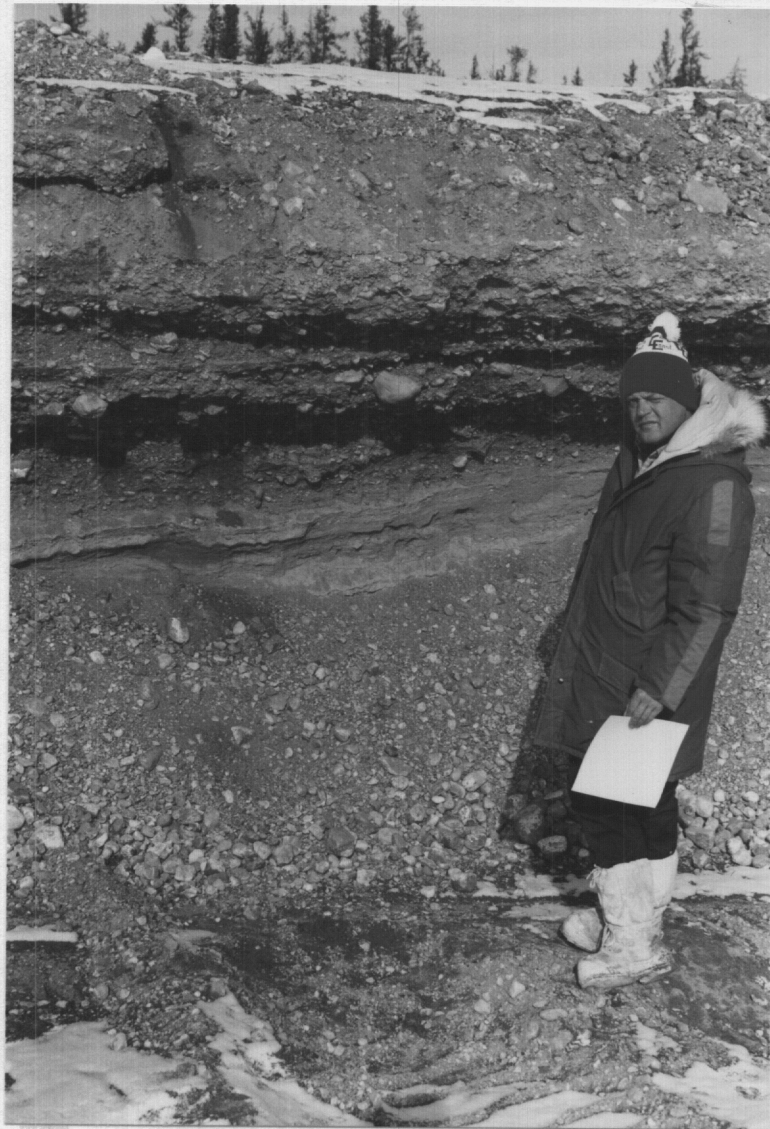
16. Deposit 5-6 (HR-109A): Close-up of "Pope's" pit, adjacent to winter road alignment and developed in well graded fine gravel.

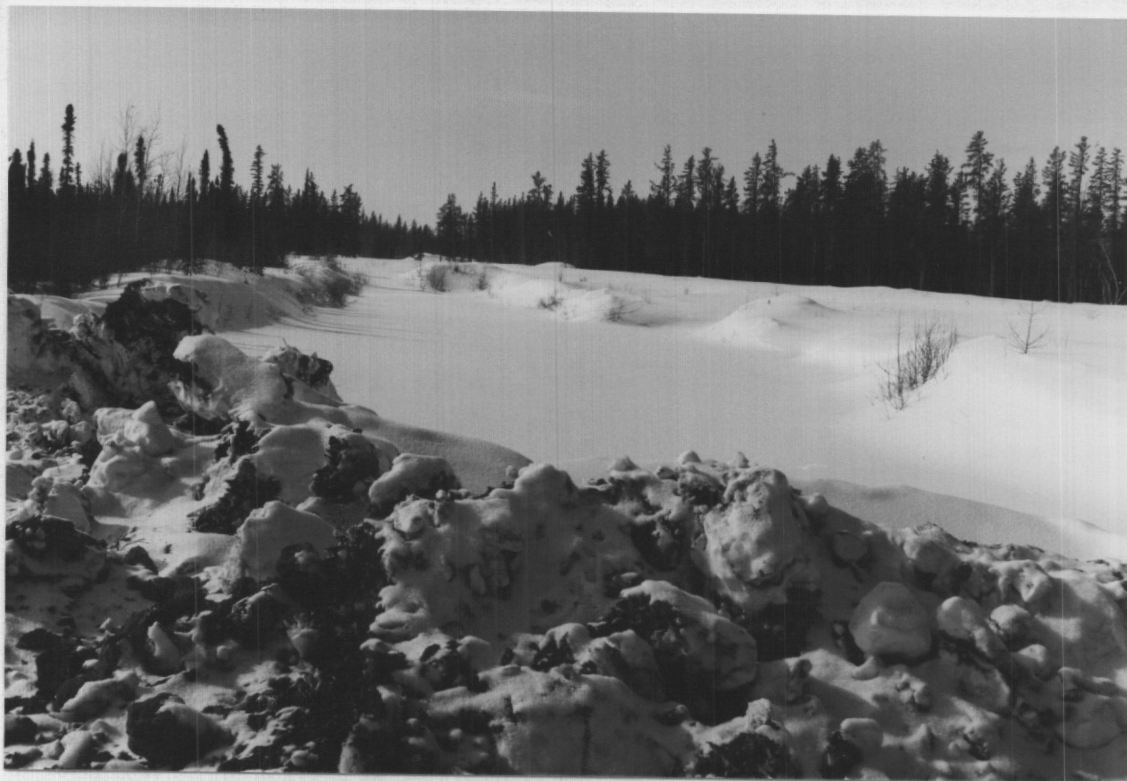
17. Deposit 5-6 (HR-109A): depleted area to west of Fort Smith winter road alignment (originally developed by CNR).

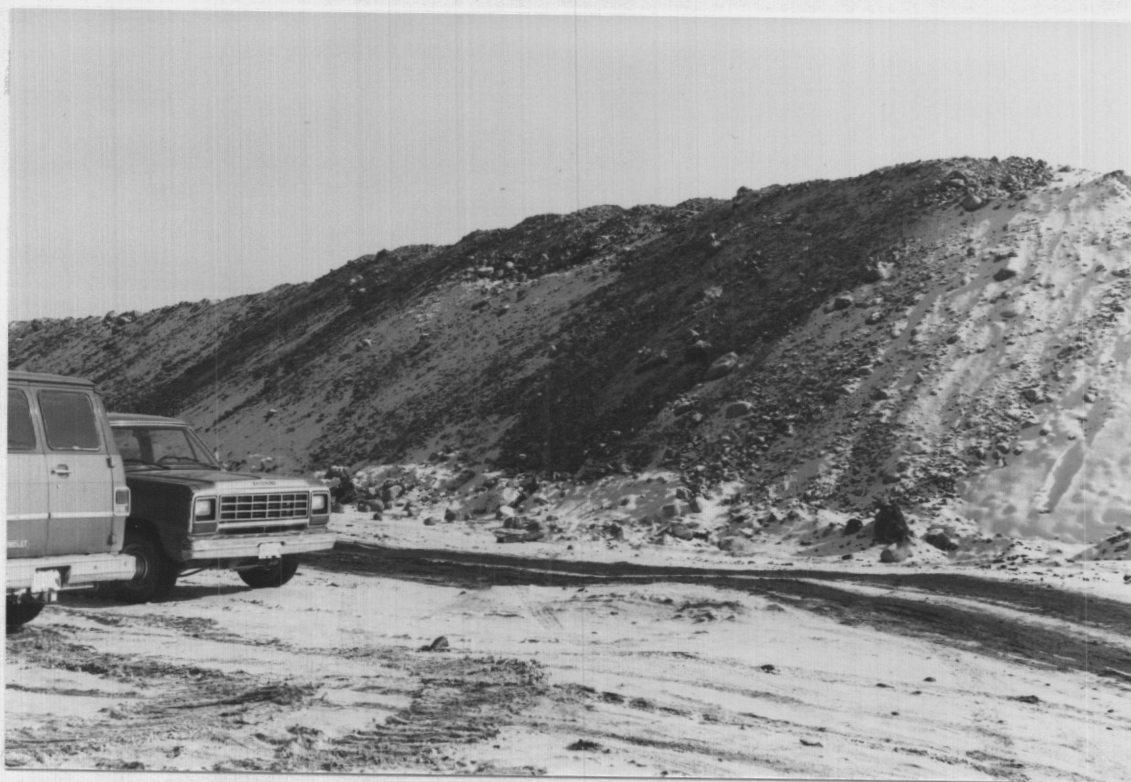
18. Stockpile at junction of Highway 5 and old Fort Smith winter road. Material is from pit developed at east end of Deposit 5-6.

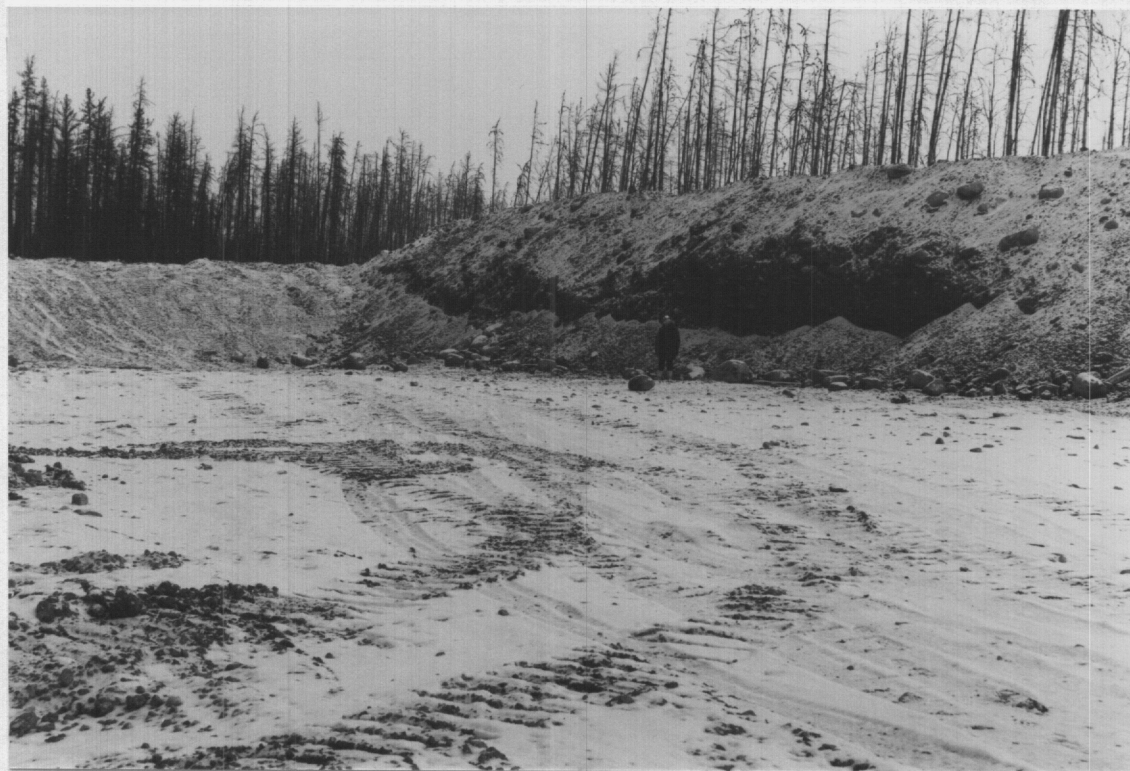
19. Deposit 5-14 (HR-124A): northeast corner of recently developed pit. 2.5 m to 3 m of gravel has been removed down to the underlying clay till.

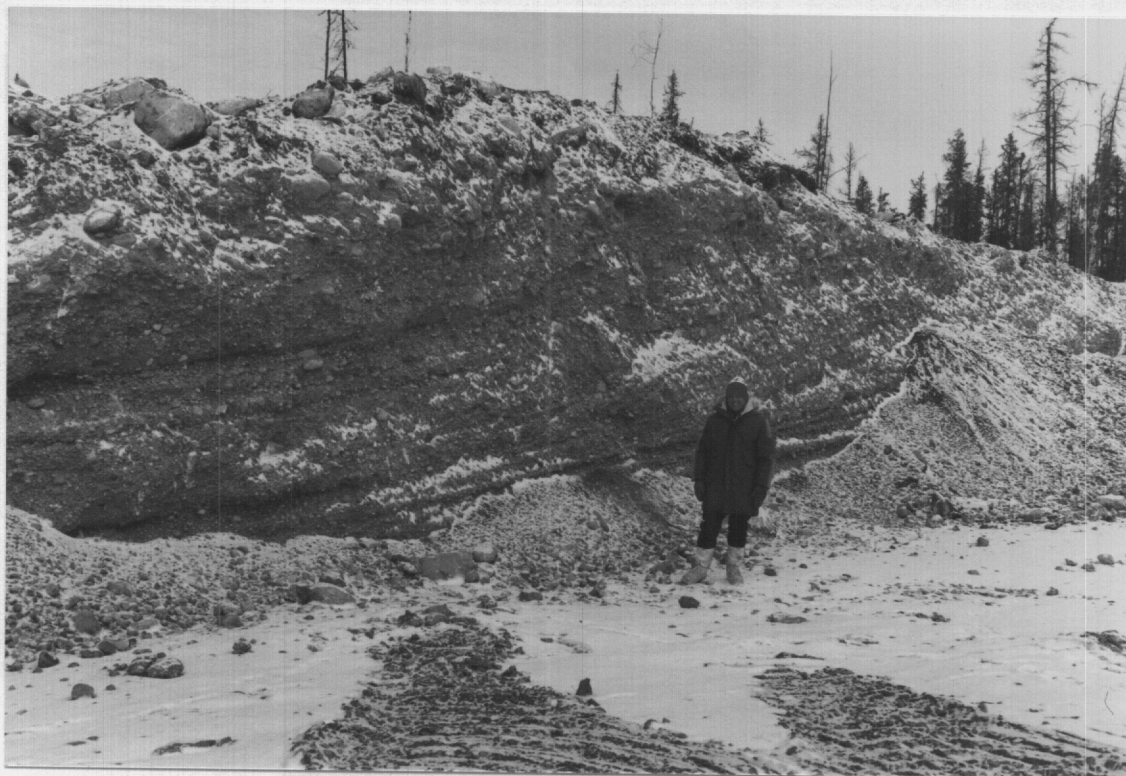
20. Deposit 5-14 (HR-124A): Exposure in side of pit access ramp, showing 2.5 m of moderately to poorly graded coarse aggregate (Class 3).

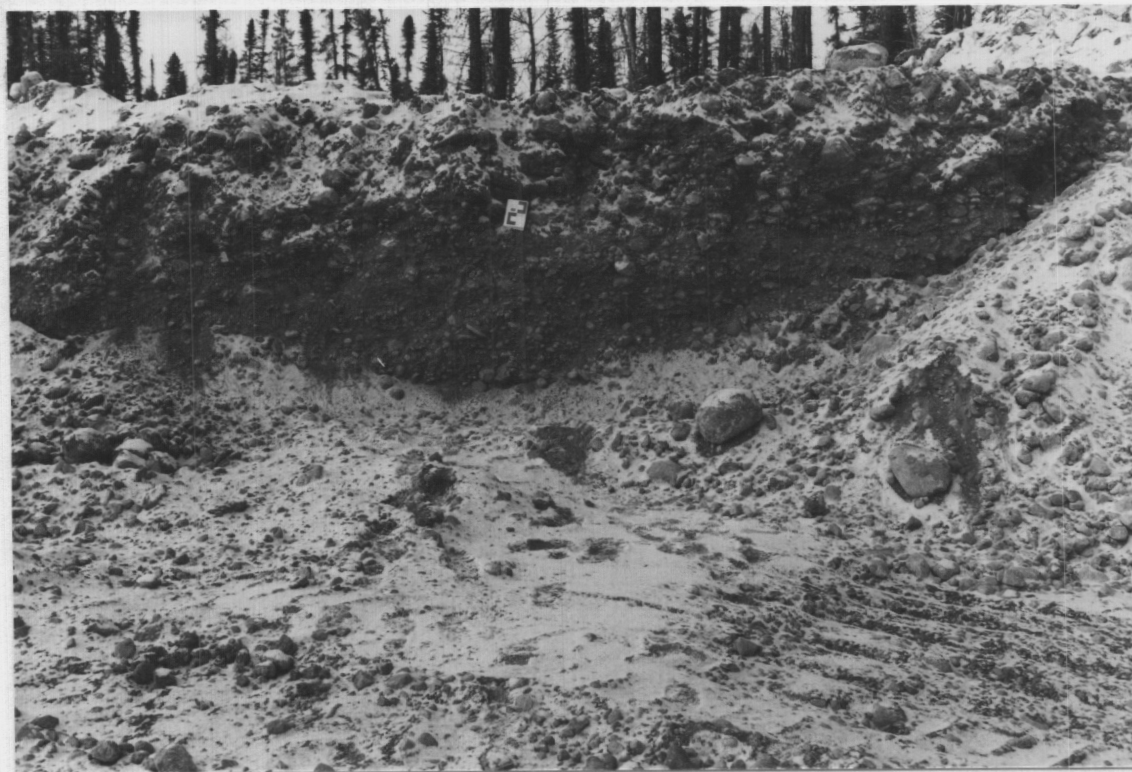
22. Deposit 5-14 (HR-124A): West end of recently developed pit. Material is only about 1.5 m thick, and less well graded.

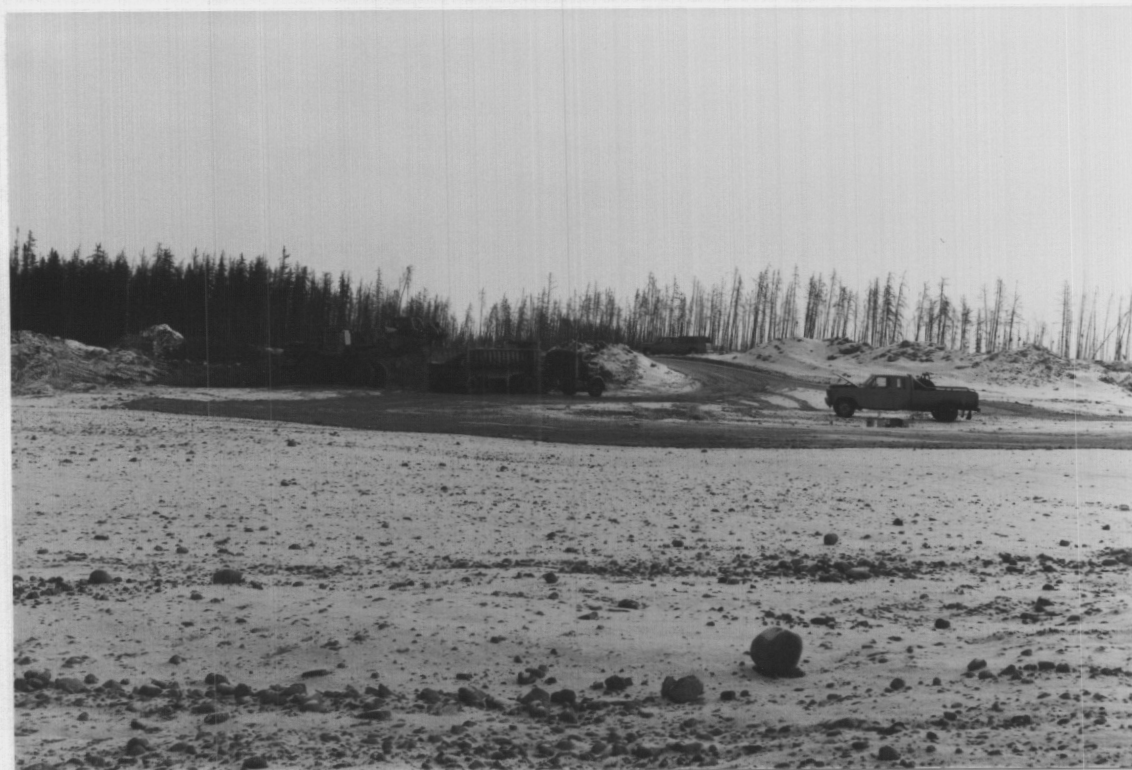
23. Deposit 5-14 (HR-124A): View to east across recently-developed pit.

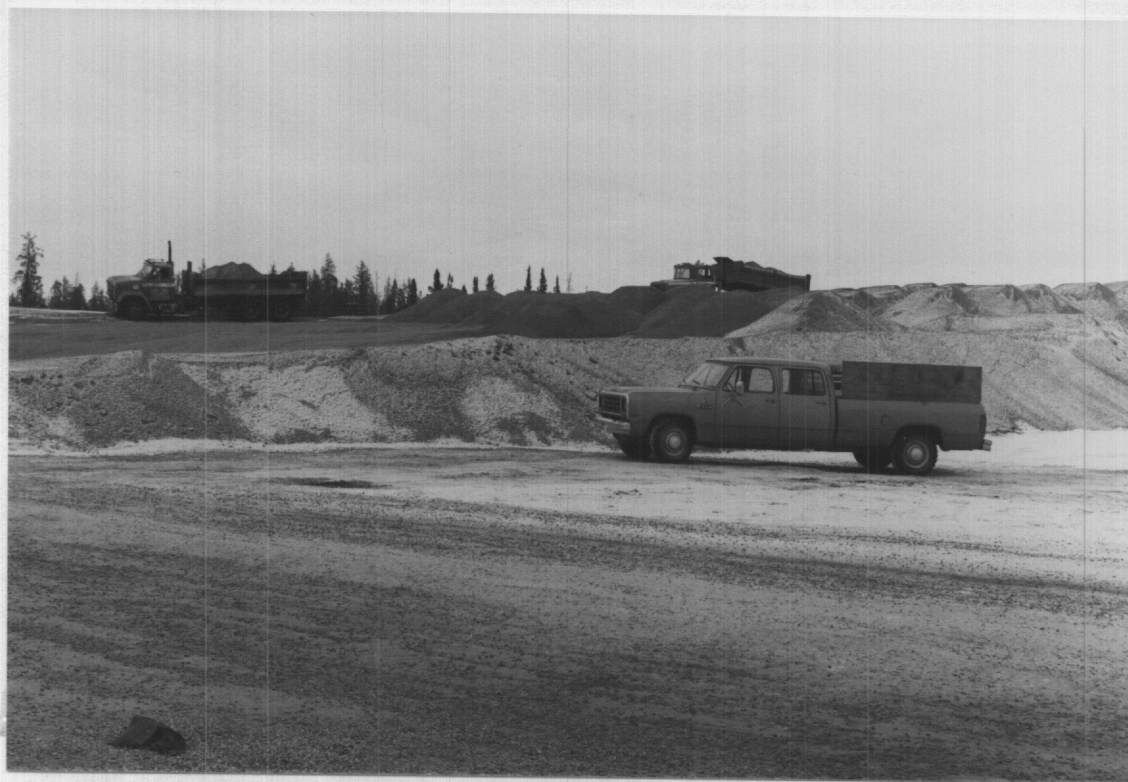
24. Deposit 5-40 (km 64.5): Crush material stockpile.

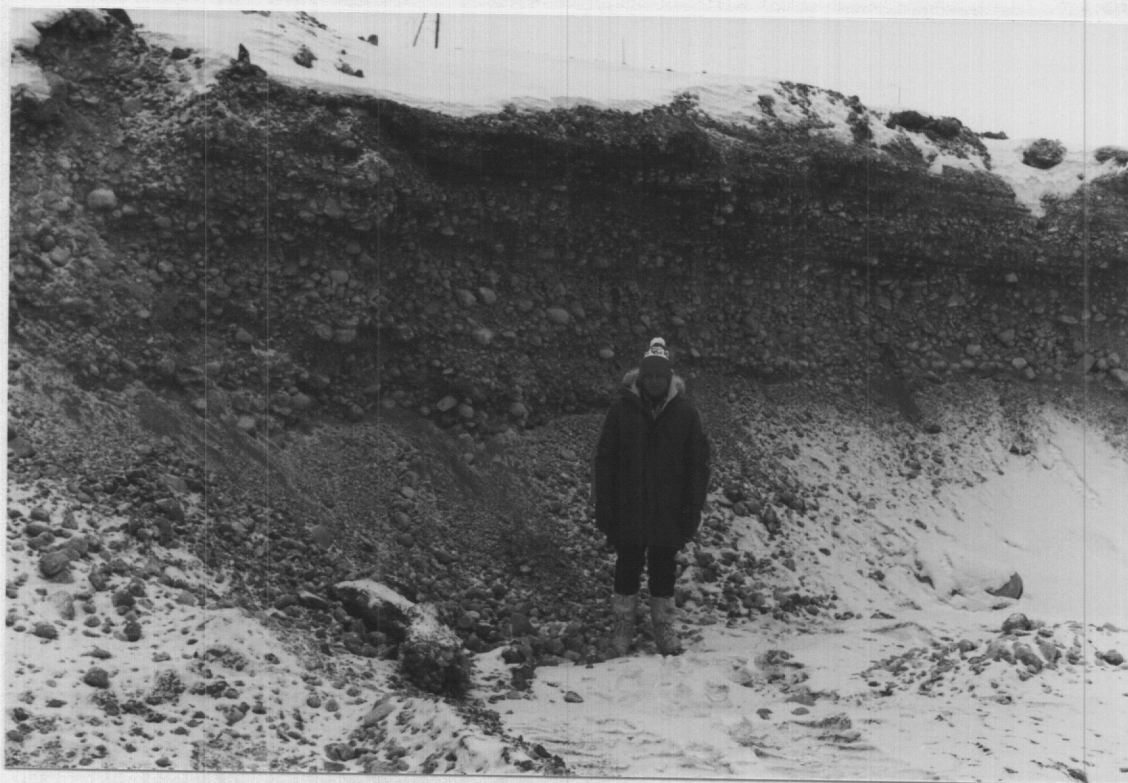
25. Deposit 5-40 (km 64.5): South end of recently developed pit, exposing about 2.5 m of moderately to well graded coarse aggregate.

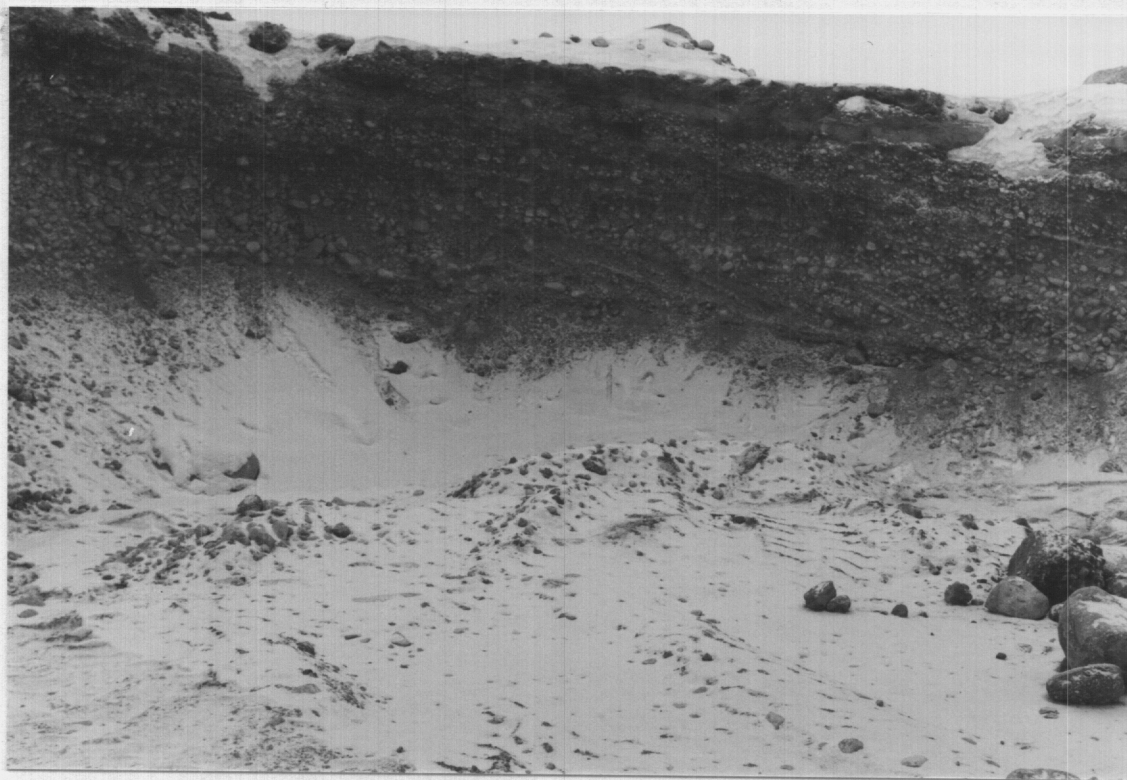
26. Deposit 5-40 (km 64.5): South end of recently developed pit, showing cross-beds (dipping to west) in finer material.

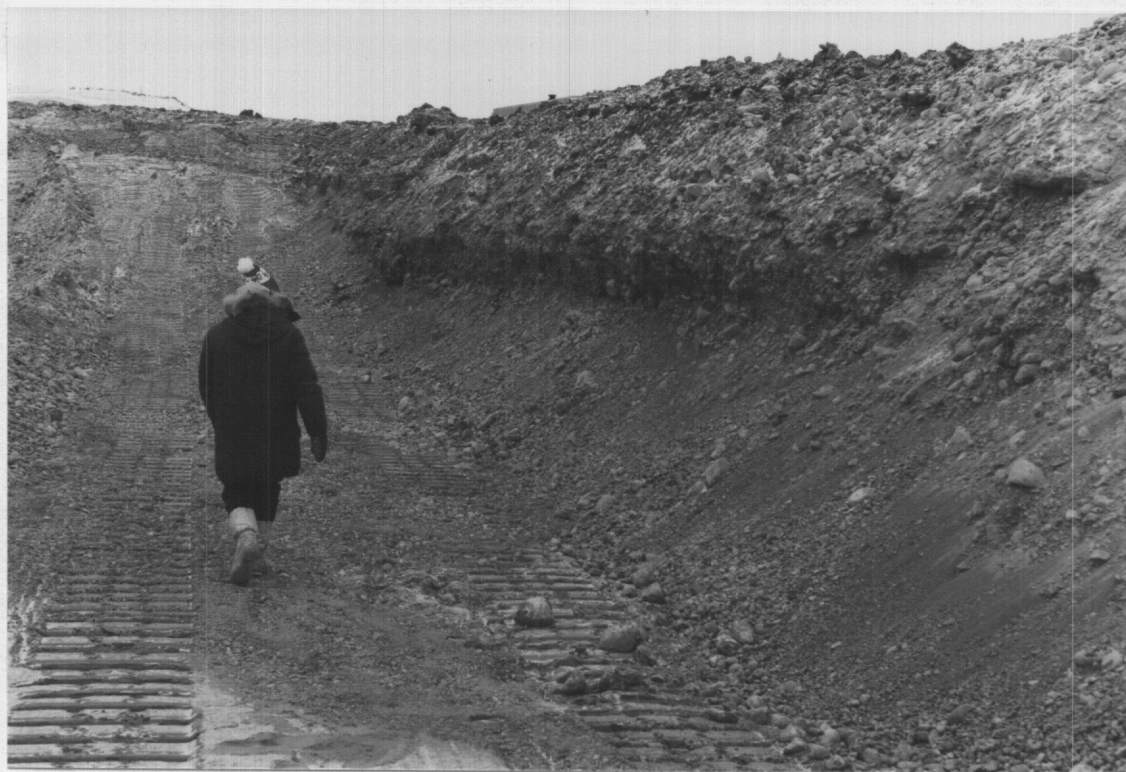
27. Deposit 5-40 (km 64.5): North end of existing pit, showing moderately to poorly graded aggregate, and uniform fine sand exposed in floor of pit.

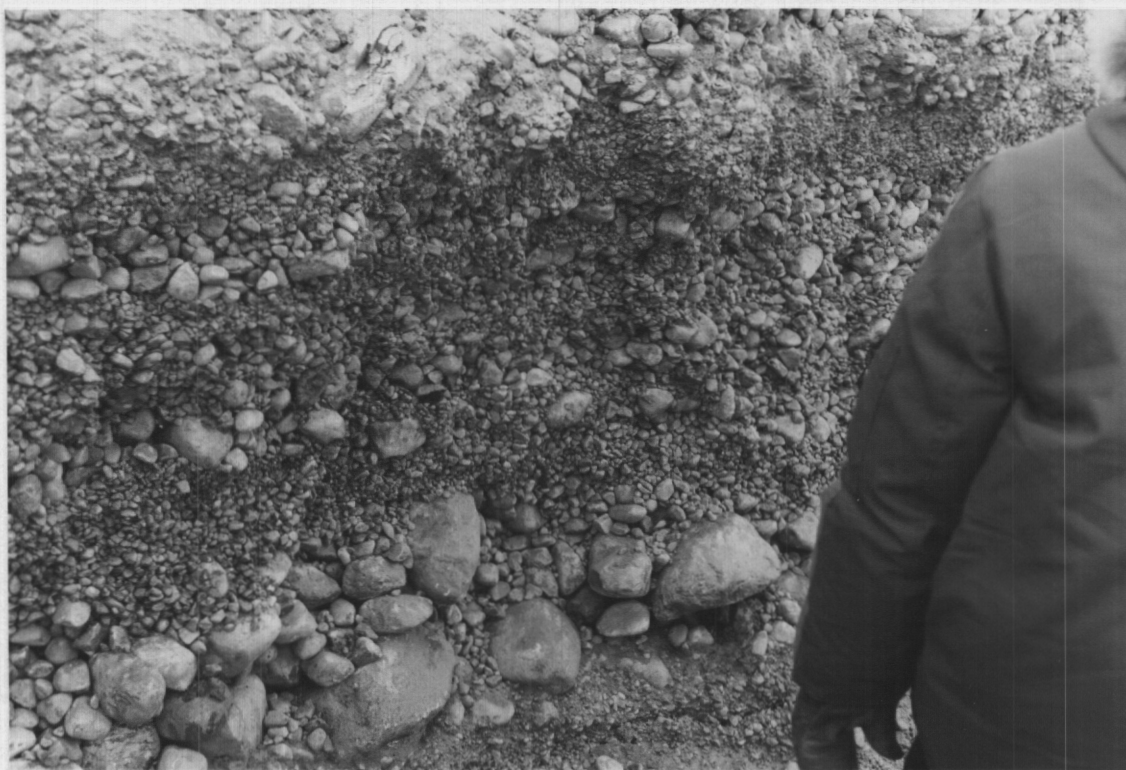
28. Deposit 5-40 (km 64.5): poorly and gap graded material in northern part of existing pit.

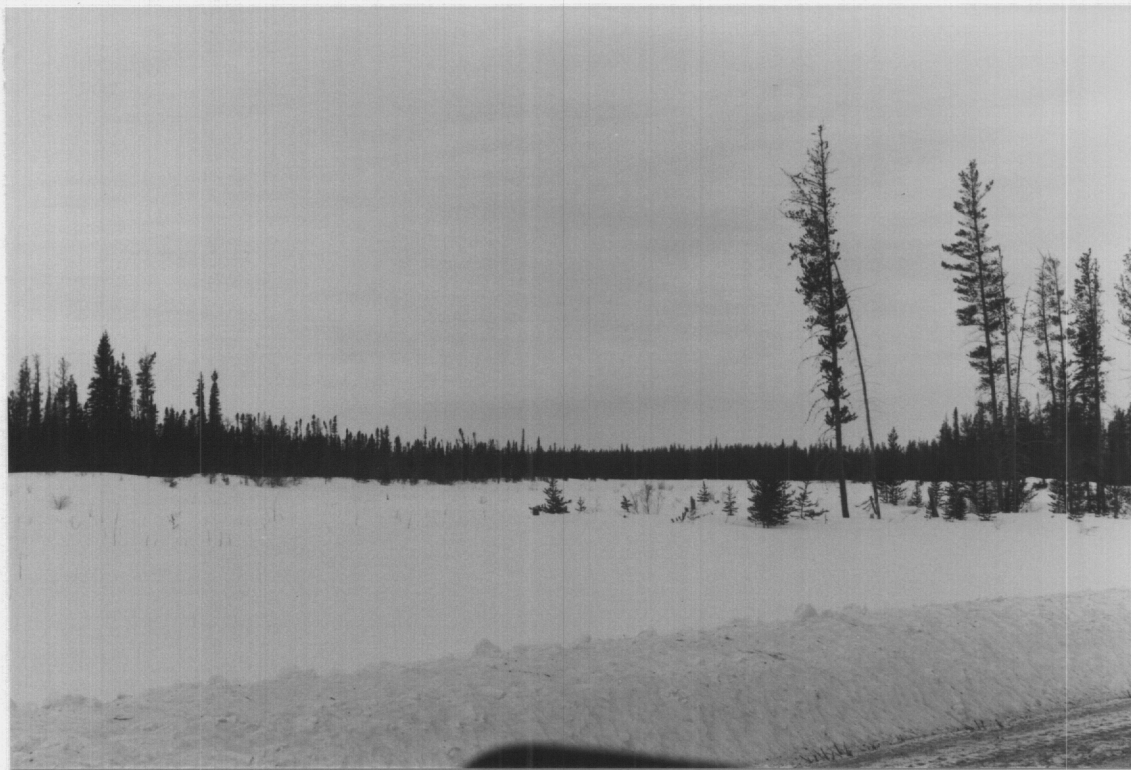
30. Deposit 5-42: View to west from Highway 5 across depleted and abandoned pit.

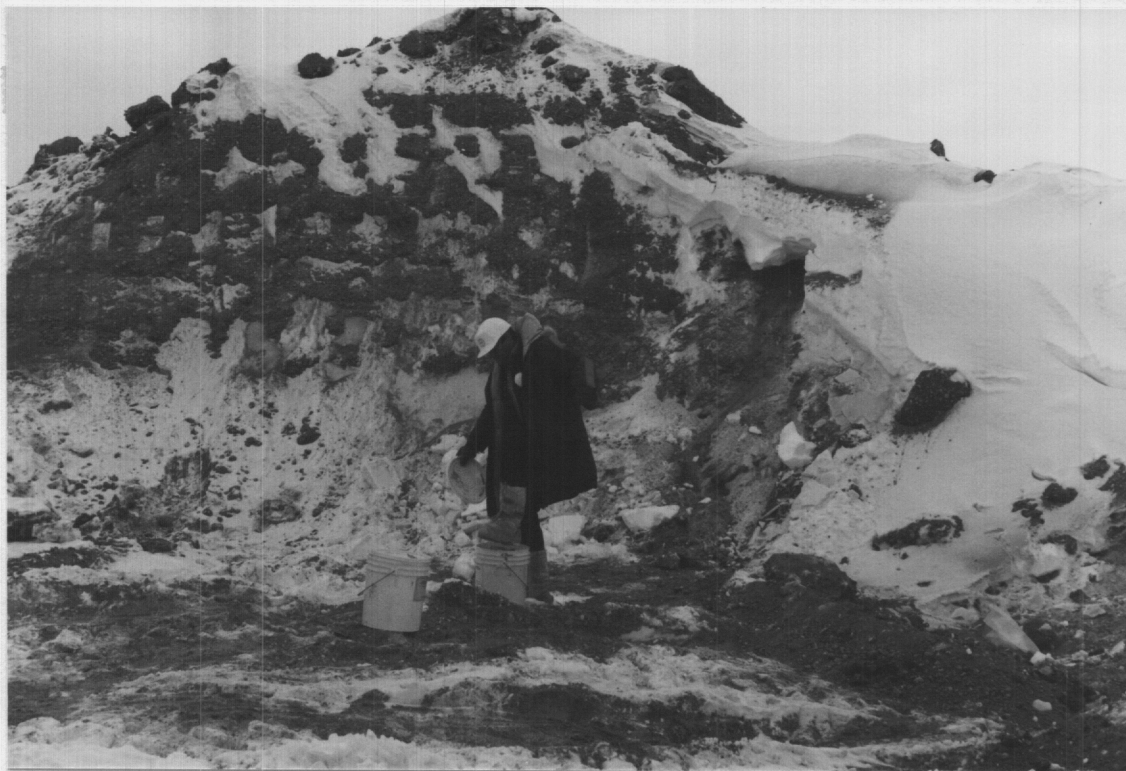
31. Concrete aggregate stockpile at Pine Point Mines plant site.

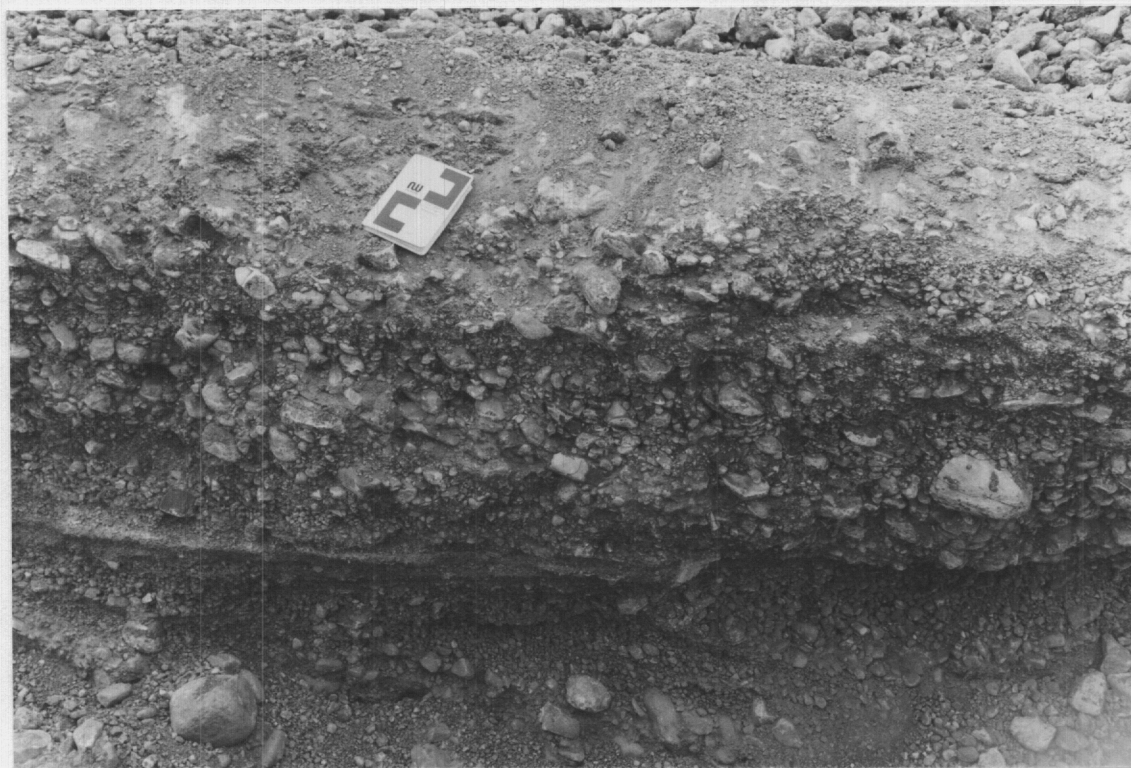
32. Poorly-graded gravel exposed in shallow road-side pit, Pine Point Mines.

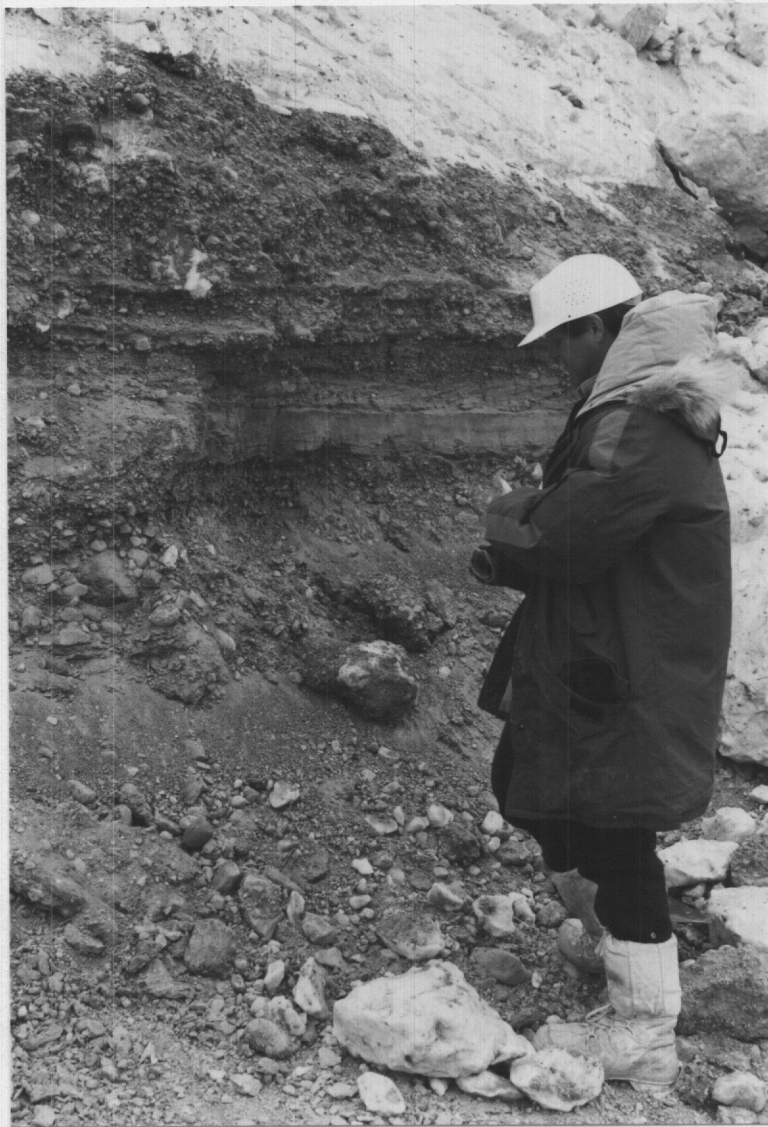
33. Poorly graded aggregate exposed in road fill pit east of Pine Point Mines plant site.

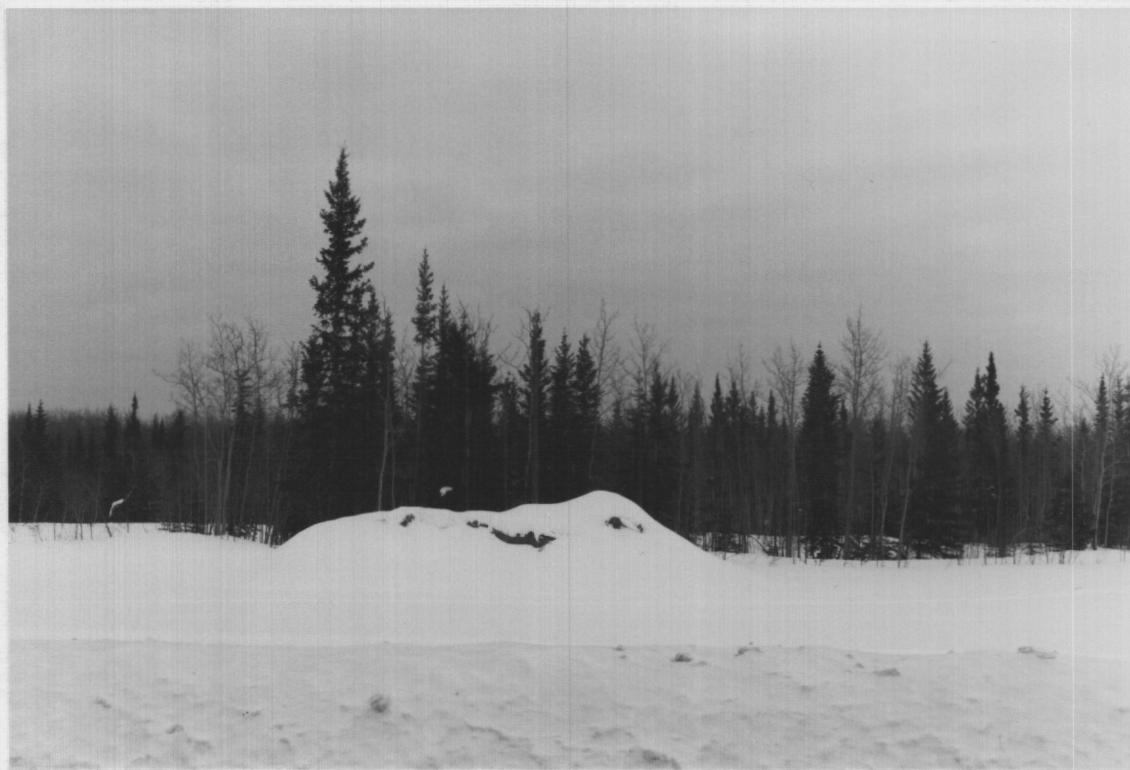
34. Deposit 6-18: View across existing shallow road-side pit at about km 62, Highway 6.

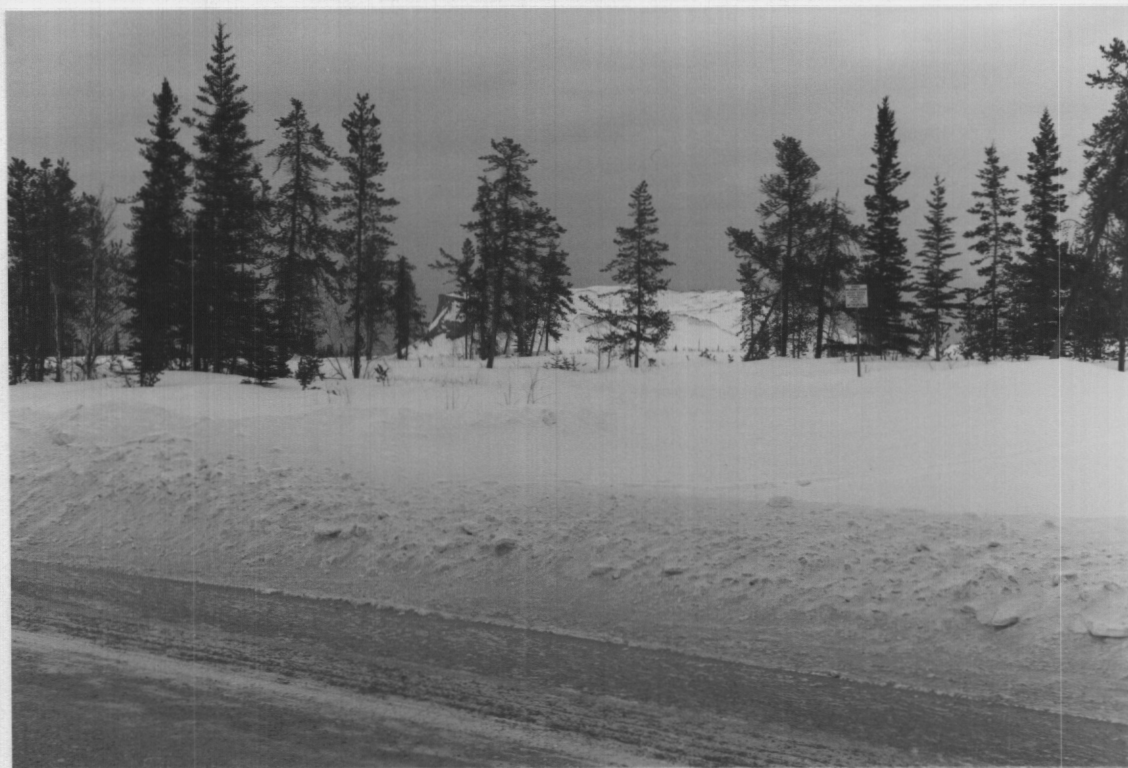
35. Deposit 6-19: View from Highway 6 towards Highways Department pit and stockpile.

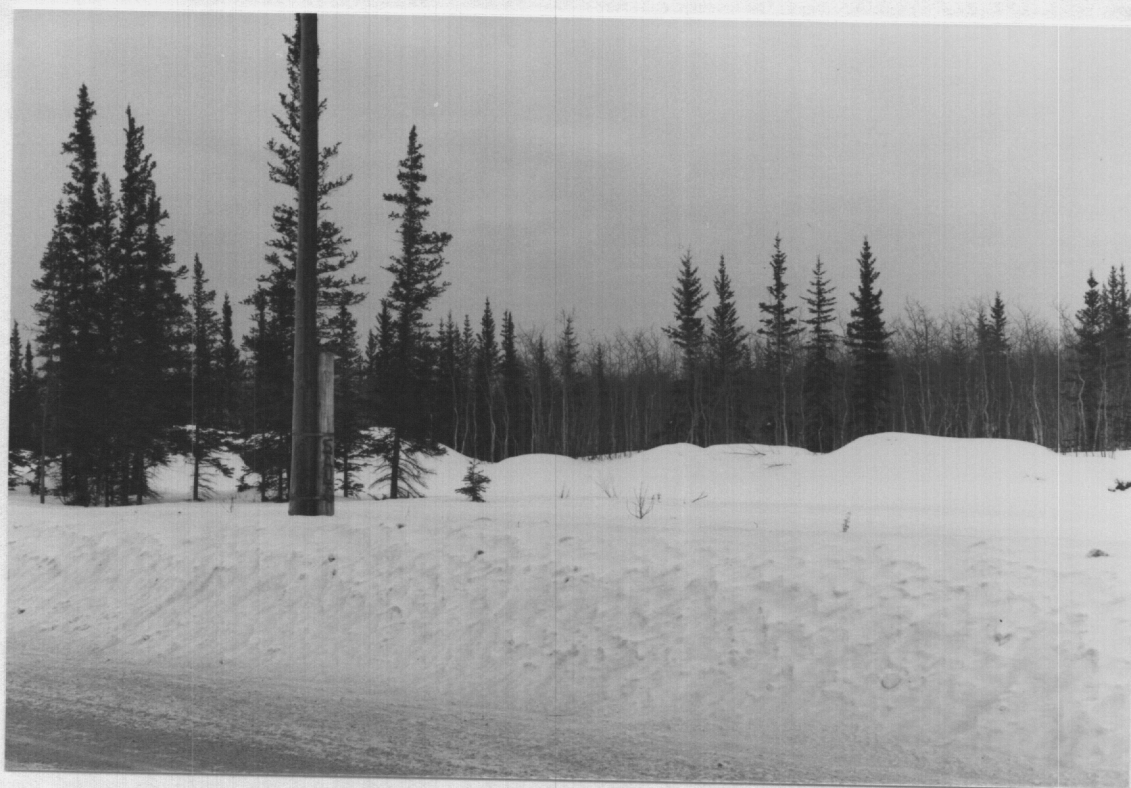
36. Deposit 6-20: View across existing pit adjacent to Highway 6 at about km 73.3.
