ENVIRONMENTAL REVIEW OF GULF CANADA
OPERATIONS IN THE MACKENZIE DELTA

DR. L. C. BLISS

GULF OIL CANADA LIMITED

FEBRUARY, 1976

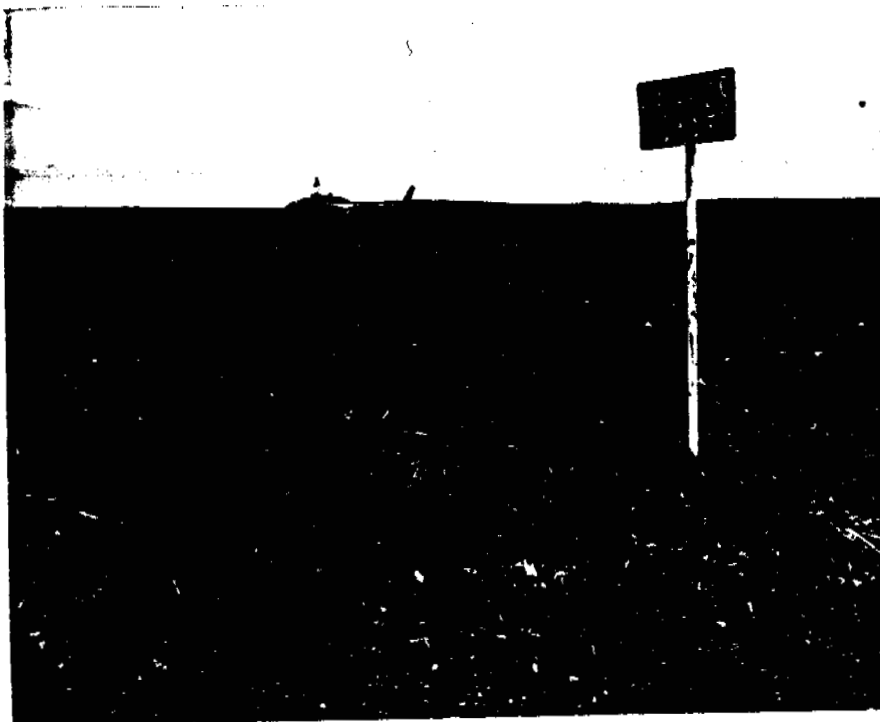
1037-5-6

Rig piling that will
continue to be exposed
for 2-3 years until the
gravel cover stabilizes.

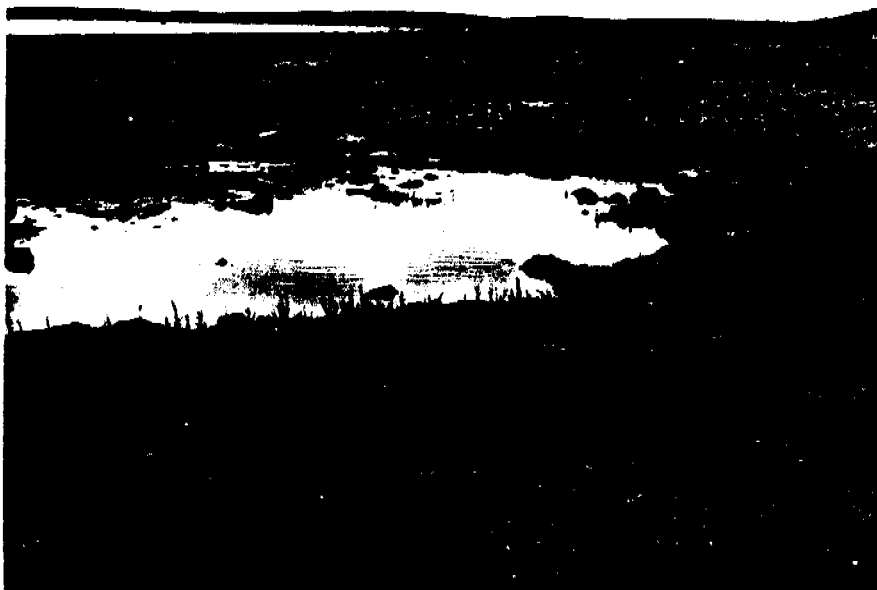
1037-11-10

Flare pit pond

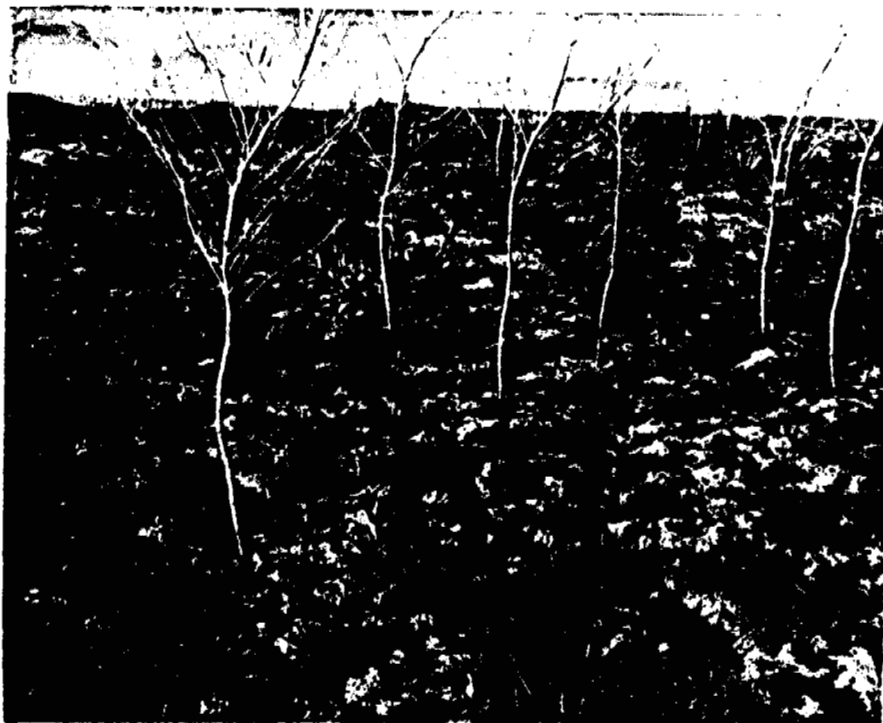
1037-26-11

Close-up of sump cap
showing establishment
of a weedy mustard plant
and a native sedge with
little or no grass

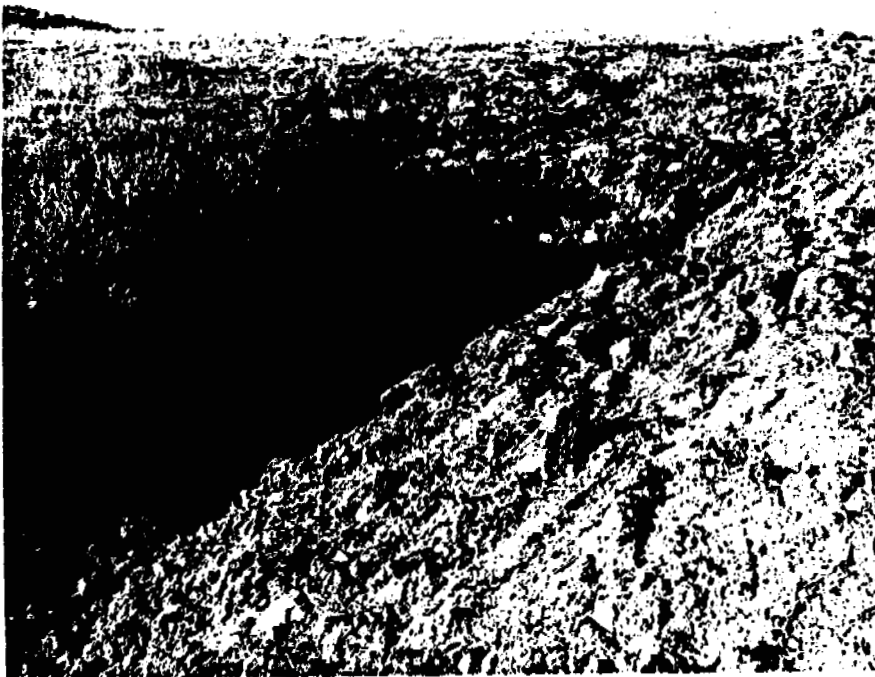
1037-17-12

This well, drilled in an area of massive ice-wedge high centre polygons has stabilized very well (1037-17-3). Initially ice-wedges 5-8 feet deep were exposed and covered with peat from the spoil pile. There appears to have been very little settlement in two summers (1037-17-12). Thus a site that had the potential for serious thermokarst problems has been stabilized. There are several small wet spots but they are smaller than in 1974 (972-20-1) and they should not be filled in, for more surface damage would be done in the process. Native species are invading the lease as well as a considerable cover of seeded grasses (1037-18-5).

Huge ice wedges were
filled with rip-rap
and peat and are now
quite stable

Rip-rap and peat were successfully used to prevent melt of massive ice wedges that were exposed at N-10. This procedure is recommended in future situations of this kind.

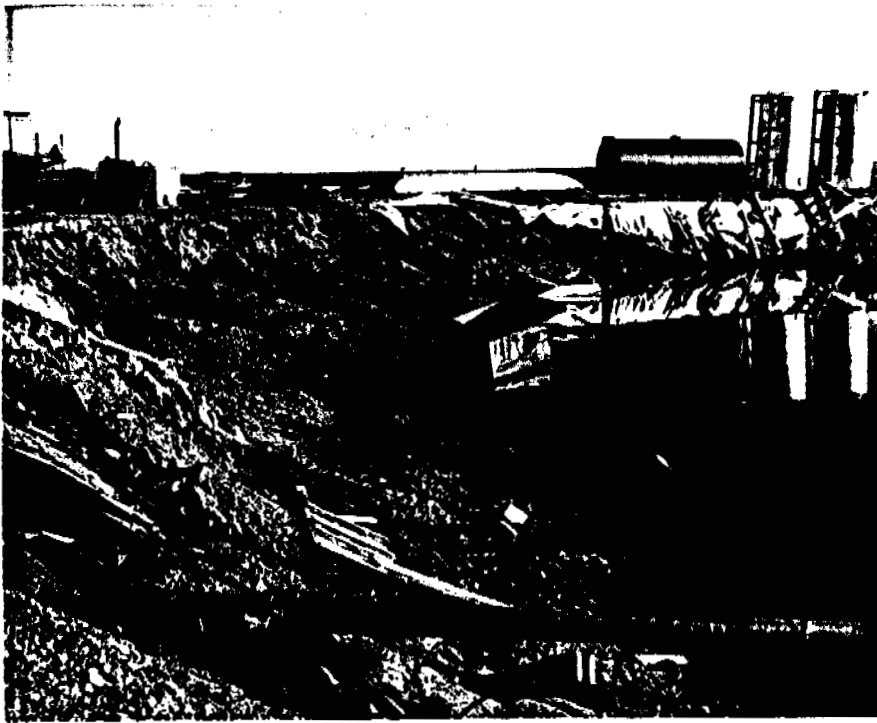
1037-20-9

Well sump showing lateral melt out from near the box to the present wall face. Note plastic and wood cover to protect the sump face below the fuel tanks.

In spring and summer drilling, angle the well sump from the rig, leaving as much land as possible between rig and sump wall. The use of extra gravel along the edges and plastic over the sump wall enable a slope of gravel to build up and protect any massive ice as the wall melts back.
