RAPPORT FINAL

ÉTUDE D'IMPACT SUR LE MILIEU SOCIAL ET L'ENVIRONNEMENT
DE L'ÉRECTION D'UNE CLÔTURE CEINTURANT
LE COMPLEXE AÉROPORTUAIRE DE KUUJJUAO
ET DE LA CONSTRUCTION D'UNE ROUTE DONNANT ACCÈS AU "RANGE"

RAPPORT PRÉPARÉ PAR :
ROBERT LANARI
SERVICE DE LA RECHERCHE
SOCIÉTÉ MAKIVIK

SOU MIS AU MINISTÈRE DES TRANSPORTS DU CANADA

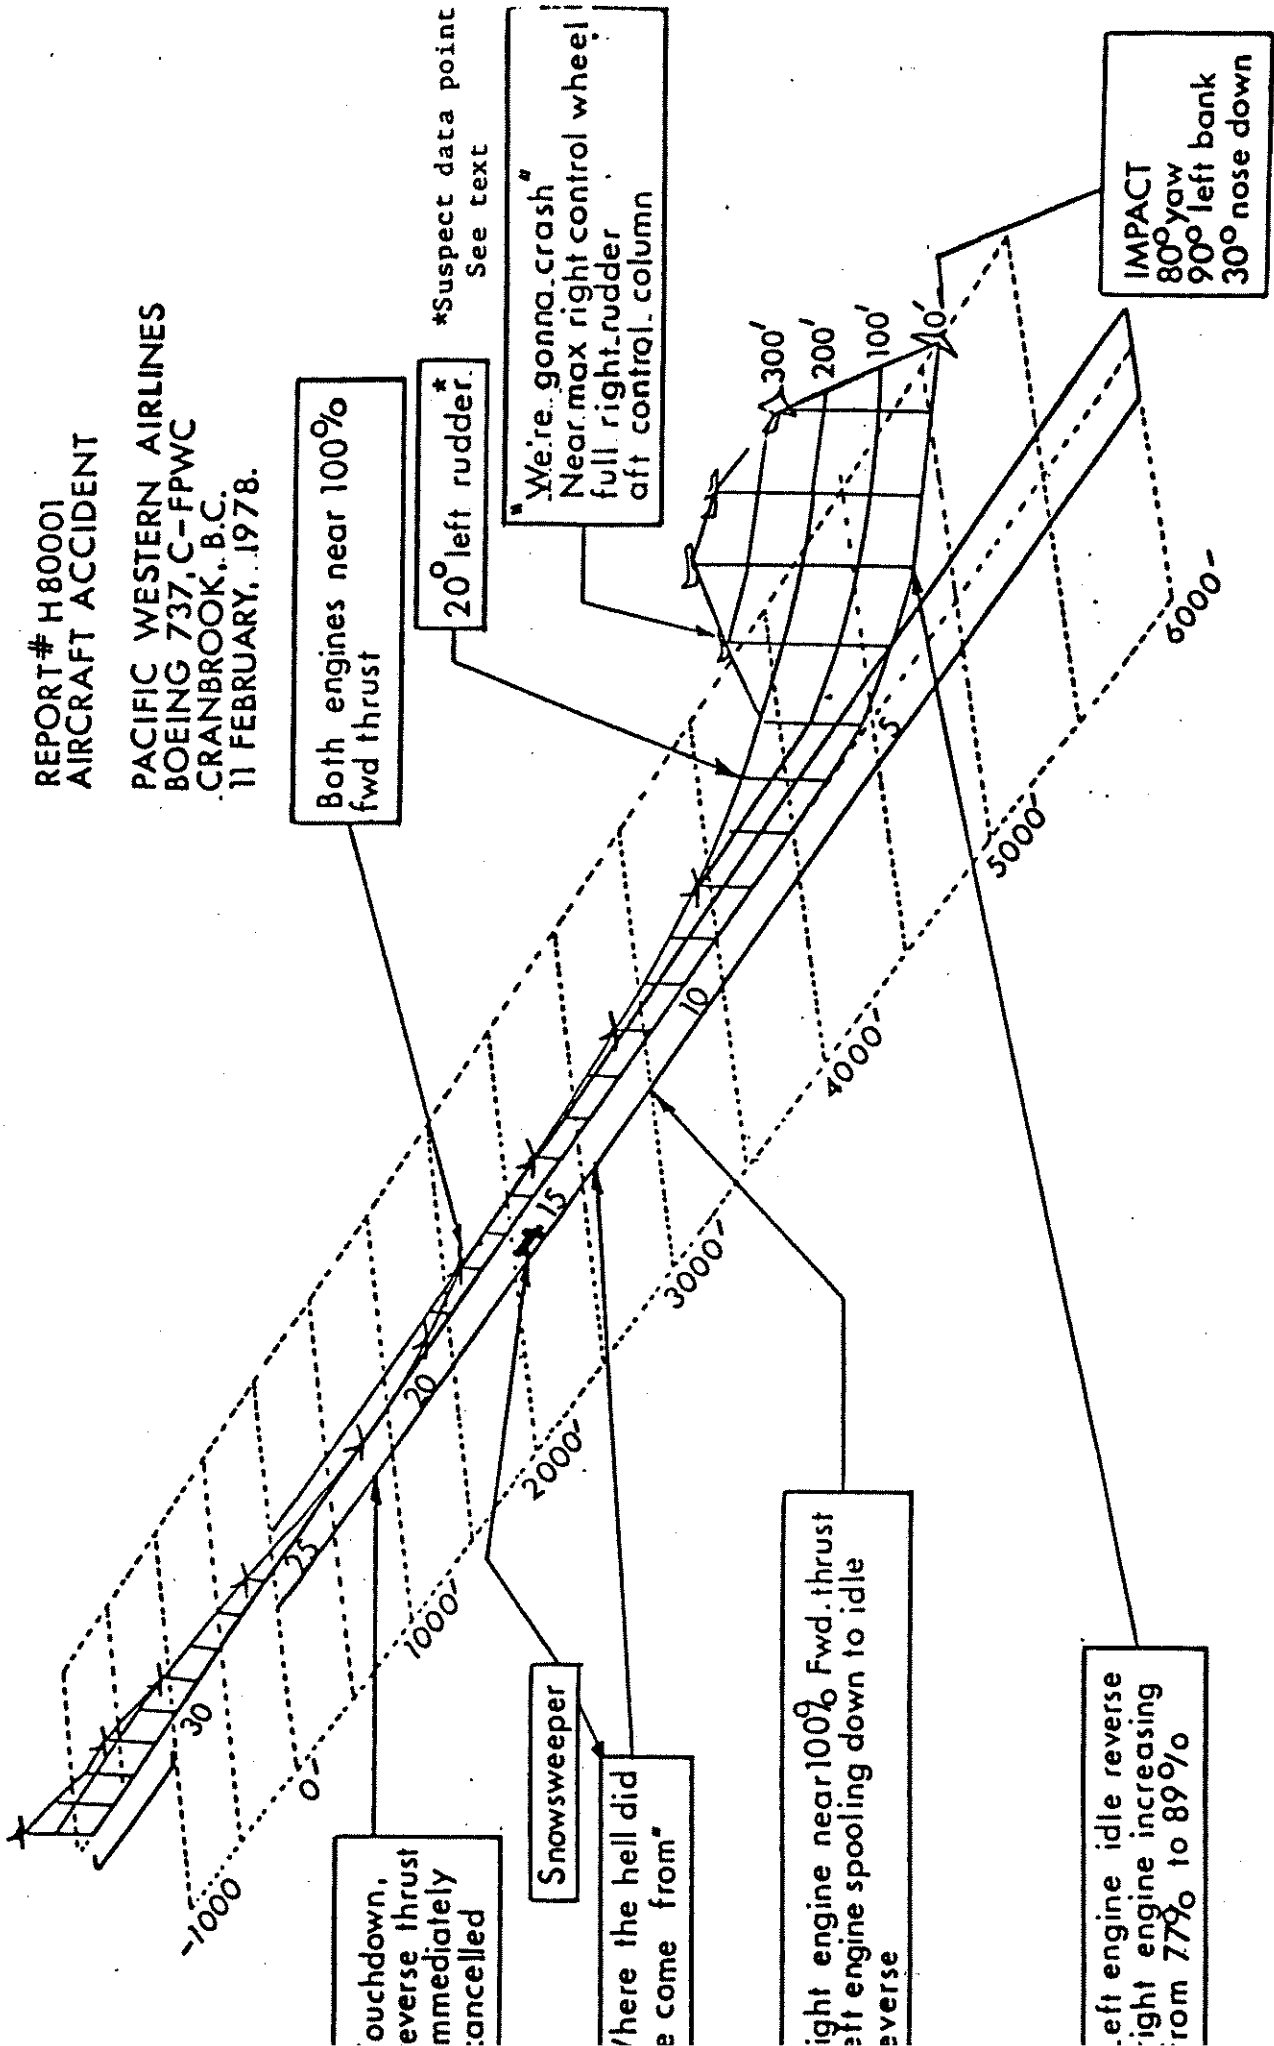
COMPOSITE DIAGRAM INCORPORATING INFORMATION FROM THE FLIGHT DATA RECORDER, WITNESSES, ENGINEERING AND FLIGHT SIMULATOR
