**GRANULAR RESOURCE
EVALUATION**

WHALE COVE, N.W.T.

**Granular Program
Technical Services Division**

February, 1993

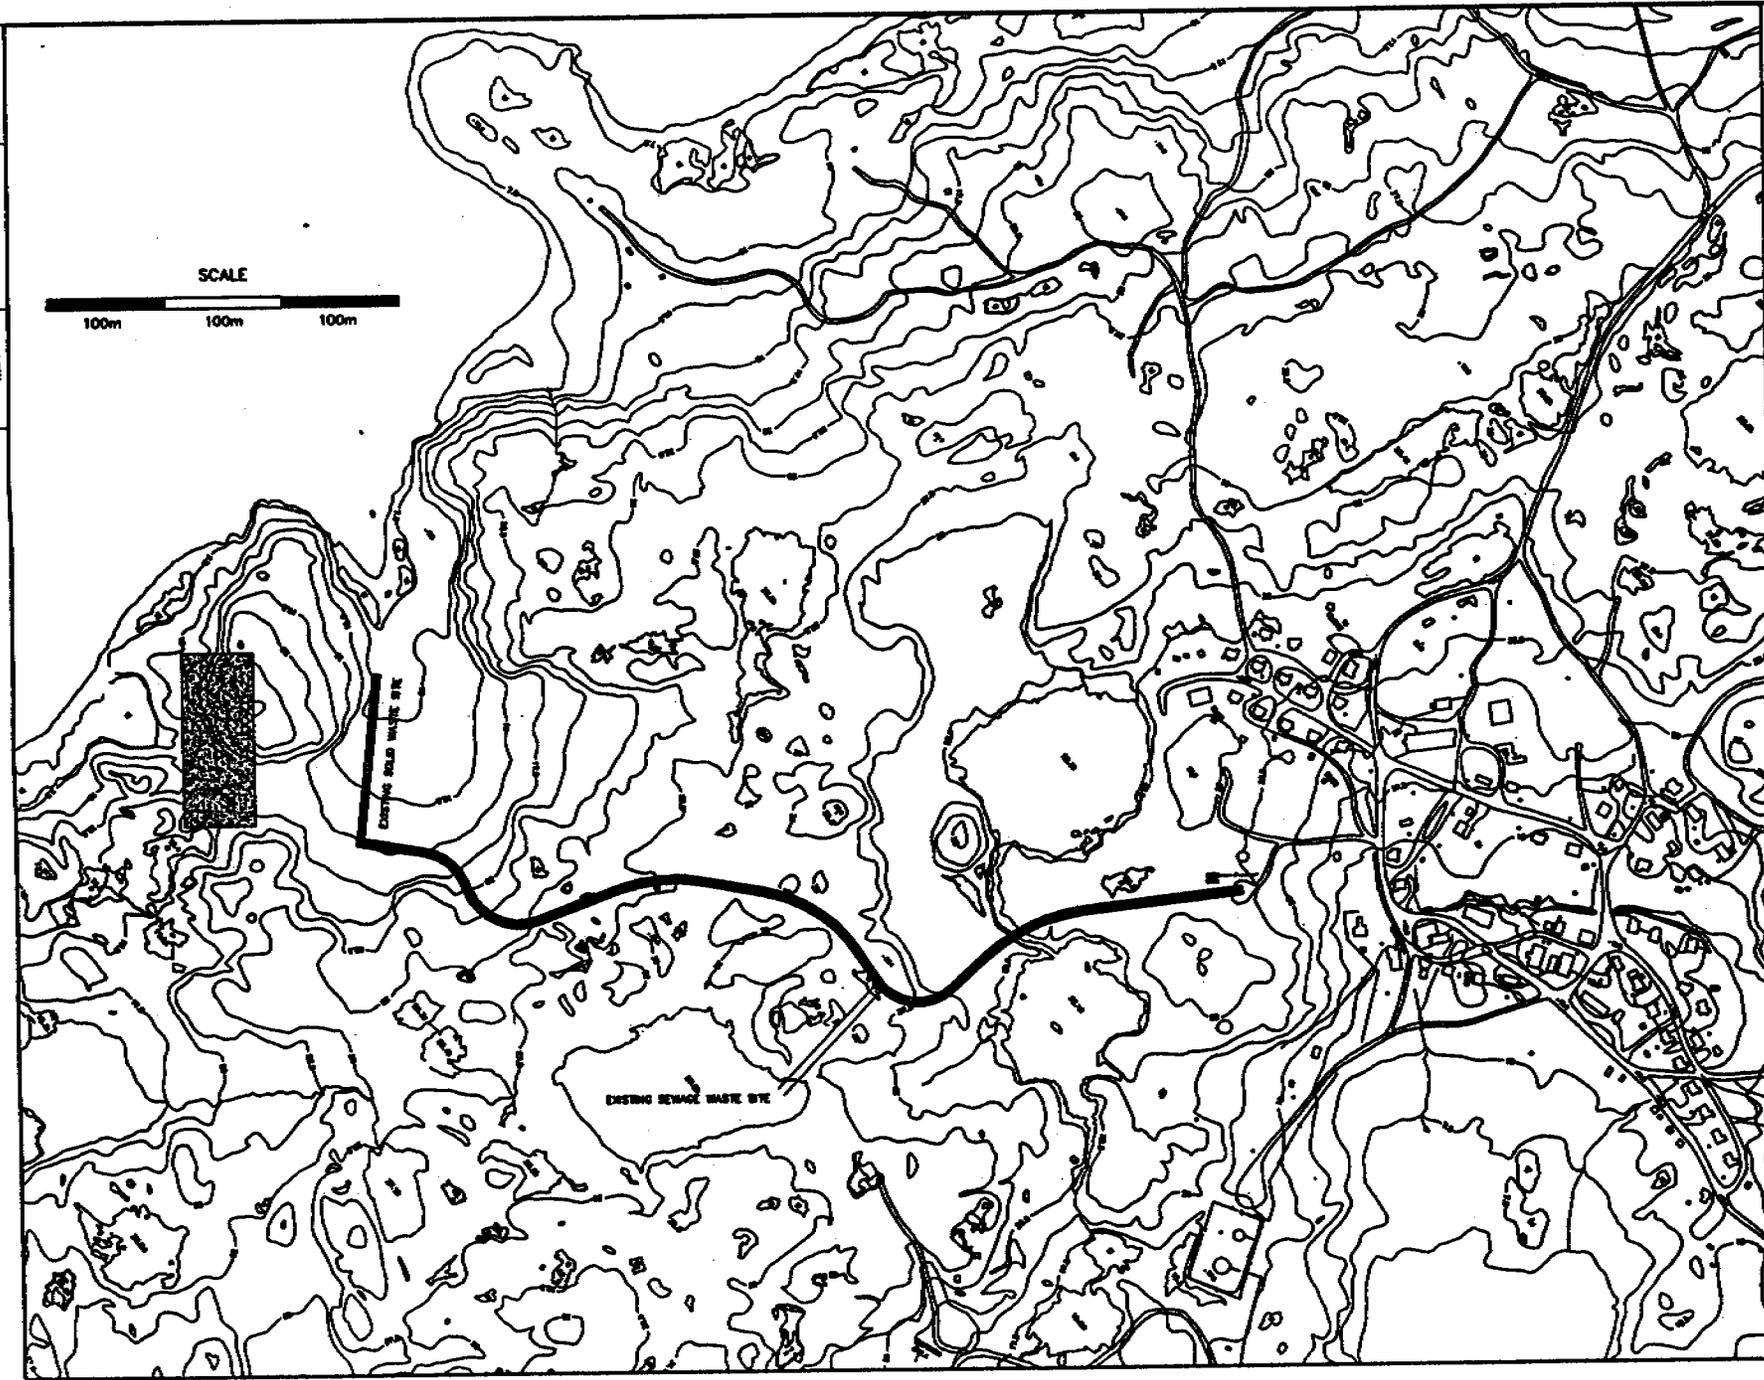
SITE LOCATION PLAN

1. THE QUARRY AND CRUSH PLANT SITE IS LOCATED AS SHOWN ON THIS PLAN.
