ᐃᖅᓂᐱᖅ ᐱᖅᓂᐱᖅ ᐱᖅᓂᐱᖅ ᐱᖅᓂᐱᖅ
Arctic Char Stream Enhancement

**TASIUJAALUK INSPECTION
1987**

**Kuujuaq Research Centre
Makivik Corporation
1988**

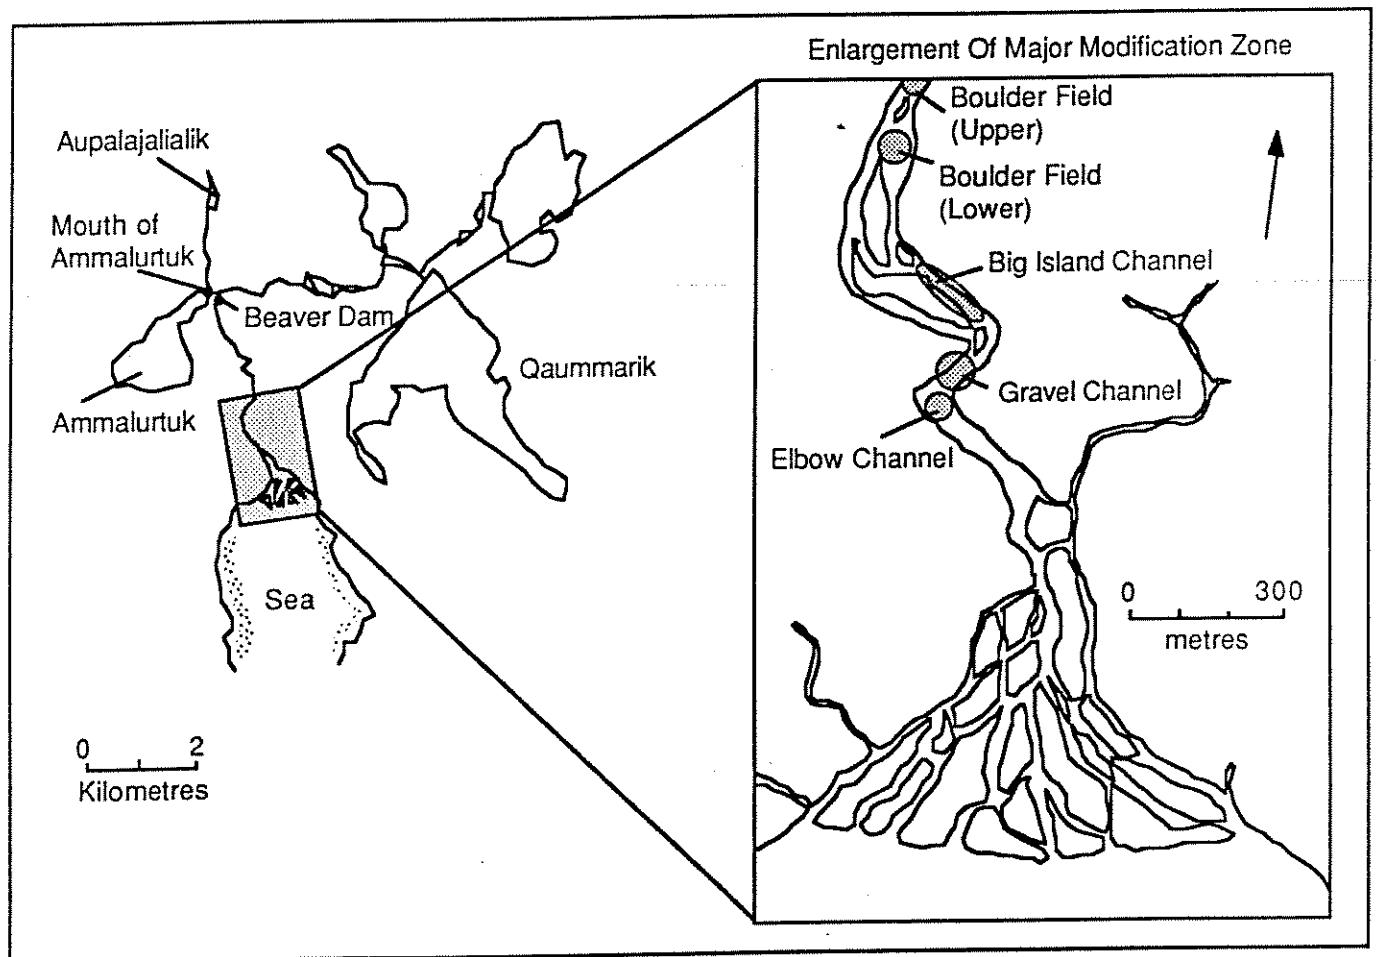
The following map shows the areas where modifications were done in 1986:

The beaver dam was dismantled and two beavers were shot. The outflow of Ammalurtuk was cleared to facilitate the access of fish to the lake on a dry year. In the lower portion of the system, the problems encountered by char migration were diverse; mainly water getting "lost" through two large boulder fields and wide gravel bars with very low water levels. For the two boulder fields, diversion walls were built with large rocks to reduce water losses through side streams and a main channel was created down through the field. For the gravel and other low water level areas, channels were deepened by removing rocks out the stream or moving gravel to the sides.
