THERMAL EROSION PROBLEMS IN PIPELINING

T.G. Watmore

This report documents observations made in the Mackenzie Delta area in early August and in mid-September 1968 with regard to surface damage caused through bulldozing seismograph cutlines. Lines bulldozed prior to freeze-up in October 1964 on the Peel Plateau west of Fort McPherson and others bulldozed in October 1965 near Tuktoyaktuk were inspected.

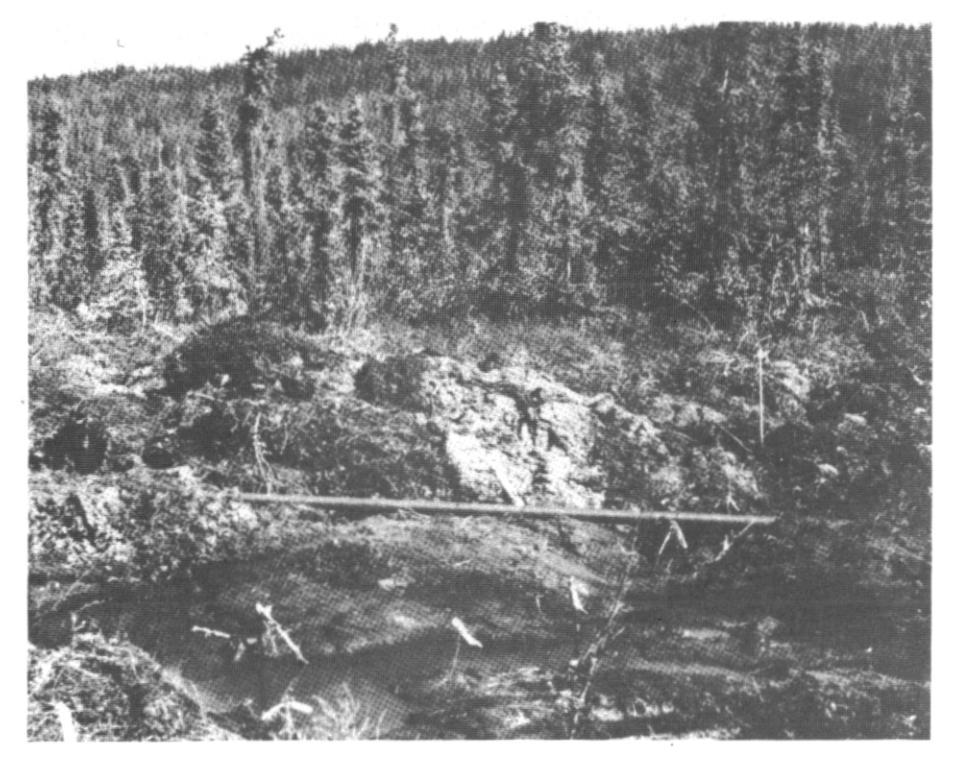
The bottom photographs show the subarctic vegetation of the Mackenzie Delta in which the pipeline is located. The black spruce is 10 to 15 feet high growing on hummocky ground of clay frost mounds covered by a mat of moss and lichen. Birch, willow and alder are also present. The clay frost mounds are 2 to 4 feet in diameter, 12 to 18 inches high and surrounded by a trench containing Sphagnum moss, grasses and sedges which cover a shallow depth of water over ice. The 4-inch return pipeline can be seen and the irregular pile of strippings cover the main line as a partial insulation. A row of ribboned profile stations cross the right-of-way in the foreground.

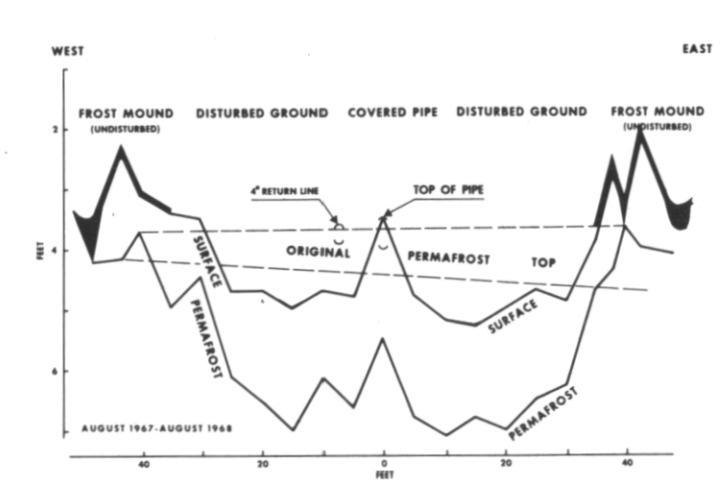
PROFILE ACROSS RIGHT-OF-WAY

Measurements recorded at the stations are shown on the profile plan below the photograph. The surface elevation line traverses between undisturbed ground on either side of the right-of-way. Depths to the permafrost table in the undisturbed areas on either side have been joined by dotted lines to indicate the assumed active layer originally present in the right-of-way. Shaded wedges between the undisturbed surface and permafrost line indicate troughs where Sphagnum moss is the only cover between the ground surface and the subsurface ice.

The disturbed working surface on either side of the line has settled approximately 1 foot in the year since construction. Permafrost has degraded 2 to 3 feet below the original position. The effect of piling surface strippings over the line shows no drop in the shallow trench in which the pipe was laid and the permafrost rises appreciably under this cover. Elevations on the line indicate there is no variation from the original values observed during construction.

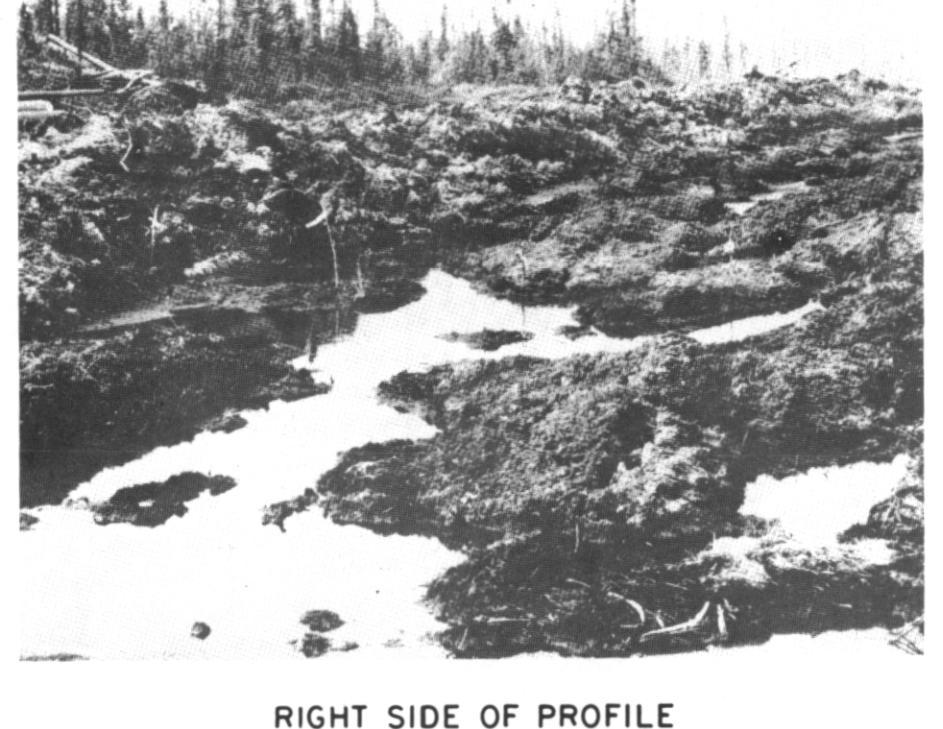
The right side of the pipeline right-of-way and a ribboned row of profile stations is shown in the upper photographs. The left side of the right-of-way was shown in Plate 1. In both photographs considerable water has collected in the cleared working areas along the line. Because only 1/4 inch of rain was recorded from June 1 to August 15, 1968, it is obvious that meltwater from the permafrost and greatest settlement in the ground with the highest ice content have accounted for the presence of the water.

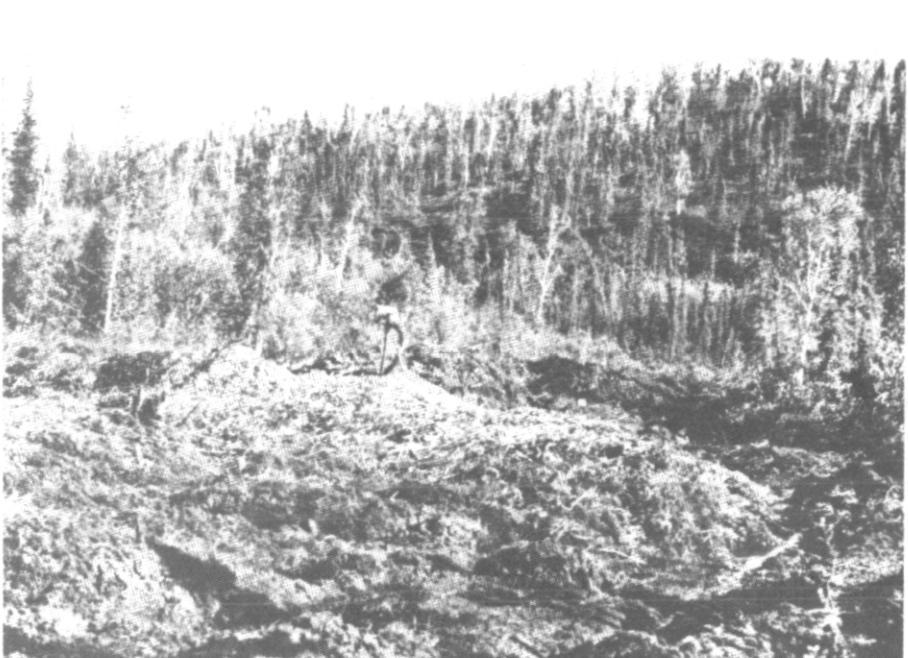
The photograph indicates, in an arc on the right, the humpy bared work area which had been scraped to the permafrost table. This was relatively flat during construction. Subsidence is now visible in the ground and water present is from thawing of the permafrost for previously mentioned reasons. Wood chip piles are seen along the line and the diagonal cross-sectioned portion crosses the line at the instrument stand.

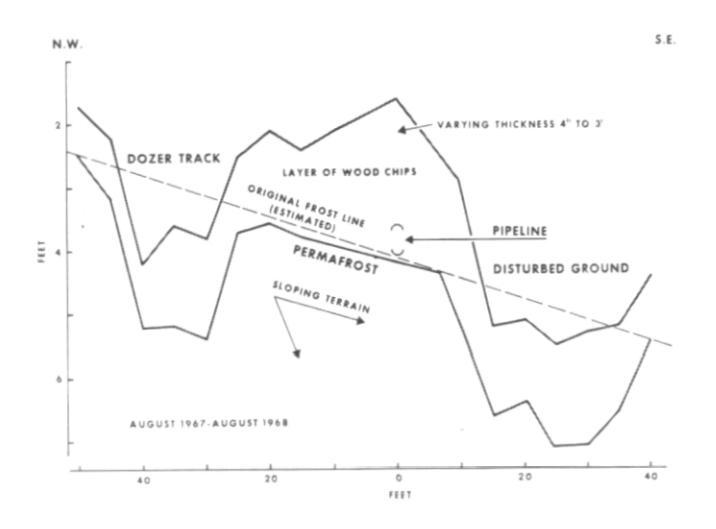
RIGHT-OF-WAY PROFILE ACROSS WOOD CHIPS

The profile indicates, by dotted line, the original estimated permafrost table which joins undisturbed sections on opposite edges of the right-of-way. Ground settlement up to $1 \frac{1}{2}$ feet is shown in the disturbed ground on either side of the line and permafrost recession approaching 3 feet can be noted. The most notable feature of this profile is the protection given to the permafrost by the wood chips. Unfortunately, the thickness varied from 4 inches to 3 feet which prevented an estimate of the depth of material required to give minimal effective cover.

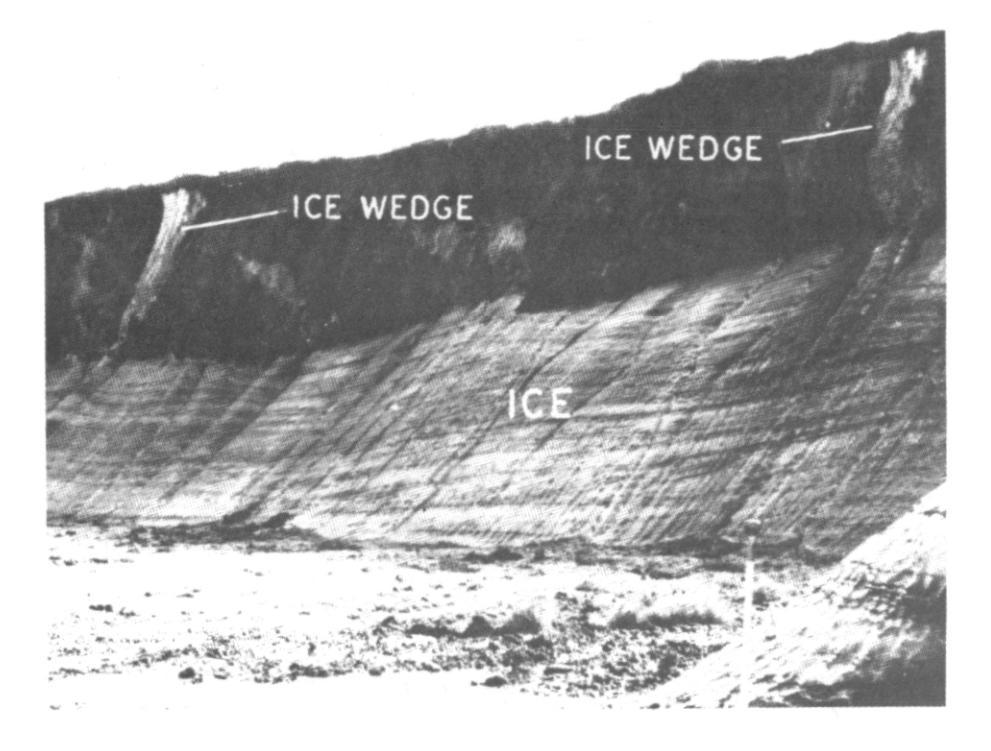
Along the coastline of the Beaufort Sea approximately 4 1/2 miles southwest of Tuktoyaktuk massive ground ice is shown exposed beneath a thick layer of soil. Vertical air photographs indicate the presence of considerable erosion and slumping over a large area. Kneedeep mud and water prevented precise measurements of ice thickness, etc. but the boat paddle in the foreground gives some indication of relative sizes. Two ice wedges are also visible in the upper soil layer and extend to the ice sheet. Ice wedges may carry their shapes into and through the planes of ground ice. The lower photograph shows a pingo in its poorly drained surroundings out of which it had been formed through freezing and ice accumulation. Ice wedge polygons can also be seen in the area surrounding the pingo.

MASSIVE GROUND ICE ALONG THE ARCTIC COASTLINE

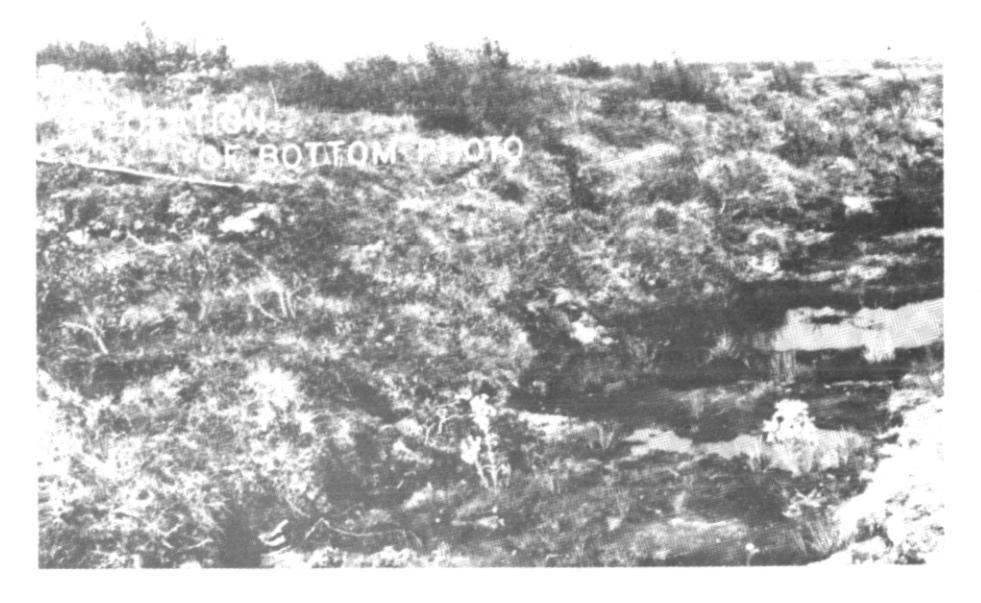
The upper photograph shows an east-west cutline three years later in which limited vegetation has returned and water is pooled in the depressions. To the left, the ground rises in an 8° slope. At the position of the level rod, lying on the surface, one of three recessions into the hillside exist. The line had removed sufficient cover to initiate thawing into either three closely associated ice wedges or what may be a mound of virtually clear ice underlying the hill.

3 YEAR OLD CUTLINE AT BASE OF HILL

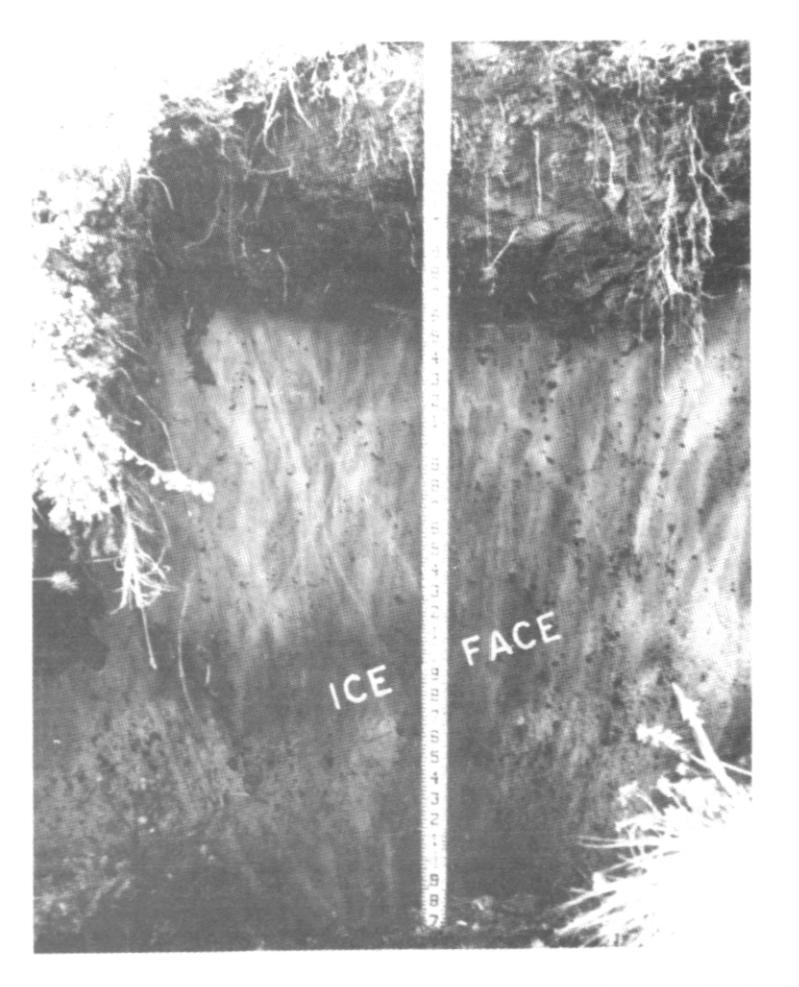
The lower photograph shows the present end of the recession which contains ice overlain by peat and clay with a thick surface vegetation mat. This recession, on the north side of the hill, has moved back approximately 27 feet from the cutline and grown to a depth of 5 feet in three years. Gradual stabilization may occur if sufficient surface cover topples and blankets the ice to provide an insulation barrier. The southern exposure has probably contributed to an increase in the thermal erosion.

RECESSION INTO HILLSIDE CAUSED BY CUTLINE IN TOP PHOTO

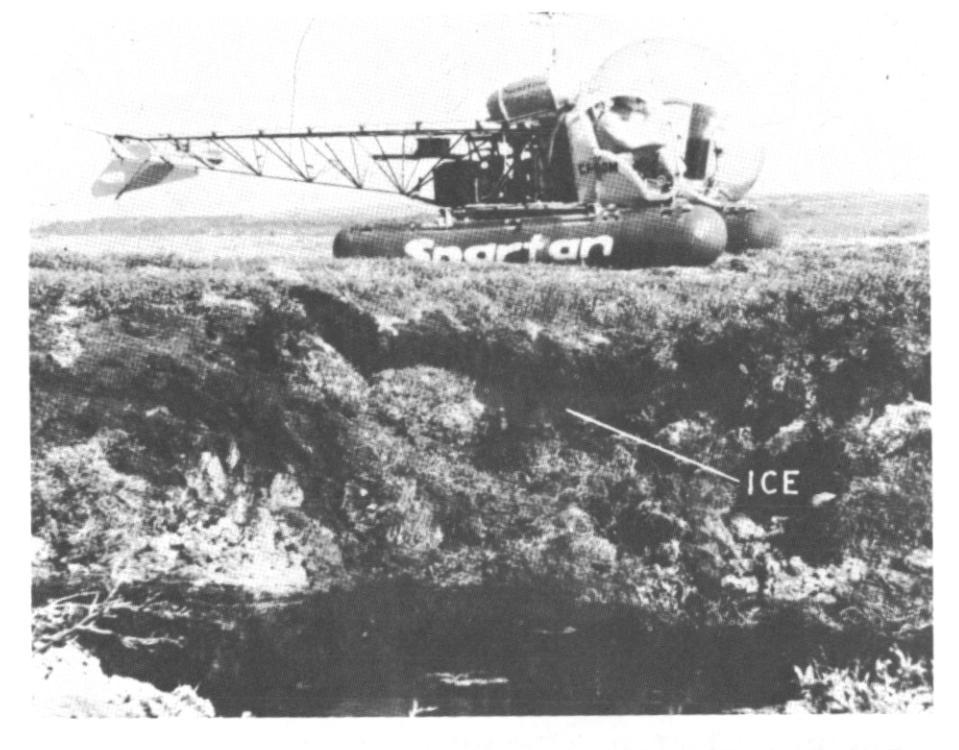
The upper photograph shows damage originated by a bulldozer blade which scraped aside no more than 1 foot of peaty surface soil and vegetation for a seismograph line in October 1965. Thawing and settlement has produced a lengthy depression in the cutline which is greater in depth than 6 feet in places. Clear ice is visible under the overhanging surface mat beneath the helicopter. This feature occurs on a relatively flat plane. Ground conditions such as this would prove a problem for stabilization of backfill in pipeline ditching. Special insulation materials or hauling of fill would be necessary to prevent ice melt and the uncovering of a buried line.

DEEP THAW RESULTING FROM BULLDOZED CUTLINE

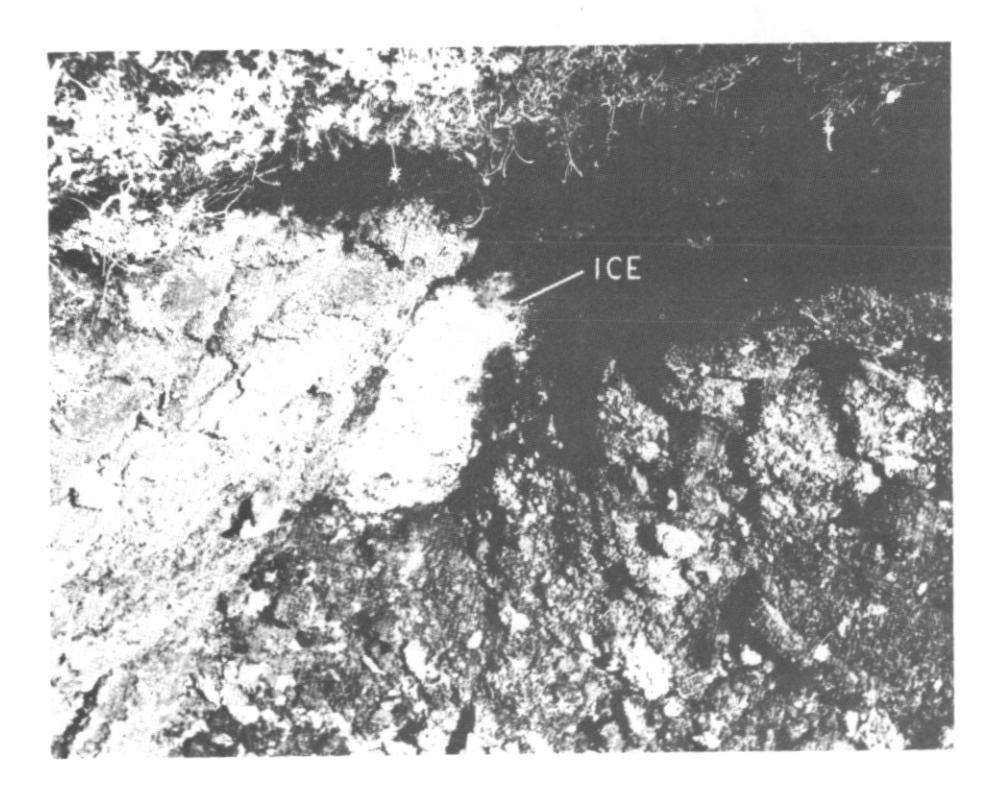
The lower photograph shows clear ice under a layer of peat and surface vegetation about 4 feet thick. A bulldozer has ploughed a line through a system of ice wedge polygons and caused considerable subsidence and pooling of meltwater throughout the line. Stabilization has occurred in the surface at a lower elevation and regrowth of vegetation is very slow in the peat.

ICE INSULATED BY PEAT IN BOTTOM OF A SETTLED CUTLINE THROUGH PEAT POLYGONS

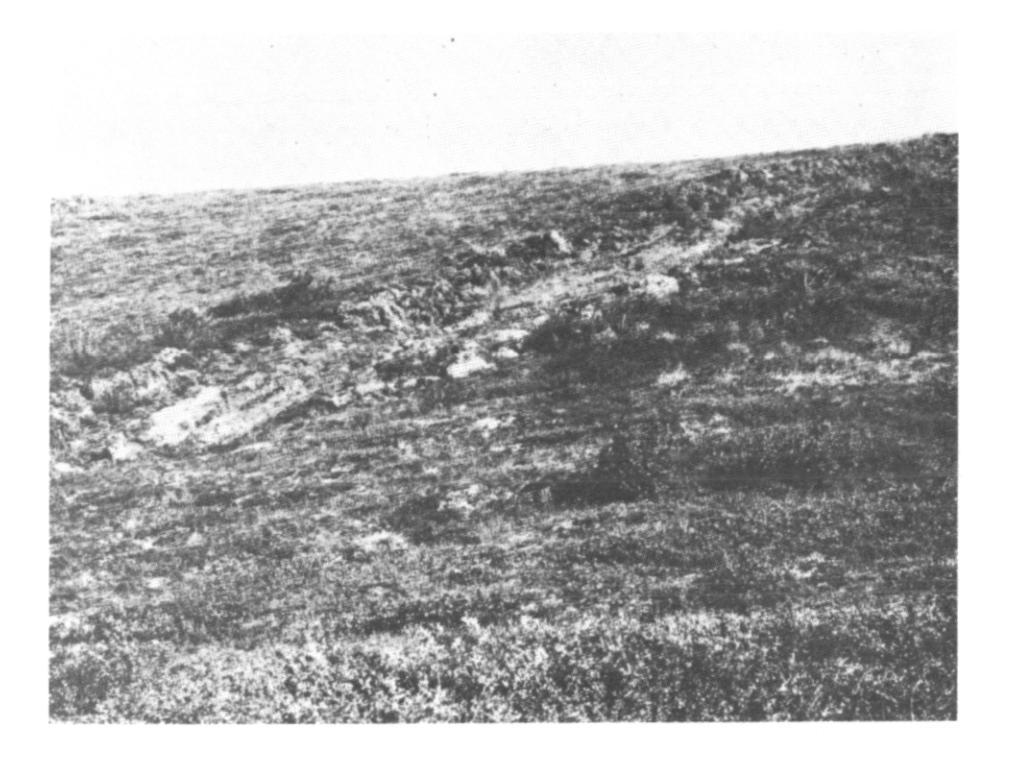
Previous photographs have indicated the more massive disturbances caused in permafrost through damage to the protective surface layers. The upper photograph of this plate shows a three-year old cutline on a moderately steep clay hillside covered by arctic vegetation. Winter gales virtually denude this higher surface of snow and, therefore, runoff water is insufficient for appreciable erosion. Rainfall is comparable in amount to that of a desert although heavy showers occur occasionally.

BULLDOZED CUTLINE ON HILLSIDE SHOWING MINIMUM DISTURBANCE

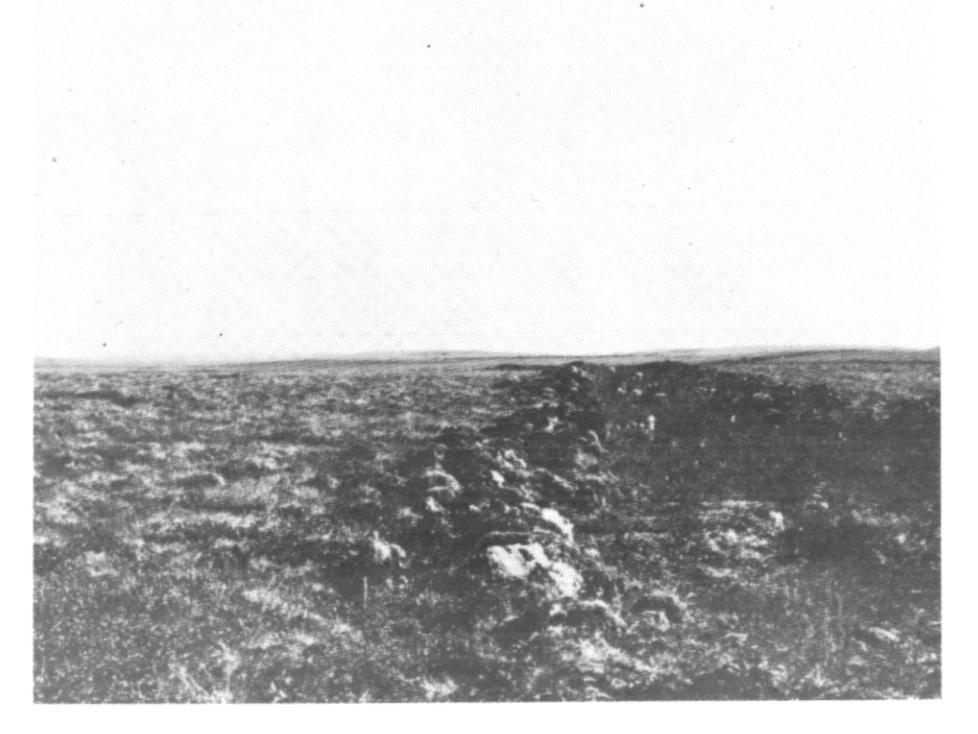
The lower photograph, in the same general area, shows a cutline in a broad flat expanse of arctic vegetation underlain by clay. Vegetation has made good recovery in three years, and only minor surface settlement is visible. A closer inspection of this vegetation showed that plants in the cutline are generally the progeny of those on the immediate edges of the line. Pipeline laying and surface restoration would not be a problem in these areas. Roads, however, might still have to be constructed by haul and fill because of permafrost conditions.

BULLDOZED CUTLINE WITH RETURN OF VEGETATION

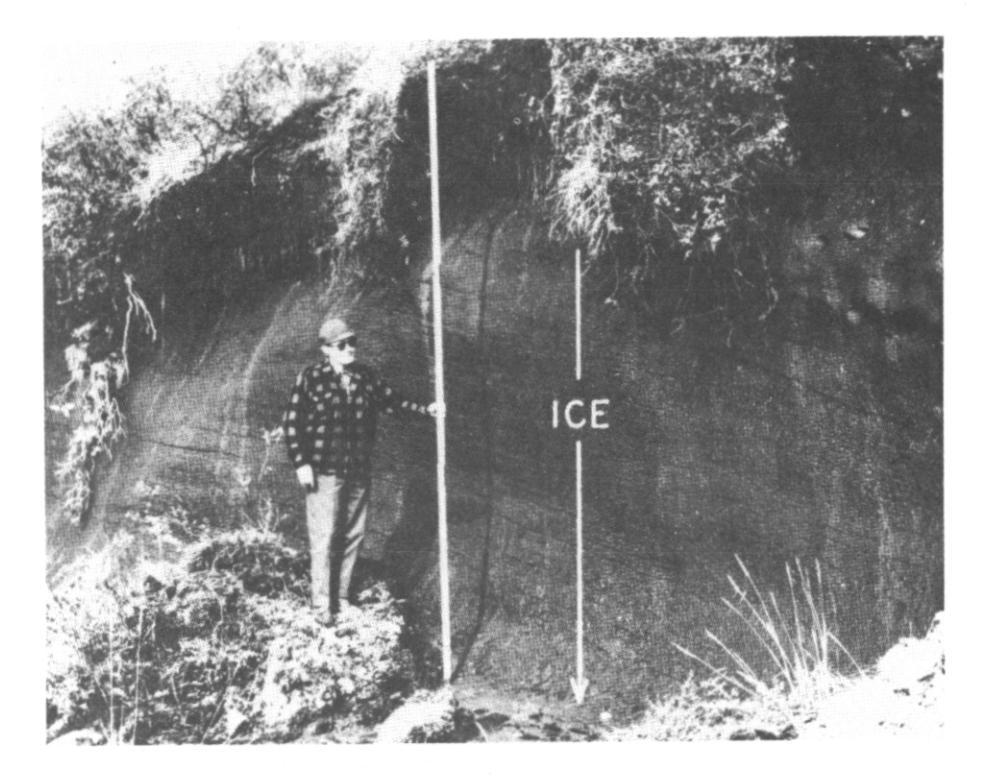
Thawing of an ice mound is in progress in the upper photograph. A saturated layer of slowly descending clay covers the ice face. The exposed ice is 10 feet thick at the apex and 2 feet of silty soil and vegetation comprise the surface cover. Clumps of vegetation hang over the face ready to fall when the ice recedes sufficiently. A bulldozed cutline goes around both sides of this feature but has not been the originating cause of the disturbance. Any construction across or through a feature such as this would require extreme caution in the preservation of the insulating mantle.

SEGREGATED ICE MOUND - MASKED BY WET CLAY FACE

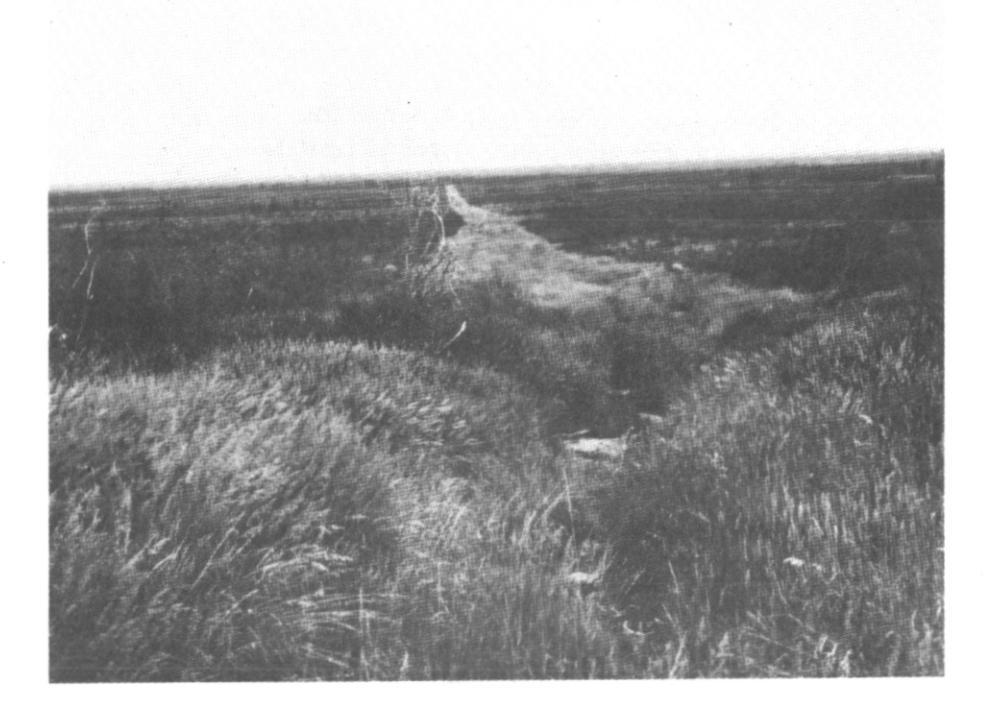
The bottom photograph shows a cutline used as the main access line from the Peel River in the distance onto the plateau beginning ascent in the foreground. The line followed a gulley up to the plateau which caused some minor localized increase in erosion. The several miles of flat bulldozed line have stabilized quickly with only a few eroded pockets amidst an excellent return of native grasses. Seeding of grasses and fertilizing for rapid regrowth would be sufficient for surface stabilization in these soils. The adjacent woody vegetation was not noted to have encroached on the line in the first four years.

NATURAL REVEGETATION OF A CUTLINE

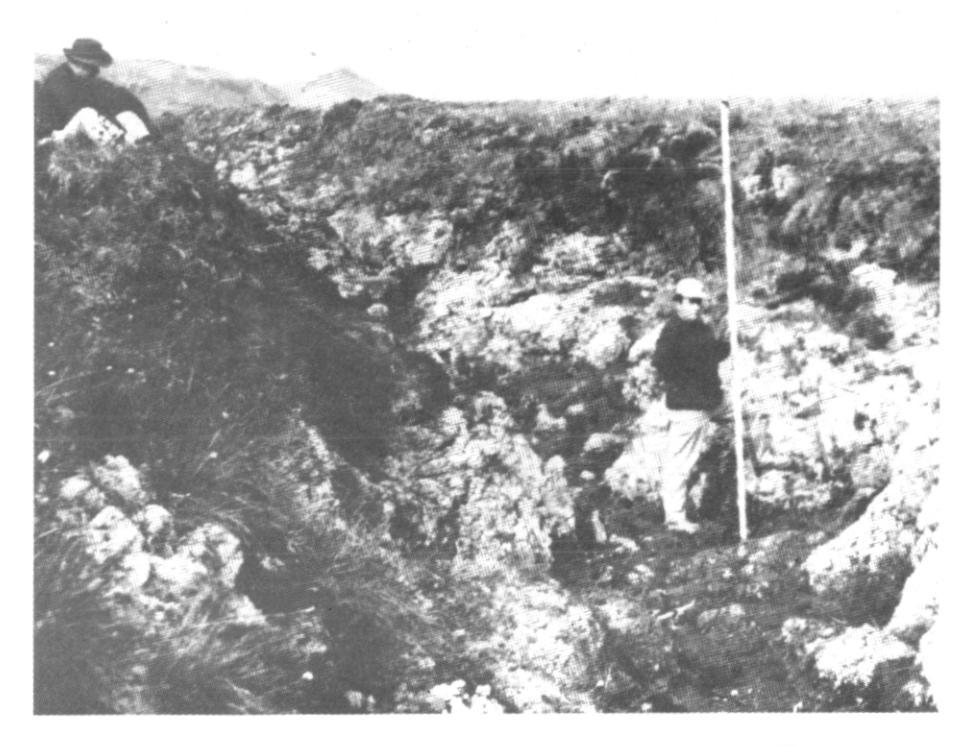
Deep erosion originating from a bulldozed line stripping off the surface vegetation mat is shown in the photograph. The view is from east to west with the Richardson Mountains in the background. The bulldozed line permitted drainage to travel down an overall 3 per cent slope for a distance of 1 1/2 miles. In four years, a gulley 23 feet across and 8 feet deep has developed at this point. Further uphill depths of gulleying range from 5 to 3 feet and gradually decrease. The slope, distance and accumulation of snow on one steep mountainside, no doubt add an appreciable amount of runoff to the new drainage course. The gulley also now acts as an excellent trap for drifting snow. If blocks had been placed originally to divert drainage into several shallow vegetated gulleys adjacent to the line, this severe erosion may have been avoided.

EROSION IN SEISMOGRAPH CUTLINE

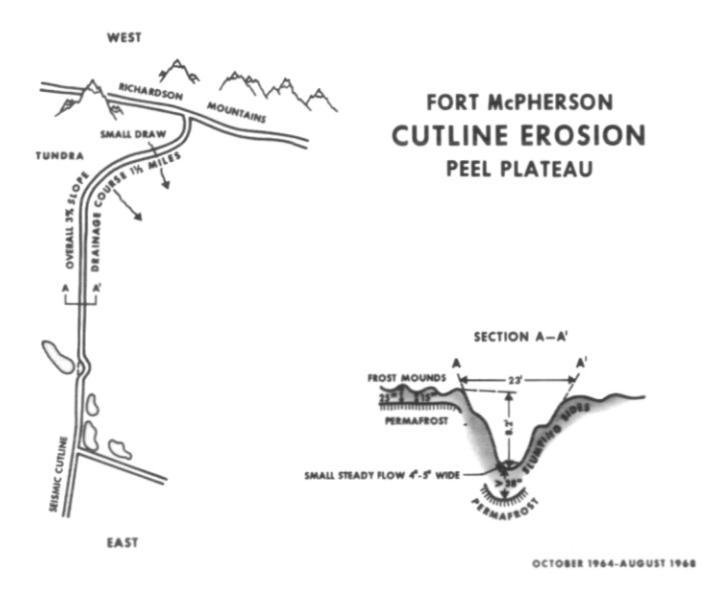
The profile reproduction gives the relative location of the feature and its cross-section. A small steady flow of water 4 to 5 inches wide and approximately 1/2 inch deep was observed. Because virtually no rainfall occurred from June 1 to August 15, it is concluded that this water supply along the new drainage course originated from melting ground ice in the permafrost.

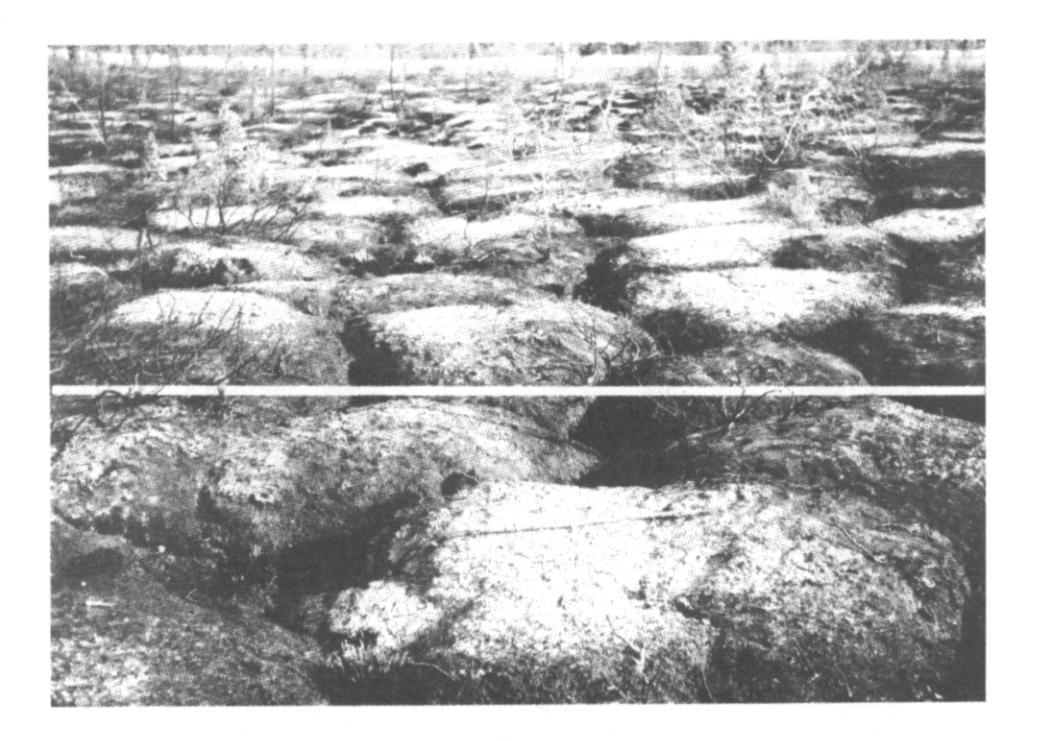
The upper photograph shows the "skeleton" of clay frost mounds whose rugged shapes are noticeable throughout the Delta area. Grasses, sedges and Sphagnum mosses filled the trenches and ground birch, Labrador tea, lichens, cranberry, and other plants grew on the tops. The photograph in Plate 1 shows similar ground with a full cover of vegetation. A road built by haul and fill method is shown in the upper portion of the photograph. A 12 foot level rod lies across the mounds in the centre. The removal of the surface vegetation cover will now permit deeper thawing of the permafrost, and it remains to be seen what new surface conditions develop.

FROST MOUNDS WITH VEGETATION BURNED OFF

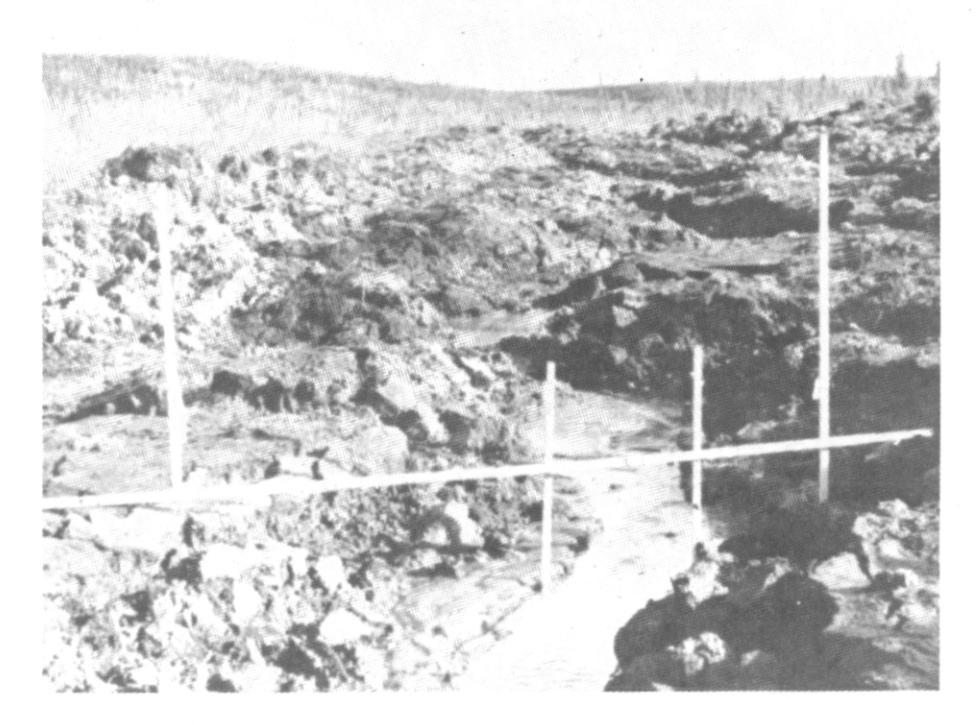
The lower photograph shows a bulldozed fireguard line on a clay surface. In thirty days or less a water course 2 feet wide was created 18 inches below the surface originally bulldozed to the permafrost table.

EROSION IN FIREGUARD - 30 DAYS AFTER FIRE

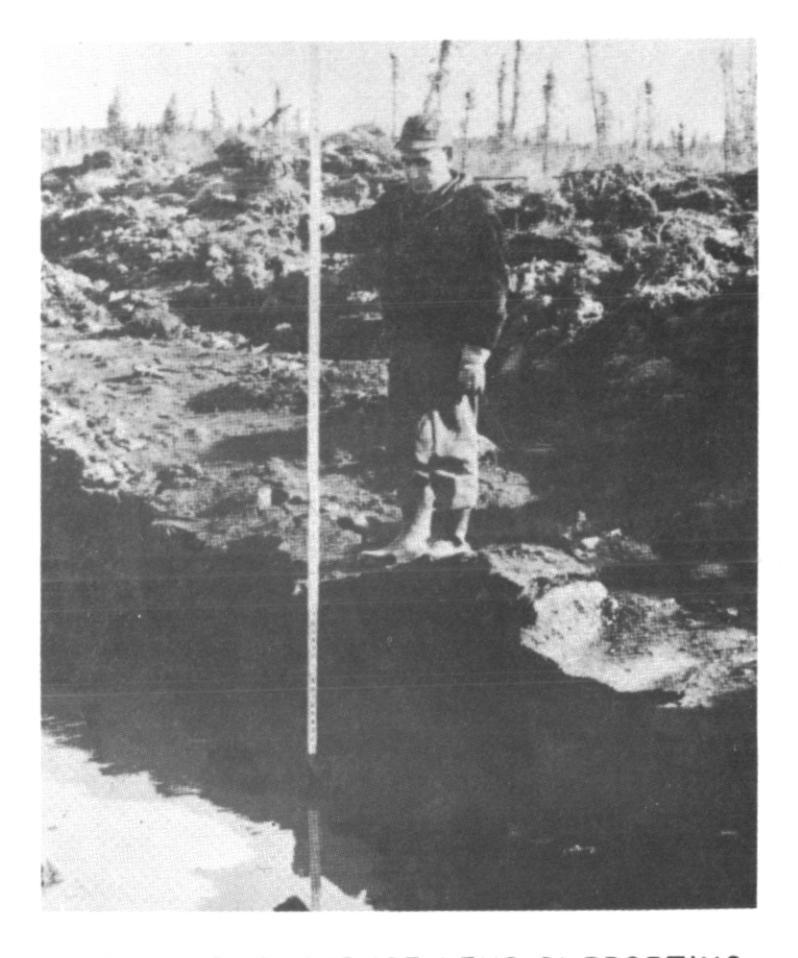
A layer of what appeared to be clear ice when chipped supports, temporarily, a layer of clay in the upper photograph.

EROSION SHOWING ICE LENS SUPPORTING SOIL BEHIND LEVEL ROD

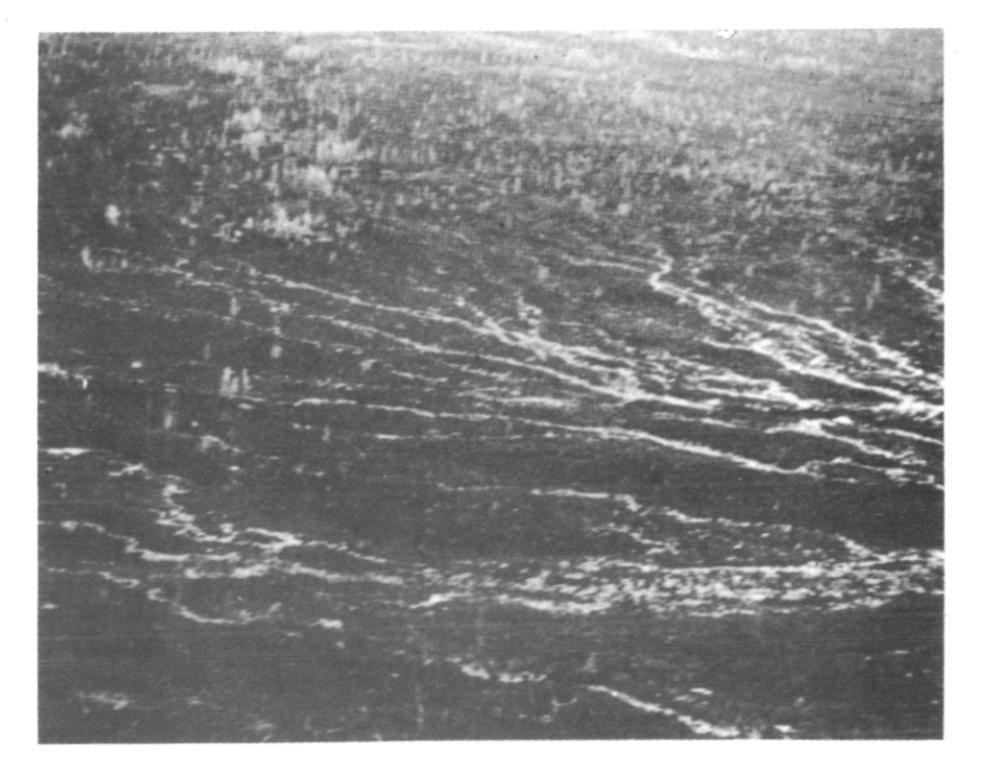
The lower aerial view shows the release of permafrost waters along the slopes of the fire-bared hillsides northeast of Inuvik. The amount of erosion in the upper photograph and the volume of released permafrost waters in the lower photograph have developed between August 15 and September 15, a period of one month. Prior to the fire, streams carried only small trickles of water due to the absence of rainfall for 2 1/2 months. Erosion will now increase and the total effect of the fire damage remains to be assessed in the seasons to come.

RELEASE OF PERMAFROST WATERS ON BURNED OFF HILLSIDE
