**GRANULAR RESOURCE
EVALUATION**

BAKER LAKE, N.W.T.

**Granular Program
Technical Services Division**

January, 1993

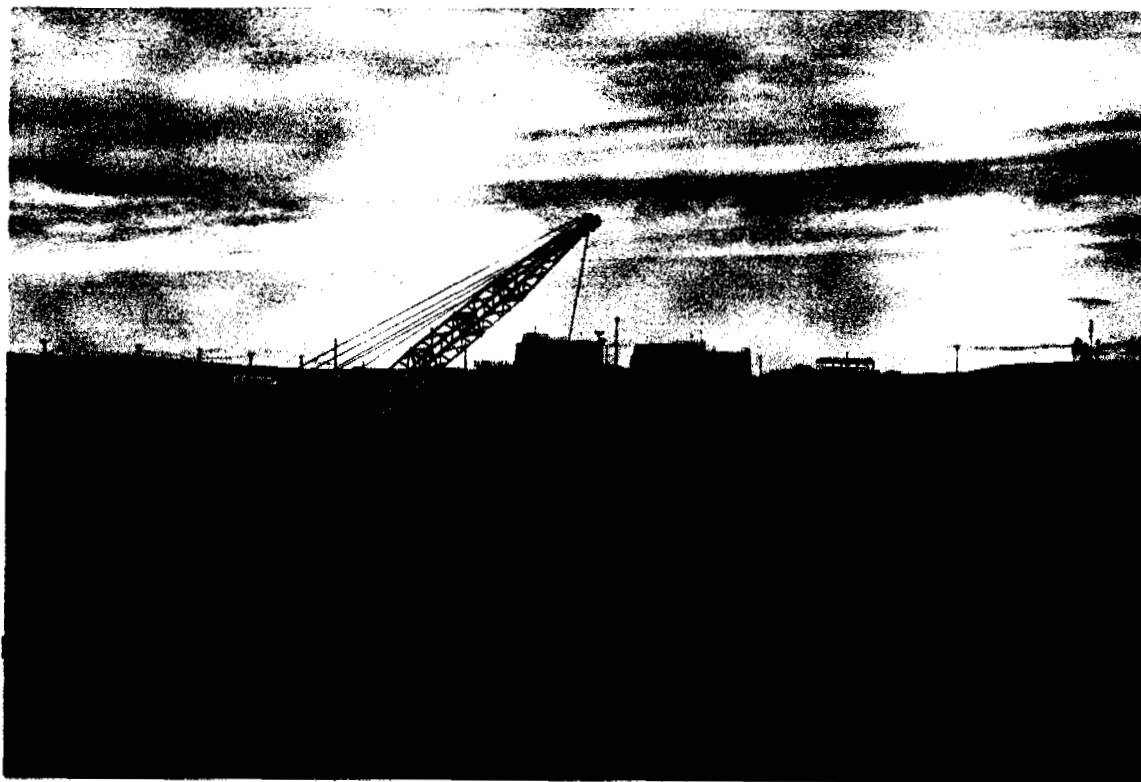
PHOTO 7: Source 1 - lower terrace.
