**GEOTECHNICAL INVESTIGATION**

MILE 347 TO MILE 690 MACKENZIE HIGHWAY  
WINTER - 1975

REPORT ON  
GEOTECHNICAL INVESTIGATION  
MILE 347 TO MILE 690  
MACKENZIE HIGHWAY

Submitted by R.D. Cook, P.Eng.  
Materials Engineer  
February 1, 1976

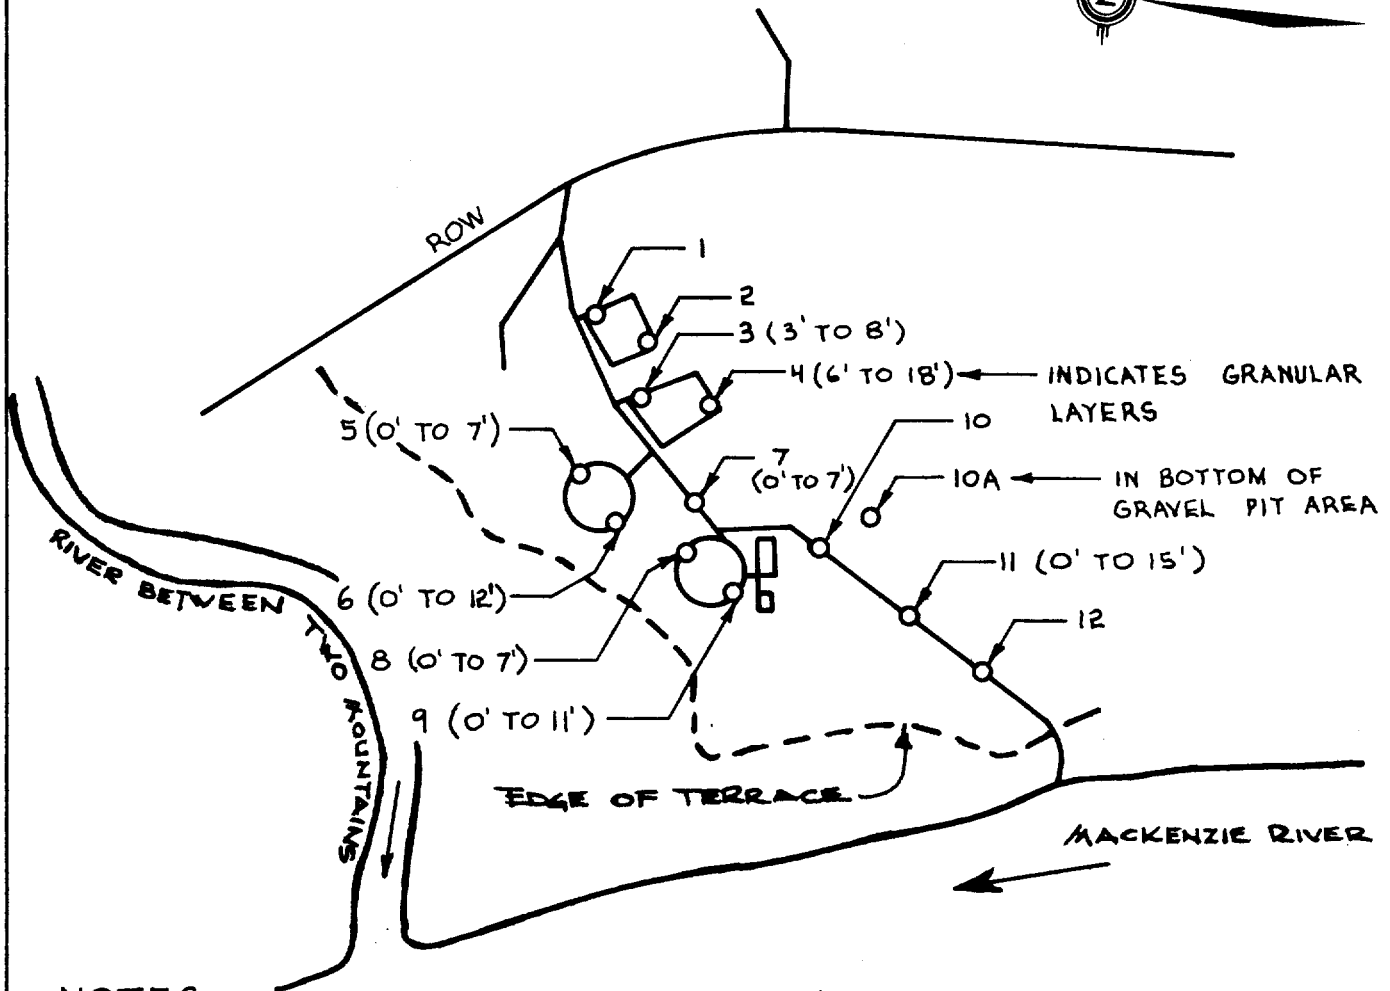
MILE 411.0 - 1000' TO 3000' LT. OF ♄

The area test drilled here is the former D.P.W. camp-site at River Between Two Mountains, and is located on a terrace of the Mackenzie River. Small amounts of sandy gravel borrow were apparently obtained here when the camp was occupied. Twelve test holes were drilled over an area measuring 1000 feet x 3000 feet. Subsoil varies from silty sandy clays to silty sandy gravels. Granular materials are, for the most part, in relatively shallow layers and large areas would have to be developed to obtain substantial volumes. Permafrost is sporadic, however, most of the granular materials appear permafrost free. This area was drilled primarily as a granular borrow source and the depths of granular material are shown on the site plan in each hole. Much of the material contains an excess of sand sizes and is short on gravel sizes, however, there is some good granular borrow available here. One drill hole (10A) was advanced in the bottom of a small open pit on the southside of the camp-site where some gravel has been obtained. Silts and clays were encountered and there is no usable granular material below the level of the present pit.

- AREA DRILLED IS ON TERRACE OF MACKENZIE RIVER
- SUBSOIL SANDY CLAYS TO SANDY GRAVELS
- NO GRANULAR MATERIALS IN HOLES # 1, 2, 10, 10A, OR 12
- PERMAFROST SPORADIC
- MOST NON-GRANULAR SOILS ARE WET ON THAWING

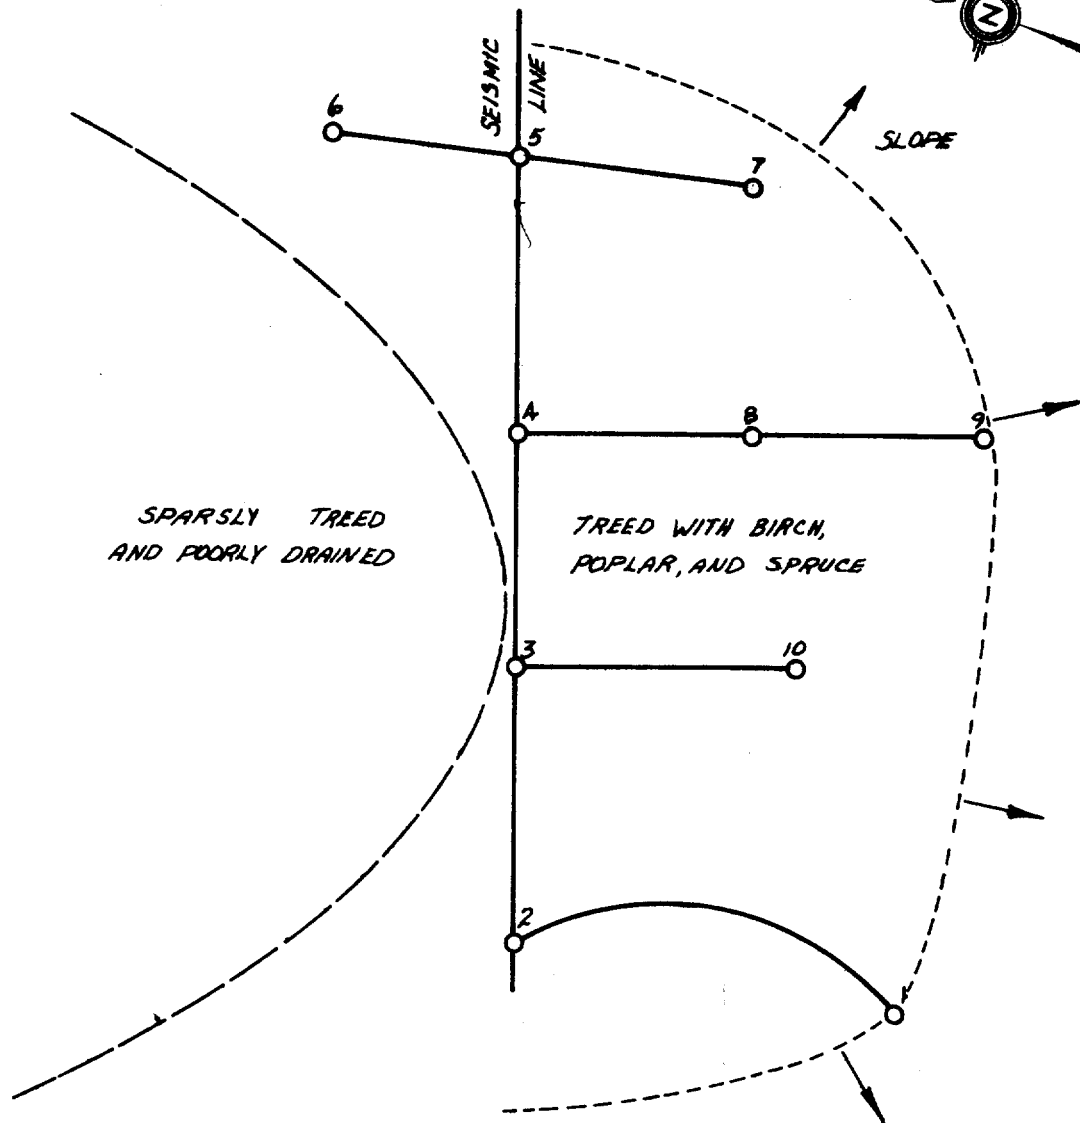
MILE 412.4 - 1500' RT OF E

- SUBSOIL MEDIUM PLASTIC SILTY CLAY
- PERMAFROST PRESENT WITH MODERATE ICE CONTENT
- STRIPPING ESTIMATED @ 3-4'
- MOISTURE CONTENT UPON THAWING ESTIMATED AT 3-4% ABOVE OPTIMUM

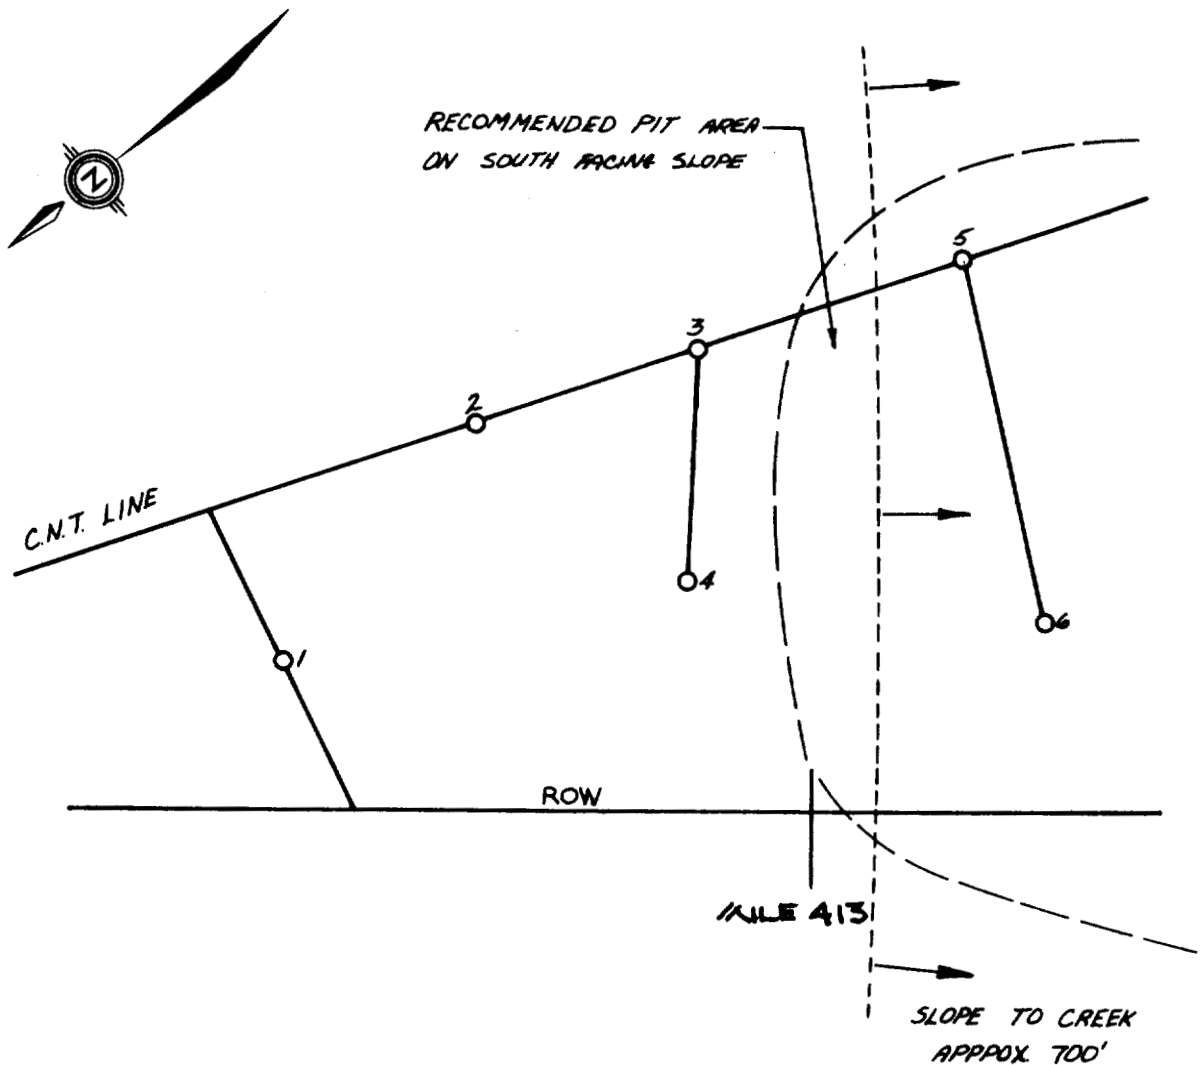
# MILE 413.0 - 400' RT OF E

The area investigated here is on the top of the valley wall and is defined on the west by the slope of the Mackenzie River Valley, and on the south by the slope of a small tributary creek valley. Tree cover varies from small poplar on the south facing slope to small spruce on the level terrain above the slope. As in Borrow Pit #49, the subsoil is glacial lake sediments consisting of medium plastic, silty clay. Permafrost is present throughout and ice contents are moderate. Moisture contents are slightly higher than in pit #49 with the exception of the south facing slope where test holes No. 5 and No. 6 are located. Should this area be developed, it is recommended the pit be confined to the poplar treed area on the south facing slope (see site plan).

- RECOMMENDED PIT AREA DENOTED BY DASHED LINES
- SUBSOIL MEDIUM PLASTIC SILTY CLAY
- PERMAFROST THROUGHOUT
- STRIPPING 1-2'
- MOISTURE CONTENT UPON THAWING NEAR OPTIMUM

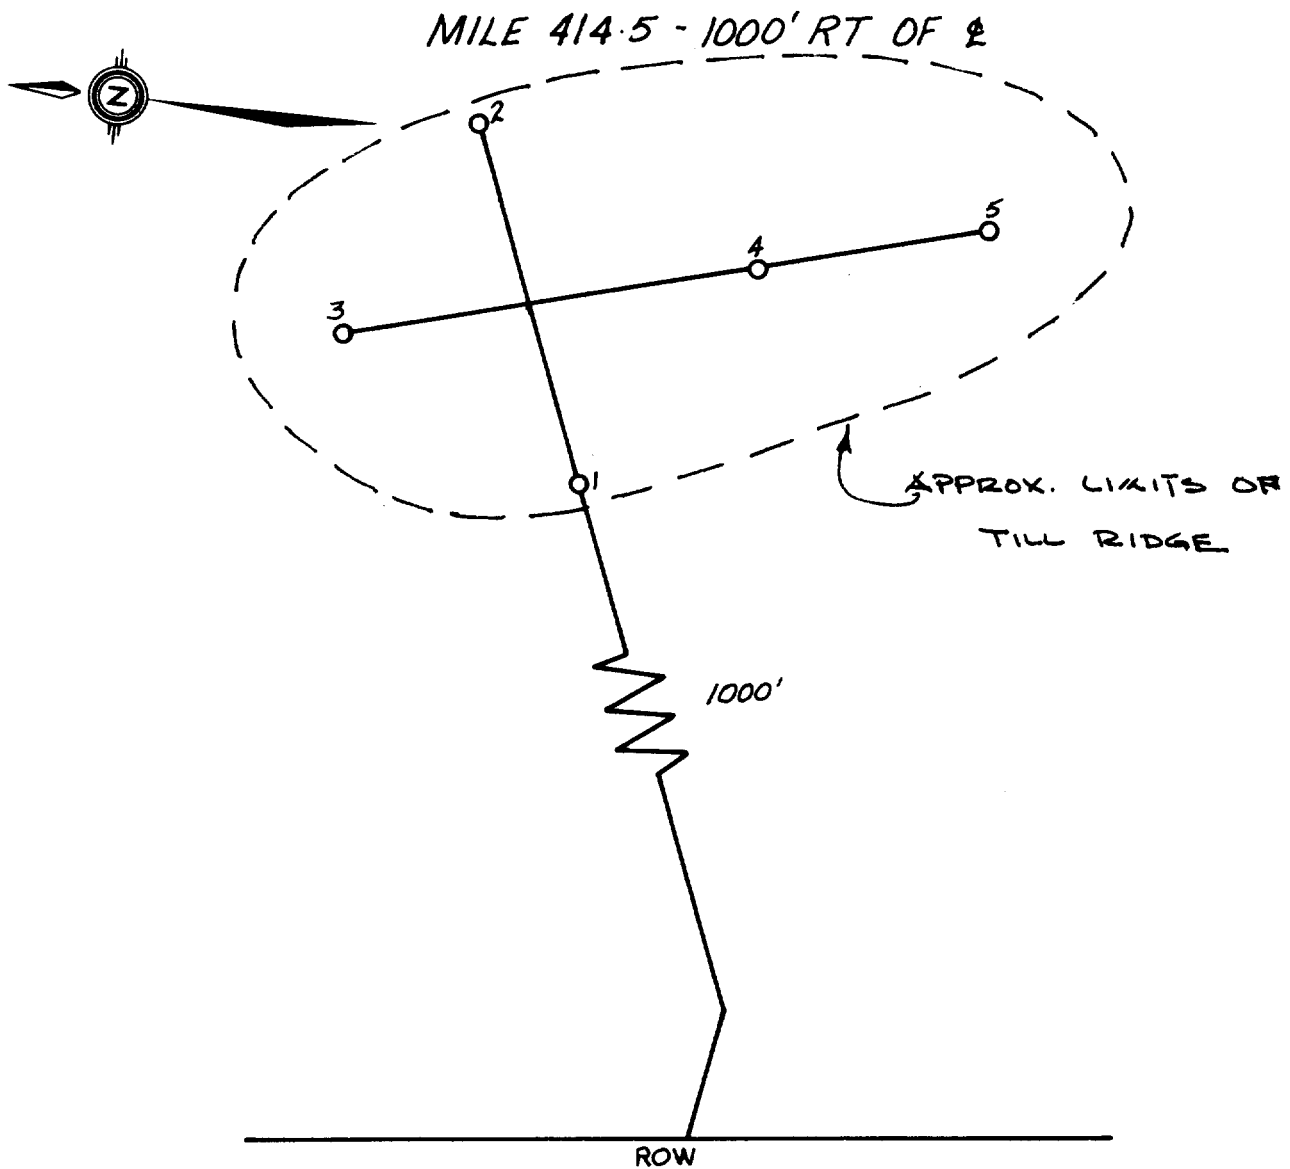
This area is located on a small elongate till ridge which is devoid of the surficial slopewash or glacial lake sediments common to the area. Tree cover is moderate to heavy with 6-8" diameter spruce. A total of 5 test holes in an area measuring roughly 400 x 700 feet encountered unfrozen low moisture content, gravelly till with some very granular zones. Moisture contents throughout are near the 10% level. This area is an excellent borrow source.

- SUBSOIL UNFROZEN, GRAVELLY CLAY (TILL)
- LOW MOISTURE CONTENT (< 10%)
- EXCELLENT BORROW SOURCE

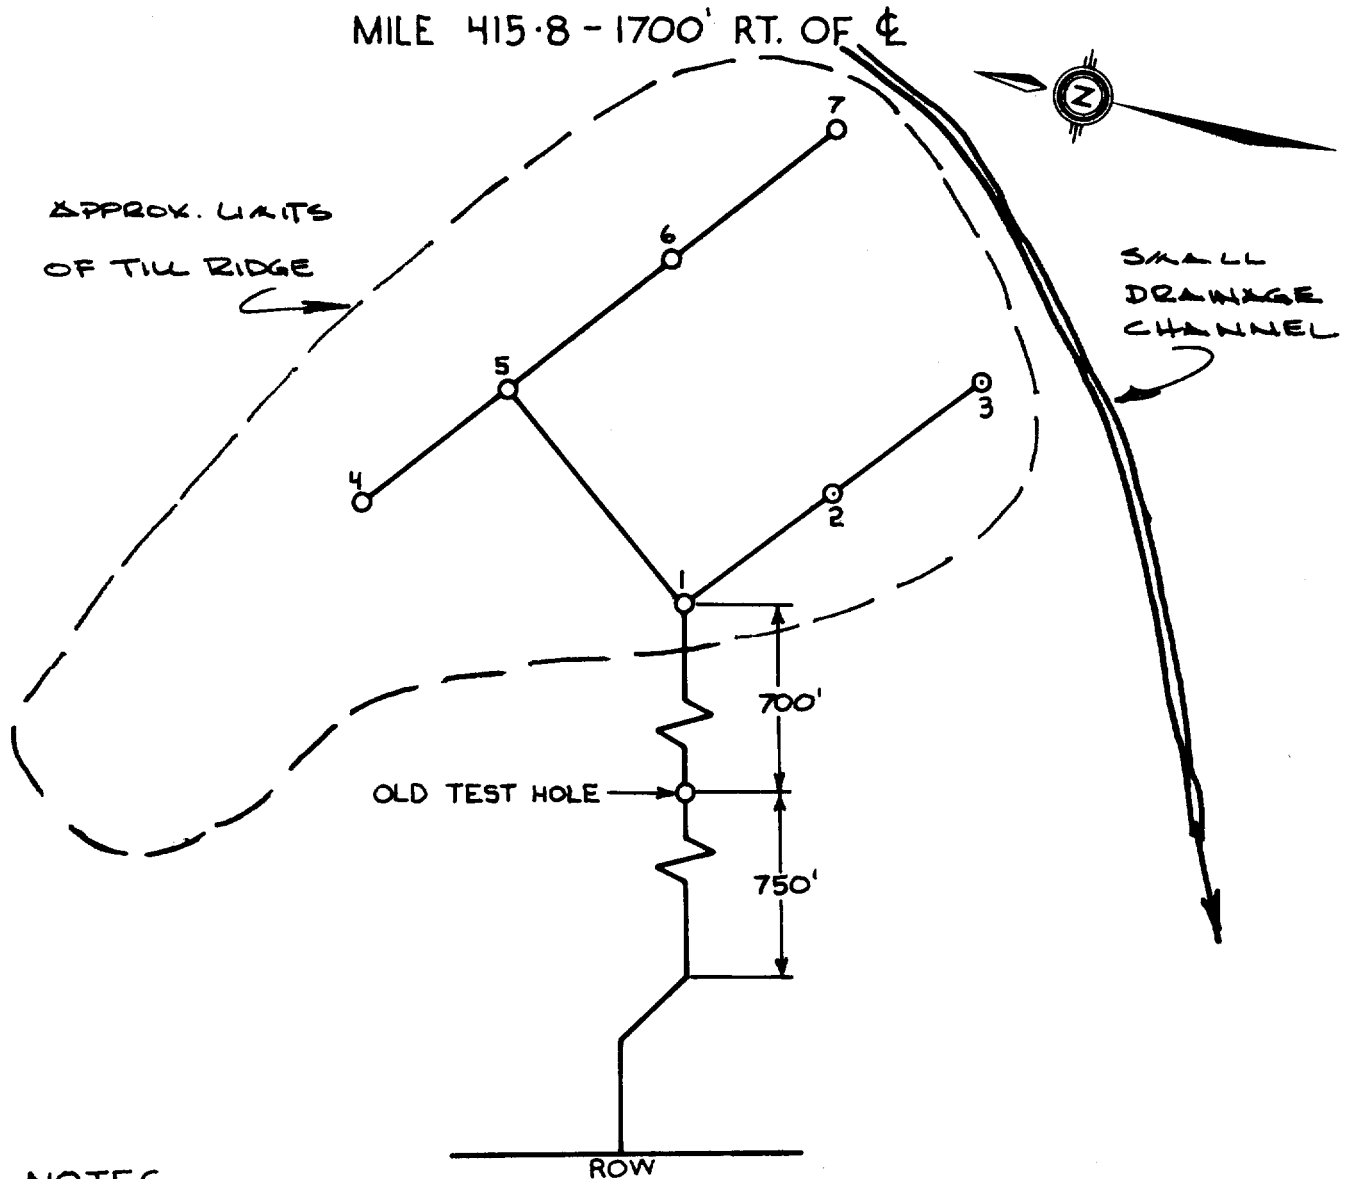
The area investigated here is located on a till ridge similar to that on which Borrow Pit No. 51 is located. It is heavily treed with 5-6" diameter spruce and with good drainage to the west. The area investigated measures roughly 800' x 600' and 7 holes revealed granular clay subsoil to depths of at least 25 feet. Moisture contents are low throughout and no permafrost was encountered. Occasional cobbles and/or boulders are present throughout. This is an excellent borrow source.

- SUBSOIL LOW PLASTIC, UNFROZEN GRAVELLY CLAY WITH OCCASIONAL COBBLES AND BOULDERS
- UNFROZEN
- MOISTURE CONTENTS LESS THAN 10%
- EXCELLENT BORROW SOURCE

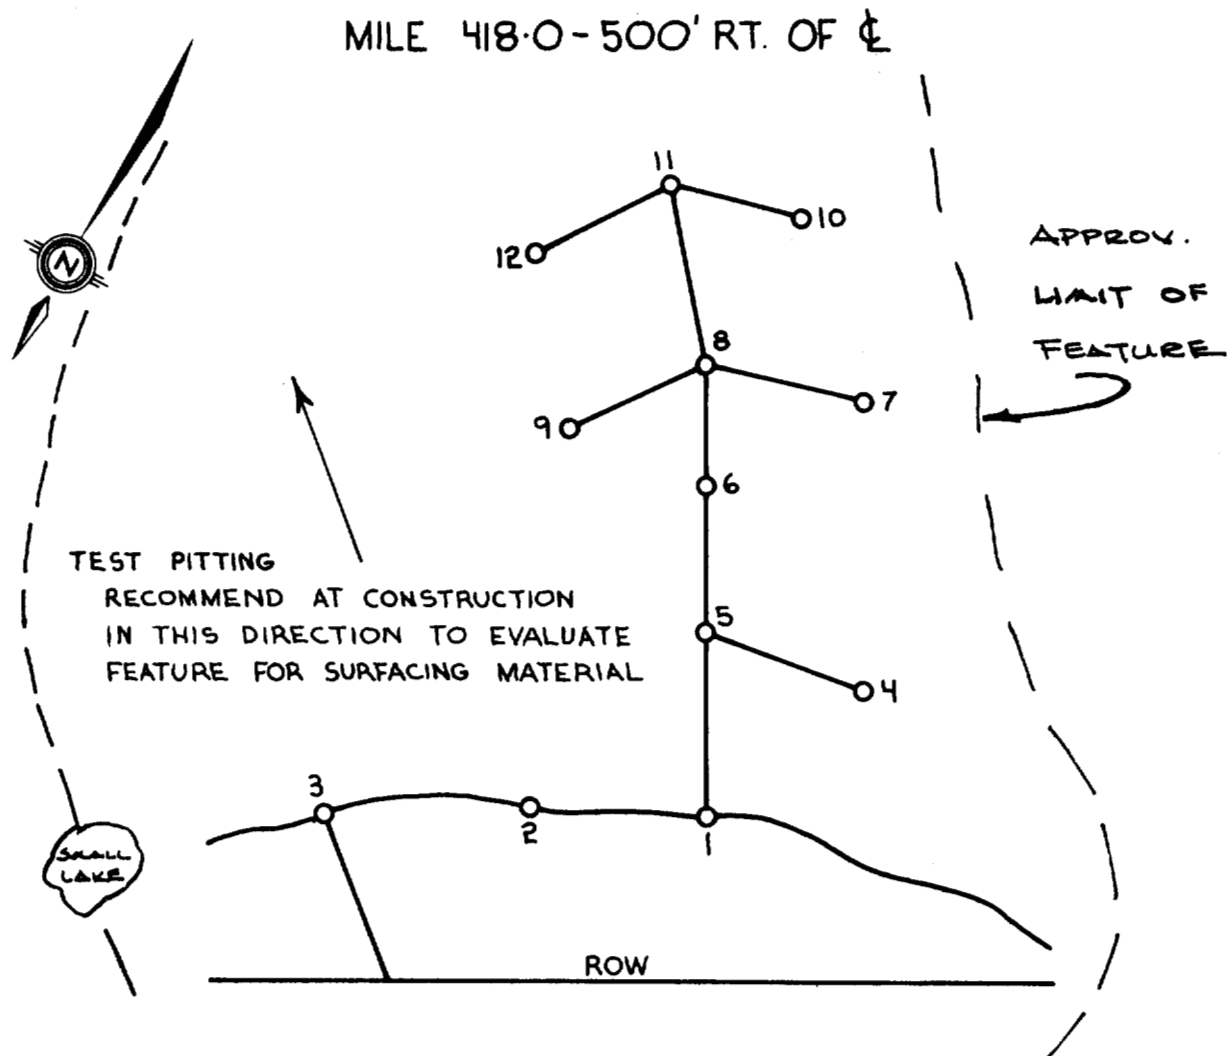
The feature investigated here is a large glaciofluvial outwash deposit measuring 2000 x 4000 feet. The feature is heavily treed with jackpine and occasional poplar stands. Test drilling for Borrow Pit No. 53 consisted of a dozen holes spaced over an area measuring 700 x 1200 feet. All holes encountered cohesionless gravelly sand with occasional sandy gravel zones. Hole depths were limited to 10 or 11 feet. Moisture contents are low throughout and the majority of the material is unfrozen. This area is considered an excellent source of embankment borrow and may be a source of surfacing material although there appears to be a shortage of plus No. 4 material and an excess of sands. Test pitting over a larger area is recommended at construction to determine the availability of surfacing materials.

- PIT AREA IN A LARGE FLUVIAL DEPOSIT
- SUBSOIL GRAVELLY SAND WITH SOME SANDY GRAVEL ZONES
- LOW MOISTURE CONTENTS
- TEST HOLES TERMINATED AT 10-11' DUE TO HOLES CAVING
- EXCELLENT BORROW SOURCE
- MAY BE A SOURCE OF SURFACING MATERIAL
- TEST PITTING RECOMMENDED AT CONSTRUCTION

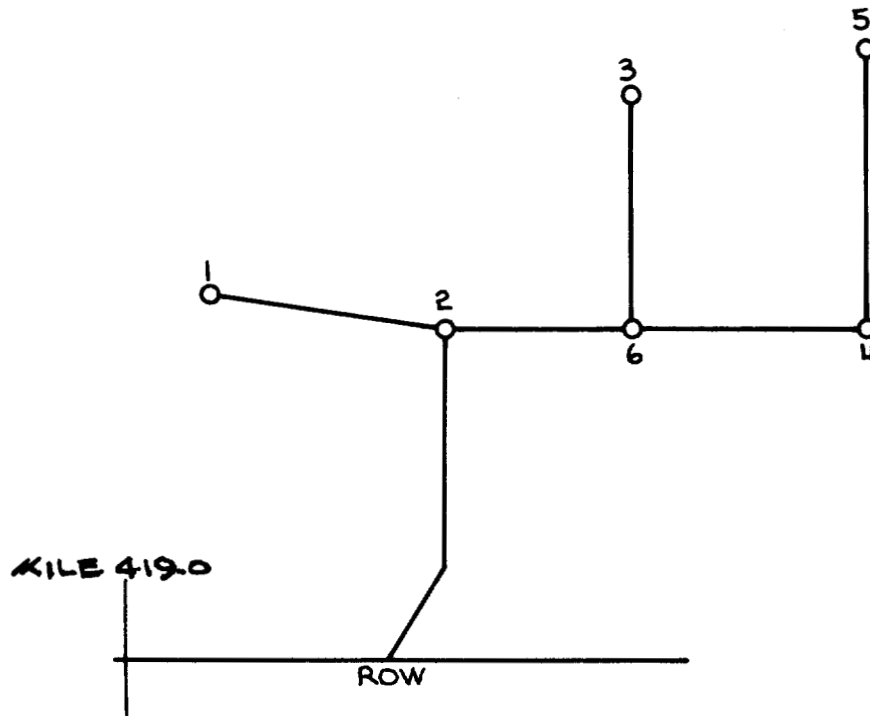
MILE 418.9 - 500' RT. OF C

Pit area No. 54 is on a portion of the glaciofluvial deposit in which Pit No. 53 is located but in an area of subdued relief. It is heavily treed with spruce, jackpine and poplar. Subsoil consists of silty sands, with occasional gravelly sand zones. Moisture contents are low throughout and the area is largely unfrozen. Recommended as an embankment borrow source if required, but holds little promise as a source of surfacing materials.

- SUBSOIL SILTY SAND AND GRAVELLY SAND
- LOW MOISTURE CONTENTS
- LITTLE OR NO PERMAFROST
- EXCELLENT BORROW SOURCE
- AREA HEAVILY TREED WITH SPRUCE AND JACKPINE
- LITTLE OR NO RELIEF

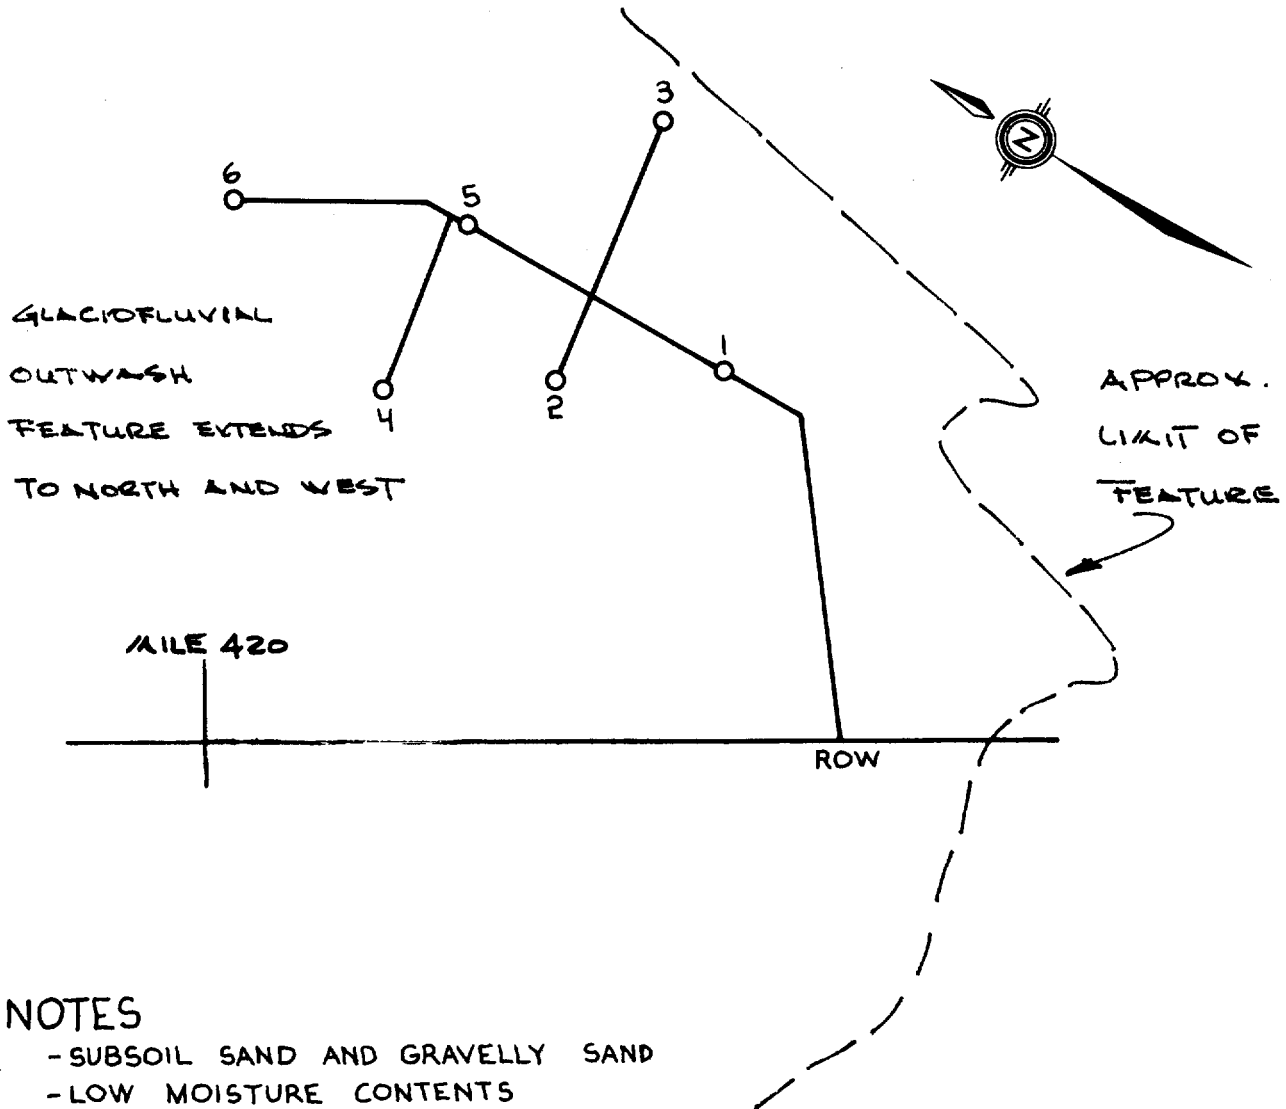
# MILE 419.8 - 500' RT. OF C

This pit is near the edge of a large glaciofluvial outwash plain and is similar to Pits 53 and 54. Subsoil is primarily sand with some gravelly zones. Moisture contents are low throughout and there is little or no permafrost. Maximum hole penetration was to 12' due to caving of the cohesionless subsoil. Area is heavily treed with spruce and jackpine. Recommended for embankment borrow but unsuitable as a source of surfacing materials.

- SUBSOIL SAND AND GRAVELLY SAND
- LOW MOISTURE CONTENTS
- LITTLE OR NO PERMAFROST
- EXCELLENT BORROW SOURCE
- AREA HEAVILY TREED WITH SPRUCE AND JACKPINE

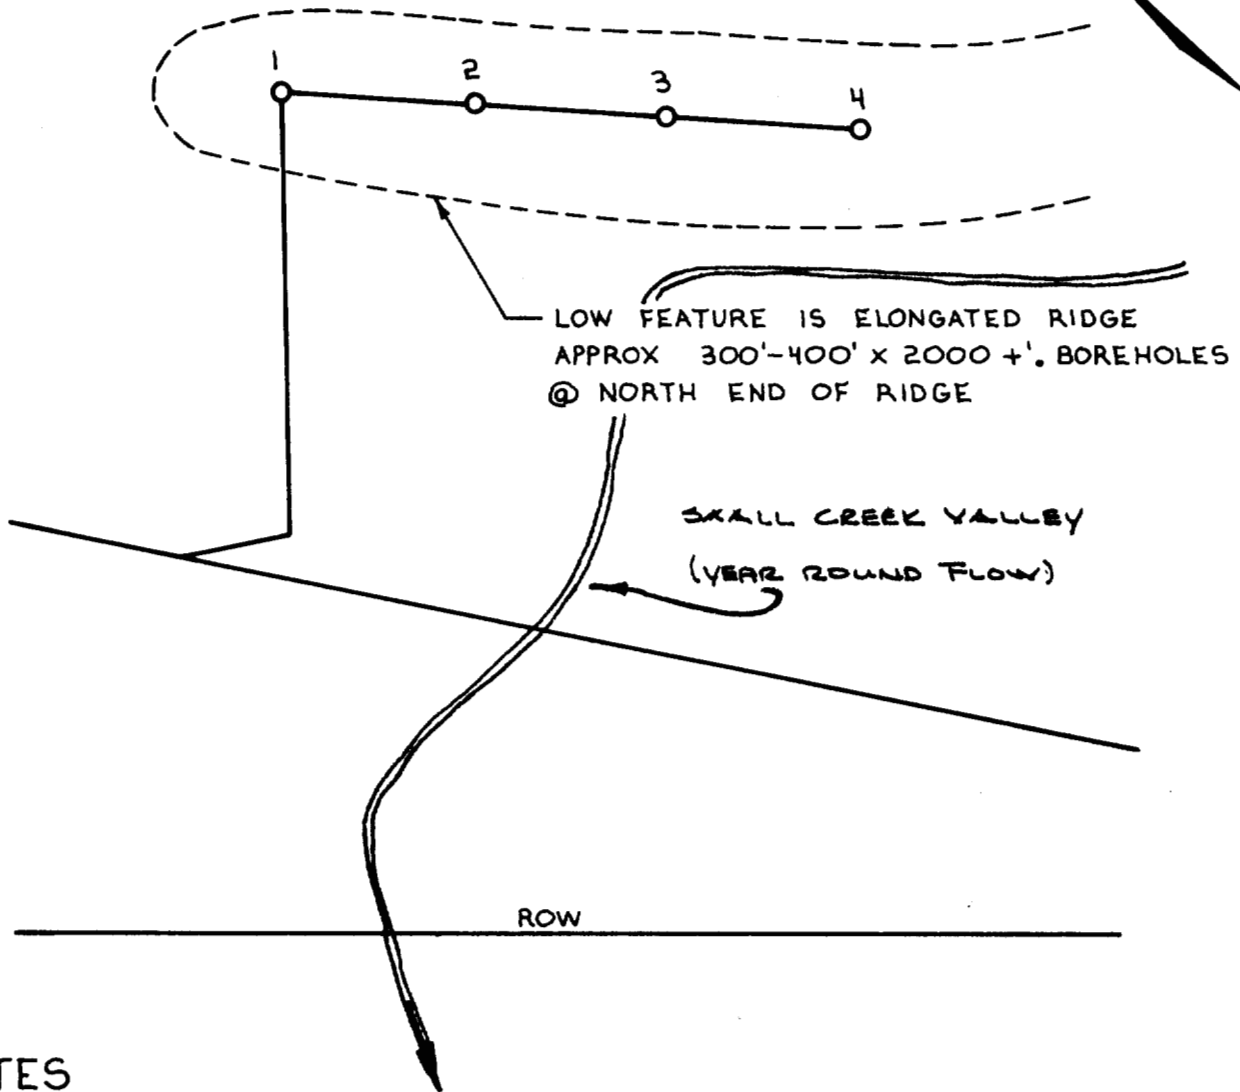
MILE 426.5 - 1200' RT. OF C

These three areas were drilled on what is thought to be thin glacial lake sediments over glacial till. Of the three areas, Borrow Pit 56B located 1200 feet right of centerline at Mile 426.5 is the preferred area. The feature here is an elongate ridge some 300 to 400 feet wide and 2000 to 2500 feet in length. It is treed with large spruce to 2 feet in diameter. Subsoil is low plastic sandy silty clay with pebbles (glacial till). Moisture contents, for the most part, are below 10% and no permafrost was reported. This is considered to be an excellent borrow source.

- SUBSOIL LOW PLASTIC SANDY SILTY, CLAY WITH PEBBLES (GLACIAL TILL)
- NO PERMAFROST REPORTED
- MOISTURE CONTENTS GENERALLY  $\leq 10\%$
- GOOD BORROW SOURCE

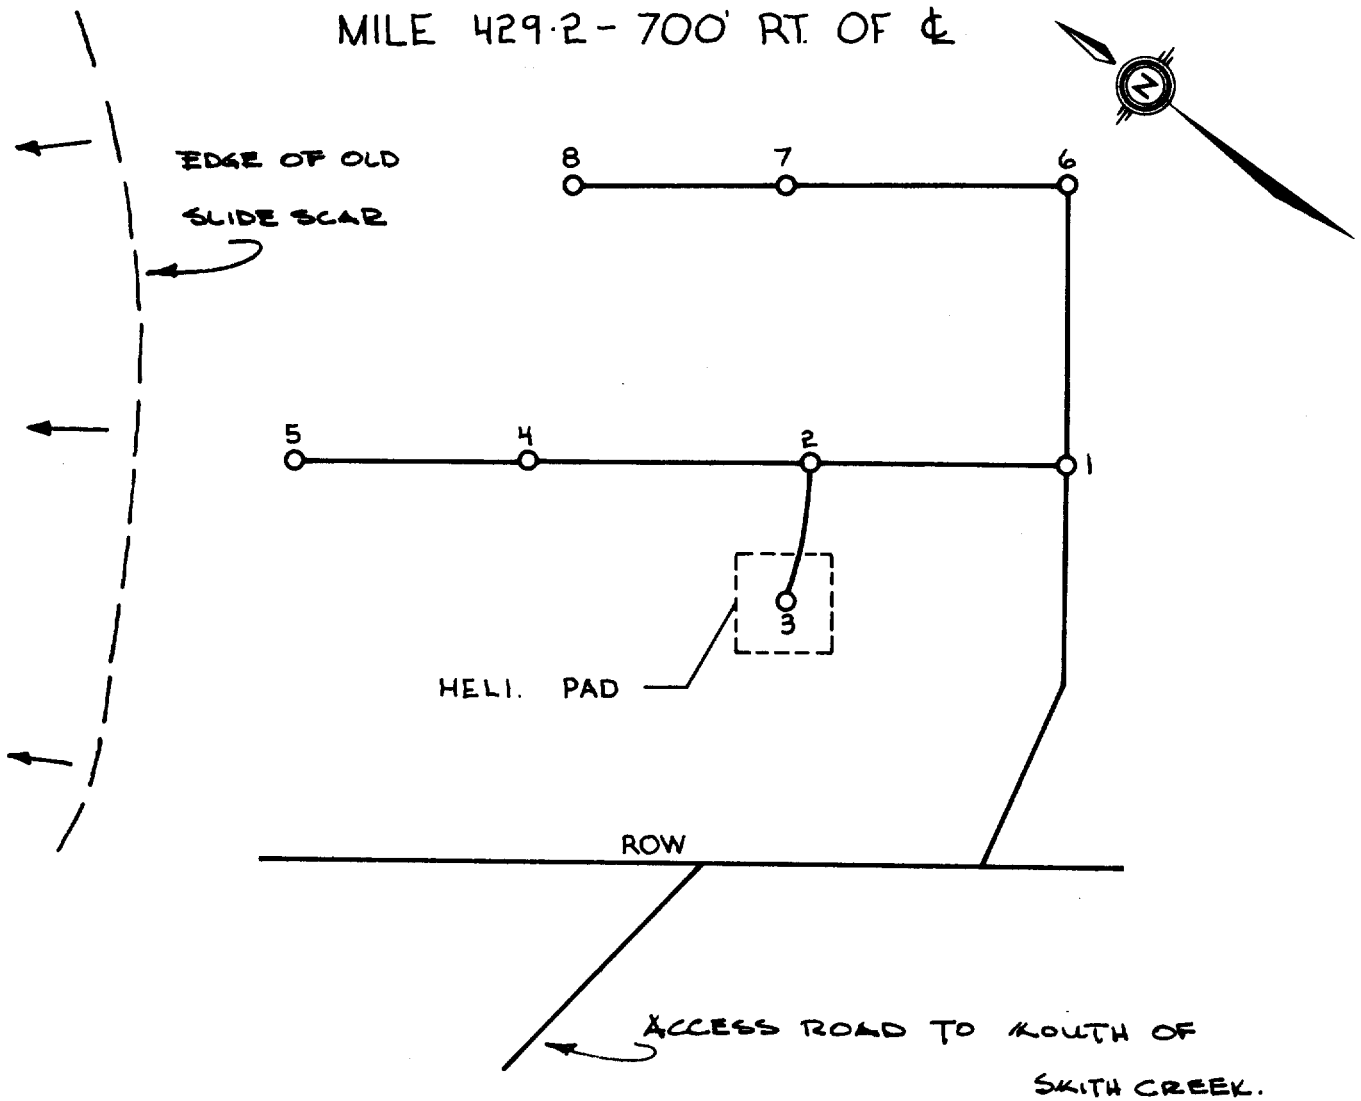
The area test drilled here is thought to be part of an abandoned terrace of the Mackenzie River. It is located immediately above an old slide area on the south side of Smith Creek and is some 3500 feet south of the Smith Creek crossing. The area is heavily treed with spruce and poplar. Subsoil varies from gravelly sands to sandy gravels and many holes were stopped short of 10 feet due to caving of the cohesionless deposits. Permafrost is at least partially present, although the surficial deposits penetrated in the drill holes were generally unfrozen with moisture contents less than 5%. This should be an excellent source of embankment borrow, and possibly a good source of granular material for culvert backfill.

- SUBSOIL GRAVELLY SAND - SOME SANDY GRAVEL
- DRY TO AT LEAST 10'
- EXCELLENT BORROW SOURCE
- PERMAFROST SPORADIC BUT GENERALLY ABSENT TO AT LEAST 10'

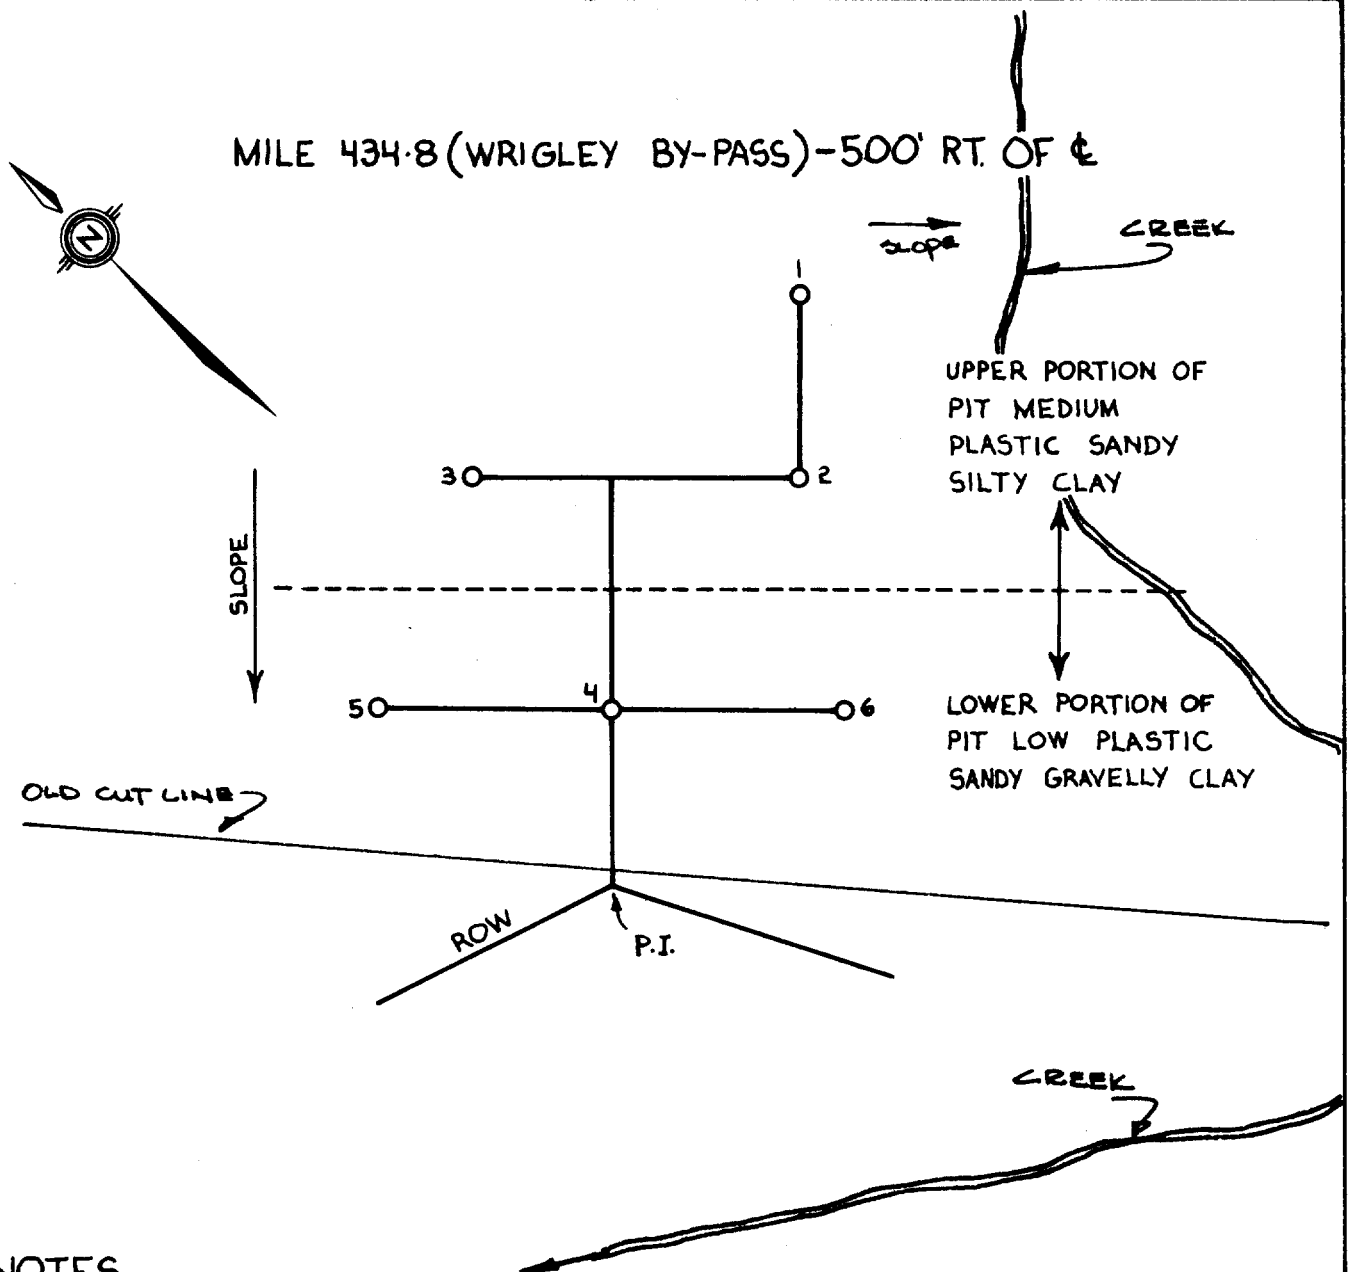
Area test drilled is near the base of the south facing valley slope. It is heavily treed with poplar and no permafrost was noted. Subsoil is medium plastic silty clay. Moisture contents are near 20% and slightly below the plastic limit. Stripping will be 1 to 2 feet. An excellent borrow source.

- AREA HEAVILY TREED WITH POPLAR
- NO PERMAFROST EVIDENT
- EXCELLENT BORROW SOURCE

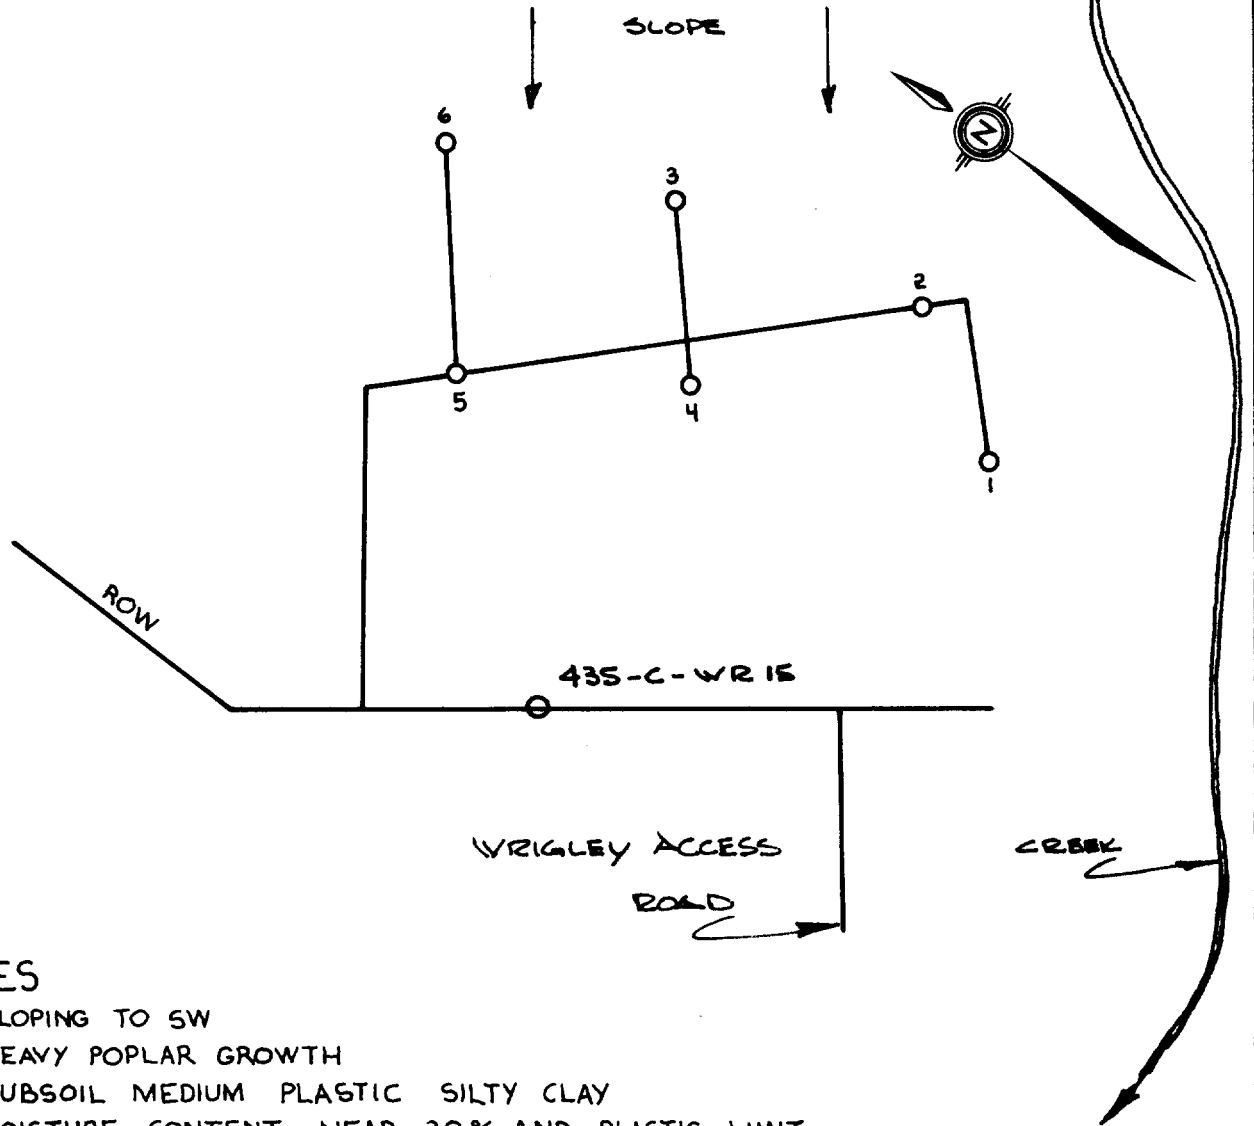
# MILE 435.9 (WRIGLEY BY-PASS)-500' RT. OF E

- SLOPING TO SW
- HEAVY POPLAR GROWTH
- SUBSOIL MEDIUM PLASTIC SILTY CLAY
- MOISTURE CONTENT NEAR 20% AND PLASTIC LIMIT
- NO PERMAFROST
- EXCELLENT BORROW SOURCE

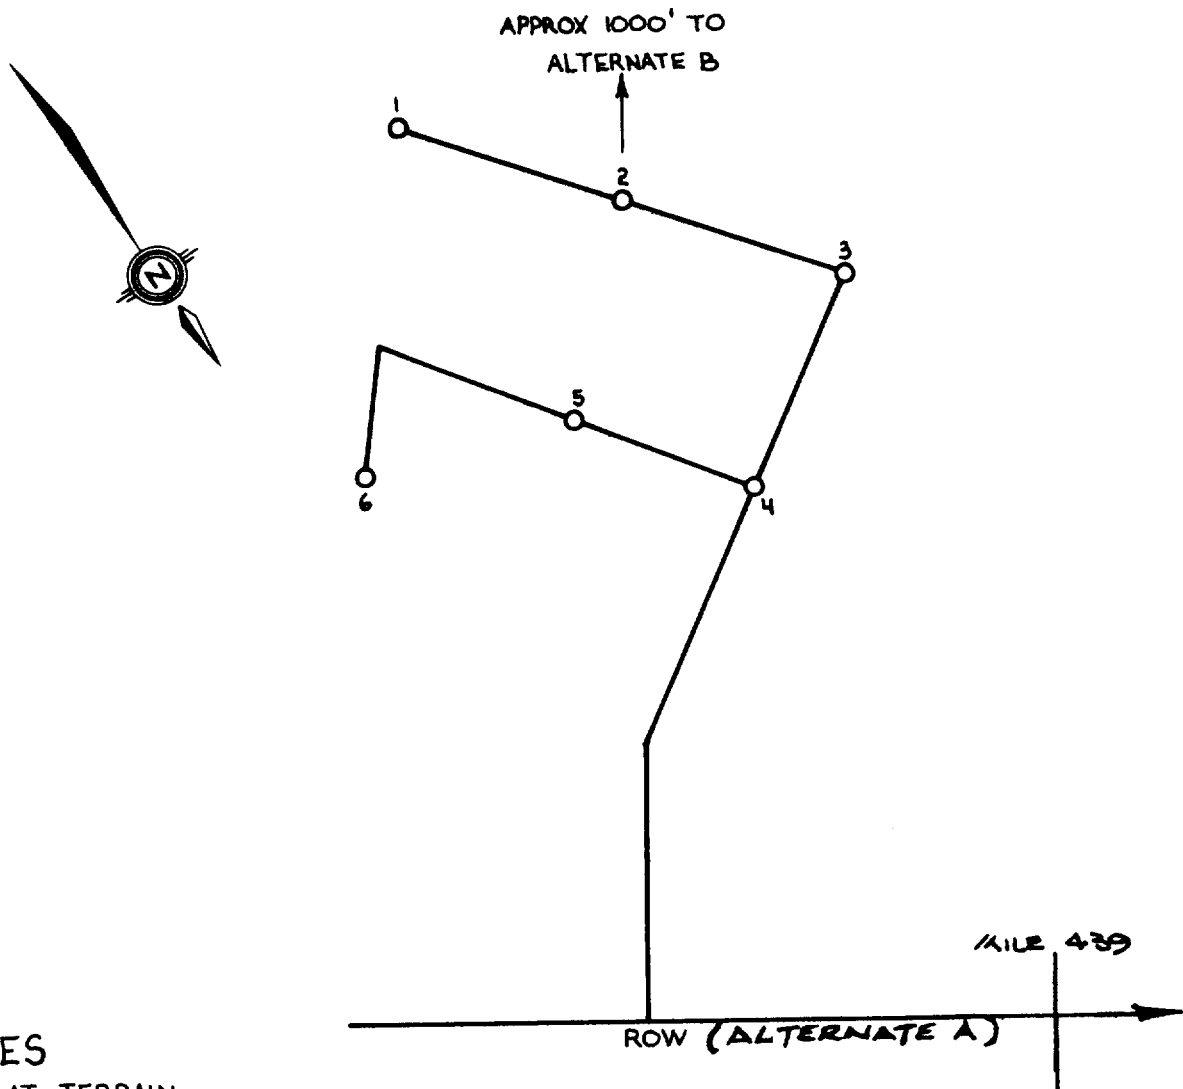
# APPROX MILE 439 (WRIGLEY BY-PASS)

Area test drilled is on flat poorly drained glaciolacustrine plain in a heavy stand of spruce and poplar. Subsoil is medium plastic silty clay. Permafrost is sporadic but the majority of the area is frozen. Moisture (ice) contents average slightly below 20% and near the plastic limit. Stripping depths are estimated at 2 to 3 feet. Considered to be a usable borrow source in an area of generally poor borrow.

- FLAT TERRAIN
- HEAVY SPRUCE AND POPULAR GROWTH
- SUBSOIL MEDIUM-HIGHLY PLASTIC SILTY CLAY
- PERMAFROST SPORADIC
- MOISTURE(ICE) CONTENT NEAR 20% AND PLASTIC LIMIT
- 2-3' OF STRIPPING
- ACCEPTABLE BORROW SOURCE

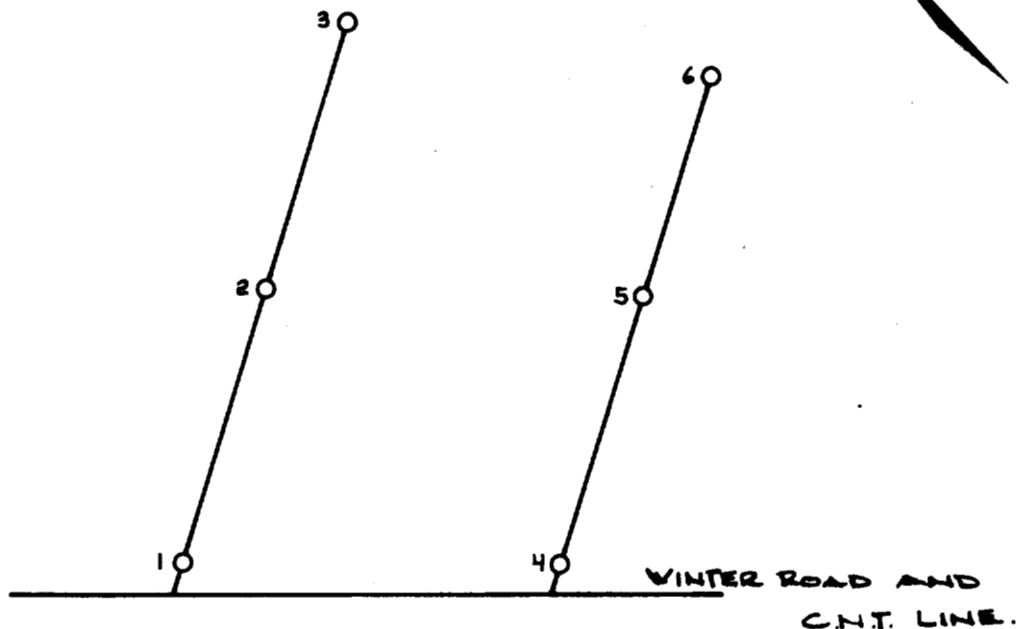
MILE 439.9-600' RT. OF E

The terrain here is a very flat, poorly drained glaciolacustrine plain which exhibits thermokarst lakes, ponds and muskeg bogs. Area test drilled is in a stand of 3 to 4" diameter spruce with some birch. Subsoil is medium plastic silty clay. Permafrost is continuous and ice contents are low. Upon thawing, moisture contents are in the 20 to 25% range and at, or slightly above, the plastic limit. Stripping depths vary from 2 to possibly 5 feet. Considered to be a borderline source of borrow, however, there is no better quality material available within 2 or 3 miles.

TERRAIN FLAT LYING WITH POOR DRAINAGE  
PIT AREA IN STAND OF SPRUCE AND BIRCH  
SUBSOIL MEDIUM PLASTIC SILTY CLAY  
PERMAFROST THROUGH-OUT WITH LOW VISIBLE ICE CONTENT  
MOISTURE (ICE) CONTENT 20-25% AND SLIGHTLY ABOVE PLASTIC LIMIT

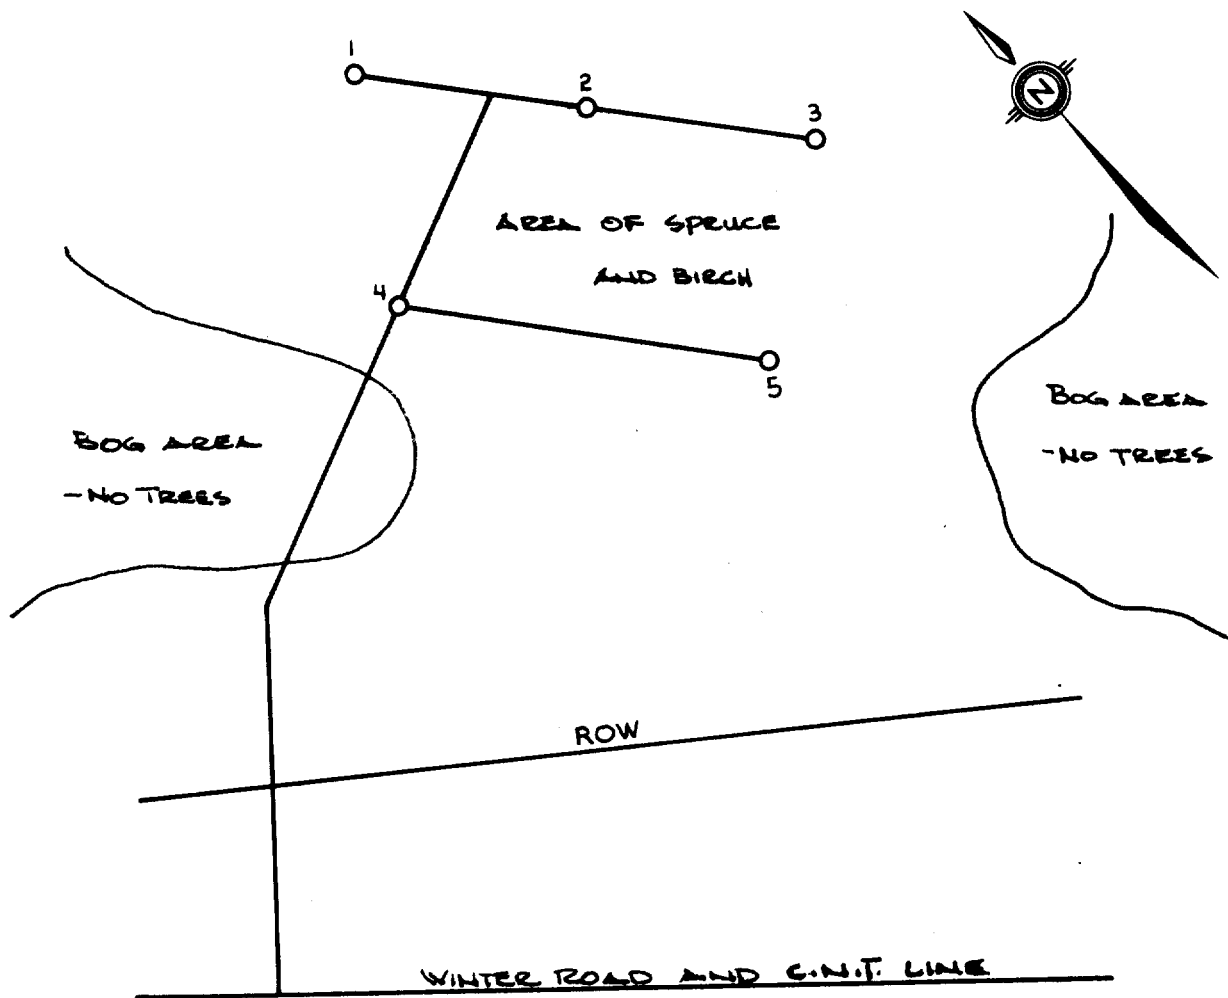
MILE 440.6-800' RT. OF E

Area drilled here is a heavy stand of spruce and birch in an otherwise sparsely treed, flat, poorly drained terrain which is part of an extensive glaciolacustrine plain. Subsoil is medium plastic silty clay. Permafrost is present throughout and ice contents are low. Moisture contents on thawing range between 20 and 25% and slightly above the plastic limit. Strip-ping depths vary from 2-4'. Material is similar in quality and moisture content to Borrow Pit 64 and as the two are in close proximity (approximately 2/3 of a mile) it is recommended that only one area be developed.

SUBSOIL MEDIUM PLASTIC SILTY CLAY  
 PERMAFROST THROUGH OUT  
 MOISTURE (ICE) CONTENT 20-25% SLIGHTLY ABOVE PLASTIC LIMIT  
 WITHIN 4000' OF BP-64  
 ACCEPTABLE BORROW SOURCE
