**GEOTECHNICAL INVESTIGATION**

MILE 347 TO MILE 690 MACKENZIE HIGHWAY  
WINTER - 1975

REPORT ON  
GEOTECHNICAL INVESTIGATION  
MILE 347 TO MILE 690  
MACKENZIE HIGHWAY

Submitted by R.D. Cook, P.Eng.  
Materials Engineer  
February 1, 1976

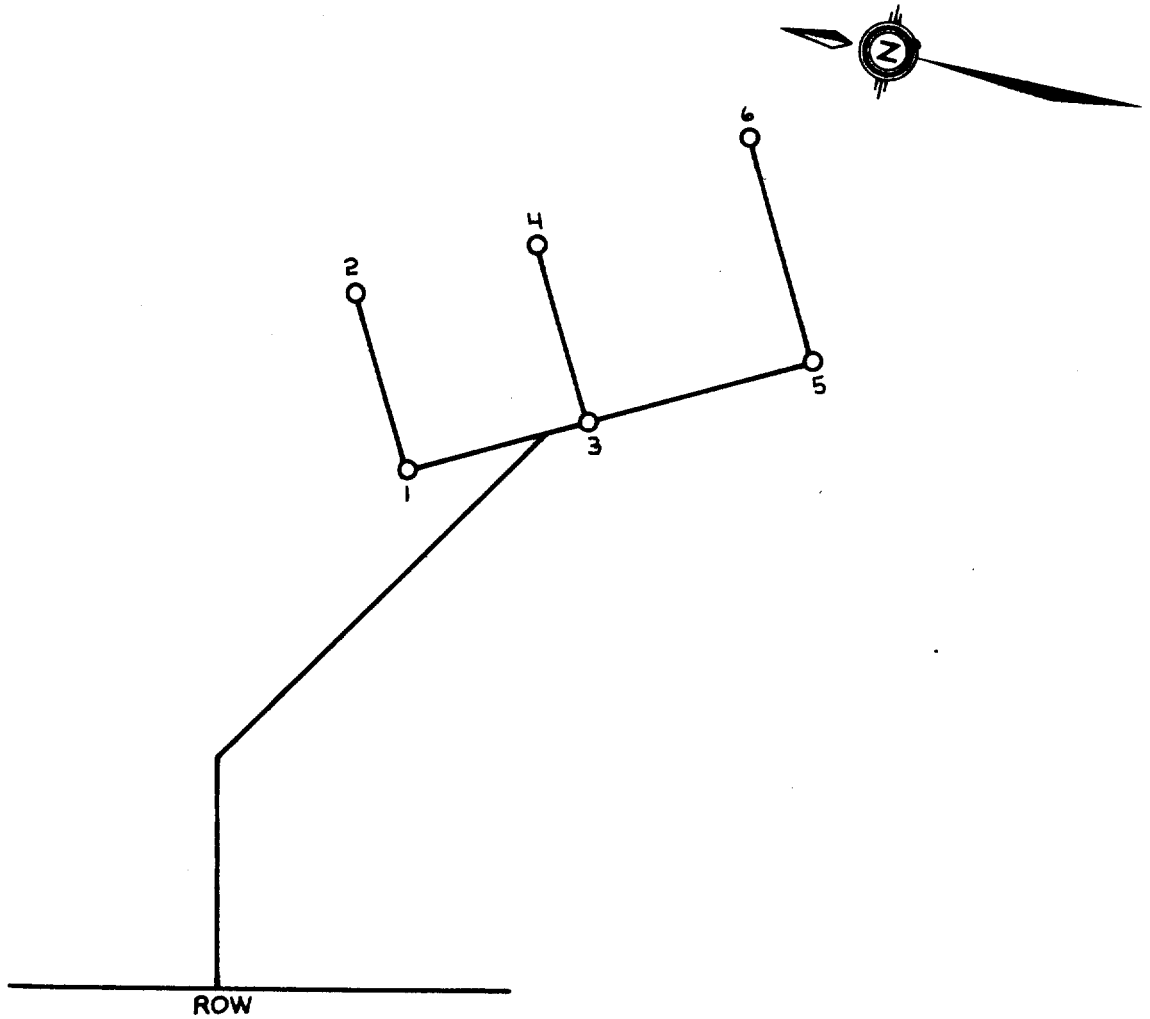
MILE 442.4-700' RT. OF E

The terrain here is a continuation of the flat sparsely treed, poorly drained, lake sediments which are marked by numerous small lakes and pot holes. Area test drilled is an isolated stand of heavy spruce and poplar. Six test holes over an area measuring 400' x 600' encountered medium plastic silty clay. Permafrost is continuous and moisture (ice) contents range up to 20% and are generally at or slightly below the plastic limit. Stripping depths are estimated at 2-3'. Considered to be an acceptable borrow source in an area of extremely poor material.

SUBSOIL MEDIUM PLASTIC SILTY CLAY  
 FROZEN WITH MOISTURE (ICE) CONTENT BELOW 20% AND  
 AT OR BELOW PLASTIC LIMIT  
 ACCEPTABLE BORROW SOURCE

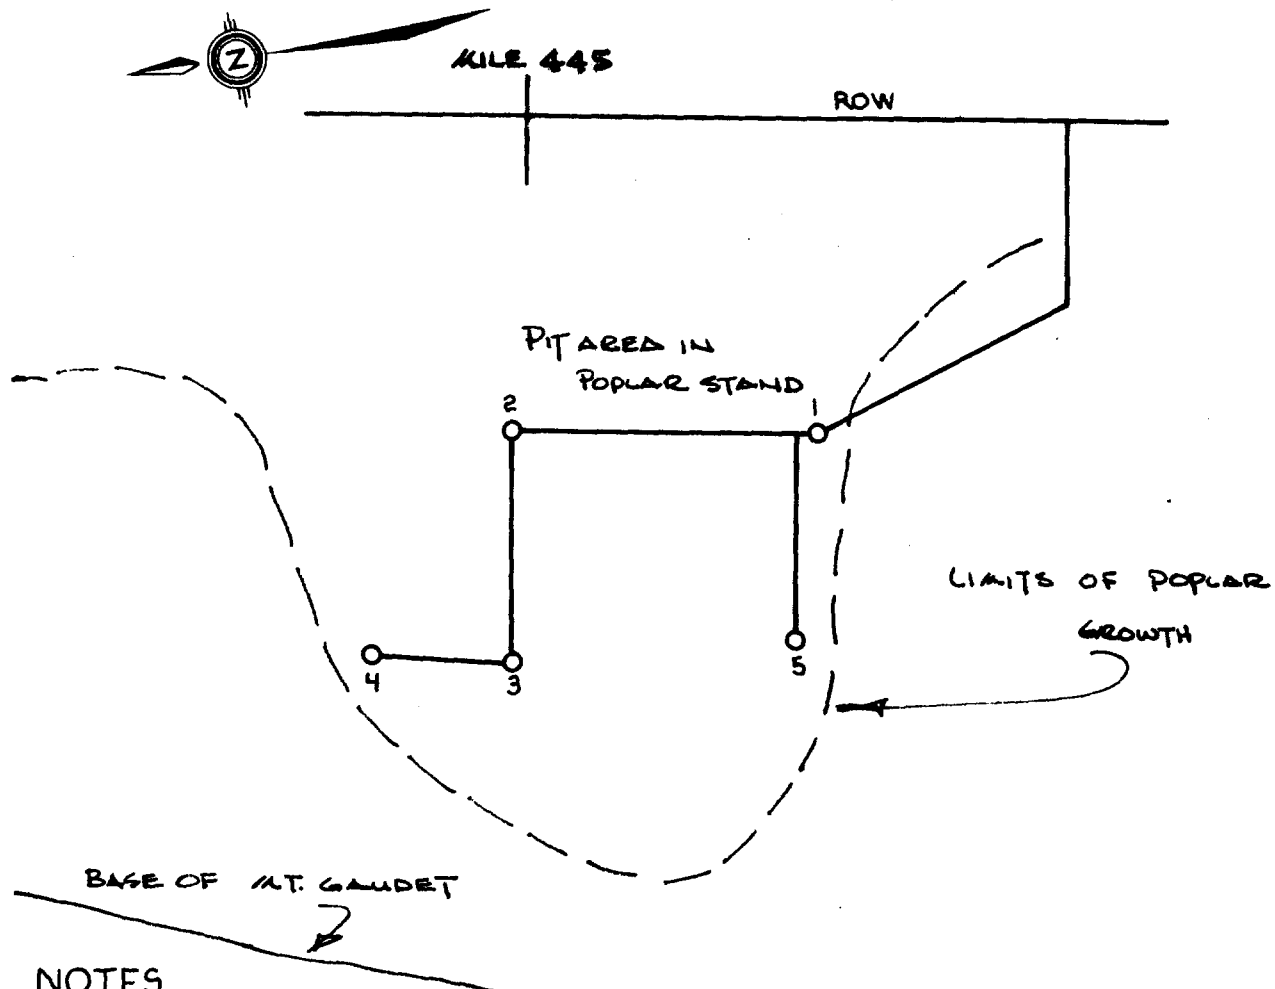
MILE 444.9-400' LT. OF E

From Mile 444 to 445 the right-of-way crosses flat, poorly drained, sparsely treed, glaciolacustrine sediments near the base of Mount Gaudet. Three potential borrow areas were investigated: At Mile 444.1 (Borrow Pit 67); at Mile 444.7 (Borrow Pit 68); and at 444.9 (Borrow Pit 69). The subsoil in all areas consisted of medium plastic silty clay. Permafrost is continuous throughout and moisture (ice) contents are erratic. It is unlikely a borrow pit could be developed in any of the areas drilled without encountering some ice-rich material. Of the three, Borrow Pit 69 is preferred although the area of suitable material is relatively small, measuring only approximately 300' x 400'. There is a stand of poplar located near Mile 444.5 which probably contains good borrow but which was not drilled as it is some 2000 feet off the right-of-way. It is suggested that the material for construction between Mile 444

- SUBSOIL MEDIUM PLASTIC SILTY CLAY
- FROZEN WITH MOISTURE (ICE) CONTENT NEAR 20% AND SLIGHTLY ABOVE THE PLASTIC LIMIT
- PREFERRED BORROW SOURCE IN AN AREA OF POOR MATERIAL

to 445 be obtained by expanding the cuts at Mile 443.5 and at Mile 445.4 and, if necessary, by developing Borrow Pit 69. Borrow Pit 67 and 68 are not recommended. Stripping in Borrow Pit 69 will probably average 2-3'.

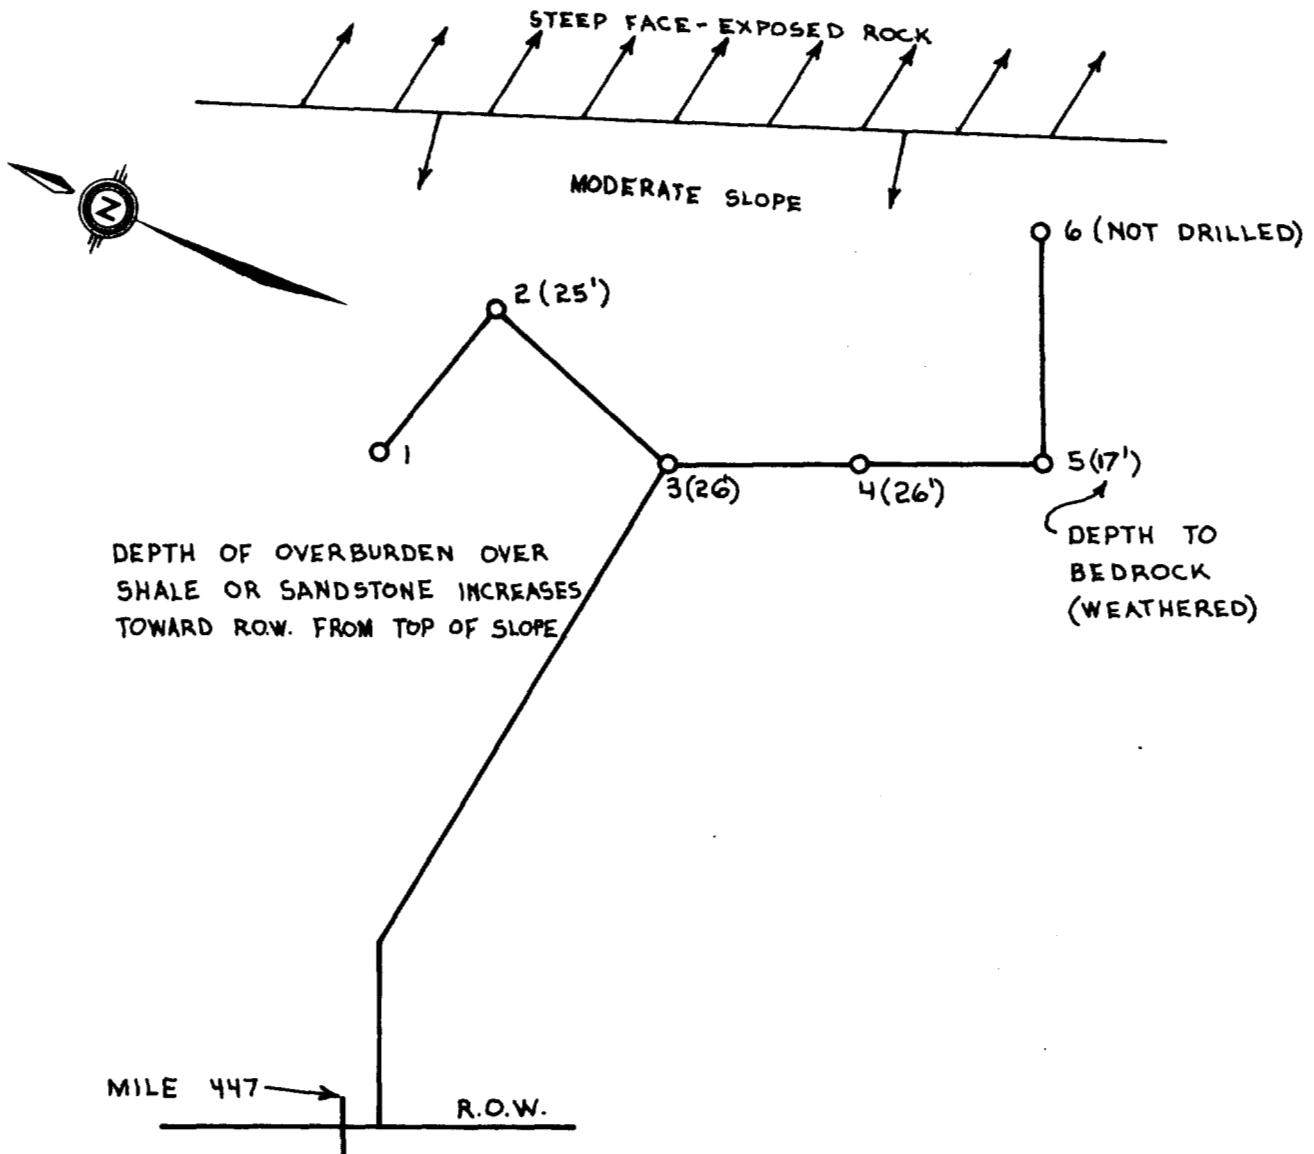
# MILE 447.0 - 800' RT. OF &

- PIT ON RIDGE THAT IS CONTINUATION OF MT. GAUDET
- SUBSOIL SILTY CLAY OVER SHALE OR SANDSTONE
- PERMAFROST PARTIALLY PRESENT - MOISTURE CONTENTS NEAR 20%
- STRIPPING PROBABLY 3'-5'
- SUITABLE BORROW SOURCE

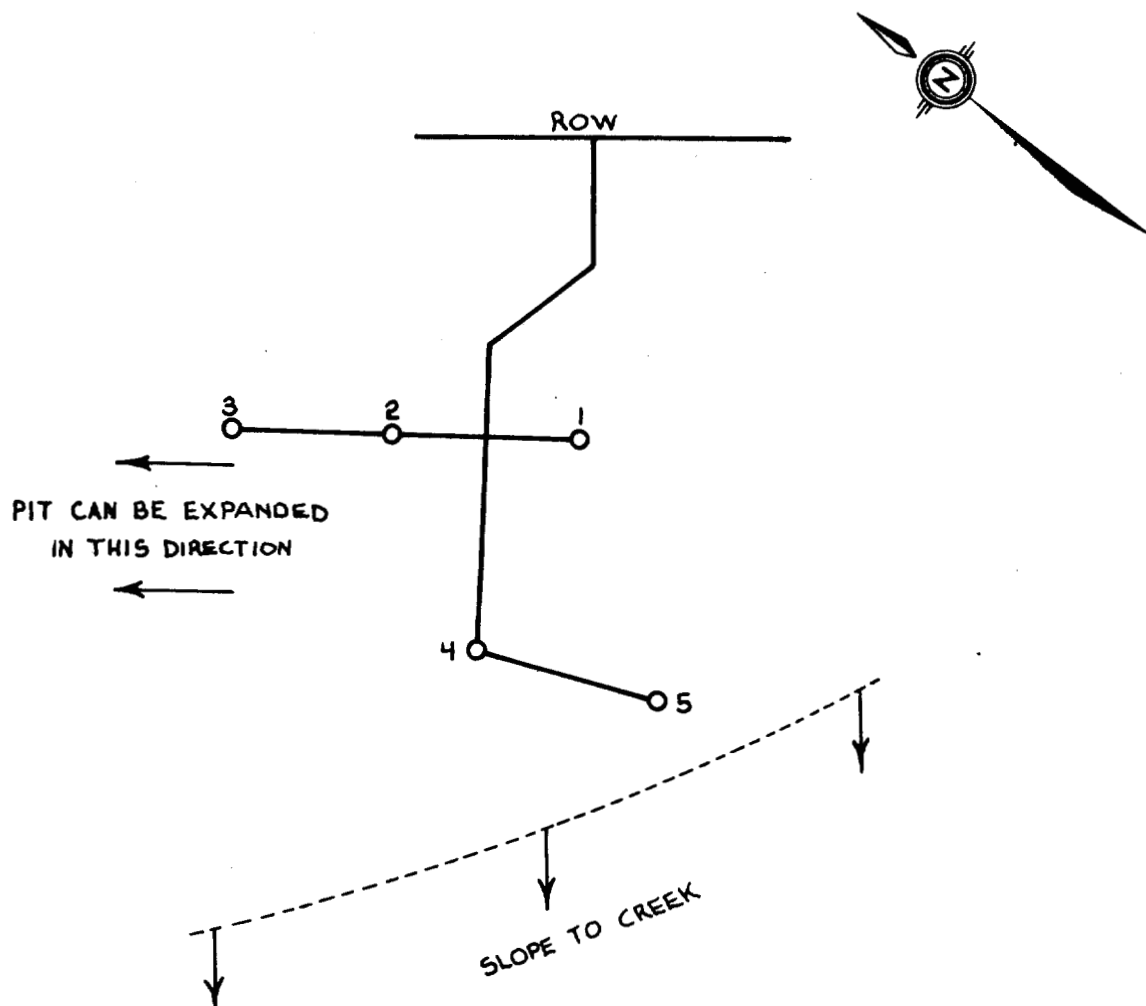
MILE 448.7-500' LT. OF E

- SUBSOIL MEDIUM PLASTIC SILTY CLAY
- FROZEN WITH MOISTURE (ICE) CONTENTS NEAR 20% AND THE PLASTIC LIMIT
- 1-3' OF STRIPPING
- ACCEPTABLE BORROW SOURCE

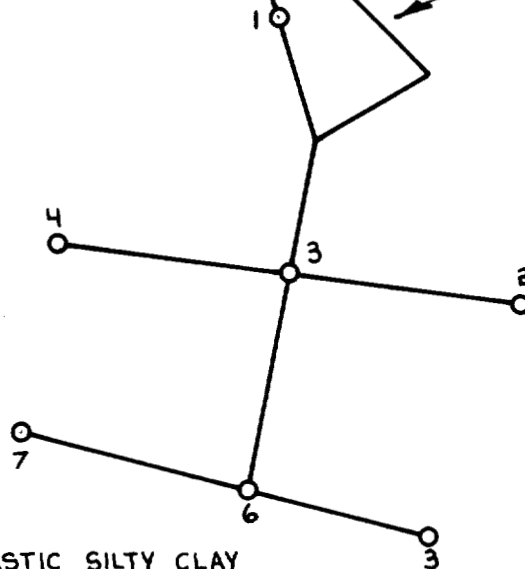
- POPLAR TREE AREA
- SUBSOIL MEDIUM PLASTIC SILTY CLAY
- PERMAFROST SPORADIC BUT EXPECTED OVER MAJORITY OF PIT AREA
- MOISTURE (ICE) CONTENTS NEAR 20% AND PLASTIC LIMIT
- 1-2' OF STRIPPING
- USEABLE BORROW SOURCE

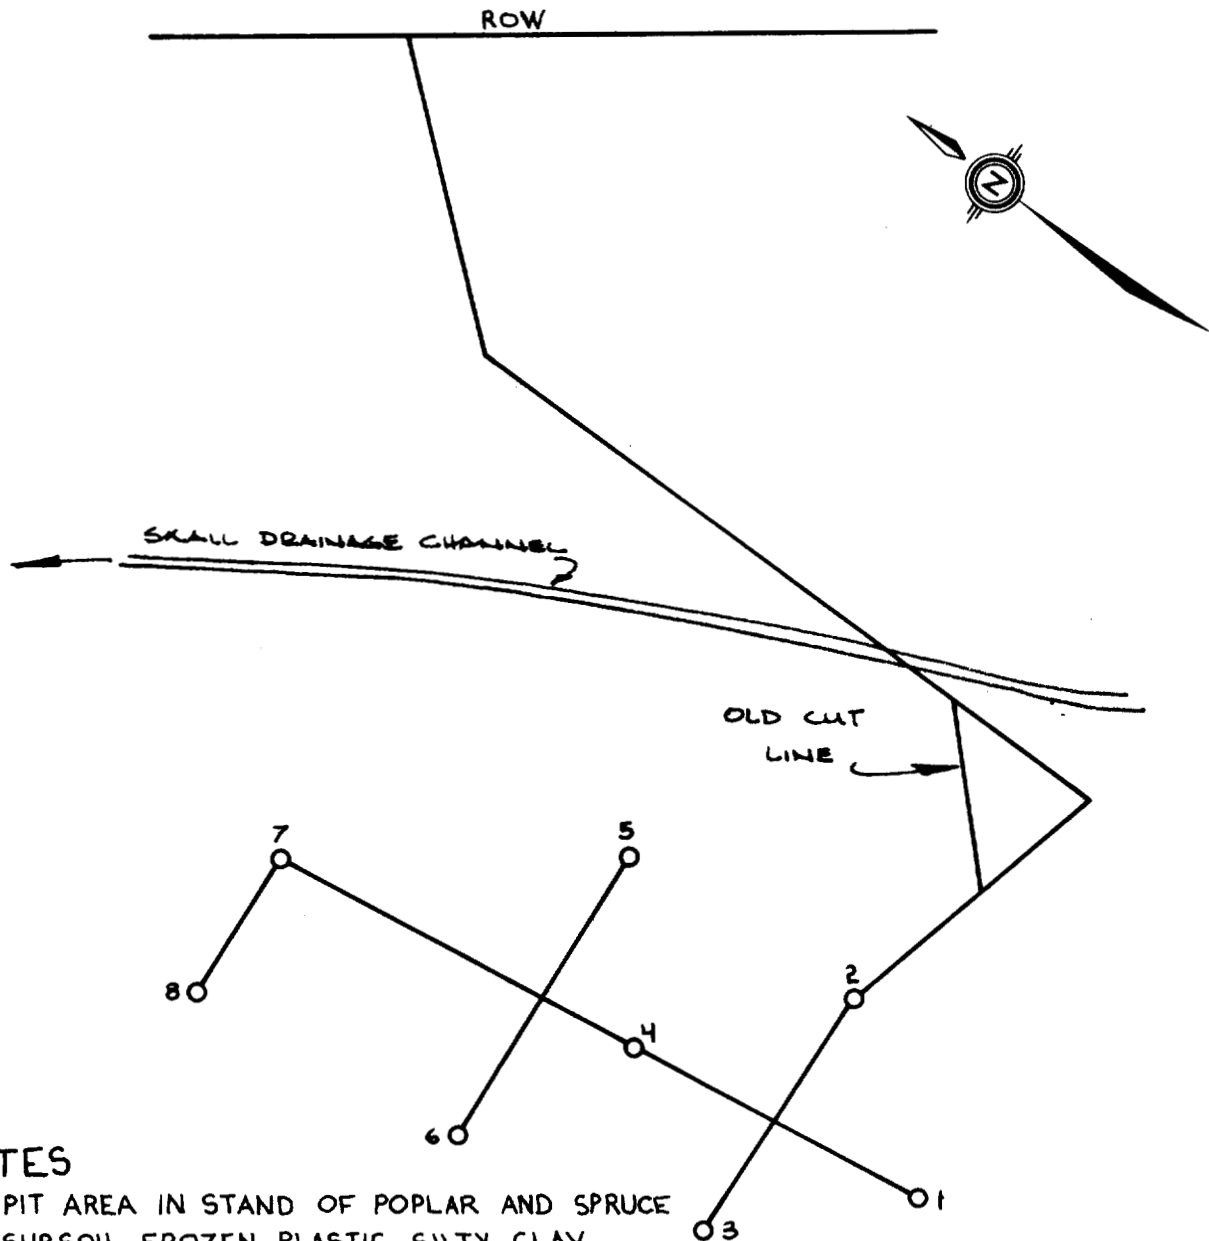
MILE 452.4 - 1100' LT. OF E

- PIT AREA IN STAND OF POPLAR AND SPRUCE
- SUBSOIL FROZEN PLASTIC SILTY CLAY  
WITH MOISTURE (ICE) CONTENT NEAR 20% AND THE PLASTIC LIMIT
- STRIPPING < 2'
- ACCEPTABLE BORROW SOURCE

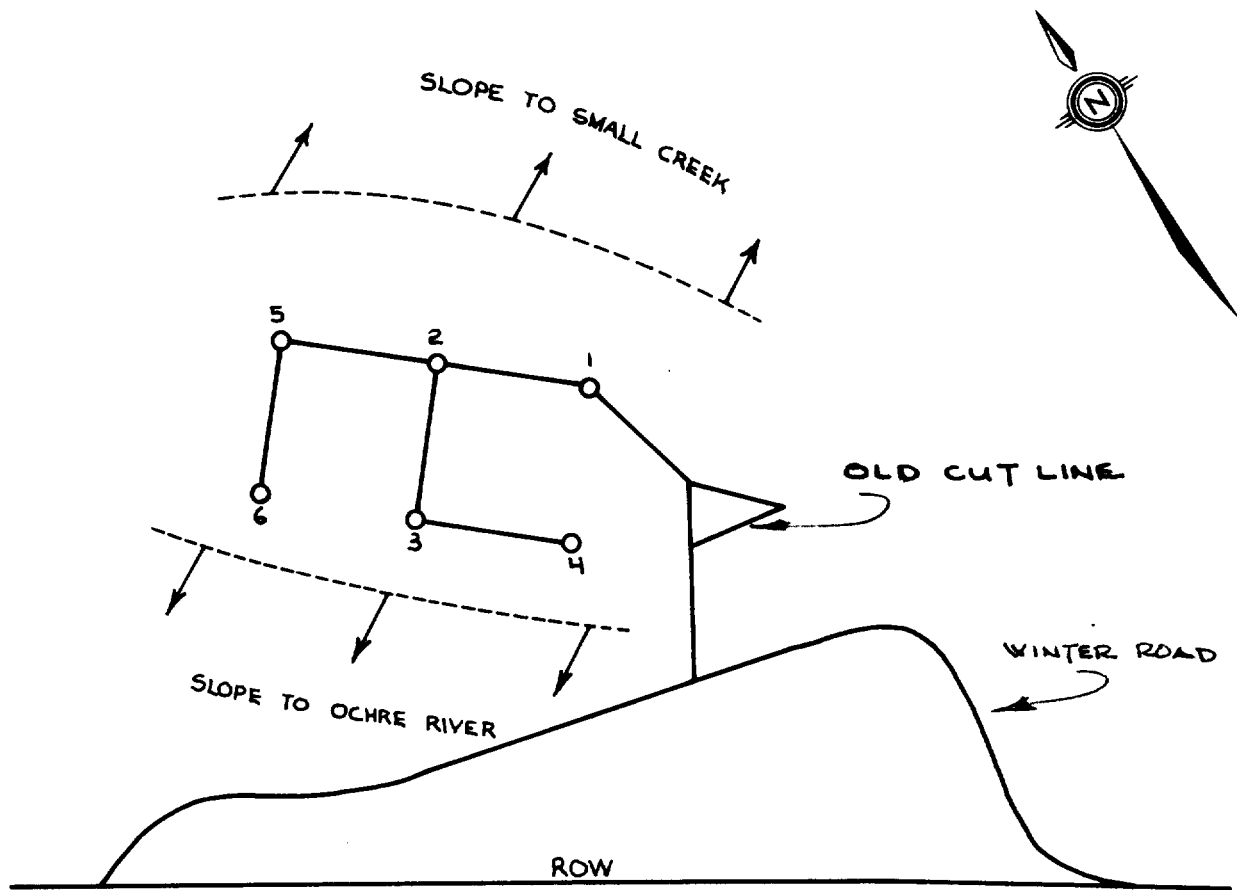
MILE 453.7- 800' RT OF E

- HEAVY POPLAR GROWTH
- SUBSOIL FROZEN MEDIUM PLASTIC SILTY CLAY WITH MOISTURE (ICE)  
CONTENTS GENERALLY BELOW 20% AND THE PLASTIC LIMIT
- STRIPPING < 2'
- GOOD BORROW SOURCE

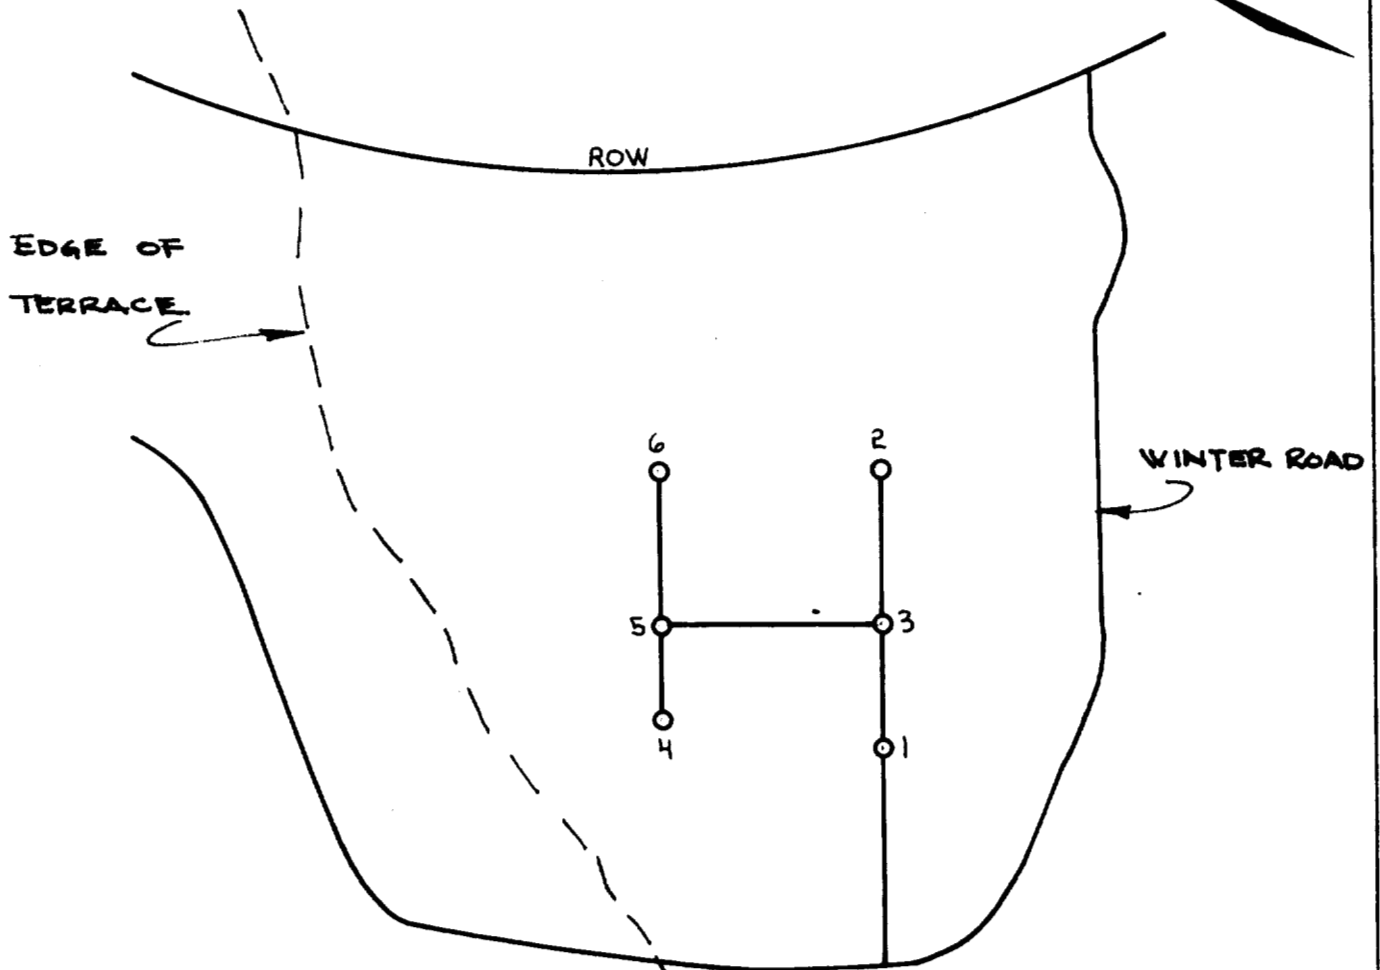
MILE 454.3 - 600' LT. OF C

- AREA TEST DRILLED ON FLUVIAL TERRACE OF OCHRE RIVER
- SUBSOIL 2-5' OF SILT AND CLAY OVER SANDS AND GRAVELS
- PERMAFROST SPORADIC
- SOME GRANULAR DEPOSITS WILL BE WET ON THAWING  
BUT SHOULD DRAIN QUICKLY
- USEABLE BORROW SOURCE

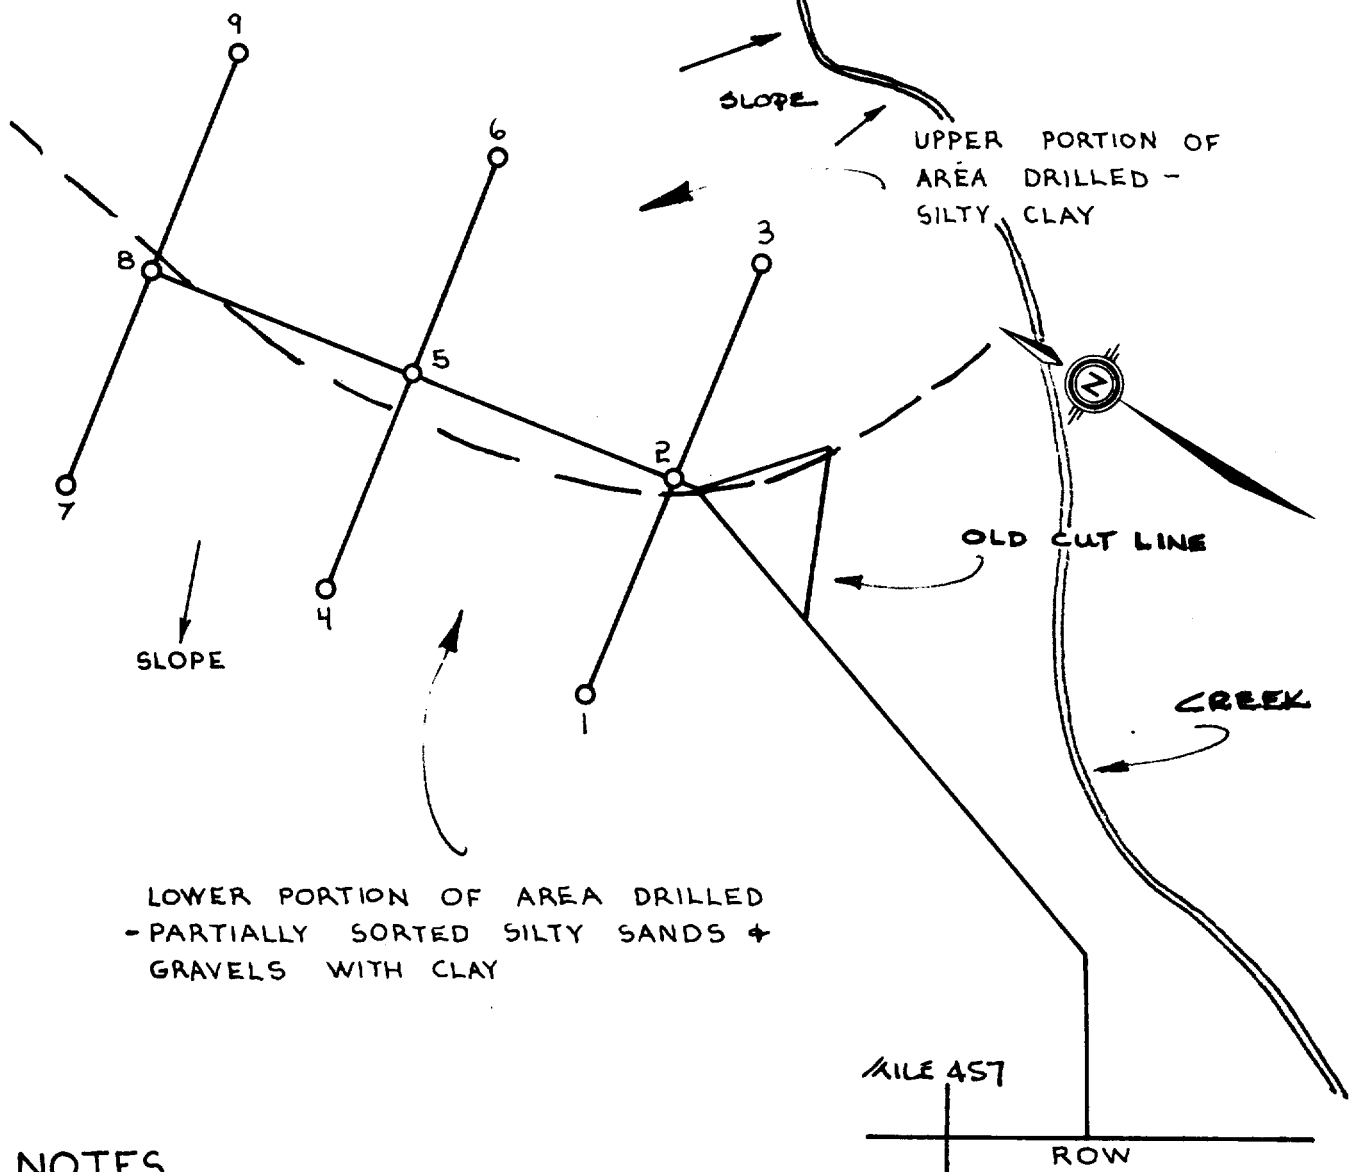
# MILE 457.0 - 600' Rt. of E

- AREA DRILLED PARTIALLY ON ALLUVIAL FAN AND PARTIALLY ON VALLEY SLOPE
- UPPER PORTION (VALLEY SLOPE) IS MEDIUM PLASTIC SILTY CLAY
- LOWER PORTION SAND + GRAVELS WITH CLAY
- PERMAFROST THROUGHOUT BUT ICE CONTENTS LOW
- GOOD BORROW SOURCE

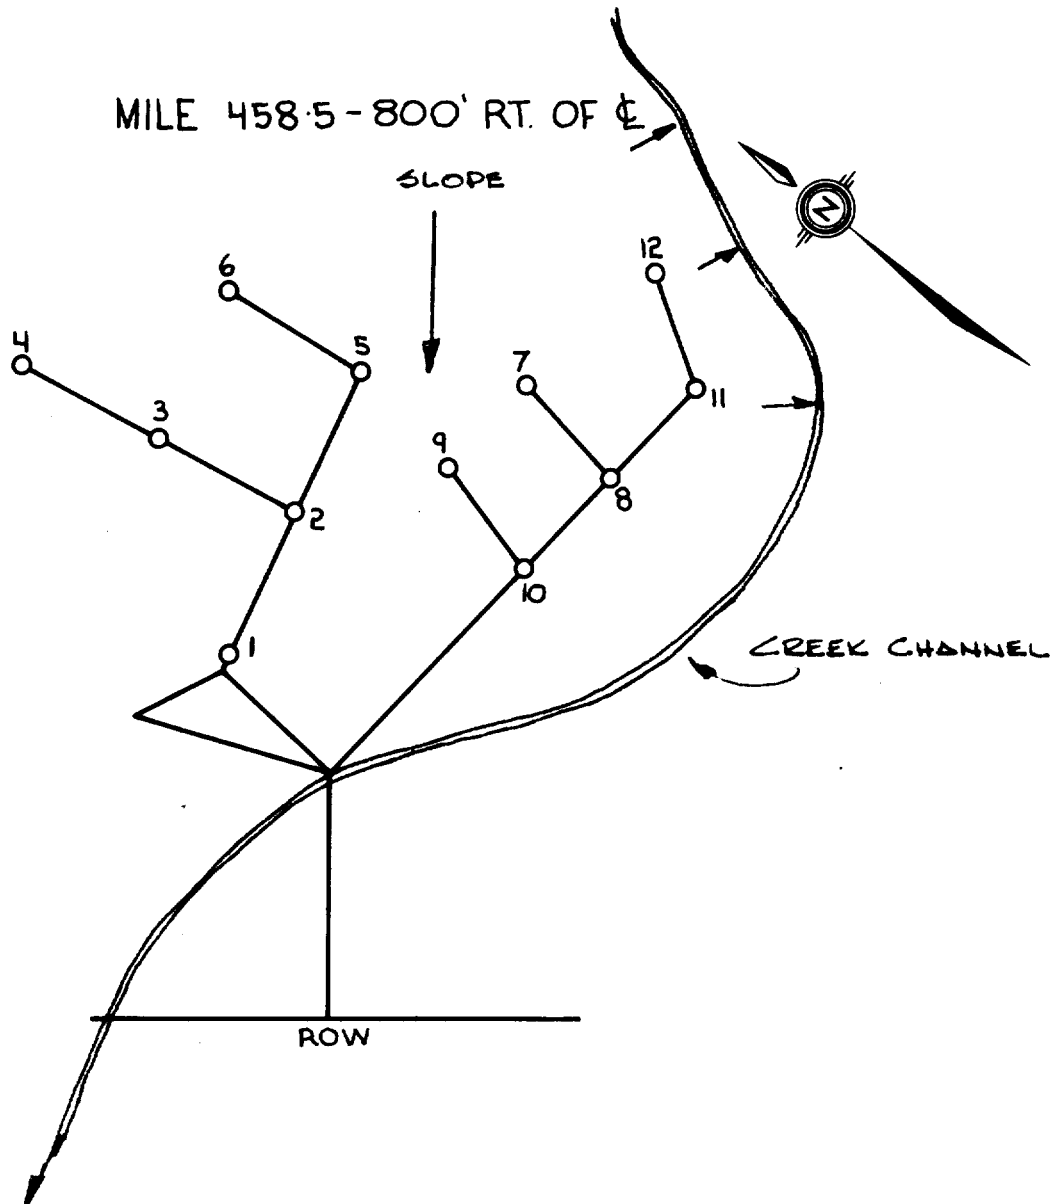
- SUBSOIL PRIMARILY SILTY CLAY WITH SOME SORTED ALLUVIAL FAN DEPOSITS NEAR BASE OF SLOPE
- FROZEN BUT LOW MOISTURE (ICE) CONTENTS
- OK. FOR BORROW BUT NOT RECOMMENDED DUE TO CLOSE PROXIMITY (1/2 MILE) TO BP-77

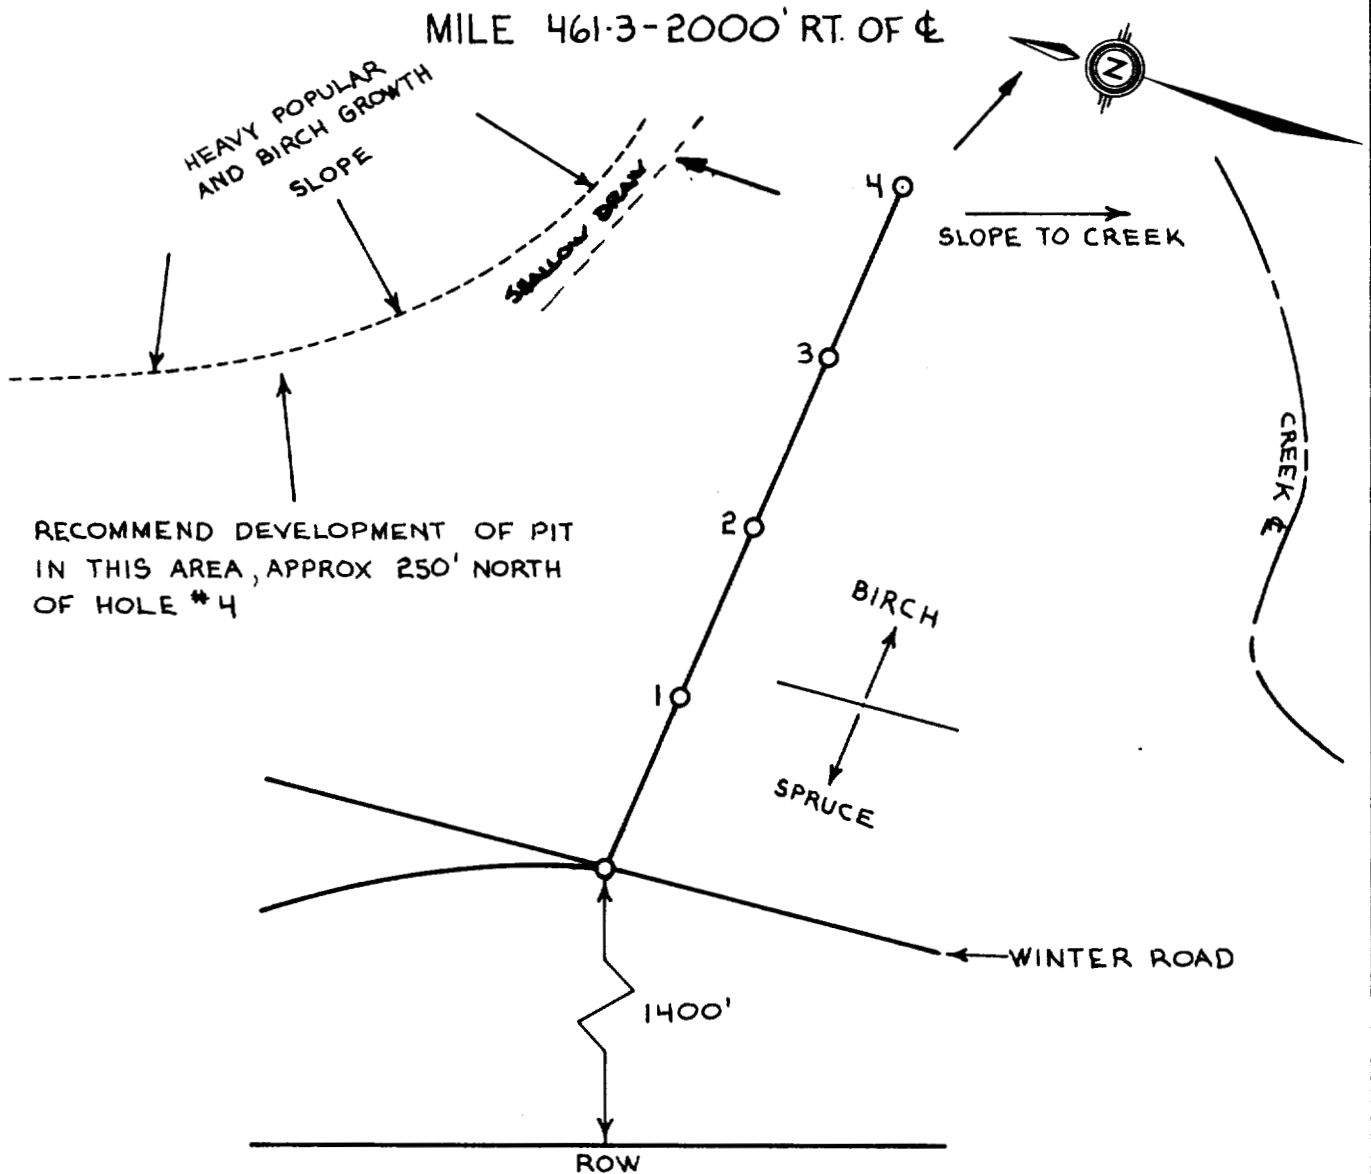
Test drilling in Borrow Pit 79A consisted of a series of five test holes at progressively higher elevations along an alluvial fan and up the valley slope. Tree cover varies from spruce at lower elevations to birch at the highest level. Only the upper portion of the pit area drilled contains suitable borrow material consisting of medium plastic silty clay, frozen but with moisture (ice) contents below 20%. The proven area of good material is very small, although it appears from the tree cover that continuation of the good material can be expected in a northerly direction. Thus it is recommended that Pit 79A be developed if required with expansion in a northerly direction as shown on the site plan. However the area of good material is some 2000' from the R.O.W. and improved economics may be obtained by hauling better material from the north side of Whitesand Creek Valley.

SUBSOIL MEDIUM PLASTIC SILTY CLAY  
PERMAFROST THROUGHOUT

RECOMMENDED DEVELOPMENT OF PIT NORTH OF HOLE #4 AS INDICATED

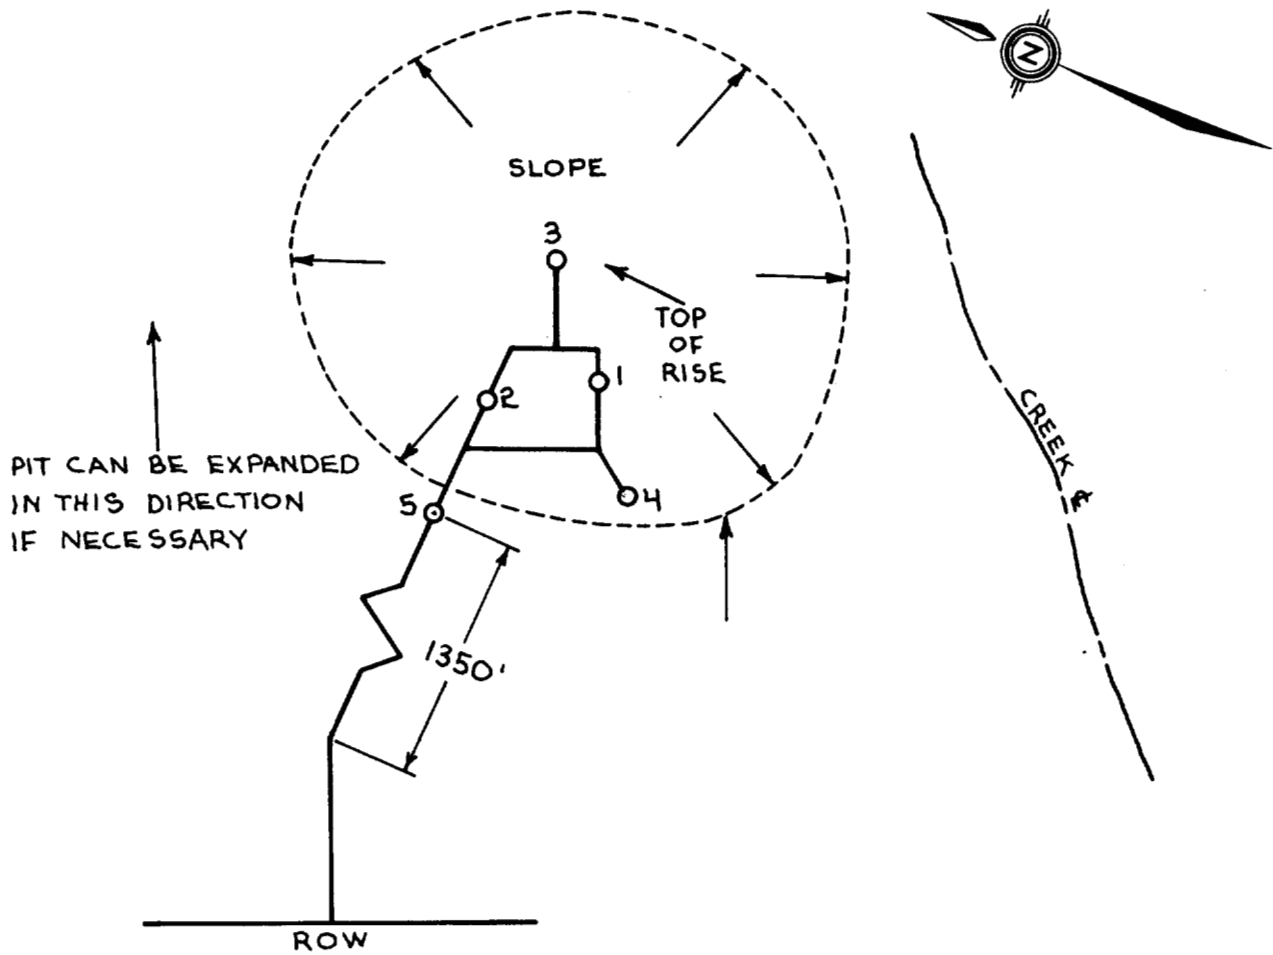
MILE 462.9-2000' RT. OF E

SUBSOIL MEDIUM PLASTIC SILTY CLAY

MOISTURE (ICE) CONTENTS < 20% AND BELOW PLASTIC LIMIT

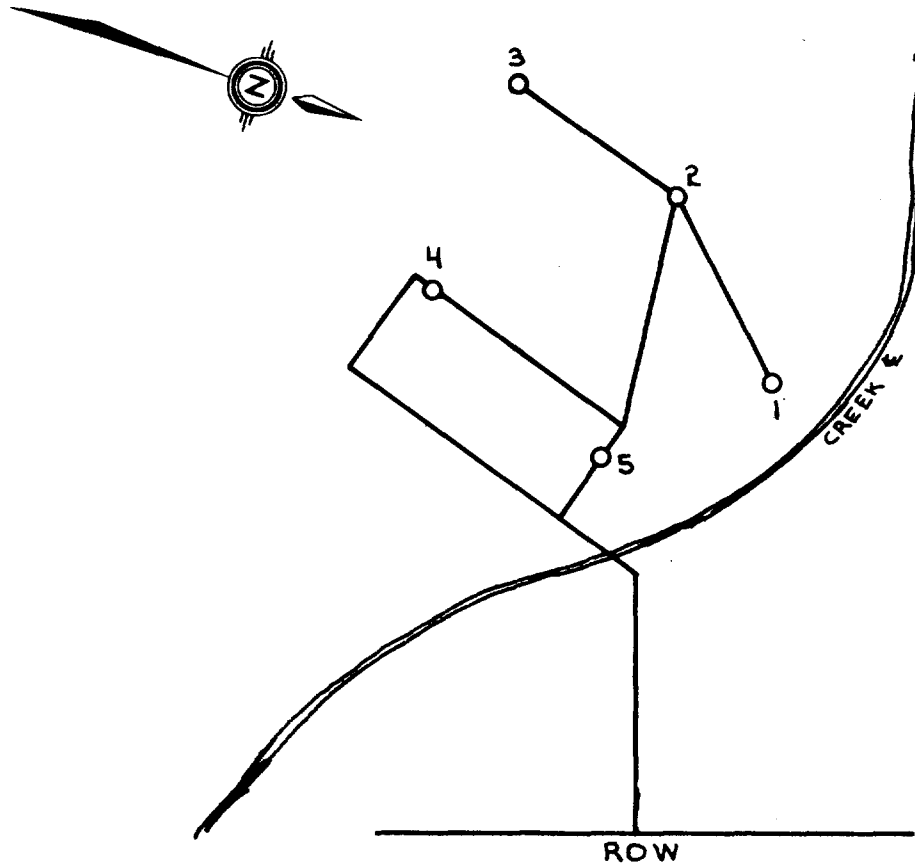
MILE 463.9-500' LT. OF E

- TREE COVER BIRCH, SPRUCE AND POPLAR
- SUBSOIL SANDY-CLAY-SILTS TO 10'-13', OVER SAND AND GRAVELS
- NO PERMAFROST REPORTED
- WET ZONES IN UPPER SILTY MATERIALS
- BORDER-LINE AS BORROW SOURCE, HOWEVER RECOMMENDED FOR DEVELOPMENT DUE TO LACK OF BETTER MATERIAL ALONG HIGHWAY

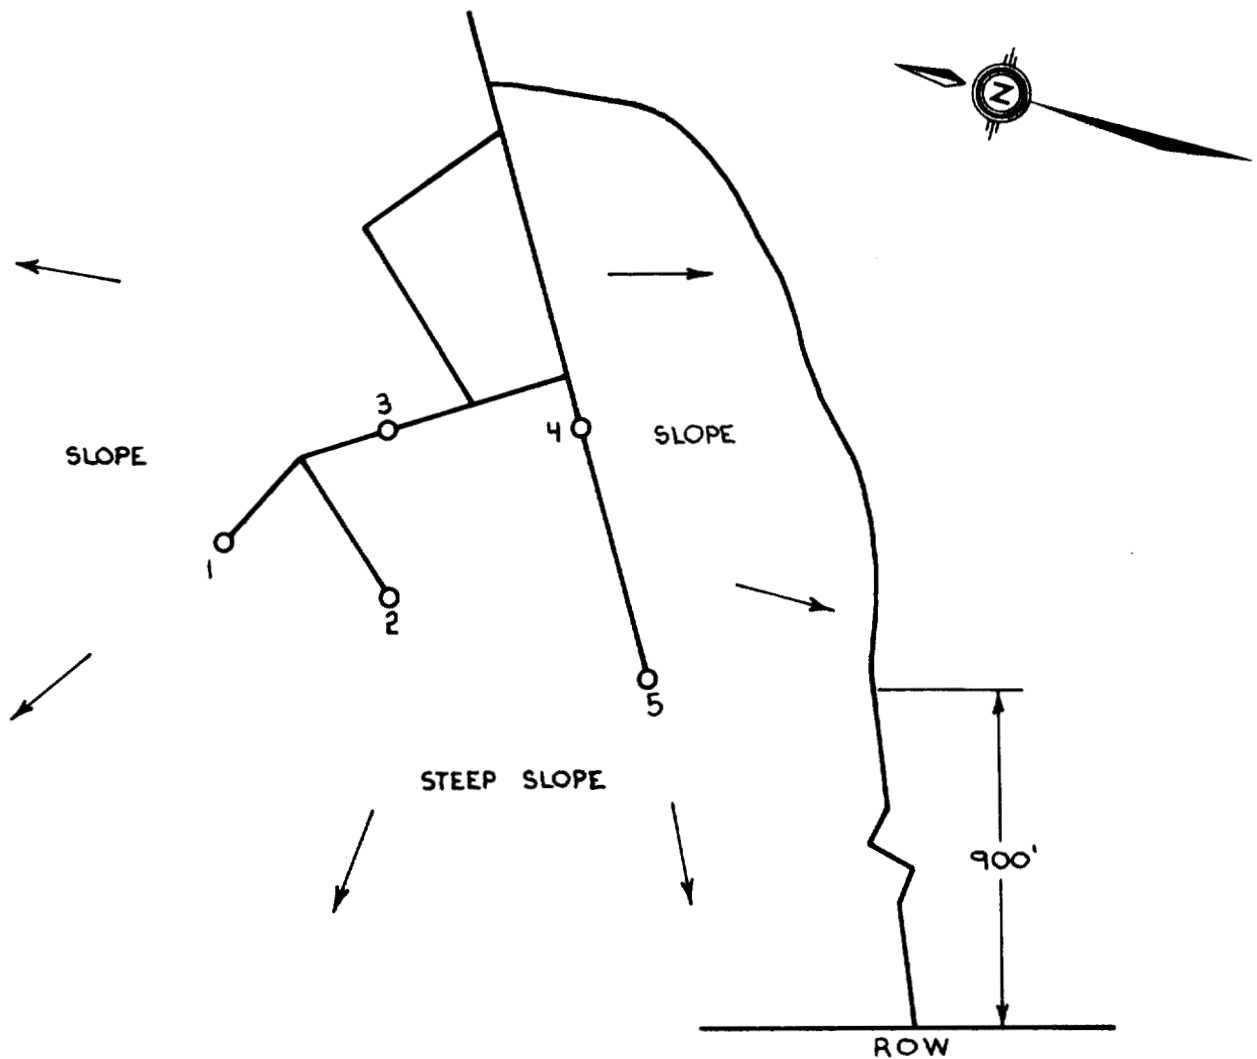
MILE 466.5-1200' RT. OF E

- SUBSOIL LOW TO MED. PLASTIC SILTY CLAY
- FROZEN WITH MOISTURE (ICE) CONTENTS RANGING FROM 15-33%,  
SOME PORTIONS WELL ABOVE OPTIMUM
- CAN BE DEVELOPED AS PIT HOWEVER BETTER MATERIAL IS AVAILABLE  
4500' NORTH IN PIT B-84

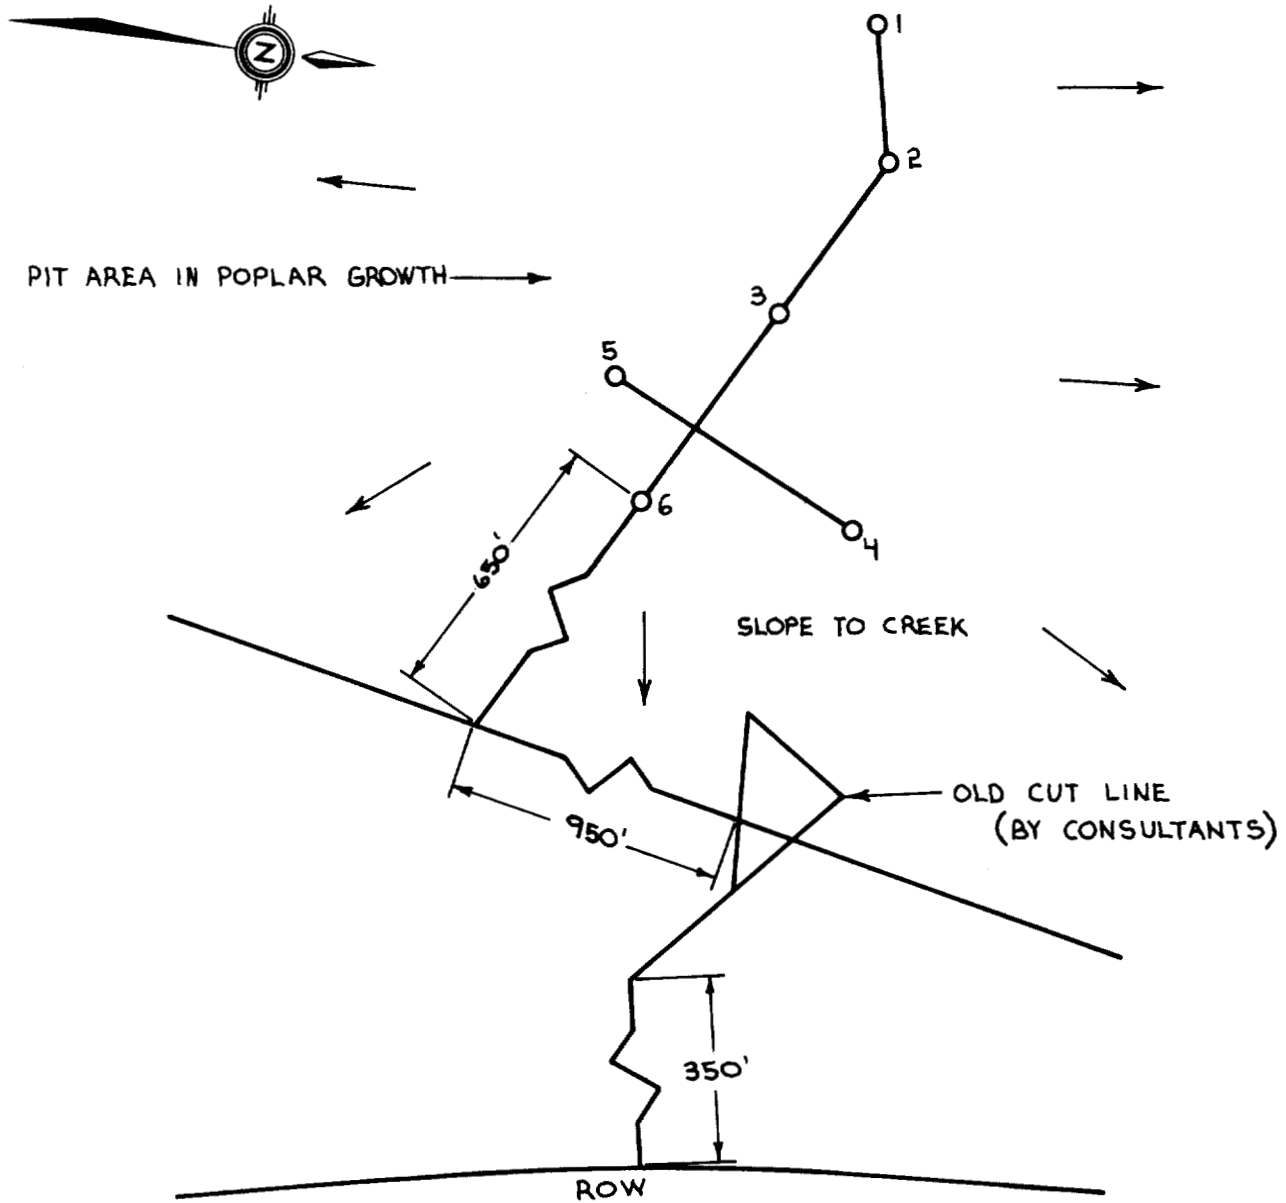
MILE 467.4-1400' RT. OF E

SUBSOIL FROZEN, MEDIUM TO HIGHLY PLASTIC SILTY CLAY  
 MOISTURE (ICE) CONTENTS AT OR BELOW THE PLASTIC LIMIT  
 GOOD BORROW SOURCE - RECOMMENDED FOR DEVELOPMENT

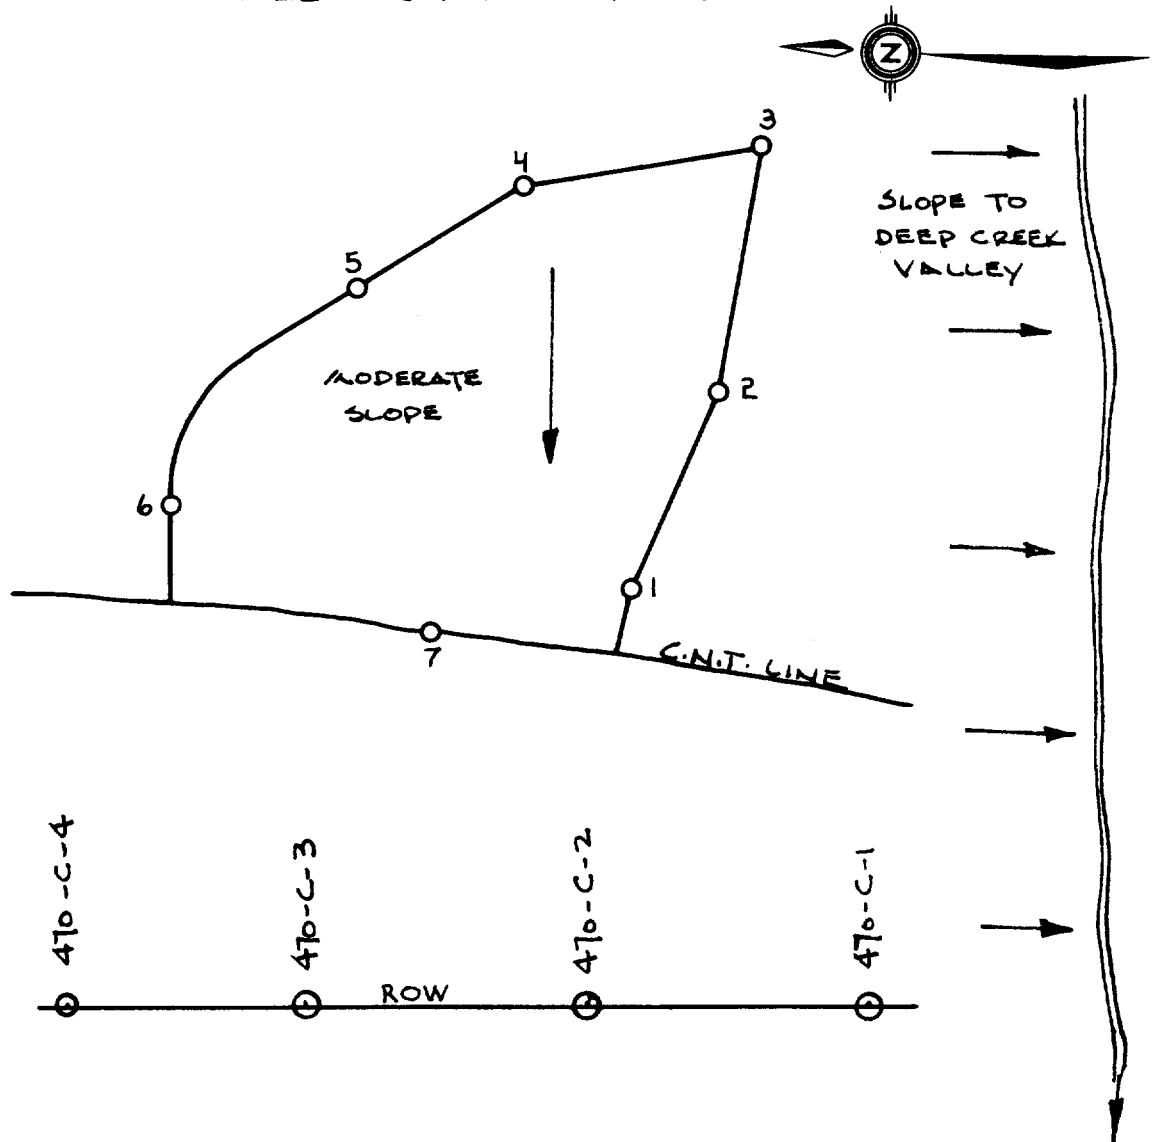
MILE 470.1-600' RT. OF C

SUBSOIL MEDIUM TO HIGHLY PLASTIC SILTY CLAY  
 FROZEN WITH MOISTURE (ICE) CONTENTS BELOW PLASTIC LIMIT  
 GOOD BORROW SOURCE
