**GEOTECHNICAL INVESTIGATION**

MILE 347 TO MILE 690 MACKENZIE HIGHWAY  
WINTER - 1975

REPORT ON  
GEOTECHNICAL INVESTIGATION  
MILE 347 TO MILE 690  
MACKENZIE HIGHWAY

Submitted by R.D. Cook, P.Eng.  
Materials Engineer  
February 1, 1976

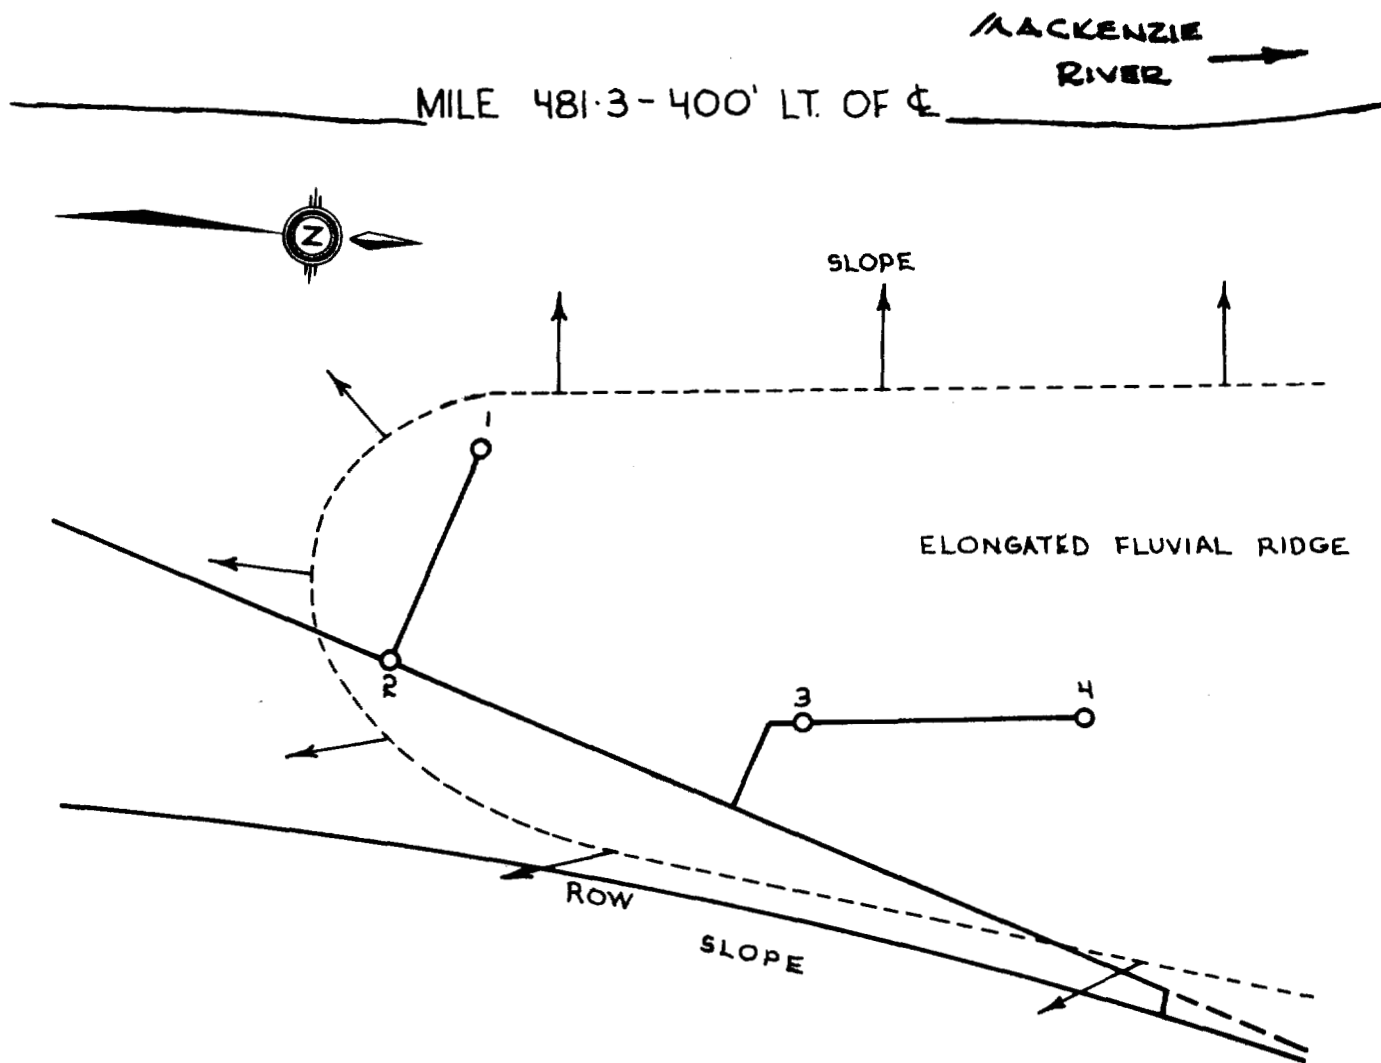
Between Mile 481 and 482, the highway is within 1000 to 2000 feet of the Mackenzie River and is separated from the river by an elongate alluvial terrace. Borrow Pit #92 is located on the southern end of this ridge. Deposits are poorly sorted and vary from sandy silty gravels to gravelly sandy clays. Permafrost is at least partly present, however, ice contents are extremely low and moisture contents on thawing average less than 10%. This is considered to be an excellent borrow source.

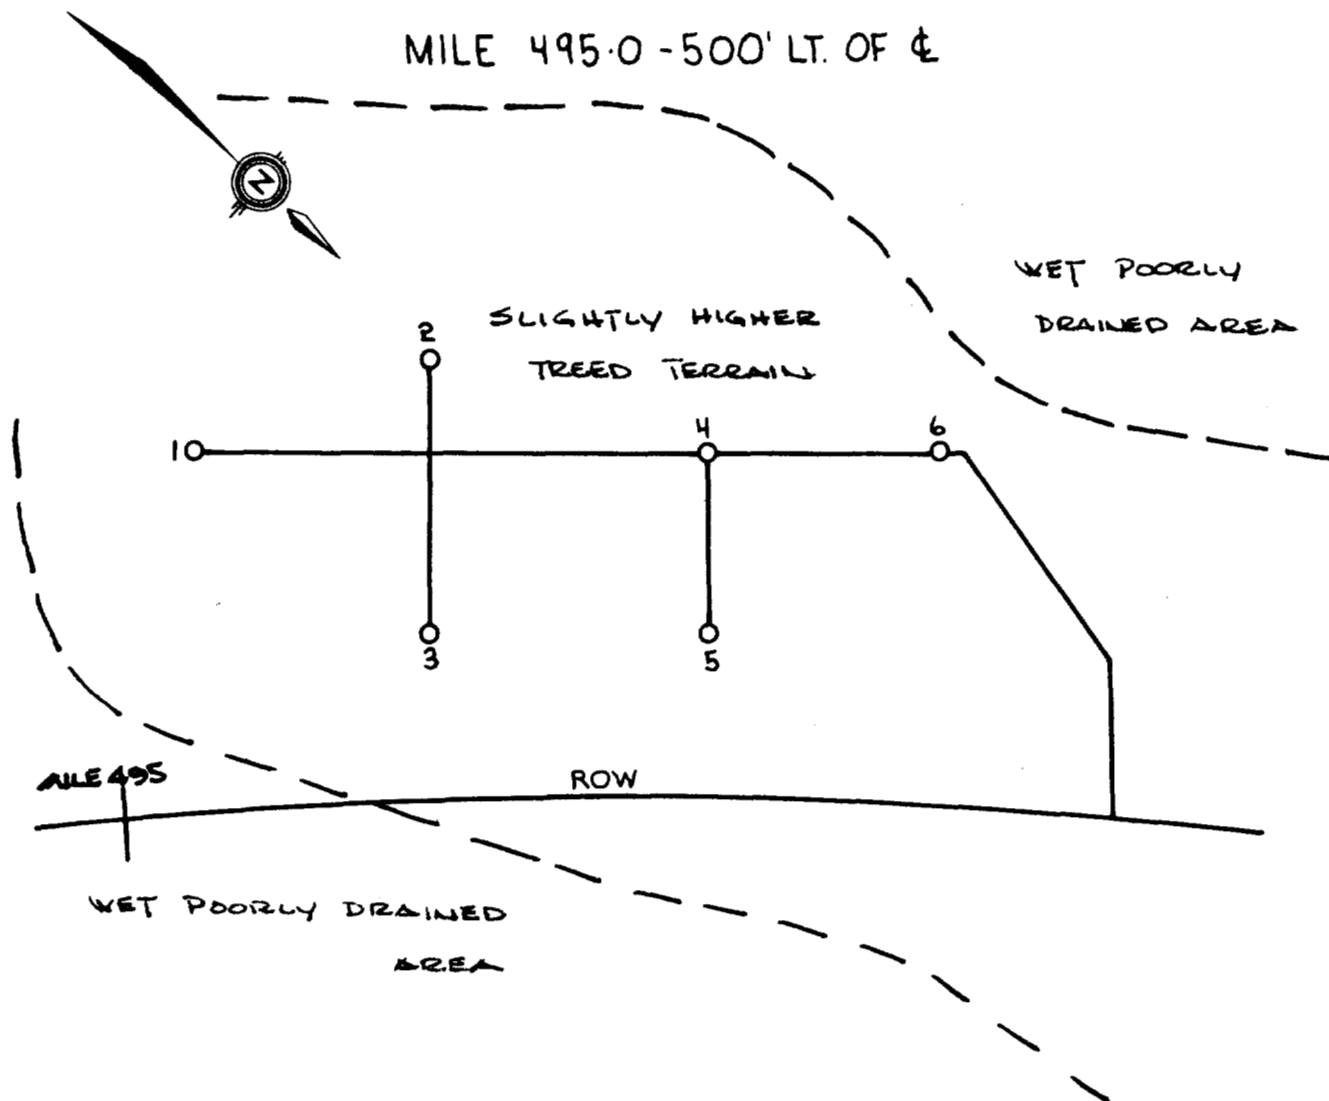
The terrain north of Mile 494 to approximately Mile 500 is a very flat glaciolacustrine plain, sparsely treed and poorly drained with numerous small lakes and potholes. Borrow area 93 is in a stand of willow, spruce and birch. Soil is medium to highly plastic silty clay and although permafrost is continuous, ice contents are low. Moisture contents upon thawing average near 20% and are at or slightly below the plastic limit. Stripping depths are estimated at 2-3'. Pit 93 is considered to be usable material in a terrain of generally poor borrow.

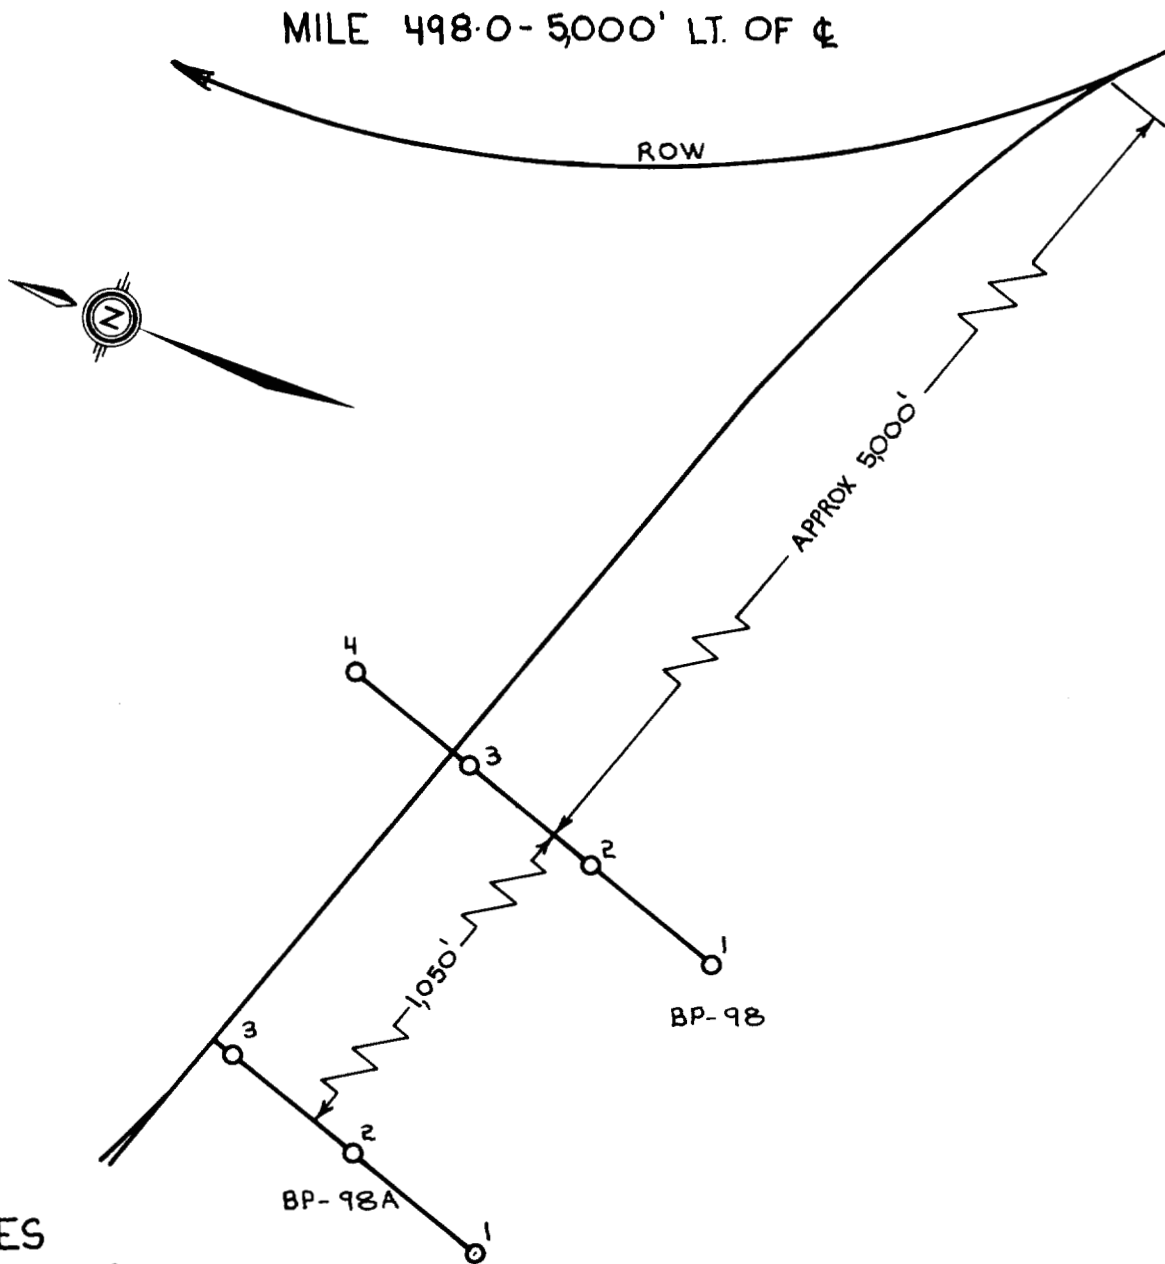
These two areas were drilled on another large longitudinal segment of the glaciofluvial plain on which Borrow Pit 94 is located. Deposits encountered during this drilling program and during previous drilling by others (Granular Materials Inventory - PEMCAN SERVICES '72) were gravelly sands and sandy gravels. This segment of the glaciofluvial plain encompasses an area of approximately 3 1/2 miles in length and averages 1/4 mile in width. Volumes have been estimated by Pemcan '72 at 10 million cubic yards. Permafrost was not encountered in the test holes and moisture contents to roughly the 15' level are low. Below 15 feet some free water was noted and the deposits are generally wet. This area would appear to be an excellent source of granular borrow.

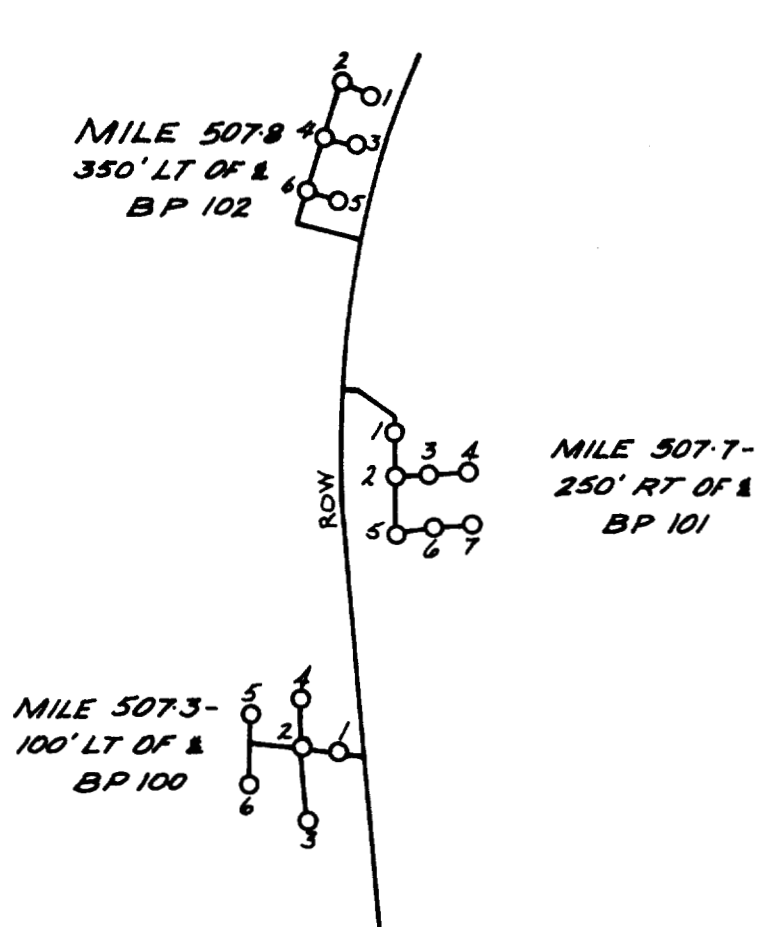
These three areas are located on a portion of a glaciolacustrine plain that is dissimilar from the adjacent terrain in that there is an absence of small ponds and peat filled depressions. Tree cover is small spruce. Subsoil deposits are somewhat variable but generally consist of low plastic sandy silty clays with pebbles to approximately 15-20', overlying partially sorted sandy deposits. Permafrost is common to the area and visible ice is generally low with occasional moderate ice zones. Moisture contents on thawing are generally below 15%. Where the subsoil contains significant amounts of clay, the material is damp to moist on thawing. Where the subsoil is primarily silt or sand the material is wet on thawing. Stripping depths will probably range from 2-4'. There is little to choose between the three areas. All contain what is considered to be usable borrow in a stretch of poor quality subsoil, and it is recommended that the location which provides the best haul economics be selected as a borrow source.
