# DEPARTMENT OF PUBLIC WORKS MACKENZIE HIGHWAY MILE 346 - 450 GEOTECHNICAL INVESTIGATION

VOLUME 1  
REPORT

D003044

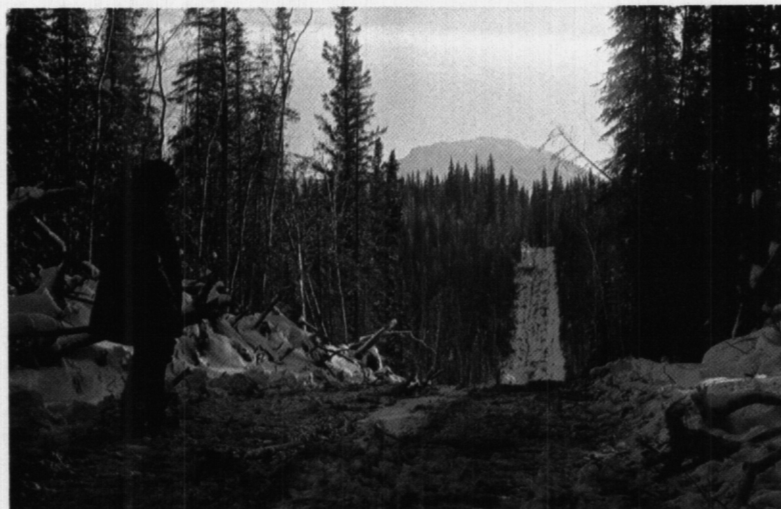
North of Willow Lake River the streams have formed a parallel drainage pattern and are deeply incised due to the narrowness of the plain between the Franklin Mountains and the Mackenzie River and the rapid changes in elevation. Substantial erosion gullies have developed even on small drainage courses as they approach the Mackenzie River. The route has been located a sufficient distance from the Mackenzie River for these gullies not to pose any problem to either construction or future maintenance of the highway as can be seen on PH. 6.

*Photo 6:  
Centreline south from Mile 448.*

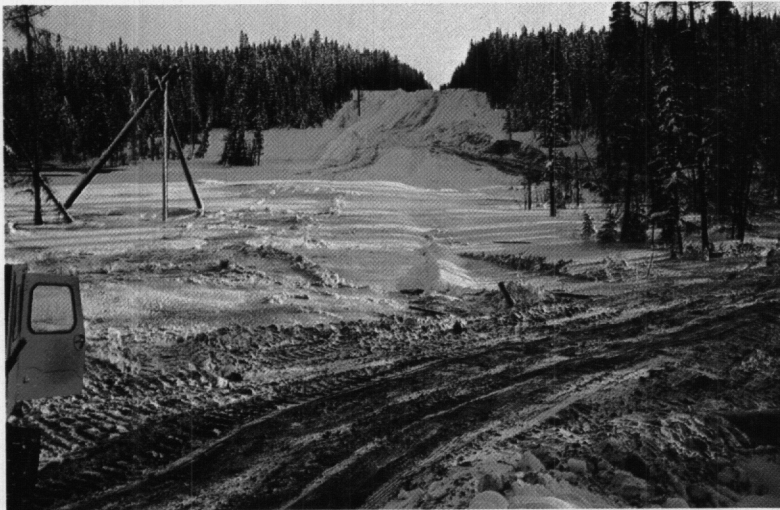
Some of the more active streams north of Willow Lake River develop heavy winter icing conditions as illustrated on PH. 7 and PH. 8. Streams and springs at Miles 394, 412, 422 and 446 were particularly active. This factor will influence the design of the drainage systems in these areas.

*Photo 7:  
Icing in creek - Mile 422.*

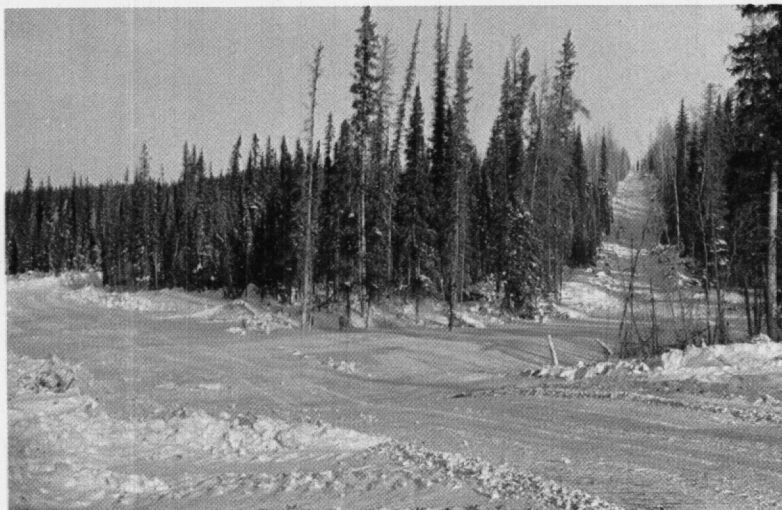
*Photo 8:  
Icing at Mile 412.*

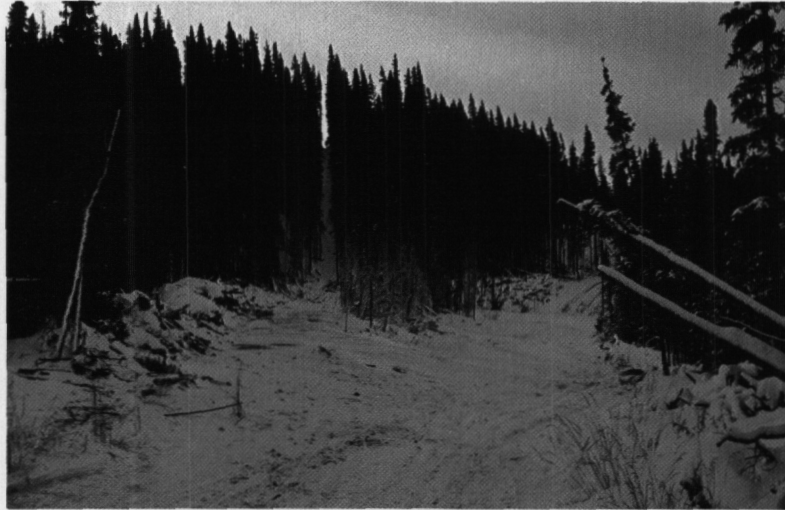
*Photo 11:  
Icing from spring - Mile 393.*

In addition to the slide area, an active spring is located at the bottom of this escarpment which drains to the northwest and produces extremely heavy icing conditions across the proposed right-of-way during the winter. This ice depth increased approximately 15 inches during February. It is considered that by relocating the road closer to the CNT right-of-way, this spring and slide area can be avoided. Several holes were drilled to determine subsurface conditions on both the CNT right-of-way and the area between the CNT right-of-way and the present road location. It was found that the clay horizon did not continue into this area. Therefore, it is recommended that the road be relocated as shown on Figure 4.

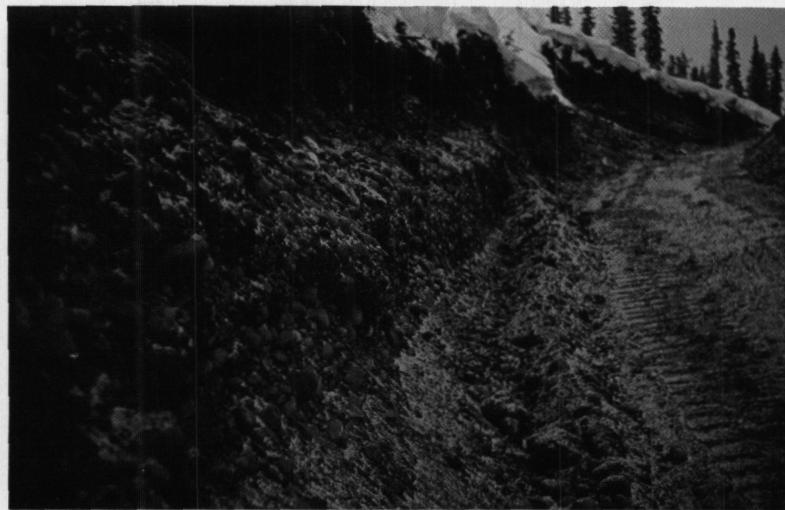
*Photo 12:  
Gravel in trench on centreline, north bank of Smith Creek - Mile 430.*

This lower-lying flat plain surrounding the village of Wrigley is underlain by predominately dense, sandy gravel up to Mile 435. The gravel content, see PH. 12, increases from Mile 435 to 438 at which point the plain ends. The granular material is classified as a glacial outwash, gradational from north to south, being coarser at the north and finer at the south. This is a very large deposit of excellent granular material with a low moisture content of 6 percent.

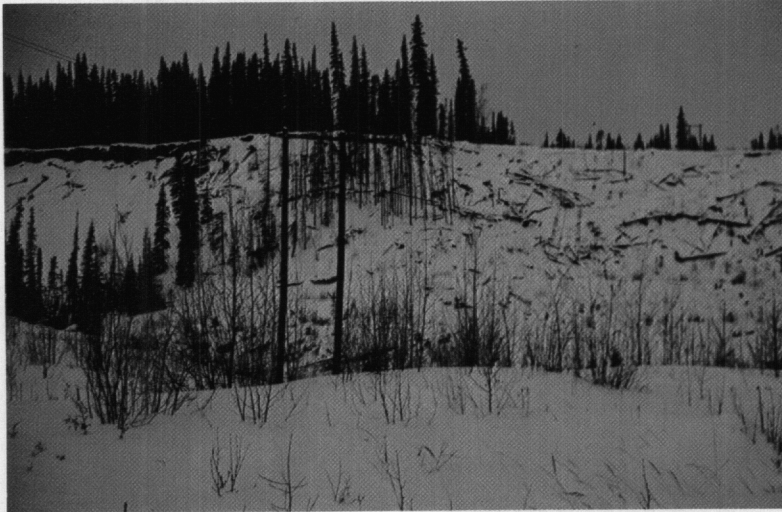
The recent slides which have occurred on the slope above the stream present a potentially serious problem. Though there is no indication that these slides are presently active, the soils are such that any change in moisture content or loading might induce further movement. Such movement could endanger any bridge abutment which might be constructed on the south side of this stream.

*Photo 27:  
North bank of Smith Creek - Mile 429.*
