**ANVIL RANGE MINING CORPORATION
INTERIM RECEIVERSHIP
PHASE 1 BORROW SOURCE SURVEY**

STEFFEN ROBERTSON AND KIRSTEN (CANADA) INC.
Suite 800, 580 Hornby Street
Vancouver, B.C. V6C 3B6
Tel: (604) 681 -4196 • Fax: (604) 687 -5532
E-mail: vancouver@srk.com Web site: www.srk.com

AUGUST 2002

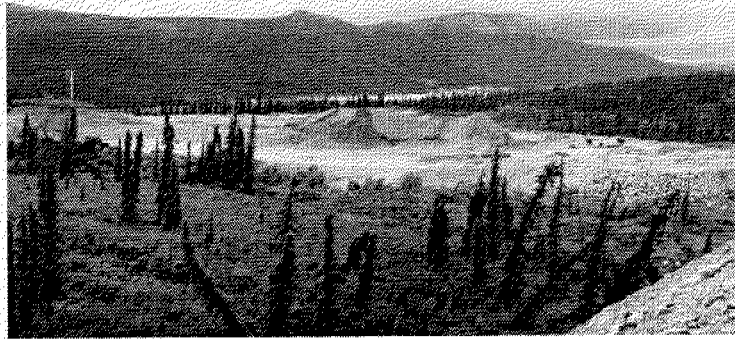
Photo 1: Haul Road Borrow Site

The haul road borrow site is located just off the Vangorda -to-Faro haul road, near the North Fork Rose Creek rock drain outlet (Photo 1, Figure 2). Bond (2001) mapped the site as glaciofluvial complex (Gx). Local contractors are currently screening 10,000m³ of cobbles and boulders (20, 40 and 60cm gradations) for lining of the Faro Creek diversion around the north side of the Faro open pit.

According to laboratory gradation tests, the material is greenish brown, poorly graded sand with gravel (SP). The cobble and boulder component was not sampled and tested in the laboratory. The deposit has been worked over a wide area (80,000m²) and there appears to be substantial remaining reserves, possibly between 150,000m³ to 300,000m³. This material can be processed for both coarse grained riprap material as well as fine -grained granular fills.

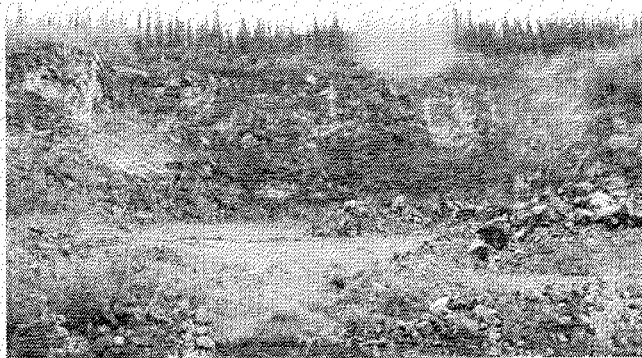
Photo 2: Rose Creek Diversion Quarry

The Rose Creek diversion quarry is located on the south side of the Rose Creek Diversion Channel, opposite the Intermediate Tailings Dam (Photo 2, Figure 2). Approximately $30,000\text{m}^3$ of phyllite schist riprap has been quarried from the site to line the Rose Creek Diversion Channel. The schist is variably strong to very strong, slightly weathered (some moderately weathered) with closely to moderately widely spaced joints which produce cobble to boulder -sized blocks. This rock is of variable quality (fair to good) but the quarry could clearly be expanded with further outcrops noted upslope of the quarry face. The Rose Creek Diversion Channel currently cuts off access to the quarry.

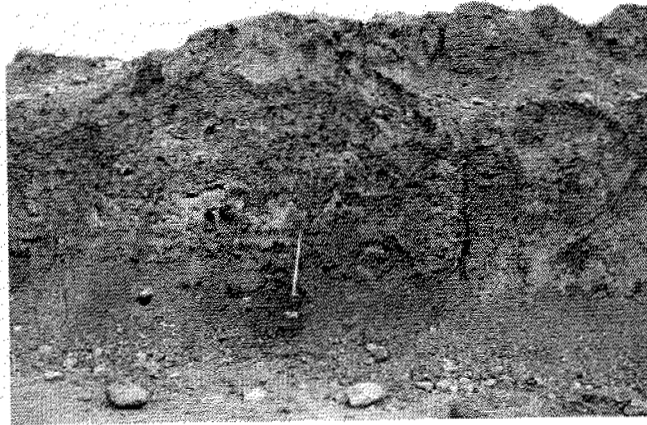
A sample taken from the uppermost borrow was rated as poorly graded sand with silt and gravel (SP -SM), which is probably indicative of the surficial colluvium (Cv) material. Typical till blanket (Tb) materials exposed in the lower middle borrow site are shown in Photo 3. There appears to be an abundance of till materials remaining at these borrow sites, but not much clean granular material.

Photo 3: Till blanket (Tb) material exposed at the Tailings Borrow Site

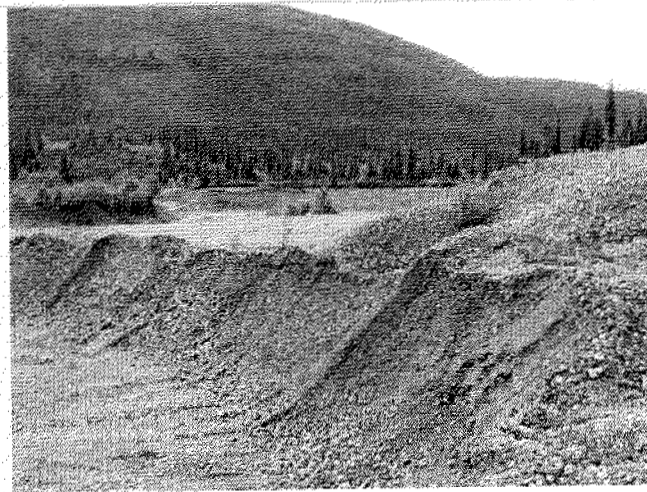
Photo 4: Rose Creek Granular Borrow Site

The Rose Creek borrow site is located approximately 1km downstream of the Cross Valley Dam (most westerly dam at the Rose Creek tailings storage facility) on the right bank of Rose Creek (Photo 4, Figure 2). The borrow site includes three existing borrow areas located within alluvial fan (Af) and glaciofluvial plain (Gp) deposits. The materials, excluding the cobble and boulder fraction, consist of poorly graded gravel with sand (GP) and silty gravel with sand (GM). There are frequent cobble sized clasts and occasional boulders.

The three existing borrow sites cover a combined area of approximately 120,000m². Assuming an average depth of 3m over an available reserve area of 500,000m², there may be up to 1.5 million (M) m³ of general granular fill available at the site. Much of the area appears to be mined out and, therefore, underlying and adjoining reserves will need to be proved by more detailed site investigation, test pitting and laboratory testing.

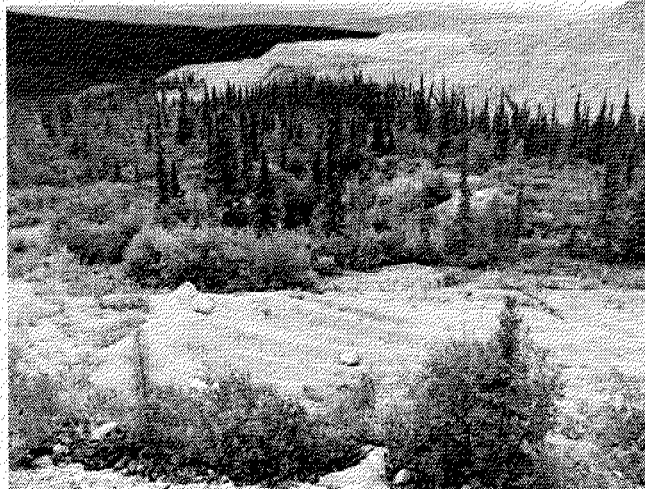
Photo 7: Grum Creek Borrow Site

The Grum Creek borrow site is located within the Grum Creek catchment on the eastern margin of the Grum waste rock dump (Photo 7, Figure 3). This area is mapped as complex glaciofluvial deposit (Gx). Lab results show that the material consists of well graded sand with gravel and silt (SW -SM). This deposit extends over an approximate area of 50,000m². With a probable average thickness of 1 to 2m, there may be further available reserves of between 50,000m³ to 100,000m³ in this area. These materials may be suitable for use as granular soils and/or general fills.

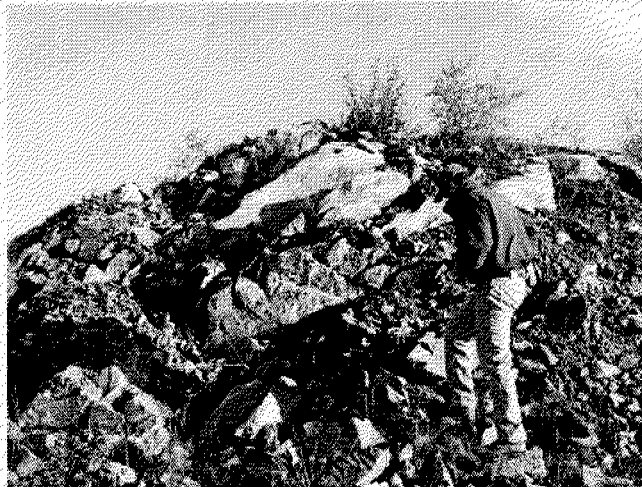
Photo 8: Faro Mine Road Outcrop

Extensive outcrop of granitic bedrock was visited on the Faro Mine Road at the old Vangorda-Grum turnoff (Figure 4). Outcrop ridges can be seen scattered over a wide area approximately 500m by 500m. The rock is generally slightly weathered and strong to very strong with moderately widely to widely spaced joints (Photo 8). Joint surfaces are planar-rough and moderately persistent (2-3m+) with iron staining and no infill. This appears to be a very good potential rock quarry site, which is reasonably close to both mine areas.
