**KOALA MINE
AIRPORT ESKER EVALUATION**

0101-94-11439.3

MARCH, 1995

BHP DIAMONDS INC.
VANCOUVER, BC

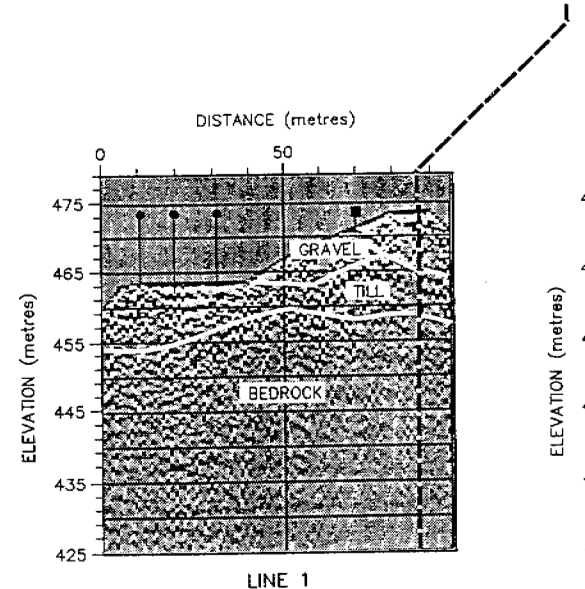
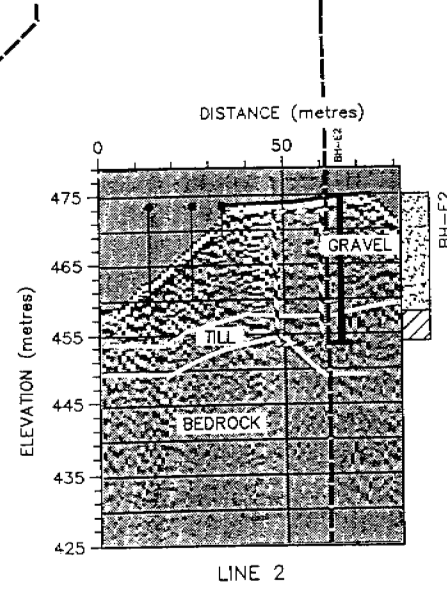
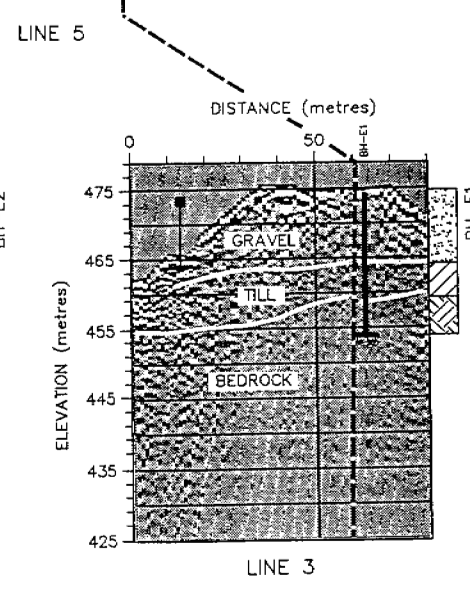
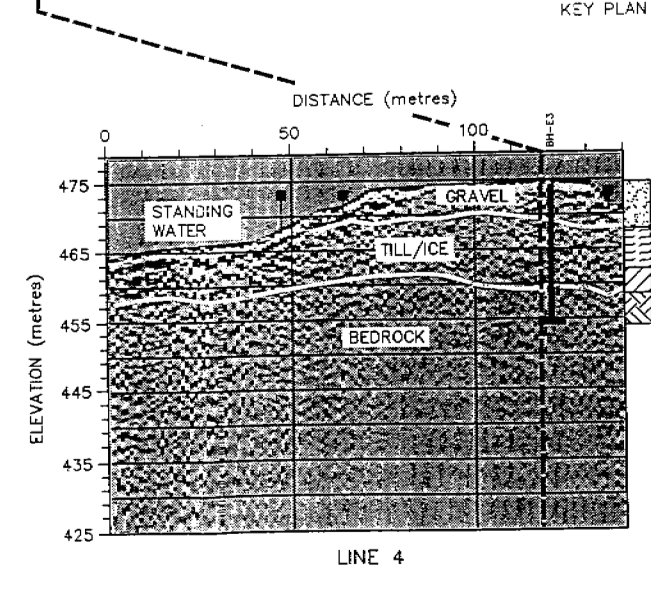
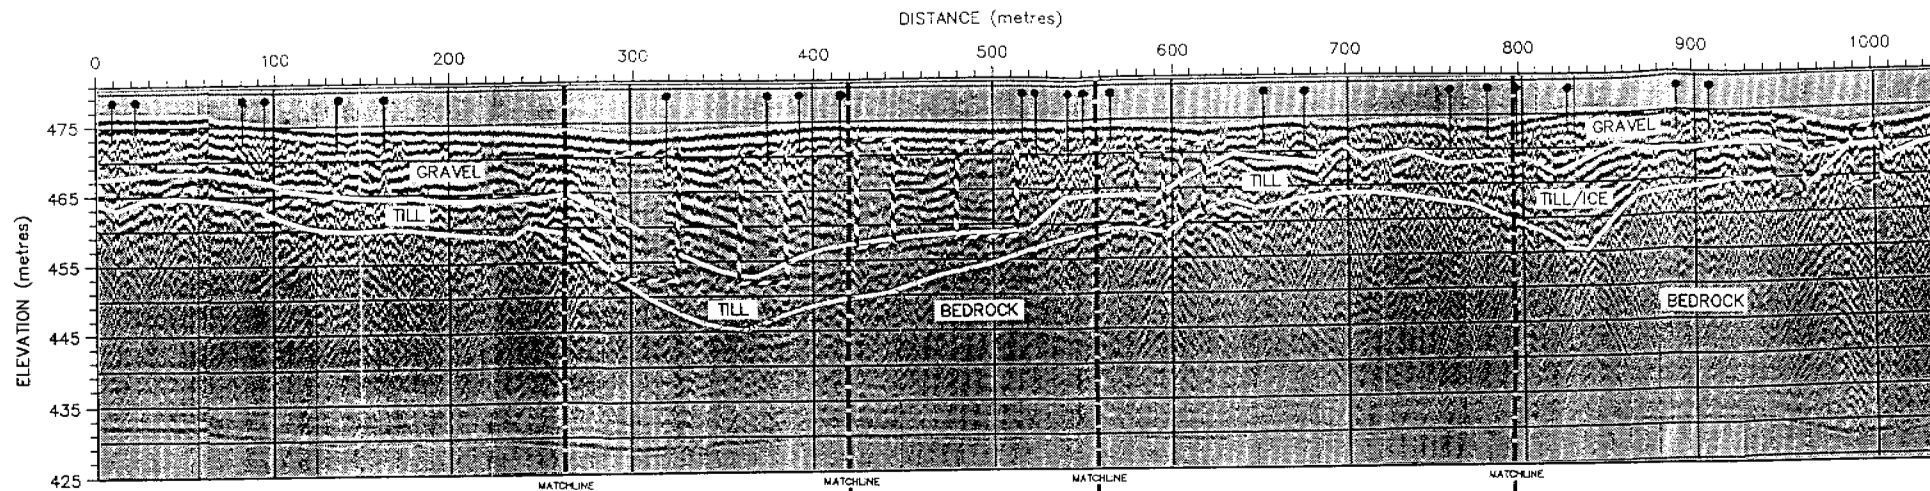
EBA Engineering Consultants Ltd.				PROJECT ESKER EVALUATION KOALA MINE SITE, N.W.T.	
CLIENT BHP DIAMONDS INC.				TITLE GPR REFLECTIONS AND INTERPRETED PROFILES	
DATE	95-03-14	DWN.	WMG	CHKD.	DCC
				FILE NO.	1439M8SB
				FIGURE 4

At several locations, the geophysical signal was attenuated; this is thought to have been caused by either higher fines contents (greater than 20% by volume) or high unfrozen moisture contents. The locations where this anomaly occurred are indicated on the geophysical profiles.

Portions of the esker are ice-cored, as has been evidenced by massive ground ice exposures at various locations during gravel extraction operation. Massive ground ice exposed at one location during extraction operations is presented in Figure 7. A massive ice zone was also encountered in Borehole E-3. Locations of possible massive ground ice, as interpreted from the geophysical data, are shown on Figure 4.

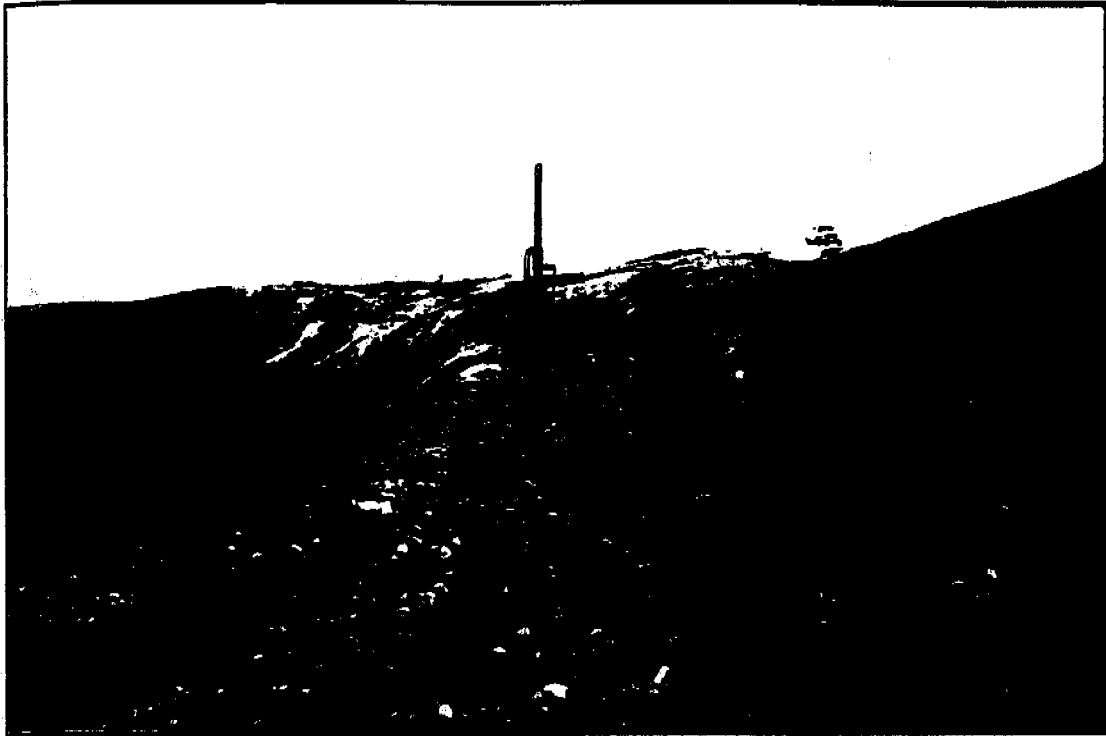
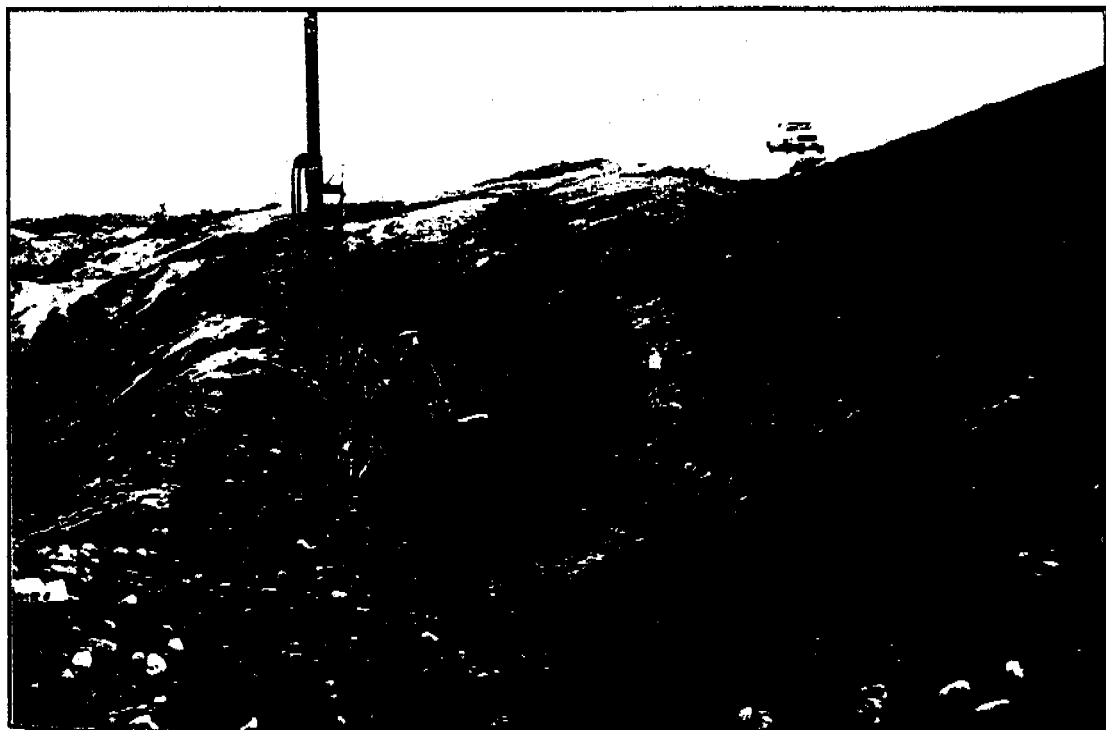
FIGURE 6 THERMOKARST TERRAIN

Surficial permafrost features, such as circular depressions and sinkholes, noted on the natural esker surface indicate the presence of massive ground ice. Thermokarst terrain, which can be described as irregular topography resulting from the melting of excess ground ice and subsequent thaw settlement, is evident along the west side of the esker (see Figure 6). Melt water from the thawing ice was observed along the base of the esker's west side in several places.

*Note ponded melt water at the base of the esker.
