PRELIMINARY BASIC ENVIRONMENTAL DATA

SHALE CREEK BRIDGE

REFERENCE MILE 332 MACKENZIE HIGHWAY

DEPARTMENT OF PUBLIC WORKS
EDMONTON, CANADA

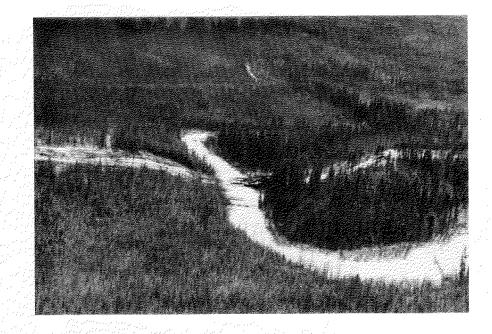
24.10.72. Shale Creek: east bank on left. Vegetation is white and black spruce with aspen. West bank consists of colluvial slope in glaciofluvial or alluvial gravel overlying glaciolacustrine deposits; bank appears stable.

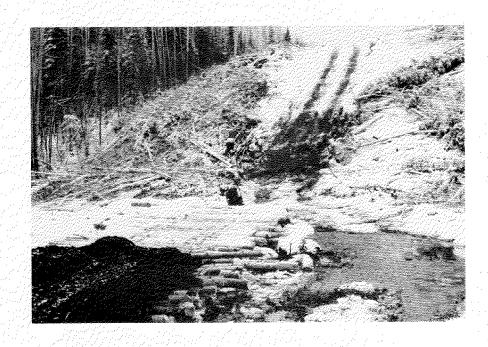
24.10.72. Shale Creek looking east. Glacio-lacustrine material; slopes appear stable; drainage along southern ditch should be diverted or settling ponds established to minimize siltation of creek.

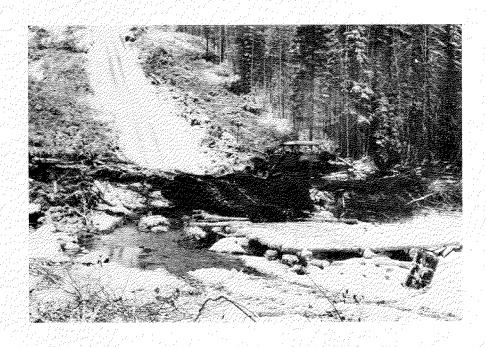
24.10.72. Shale Creek looking west. Gravel outcrops at top of bank in cut; composition of underlying material unknown, believed to be glaciolacustrine origin; colluvial slopes appear stable; surface drainage on north side must be controlled to minimize siltation; groundwater drain recommended.

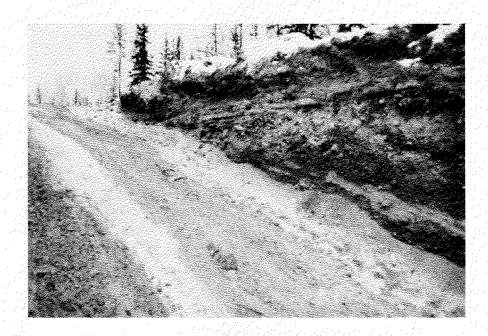
5.11.72. West slope of Shale Creek. Pebble gravel exposed in route cutbank on west side of Shale Creek. Unit appears to be quite extensive and is believed to be a glaciofluvial terrace of the Mackenzie River.
