PRELIMINARY  
BASIC ENVIRONMENTAL DATA

MARTIN RIVER  
BRIDGE

REFERENCE MILE 308 MACKENZIE HIGHWAY

DEPARTMENT OF PUBLIC WORKS  
EDMONTON, CANADA

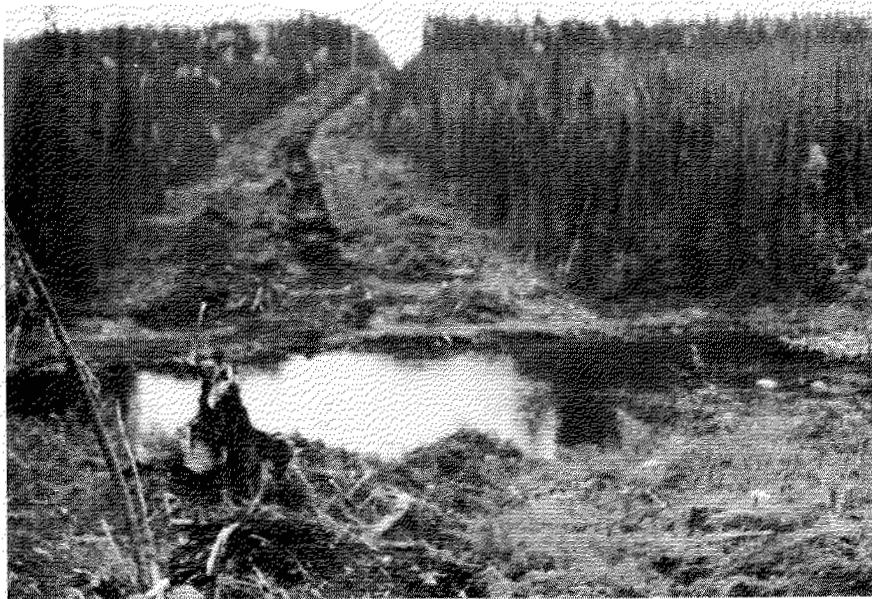
16.9.72. East bank of the Martin River. Vegetation is mainly black spruce with some aspen on peaty gleysol soils. Landform is an abandoned alluvial terrace mantled by silt and sand which is overlain by organic material. The upper 10 feet is believed to contain abundant ground ice, this is partly manifested by pools of water along R.O.W. as shown in photo.

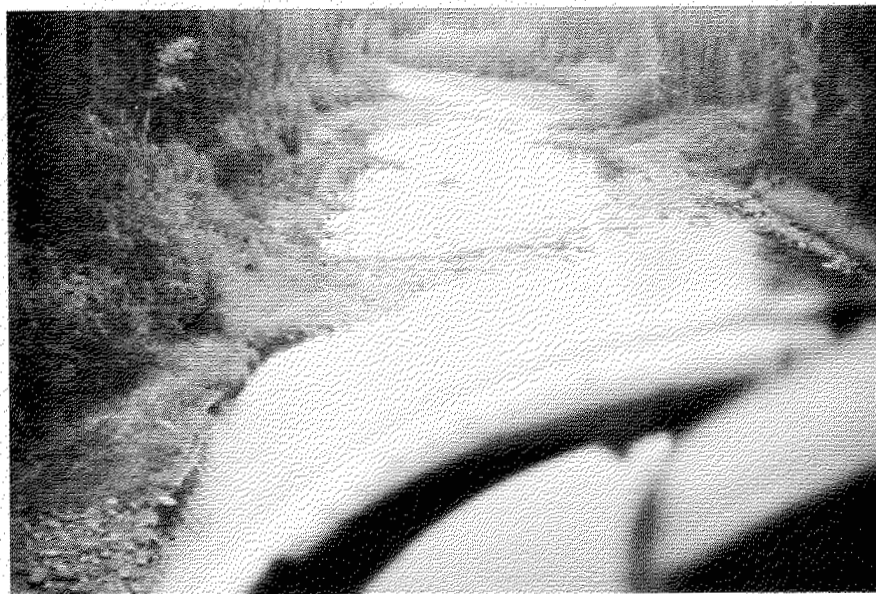
16.9.72. East bank is on the left, stream channel is straight at site; erosion and deposition appears equal on each side of stream. Bridge footings should be located above High Water and Ice Level. Rip-rap at base of footing and along base of fill will be required.

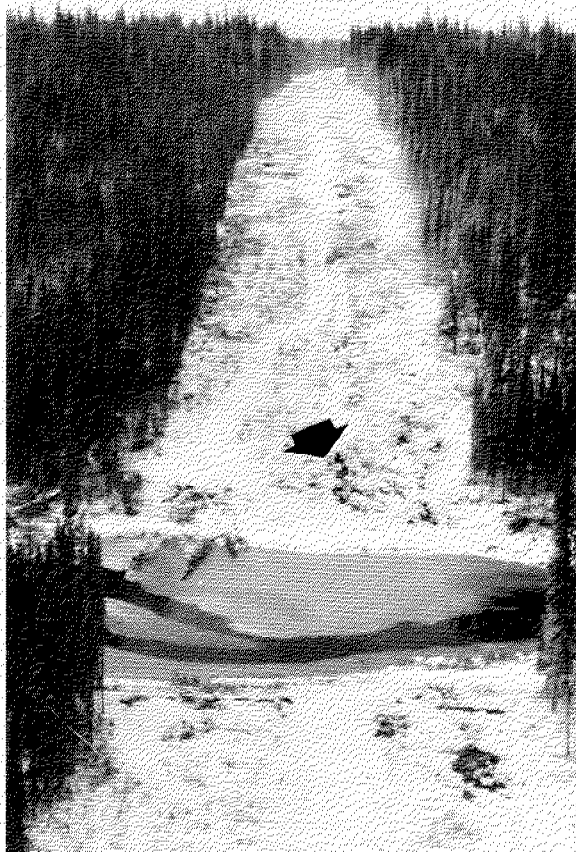
#### 7.10.72. Martin River

Exposed bank is subject to surface solifluction. The arrow shows an area stabilized temporarily with tree limbs and tops. The slope is underlain by glaciolacustrine silt, clay and sand with possible high ice content. Further thermal erosion may result in extensive degradation. Fill should be placed immediately in layers two to three feet thick allowing time for frost penetration between applications. Slope must be treated with adequate drains to intercept groundwater seepage. Fisheries personnel have sampled aquatic insect populations both above and below the crossing site.
