Some Characteristics of Grounded Floebergs near Prudhoe Bay, Alaska

Austin Kovacs

Anthony J. Gow

U.S. Army Cold Regions Research and Engineering Laboratory
Hanover, New Hampshire 03755
U.S.A.

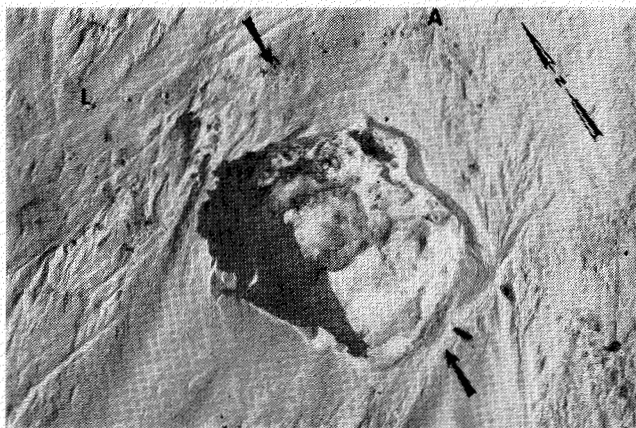
FIG. 1 Aerial view of Floeberg A. The line of drilled holes marked A-L measures approximately 44 m; arrows indicate the position and direction of the cross-section profile.

An aerial view of Floeberg A is presented in Fig. 1. This shows the ice surface to be substantially free of voids, that is, the space between the original ice blocks is now thoroughly filled with refrozen melt or rain water. The fracture faces on the east and west sides of the floeberg also lacked voids. Thus, for all intents and purposes, this fragment of a multi-year pressure ridge now consisted entirely of solid ice.

To determine if the ice keel had scored the sea floor during grounding, a series of holes (marked A-L in Fig. 1) were drilled through the ice cover along a line parallel to the north side of the floeberg, and the depth to the sea floor then measured by lowering a weighted tape through the holes. Results of these measurements, presented graphically in Fig. 3, reveal some micro-relief between stations A and C, where depths were measured every metre, but no major depression was observed that would indicate the keel had scored the sea floor significantly. Soundings made along the east and west side of the floeberg also

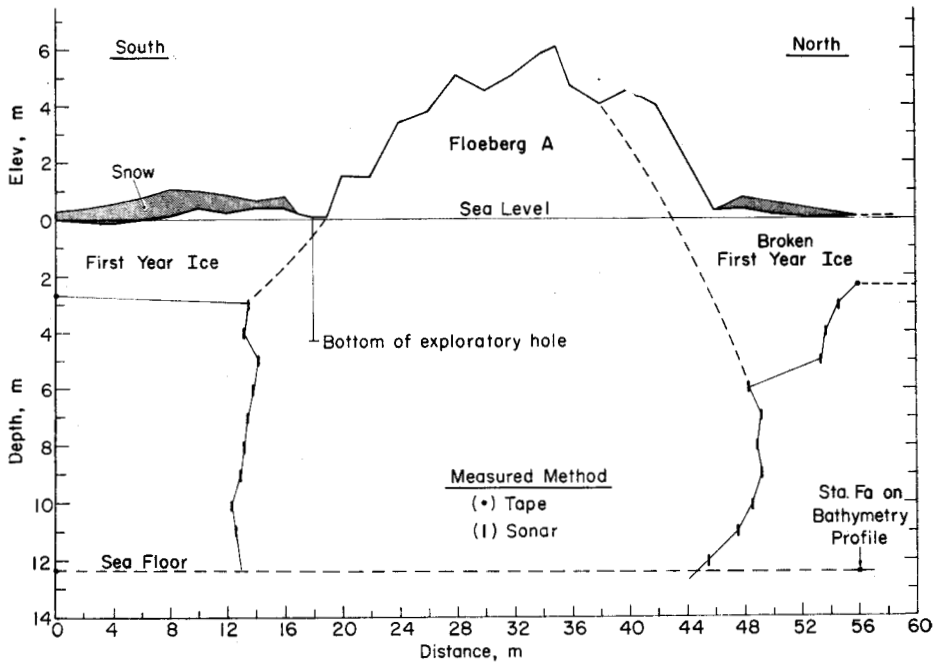
FIG. 2 Cross-section of Floeberg A.

and marked the position of the water line when the ice formation was free-floating. The ledge was elevated approximately 1.85 metres above the surrounding ice surface, indicating that the floeberg had been driven upward onto the sea floor by this amount during grounding.

A cross-section of Floeberg A is presented in Fig. 2. No voids were encountered at the site of the exploratory hole, indicating that this part of the floeberg was composed of a solid mass of ice blocks. The maximum sail height of Floeberg A was 6.06 m; the keel depth measured approximately 12.4 m. If these dimensions are adjusted to take account of the uplift of 1.85 m associated with grounding, then the sail height reduces to 4.21 m and the keel depth increases to 14.25 m. A sail height to keel depth ratio of 1 to

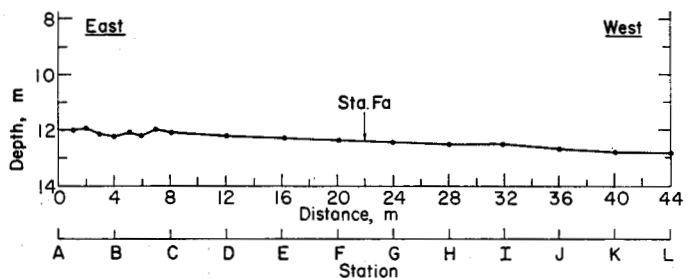
FIG. 3 Profile of sea floor from directly behind Floeberg A.

failed to reveal any definite trace of scoring of the sea bed. This lack of scoring behind Floeberg A might be attributed to a flat-bottomed keel that "slid" along, rather than "ploughed" through the sea floor which, at this location, was composed mainly of coarse sand.

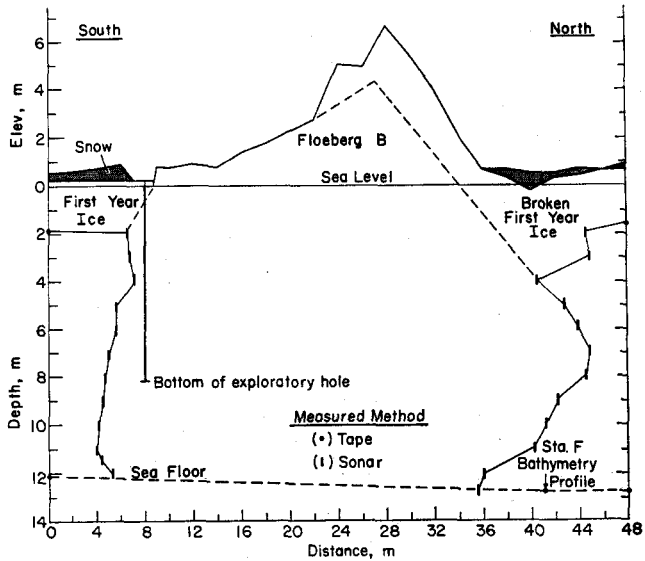
FIG. 4 Cross-section of Floeberg B.

The cross-section of the floeberg is shown in Fig. 4. The highest elevation on the surface profile was 6.65 m and the keel is shown to be grounded in approximately 12.5 m of water. The extent to which first-year ice has piled up on the north side of the floeberg is also indicated.

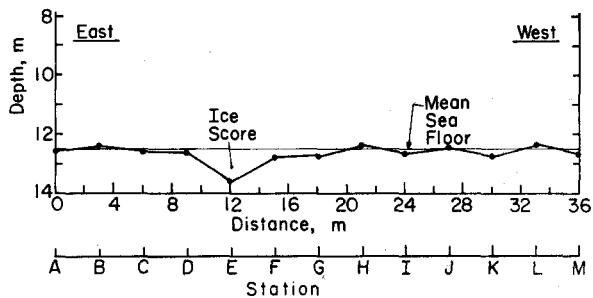
FIG. 5. Profile of sea floor from directly behind Floeberg B.

The profile of the sea floor immediately behind the floeberg is shown in Fig. 5. The sea floor has a deep depression near the centre of the north face of the floeberg at Station E. On each side of this depression the sea bed has an undulating relief, with a mean depth of approximately 12.5 m. The depression is attributed to the keel of the floeberg as it ploughed into the sea floor during grounding. The maximum depth of the score below the mean sea floor depth is 1.1 metres. The score is approximately 15 m wide and has an average depth of 32 cm.

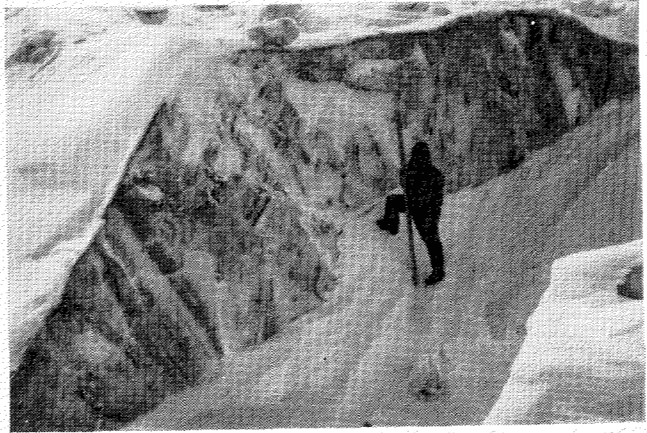
FIG. 6 Exposed section through centre of floeberg showing structural arrangement of ice blocks. Ice contains abundant algal remains and some sedimentary material (dark patches).

Visual examination of some 50 additional floebergs in the general area of Floeberg A and B indicated that all were composed of tabular blocks and assorted fragments of ice, ranging in size from a few centimetres to several metres across, and firmly frozen together with no trace of interblock voids. Internal structure was best revealed in the exposed faces of floebergs that had split apart, and a typical example of such structure is presented in Fig. 6.

All floebergs contained variable quantities of debris enclosed within the blocks of ice and between them. Most of this debris was organic in nature, composed principally of brown algae that had obviously been trapped in the ice during freezing. Sedimentary material was identified mainly as of silt-clay composition, though coarse sandy debris was occasionally observed. The finer sedimentary particles are probably of aeolian origin, but the exact source and manner of entrapment of the coarser particles have not been firmly established.
