Thawing Hazards and Their Developing States along the Qinghai-Tibet Engineering Corridor

Zhanju Lin, Fujun Niu, Hua Liu, & Jiahao Lu

State Key Laboratory of Frozen Soil Engineering, Cold and Arid Regions Environmental and Engineering Research Institute, Chinese Academy of Sciences, Lanzhou, Gansu, China

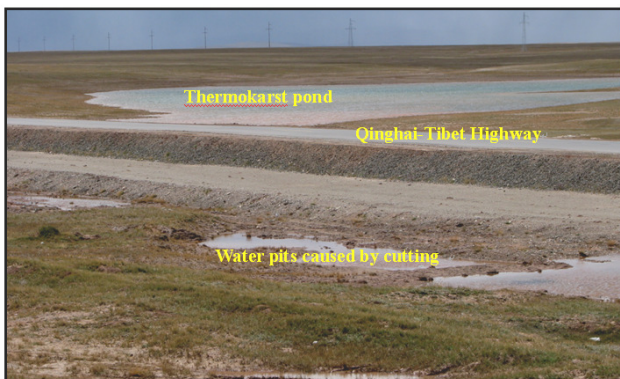
Figure 3 Thermokarst pond and small water pits developed at Chumarhe High Plateau along the QTH. These, sporadic or string-like distributed, are existed in the section of bottomland or intermountain basin with ice-saturated permafrost or massive ground-ice. The water depth is about 0.5 to 3.0 m, and the areas rang from less than 100 m^2 to about $60,000 \text{ m}^2$.

Thermokarst ponds (including water pits) are widely located in the Chumarhe High Plateau, Wudaoliang Basin (a special part of Hoh Xil Hill Region), and Beiluhe Basin (Figure 1 and 3). A detailed statistical data in 2007 showed that approximately 69 thermokarst ponds and 234 water pits were developed at both sides of roadway of QTH from Xidatan Basin to Hoh Xil Hill region, and their areas were about $1.5 \times 10^4 \text{ m}^2$ and $1.0 \times 10^4 \text{ m}^2$, respectively (Niu et al., 2008). The current survey in September 2009 showed the surface water areas (including thermokarst ponds and water pits) from Xidatan Basin to Beiluhe Basin have already been up to $3.5 \times 10^5 \text{ m}^2$, and exceeding about ten times because of the disturbance from the current improvement project which started in 2008.

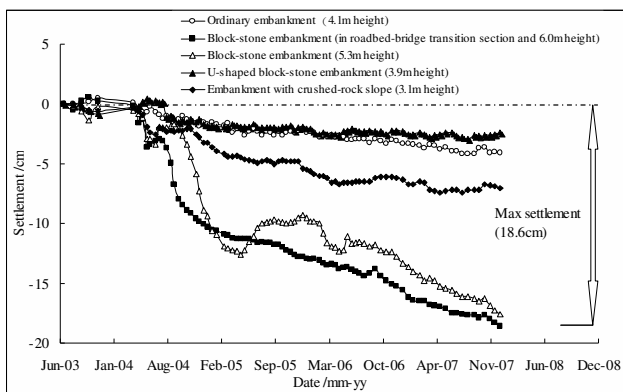
Figure 4 Time-settlement curves of the five embankments in Chumaerhe test sections along the QTR

Figure 4 shows that the maximum settlement occurred in the block-stone embankment (in roadbed-bridge transition section) with 6.0 m of embankment height reached 18.6 cm, and the minimum settlement was only about 3 cm. However, the settlement value always creased (curve decline) during the observation period. These results indicate that the settlement could continue to develop under the influence of the global warming and the degradation process of permafrost. Thaw settlement has also been characterized along other corridors such as the Norman Wells Pipeline corridor in the Mackenzie Valley NWT Canada (Burgess and Smith, 2003; Smith et al., 2008; Smith and Riseborough, 2010). Thawing beneath the right-of-way (ROW) and associated thaw settlement in response to vegetation clearing, surface disturbance, pipeline construction and operation is still continuing, and in ice-rich terrain, increases in thaw depth have been accompanied by settlement of the ground surface.
