Experimentation of mitigation techniques to reduce the effects of permafrost degradation on transportation infrastructures at Beaver Creek experimental road site (Alaska Highway, Yukon)

Julie M. Lepage, Guy Doré
Québec City, Québec, Canada
Department of Civil Engineering – Laval University, Québec, QC, Canada

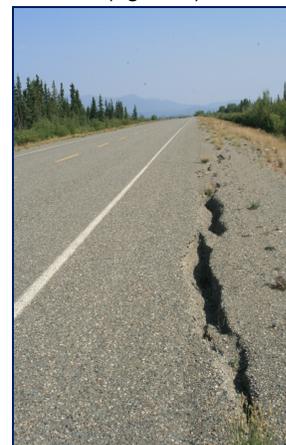
Figure 1 : Longitudinal cracking observed along Alaska Highway (2009)

cause rapid thawing of permafrost as well as longitudinal cracking along the road (figure 1).

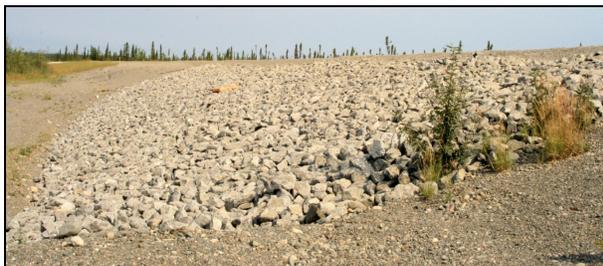
Three of the sections are using ACE layers. Section 1 is characterized by the presence of a convective layer across the full width of the embankment. The embankment's slopes are also covered by an organic layer to impede heat intake and reduce warming of the ACE material during summer. Section 3 differs from section 1 by the fact that the application of ACE material was limited to the shoulder of the embankment. The slope of the section is also protected by a granular layer. In an attempt to maximize the effectiveness of the convective system, two ventilation pipes have been placed at the base and at the top of the convective layer: the first one is one meter away from the traffic lane and the second one is located at the toe of the embankment slope. For each pipe section, five 150-mm-diameter inlets and outlets of have been placed at even spacing along the road. Theses pipes are in contact with the ACE material and are designed to improve the circulation of cold air in the embankment during winter. Finally, section 9 (figure 4) is similar to section 3 with the exception that the ACE material is exposed at the surface.

Figure 4 : Air convection embankment uncovered

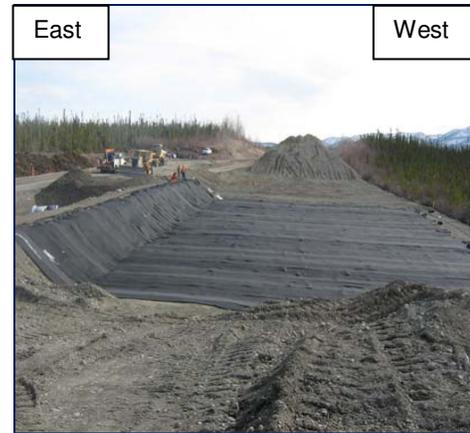
The heat drain is an innovative technique proposed by the Pavement engineering research group of Laval University (GRINCH). This protection technique is based on the use of a highly permeable geocomposite made of a corrugated plastic core covered on both sides by geotextile. The 25 mm-thick geocomposite is placed approximately 1 m above the natural ground level and extends towards the embankment surface to facilitate heat drainage (figure 7). The heat drain can be used across the full width of the embankment or in the embankment shoulder.

Figure 7: Placement of the heat drain across the full width of the embankment (section 2)

There are three different tests sections using this heat drain technique. First, section 2 was constructed using a heat drain extending across the full width of the embankment (figure 7). Section 4 uses also the heat drain but limited to the embankment shoulders. Figure 9 illustrates the ventilation system of the shoulder application of the heat drain in section 4. Finally, section 8 is also based on the heat drain mitigation method similar to the one described for test section 4. In addition, the system used in section 8 involves the use of an insulation layer above the heat drain. The insulation layer is constituted of 50-mm-thick polystyrene boards placed uniformly 40 centimetres under the surface along the slope of the experimental section.

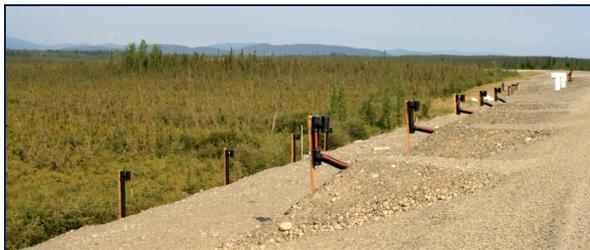
Figure 9: Heat drains on side slopes (section 4)

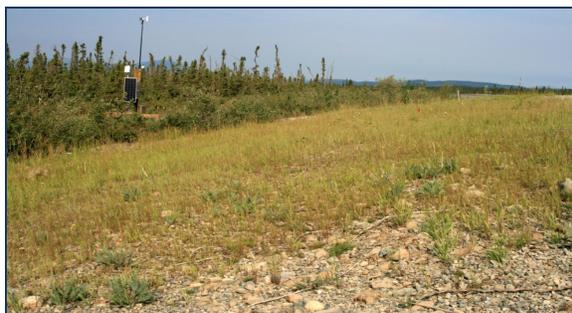
This test section is mainly characterized by the addition of a layer of approximately 300 millimeters thickness of organic material on the slopes of the pre-existing slopes embankment. Vegetation is a good natural insulator and allows the presence of permafrost

where it would be normally absent. Thermal conductivity of organic soils is weak during summer contributing thus to a reduction of heat penetration in the embankment. Moreover, the presence of a vegetation cover is likely to reduce solar radiation at the ground surface during summer. The main advantage of this thermal protection method is that the costs of implementation are very low. However, a few difficulties appeared in this project when trying to find good organic material in the area of the experimental site. The only good quality organic material has been found more than 80 kilometers away from the site. One year after construction, it was possible to observe that grass has a very low density on the slope of the test section. It was then recommended to add native grass seed mixture to help the development of a proper grass cover. A longer observation period is required to assess the benefit of this technique.

Figure 14: Grass covered on the slopes of the embankment (summer 2009)

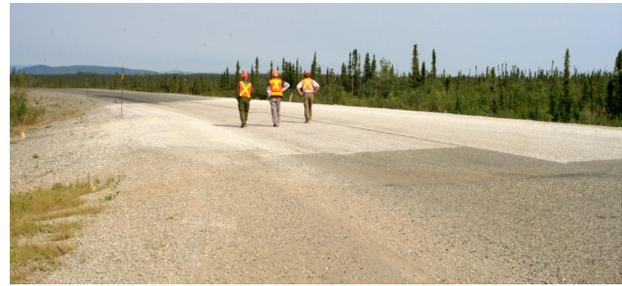
This section is a bituminous surface treatment using light-colored aggregates in order to reduce heat absorption from solar radiation at the road surface (figure 15). The main advantage of this mitigation technique is that the application of the BST and the equipment used are following the exact same process than that of a normal BST surfacing. The main constraint is that a source of light color aggregate has to be available near the construction site. In the case of the Beaver Creek project, granular material had to be hauled over more than 80 km. However, the quantity needed was not very important considering the size of the section. Since the effect of a light colored surface is limited to the center of the embankment, the performance of this section will be assessed using the thermistor string located at the center of the embankment. A technical problem occurred in the first year of monitoring at this section making the thermal regimes unreliable for a short term assessment of the performance of the section.

Figure 15: Light-grey coloured BST
