WESTERN BEAUFORT REGION  
CONCRETE AGGREGATE STUDY

INDIAN AND NORTHERN AFFAIRS CANADA  
OTTAWA, ONTARIO

PA 2291

APRIL 1988

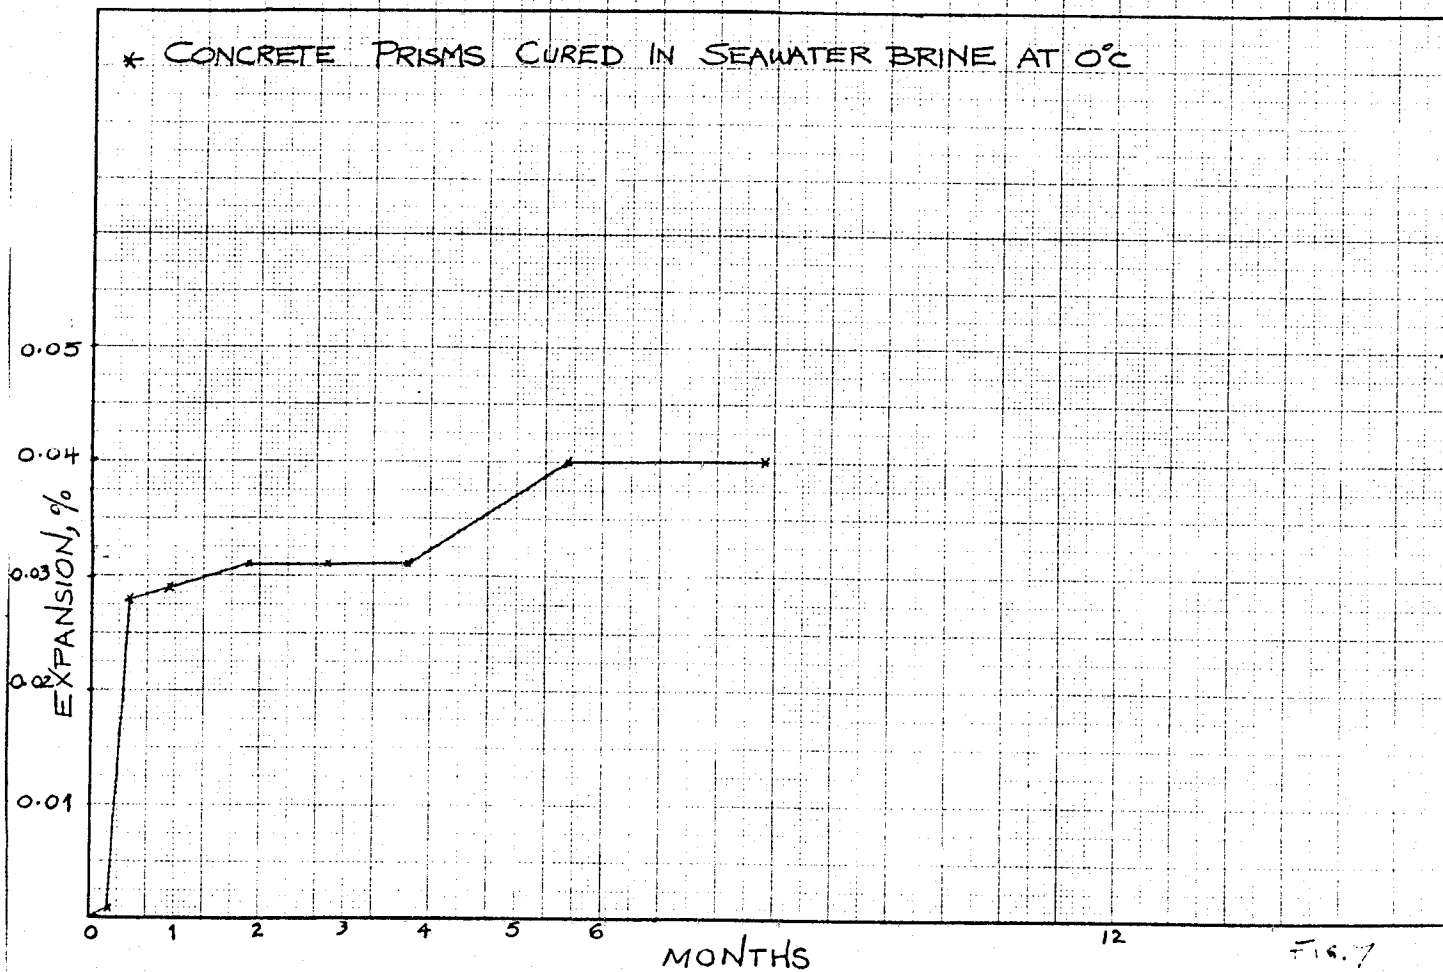
FIG. 7

SAMPLE NO. 1 - SHINGLE POINT  
EXPANSION CURVE - NON STANDARD\* ALKALI REACTIVITY TESTING

\* CONCRETE PRISMS CURED IN SEAWATER BRINE AT 0°C

Since there are no standard limits to results of a non standard test procedure one must rely on first principles in interpreting the results. Therefore, although no limits are shown on the graphs of Figures 7 to 12 we have used the basic criteria used in establishing both the ASTM and CSA limits in setting our unofficial criteria for the Pass-Fail evaluation listed for this test in Table 1.

Our Pass-Fail criteria for this test was thus arbitrarily taken as an upper limit of expansion in three months in the order of 0.016% being related to CSA's 0.01% and ASTM  $0.05/4=0.012\%$ . That is to say because we can't be precise we must be less rigid in our limit than is the case with more extensively documented standard tests.

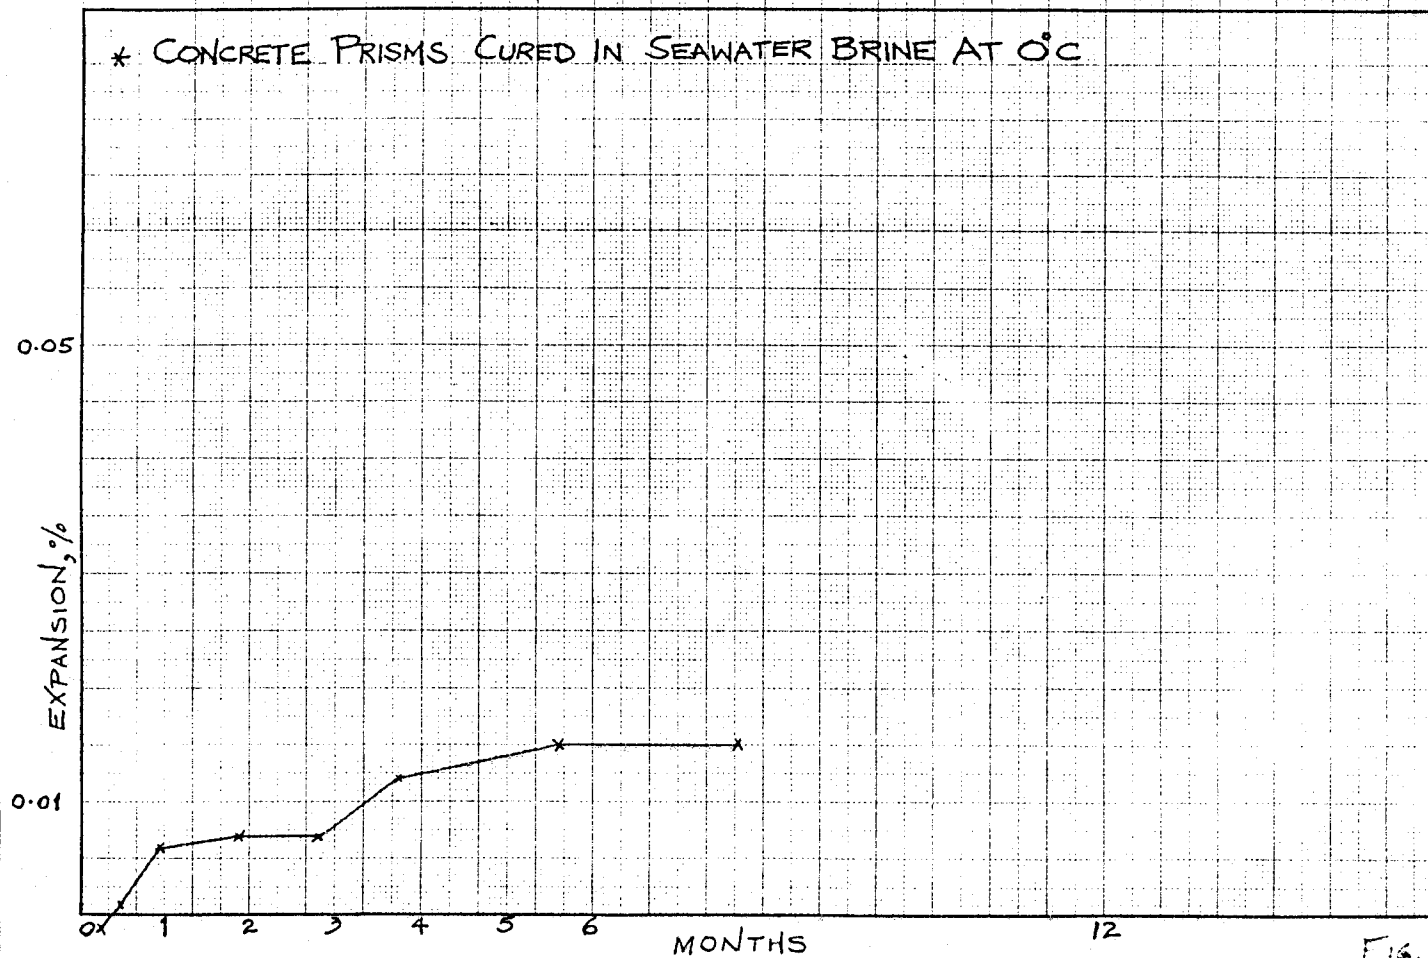
Fig. 3

SAMPLE NO 2 - RUNNING RIVER  
EXPANSION CURVE - NON STANDARD\* ALKALI REACTIVITY TESTING

\* CONCRETE PRISMS CURED IN SEAWATER BRINE AT 0°C

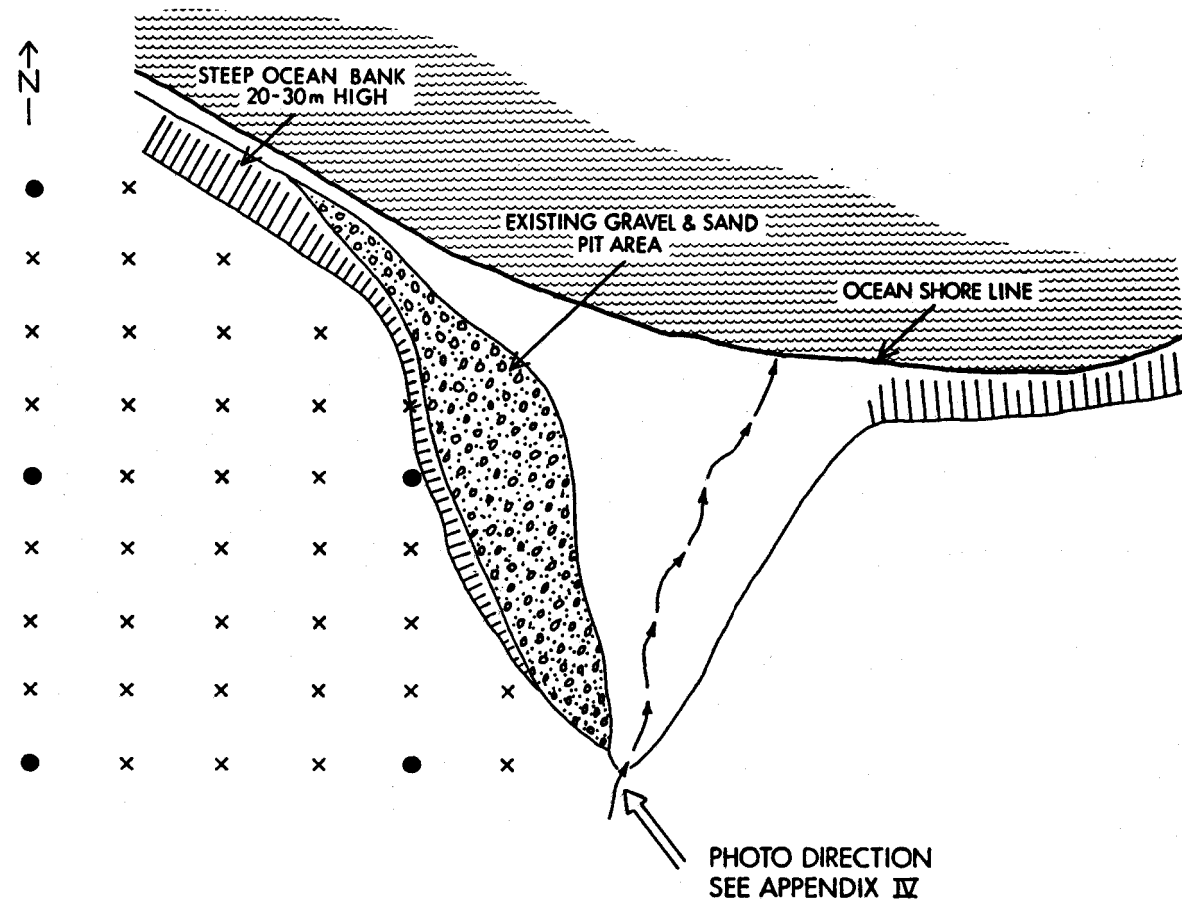
EXPOSURE NO. 4  
SHINGLE POINT

- LEGEND:
- FIRST STAGE PROGRAM  
RANDOM SPACING (150-200m)
  - x SECOND STAGE PROGRAM  
GRID SPACING (50m)

Two stage programs for investigation are recommended. The first stage would include the drilling of test holes in each of the 4 sources to confirm that the required quantity and quality could be obtained from the area. The first stage test holes would be widely spaced on a random basis and would cover an area large enough to confirm that sufficient volumes of aggregate are available in the source.

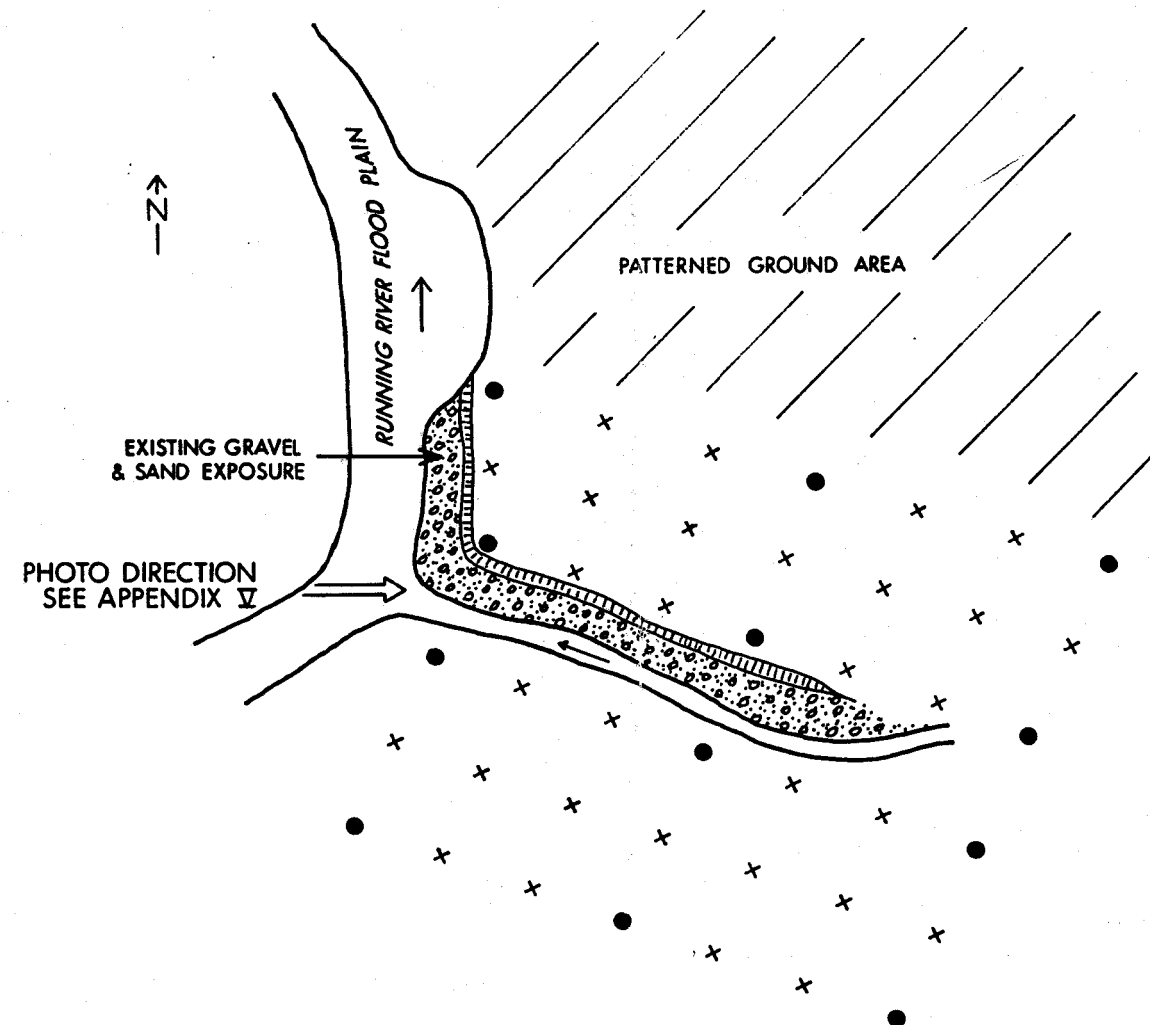
EXPOSURE NO. 5  
RUNNING RIVER

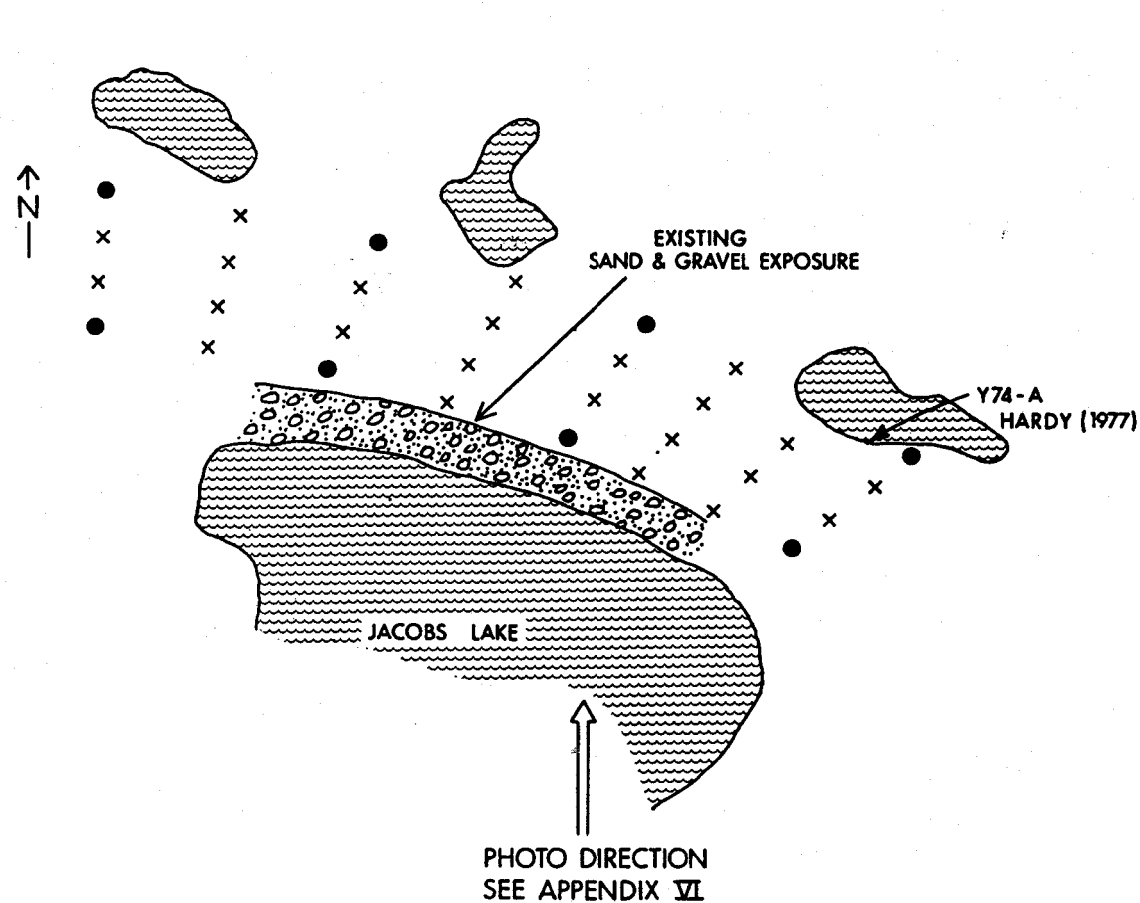
EXPOSURE NO. 6  
JACOBS RIDGE

- LEGEND :
- FIRST STAGE PROGRAM  
RANDOM SPACING (150-200m)
  - × SECOND STAGE PROGRAM  
GRID SPACING (50m)

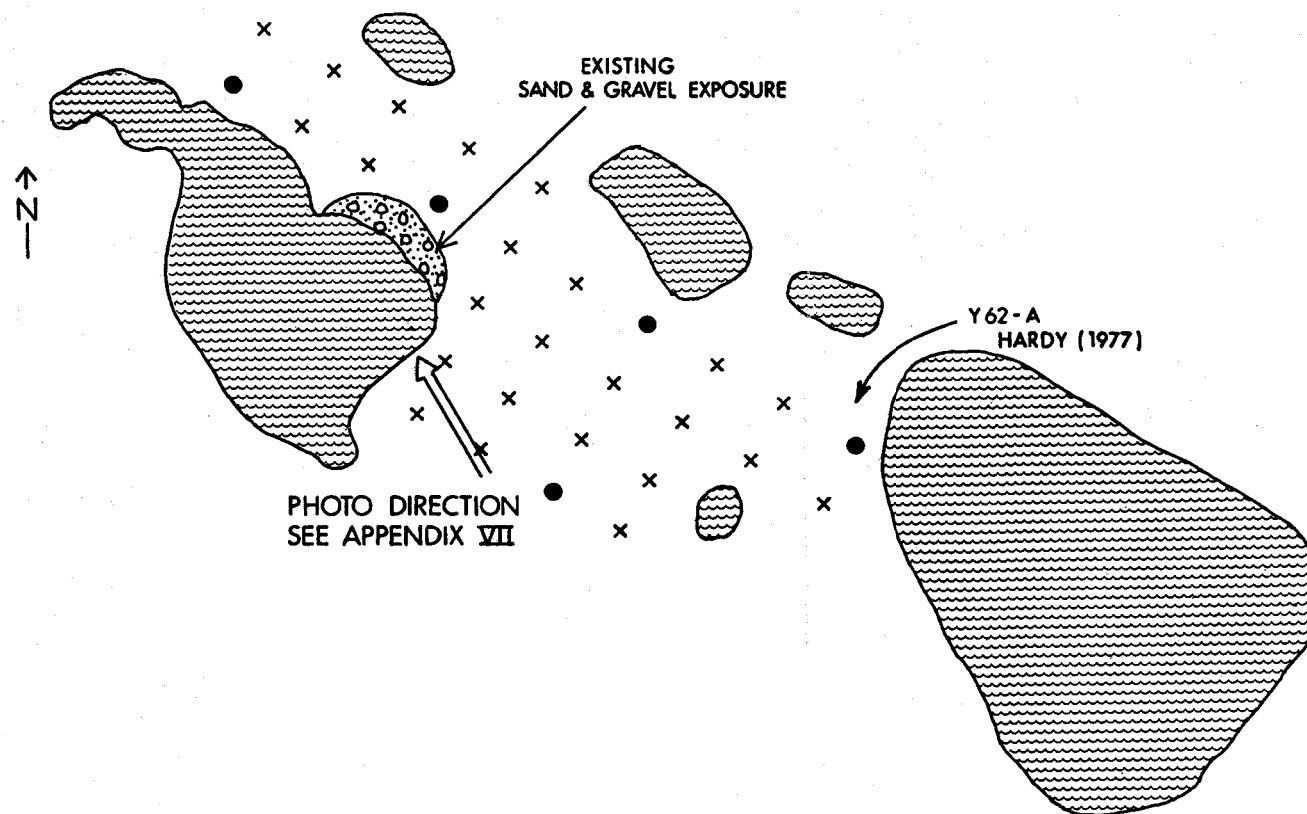
EXPOSURE NO. 7  
KING POINT

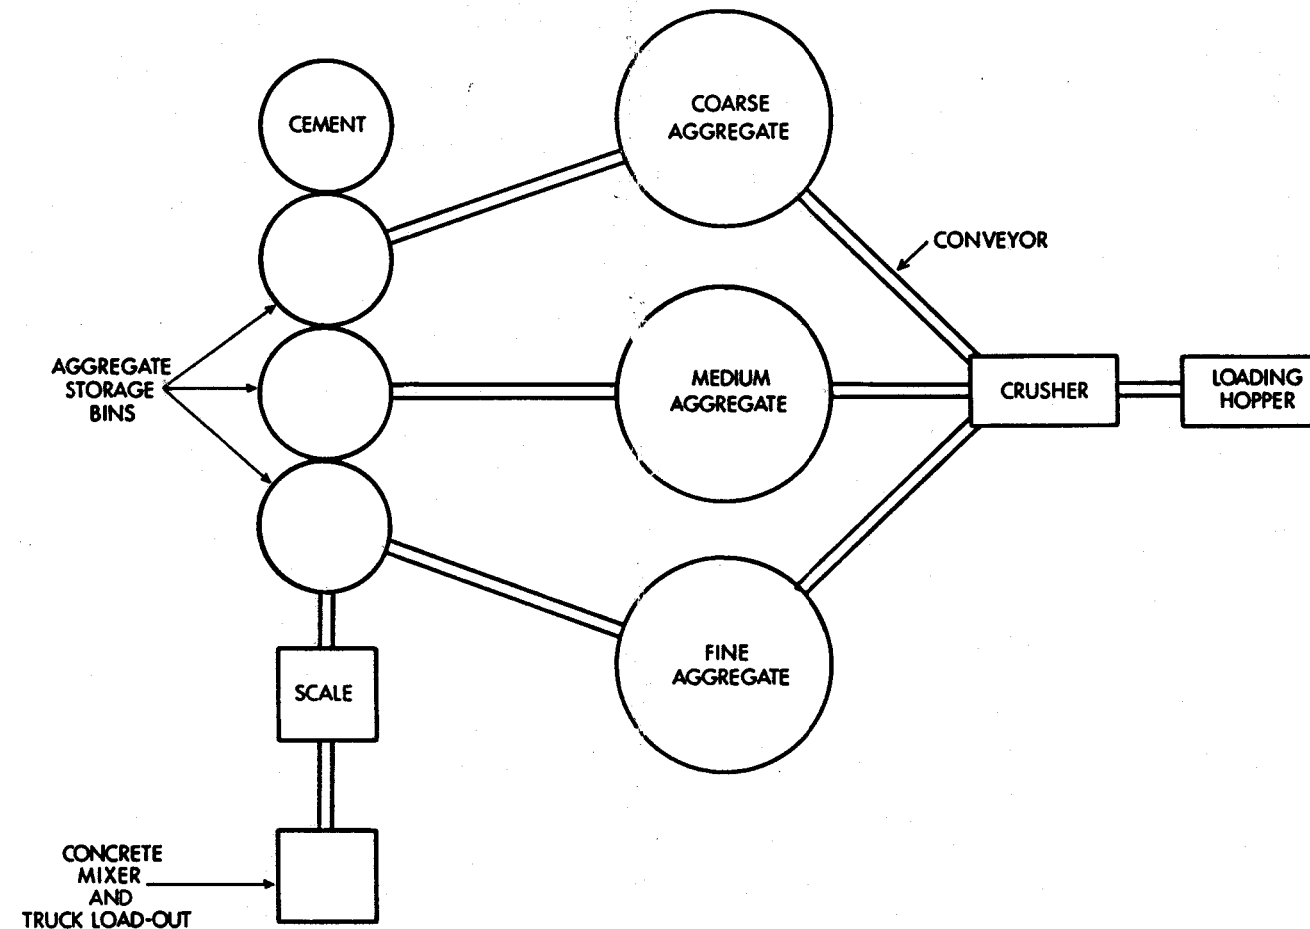
←FABRICATION, CURING AND STORAGE→ ←CONCRETE BATCH PLANT→ ←AGGREGATE PROCESSING→ ←PIT RUN GRAVEL STOCK PILES→

The land area required for the complete processing plant could be in the order of 5 Ha depending on the scale of the operation. The site would have to be located on generally flat and thaw stable terrain close to the gravel pit or close to a loading facility on the Beaufort Sea shore. From visual inspections, it is judged that these conditions are present at the Running River, Jacobs Ridge or King Point sources. At Shingle Point, terrain is more rolling and patterned ground is present. Helicopter flights around the DEW station were severely restricted. The Shingle Point site was therefore selected from air photographs.

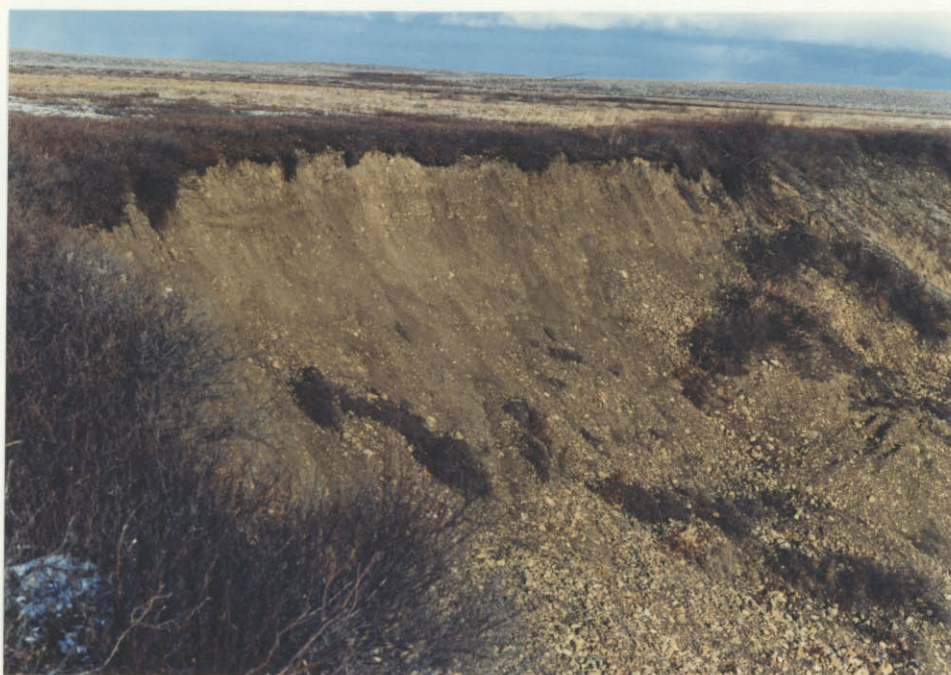
Scarp of flow slide towards east end of source. Note thin silt seams in exposure. Scarp 8 to 10 m high.  
(Exposure No. 1)

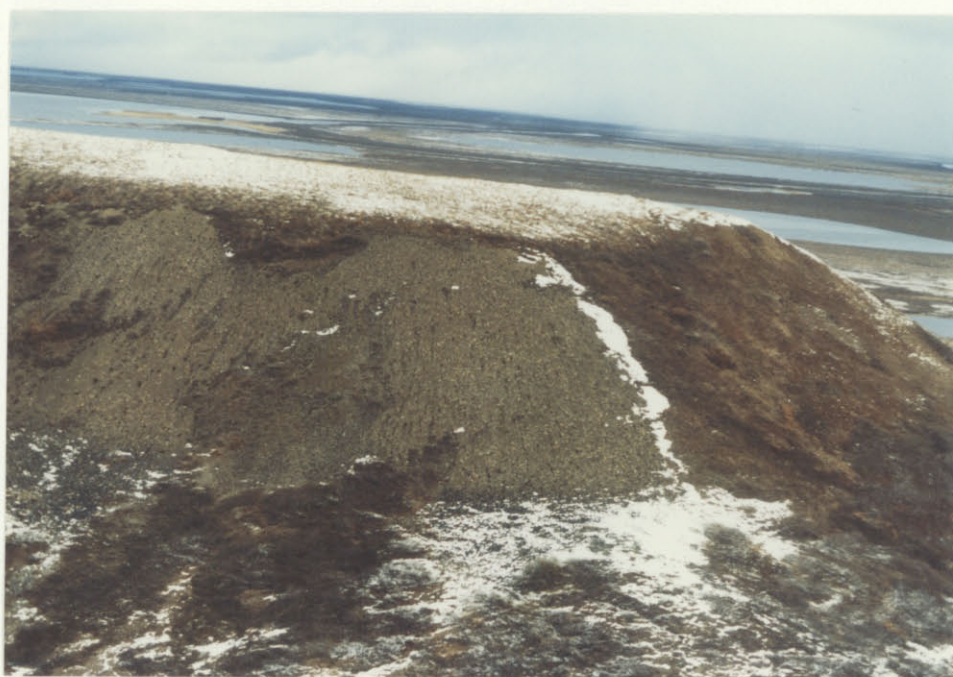
Exposure No. 2, 1 mile southeast of Y-102 source.

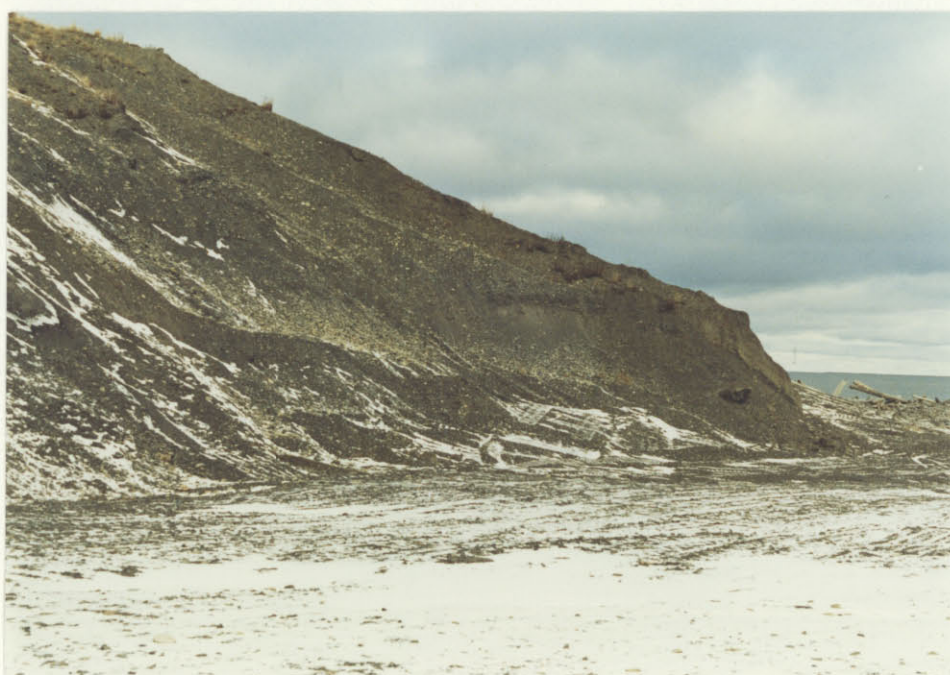
Exposure No. 3 at sample area.

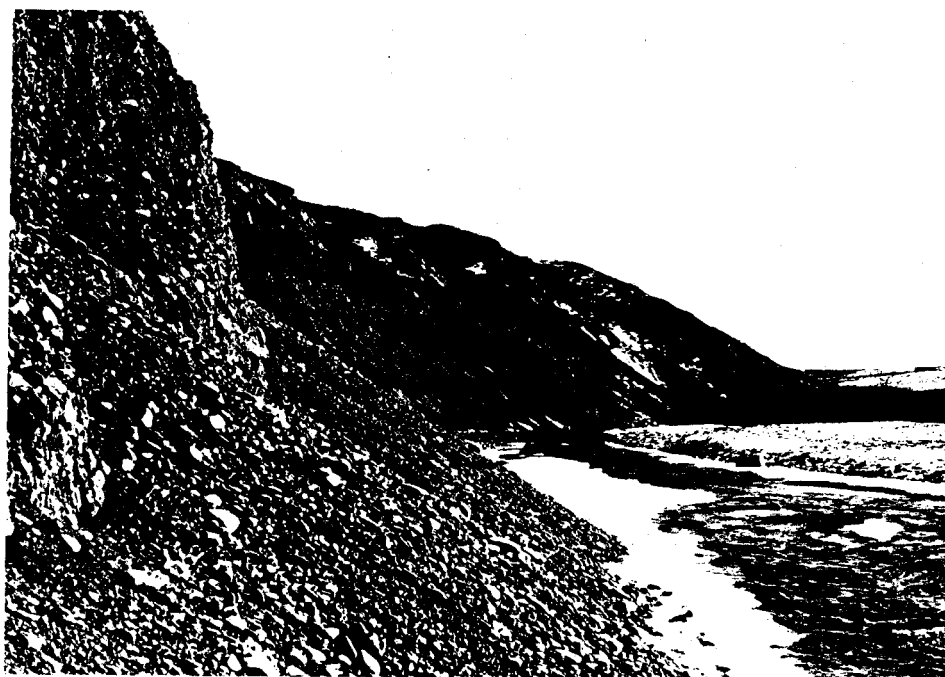
Exposure No. 4 looking upstream adjacent to area sampled.

The Hardy (1977) report delineated potential sources along the active flood plain and in the adjacent glaciofluvial terraces of the Running River. As discussed previously for the Blow River Source in Section 3.3 above, the development of the source in the active flood plain (Hardy Y-80) is not considered to be practical. Accordingly the glaciofluvial river terraces along the Running River and source Y-79 Hardy (1977) were investigated. Apart from the exposures and test pits logged by Hardy, the best gravel exposure observed by us was up to 13 m thick and extended along the east side of the Running River flood plain on both sides of a junction with a small tributary stream. Thick gravel and sand underlie up to 5 m of moraine overburden. This exposure has been designated as Exposure No. 4.

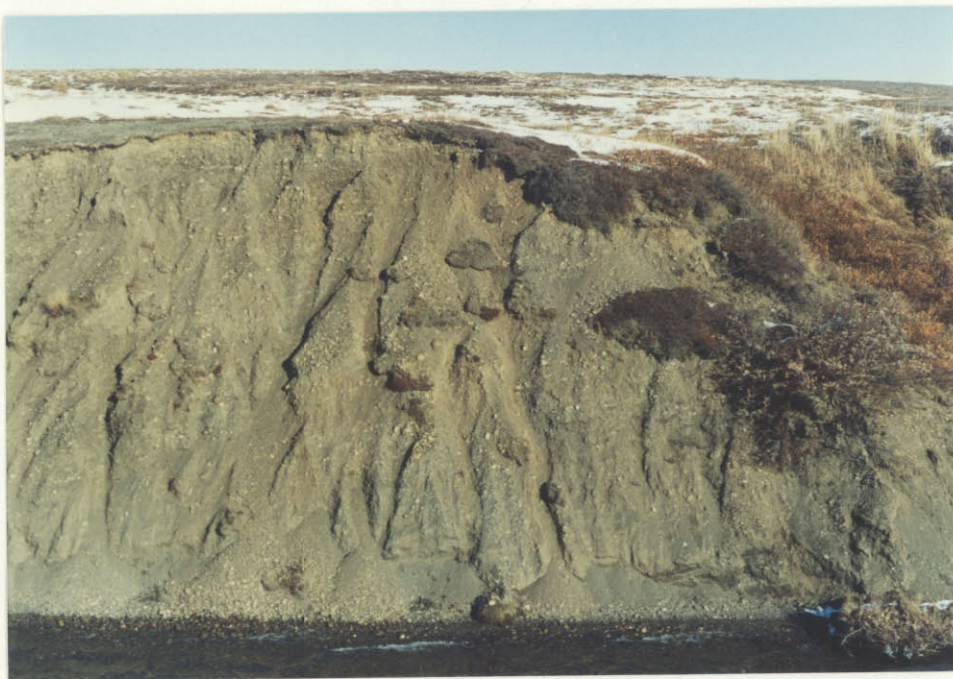
Exposures in Jacobs Lake

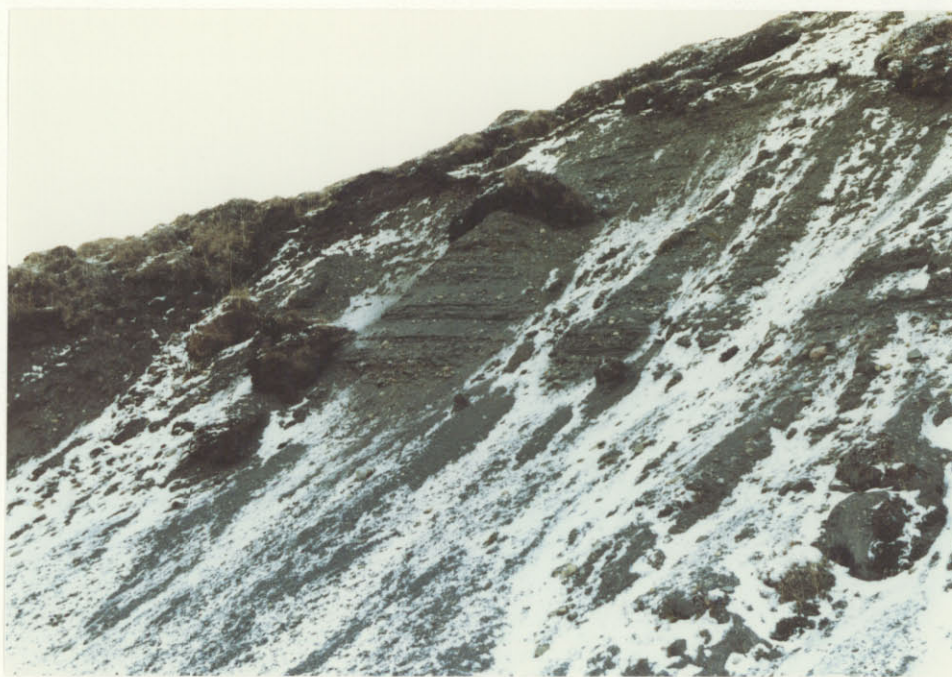
Exposure along gully at north end of source (HARDY Y-62D[e])
