REPORT  
TO  
DEPARTMENT OF INDIAN AFFAIRS  
AND NORTHERN DEVELOPMENT  
ON  
BEAUFORT REGION QUARRY ROCK STUDY

CONSULTING GEOTECHNICAL AND MINING ENGINEERS

August, 1987

862-1806

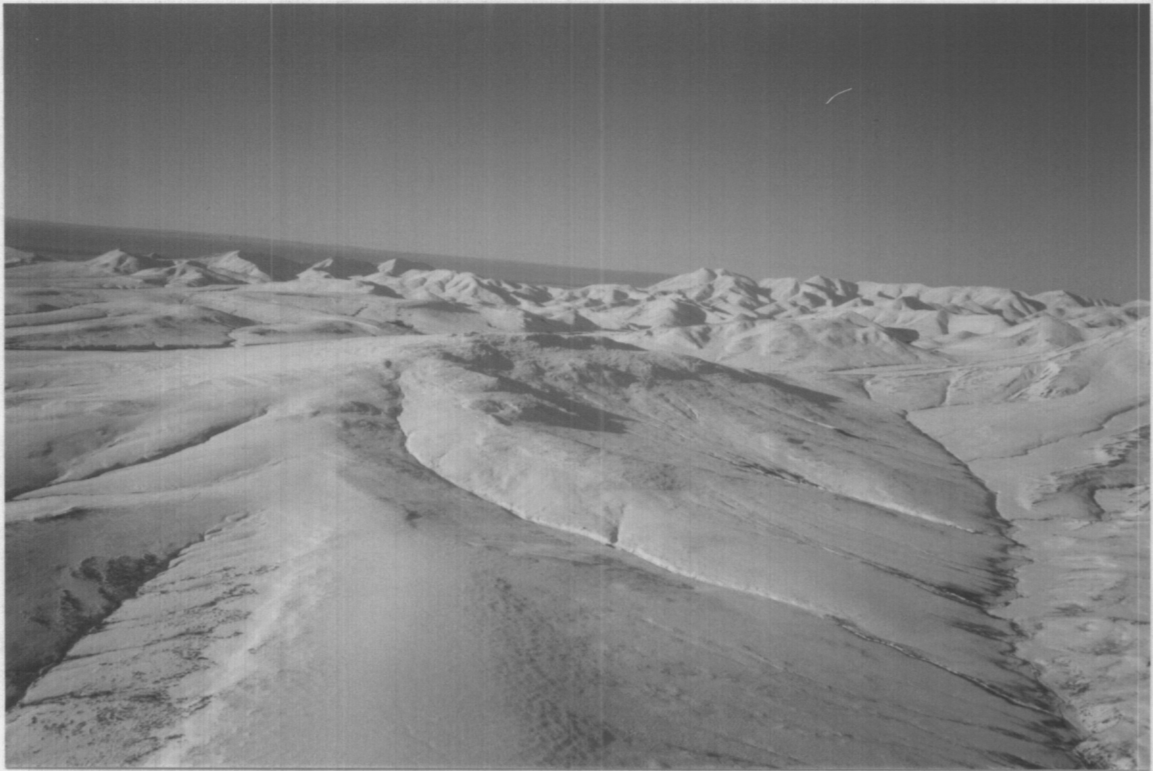
PHOTOGRAPH 1: AERIAL VIEW OF MT. FITTON LOOKING SW

The porphyritic granite of Mount Fitton would make an excellent quarry source for all grades of rock required. There is plenty of space around the potential quarry site for facilities infrastructure, stockpile, working space and camp. Summer quarrying is indicated, since water supply is likely to be limited to non-freezing conditions without drilling wells near to the quarry site, since the Blow River is reported to freeze solid. The rock mass appears ideal for blasting and producing a durable product, with little weathering noticed in outcrop and good laboratory test results.

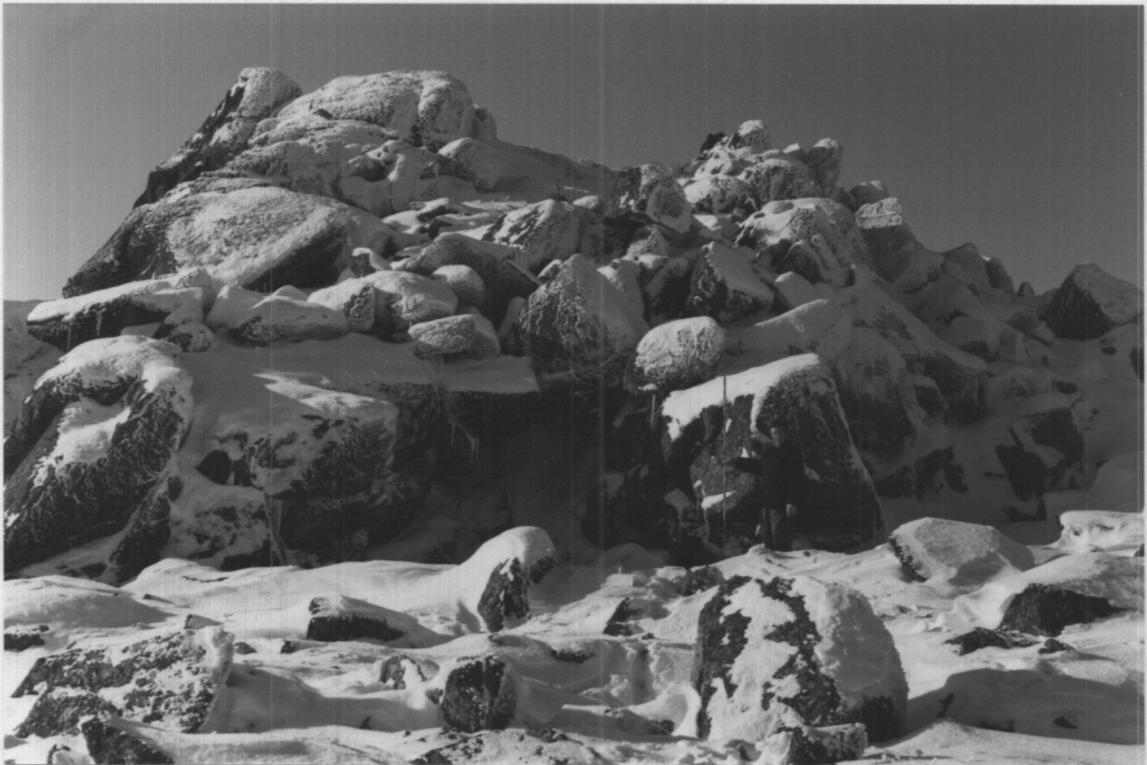
PHOTOGRAPH 2: GRANITIC BLOCKS NEAR SUMMIT OF MT. FITTON

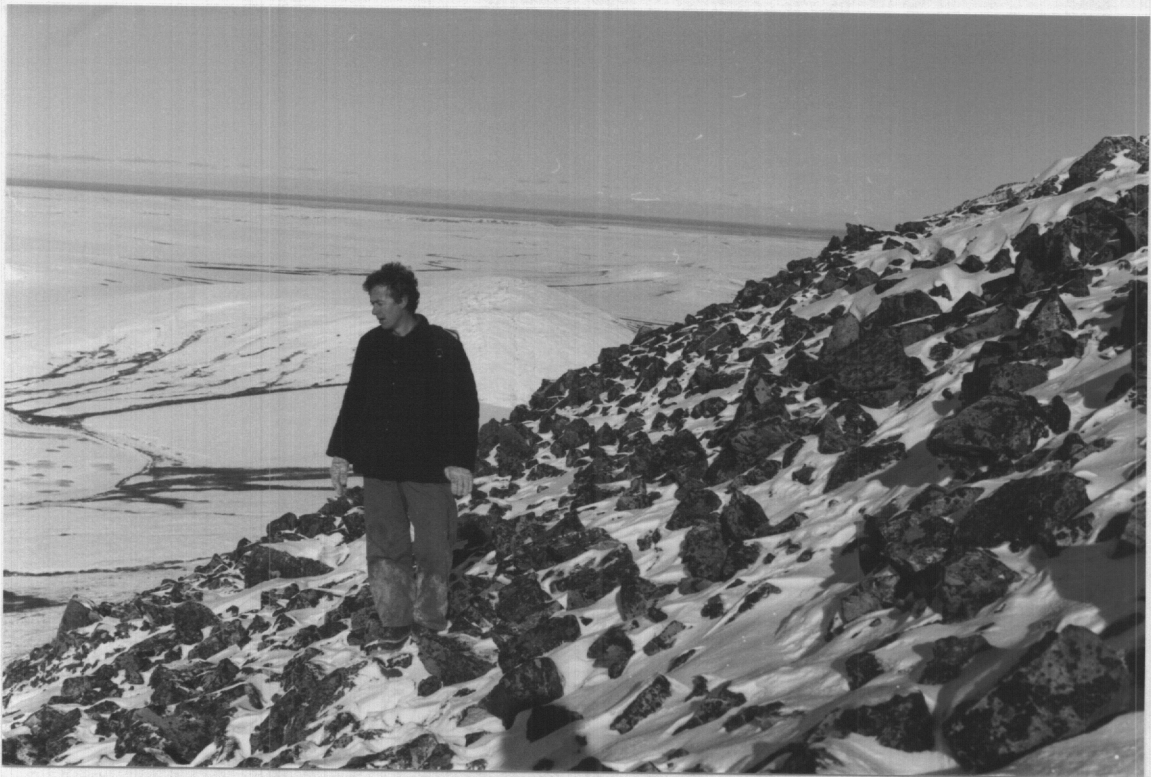
PHOTOGRAPH 4: QUARTZITIC FELSENMEER ON WEST SLOPE OF MT. DAVIES GILBERT

- o The broken quartzites which form the very steep hogsback ridge to the north of Mount Davies Gilbert did not appear to favour this prospect as a source of armour stone. The average block size was in the order of 0.2 - 0.3 m across. The steep topography would make quarrying difficult and the flatter areas surrounding the ridge, where facilities would be required, are generally poorly drained. Haulage would require a road to the coast and either small barge to King Point or an extension of the haul road to truck the product to shipping facilities at King Point. Rehandling of the product would be required if a shorter access haul were to be considered.

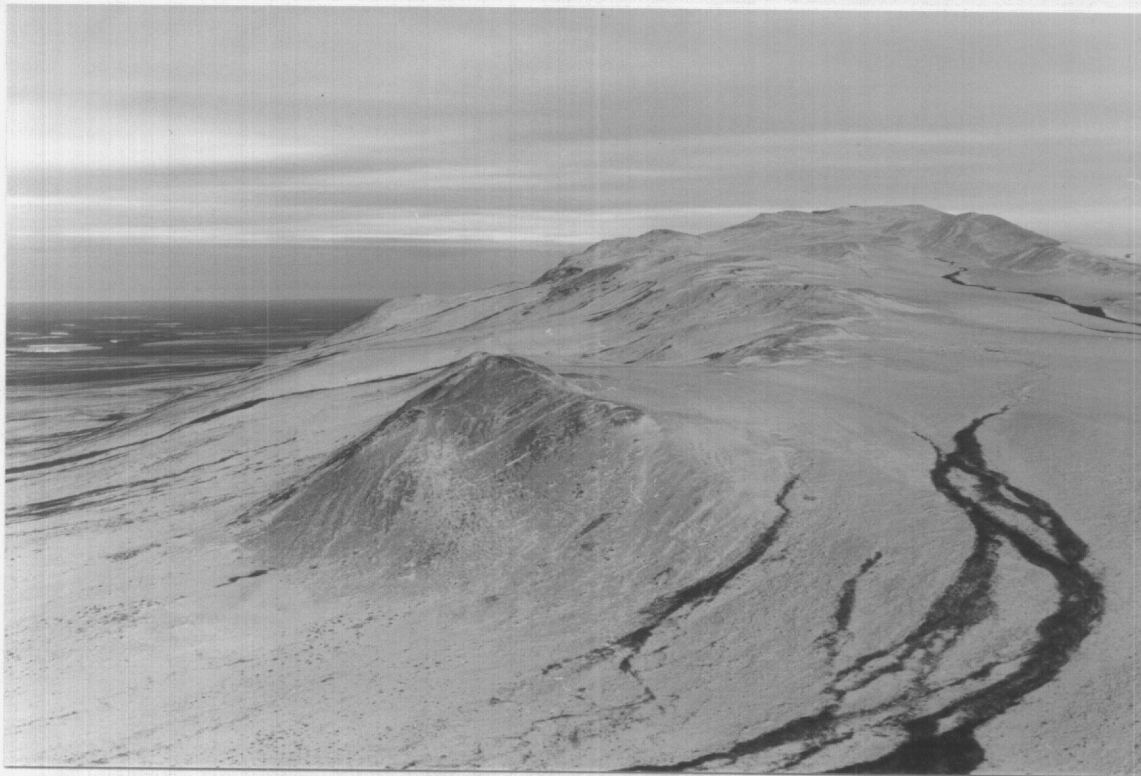
PHOTOGRAPH 5: AERIAL VIEW OF MT. GIFFORD LOOKING SW

The northern spur from Mount Gifford comprises gently undulating terraces which drop away steeply to the east and the Mackenzie Delta. The lower flanks of the mountain range, closer to the deltaic plain, are gently sloping and poorly drained, probably permafrost bearing, outwash fans resulting from erosion of the sandstone/siltstone ridges, in combination with moraine deposits. The steep eastern face of the local range has good bedrock exposures while the flatter, western face is predominantly covered with colluvial debris and sparse vegetation. Local bedrock knobs, more erosion resistant, protrude through the thin mantle of recent deposits.

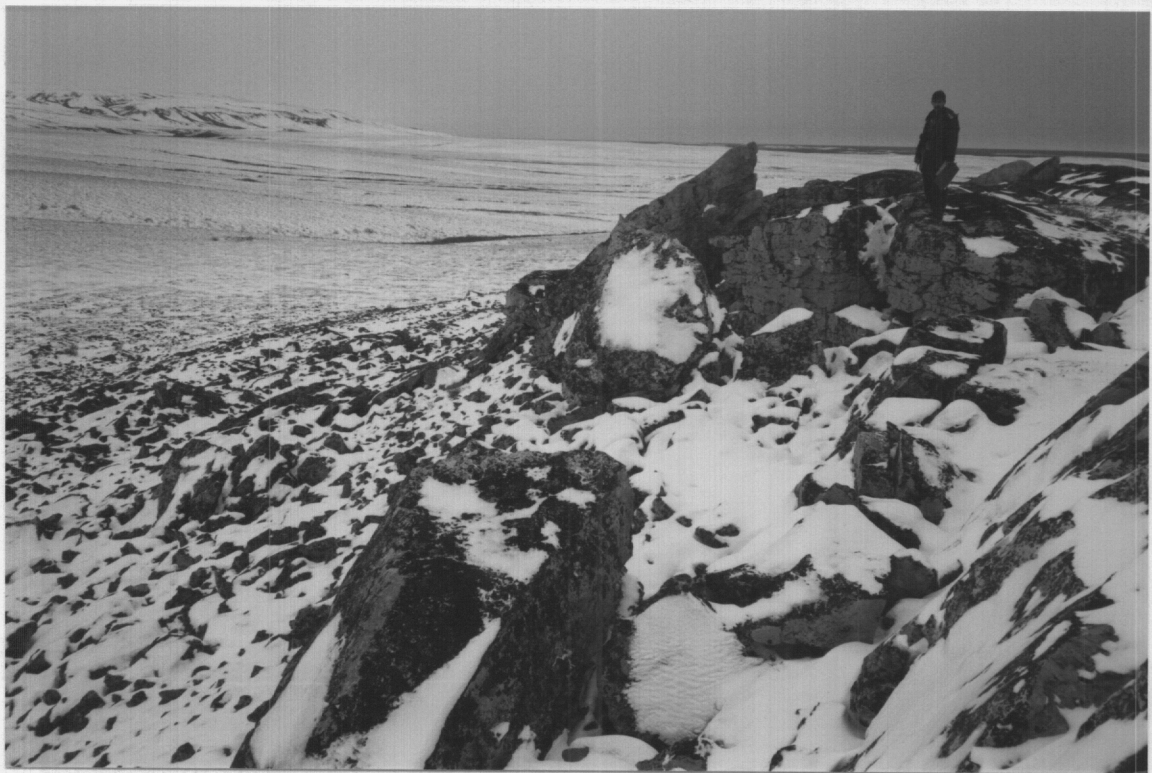
PHOTOGRAPH 8: SANDSTONE BLOCKS ON WEST SLOPE OF ROCHE MOUTONEE

Although the quality of the rock material has proven itself in laboratory testing, block sizes found on the ground, and outcrop limitations lead to the conclusion that the deposit may not be able to provide armour stone in great quantities. The site would be technically feasi-

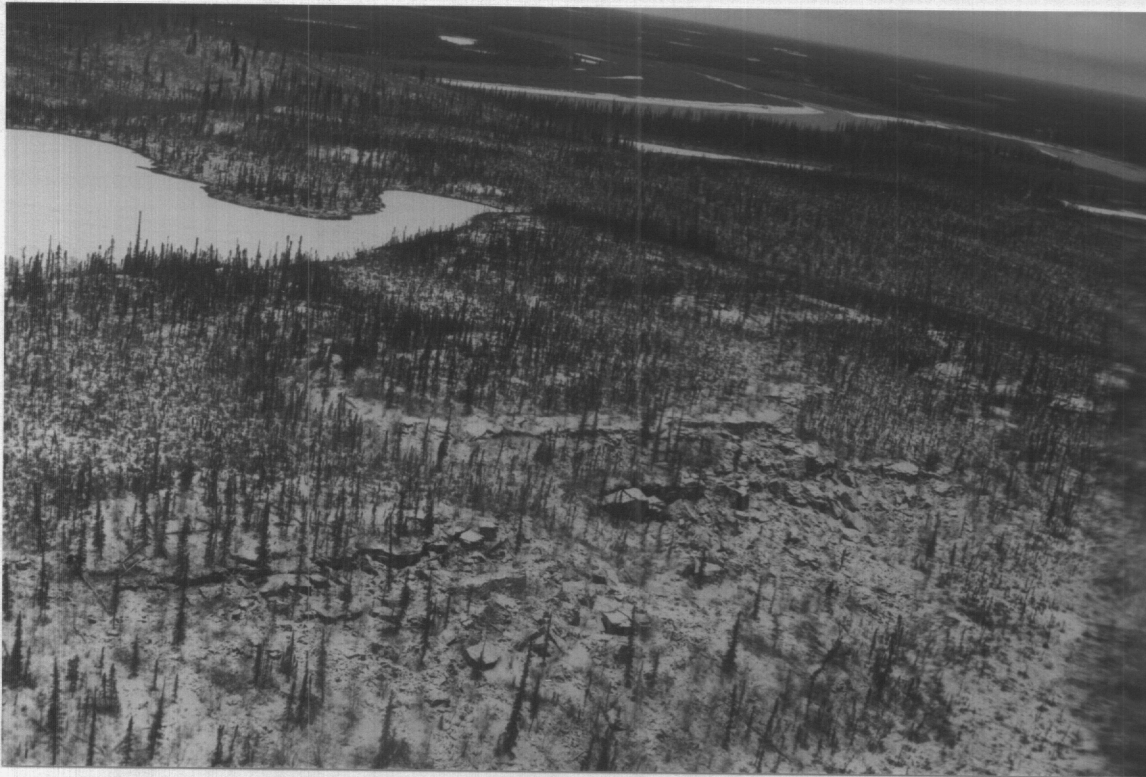
PHOTOGRAPH 9: AERIAL VIEW OF GULL CREEK QUARTZITE LOOKING NW

- o The Gull Creek Quartzite appeared to be a good rip rap prospect and the Dolomite an excellent source of armour stone. Both areas are close to the East Channel where shallow barging or ice road haulage to Tuktoyaktuk would be needed. Re-shipment of the product would be required for offshore development. The outcrops of quartzite were found to be highly broken and more susceptible to degradation than the coarsely crystalline dolomite prospect. Both sites could be developed with work crews residing in Inuvik which would reduce the need for infrastructure facilities in the Gull Creek area. Suitable terrain for waste disposal and produce stock piling could be found adjacent to the proposed quarry sites.

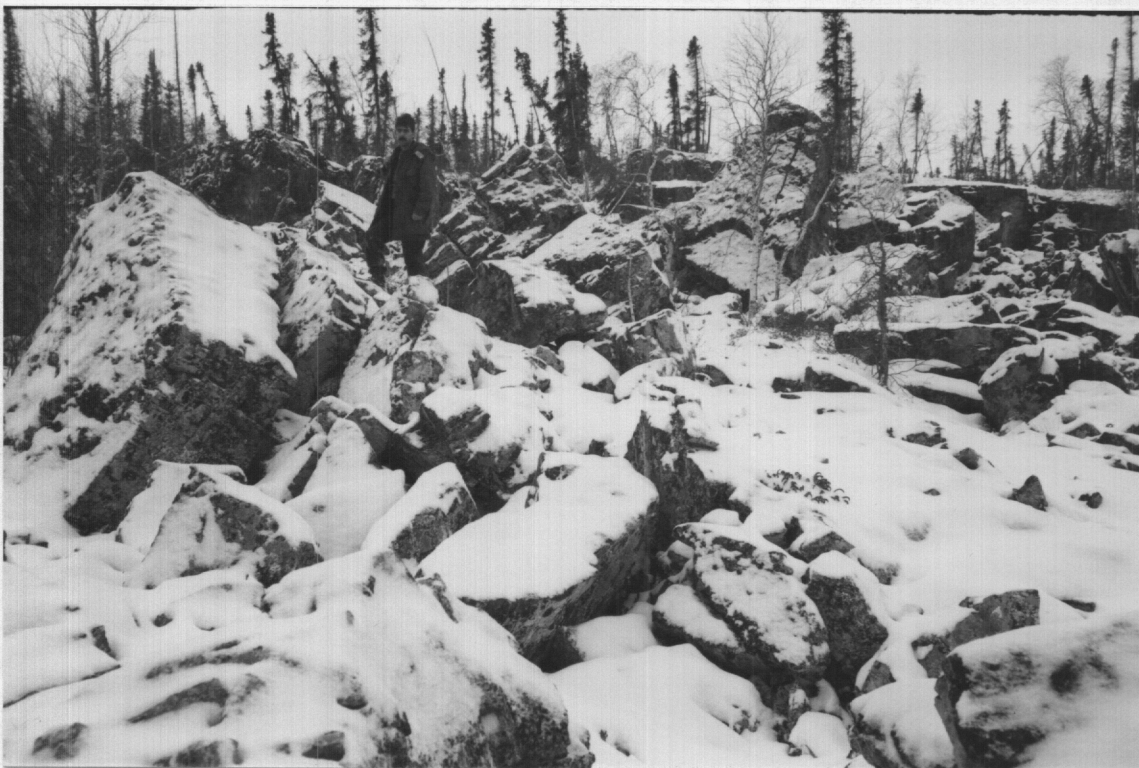
PHOTOGRAPH 10: LARGE BLOCKS ON EAST SLOPE OF GULL CREEK QUARTZITE

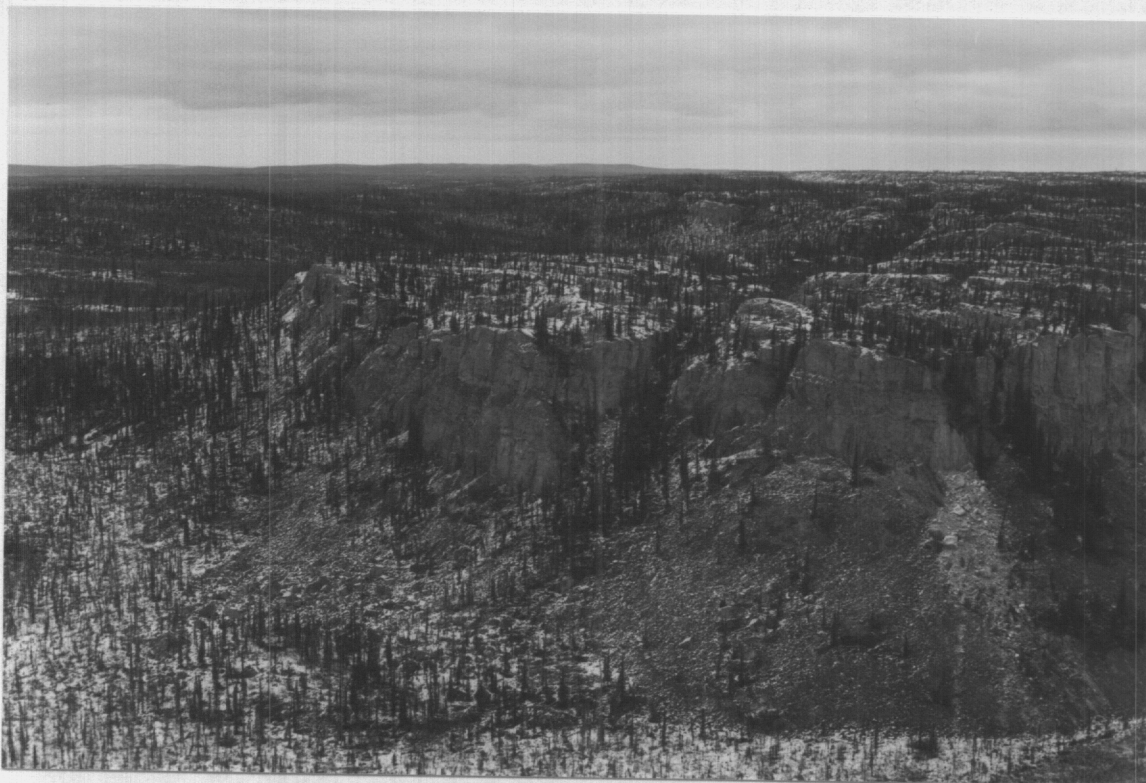
PHOTOGRAPH 11: AERIAL VIEW OF GULL CREEK DOLOMITE LOOKING N

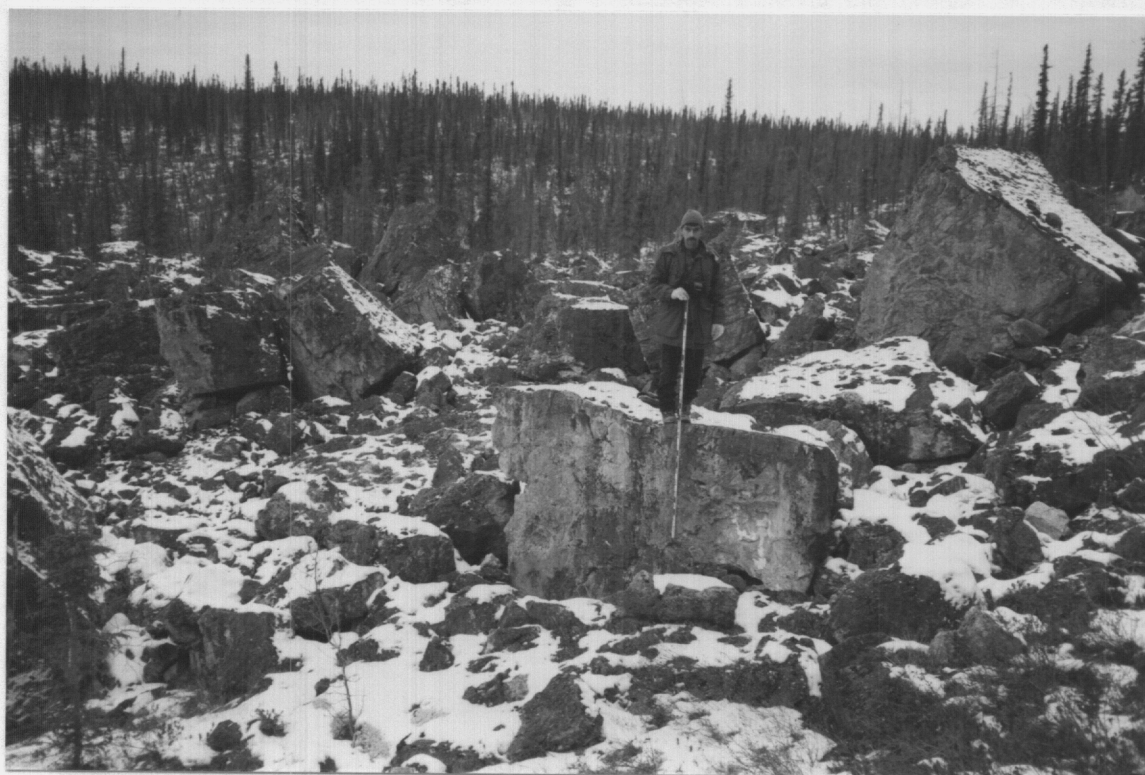
PHOTOGRAPH 12: BLOCKS IN TALUS BELOW GULL CREEK DOLOMITE CLIFFS

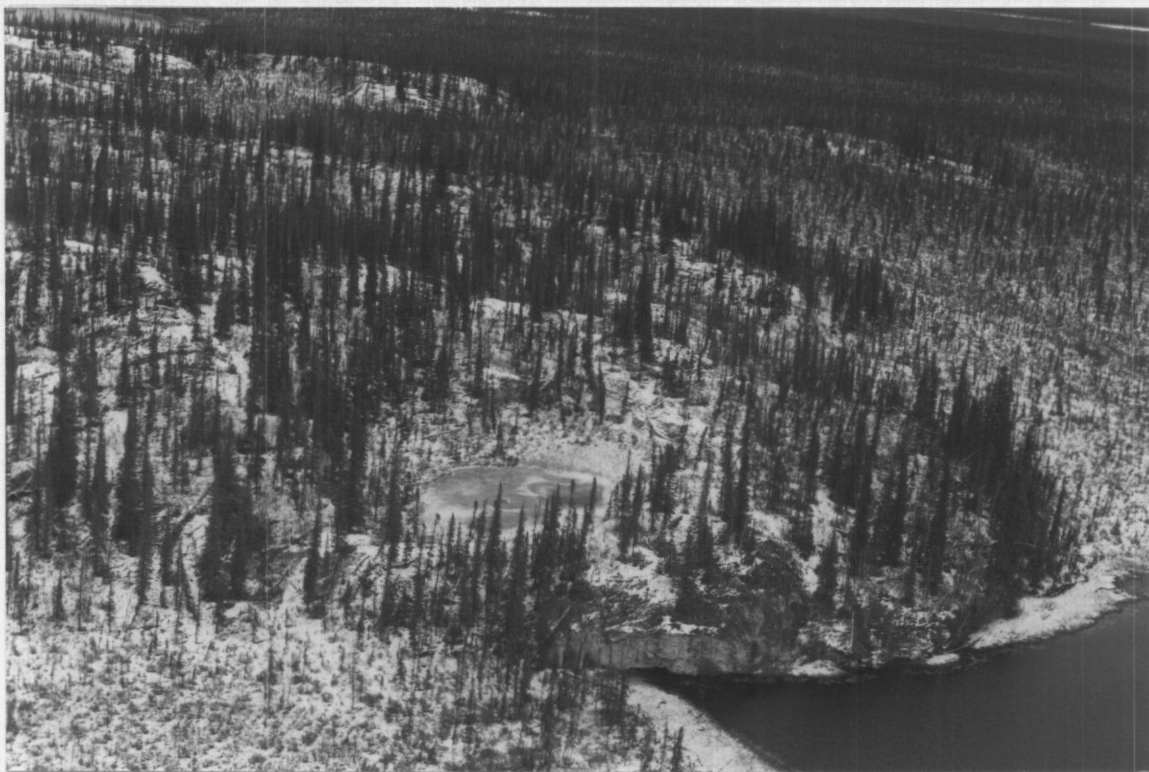
PHOTOGRAPH 13: AERIAL VIEW OF DELTA OUTLIERS LOOKING NE

- o The Delta Outliers are notable for their low topographic relief which would mean either very large excavations or a quarry extending below the natural water table. The degree of surface fracturing of the rock seen during this phase of the study indicated that these rock masses would comprise poor armour stone and only fair rip rap prospects. Access and product handling considerations in the Gull Creek area apply equally to these outliers.

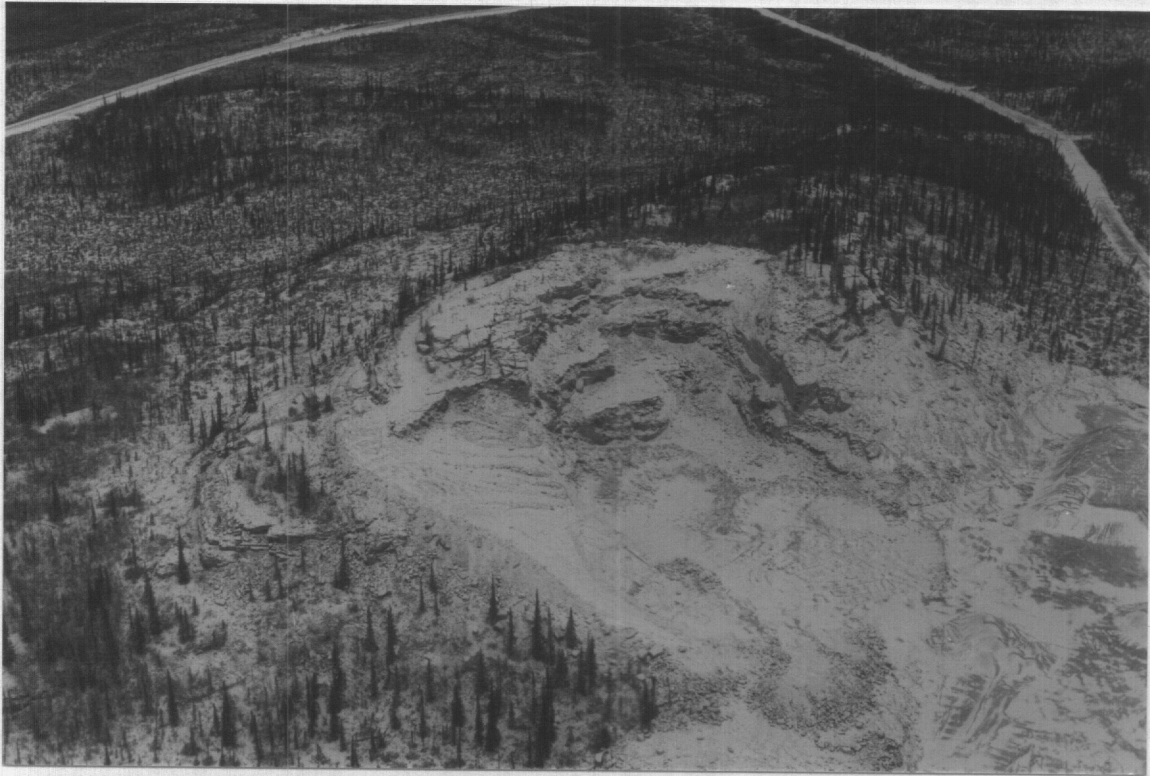
PHOTOGRAPH 15: AERIAL VIEW OF EXISTING DPW QUARRY LOOKING W

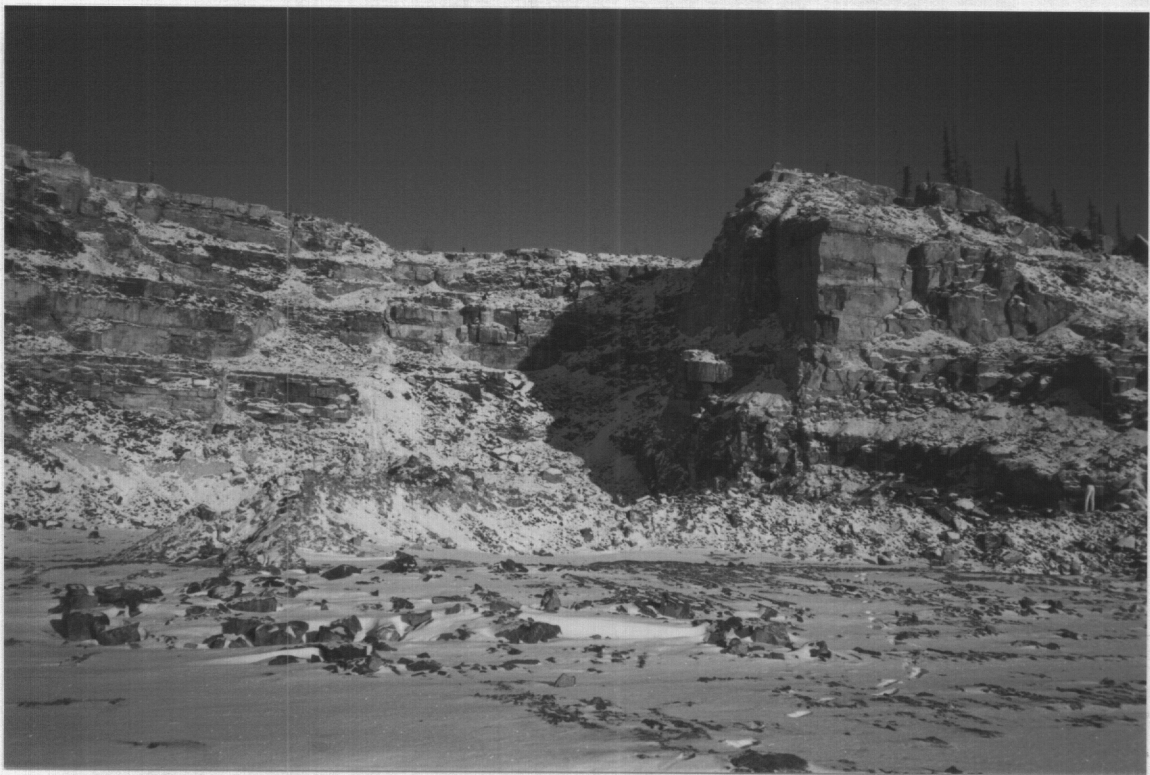
PHOTOGRAPH 16: GROUND VIEW OF DPW QUARRY LOOKING W

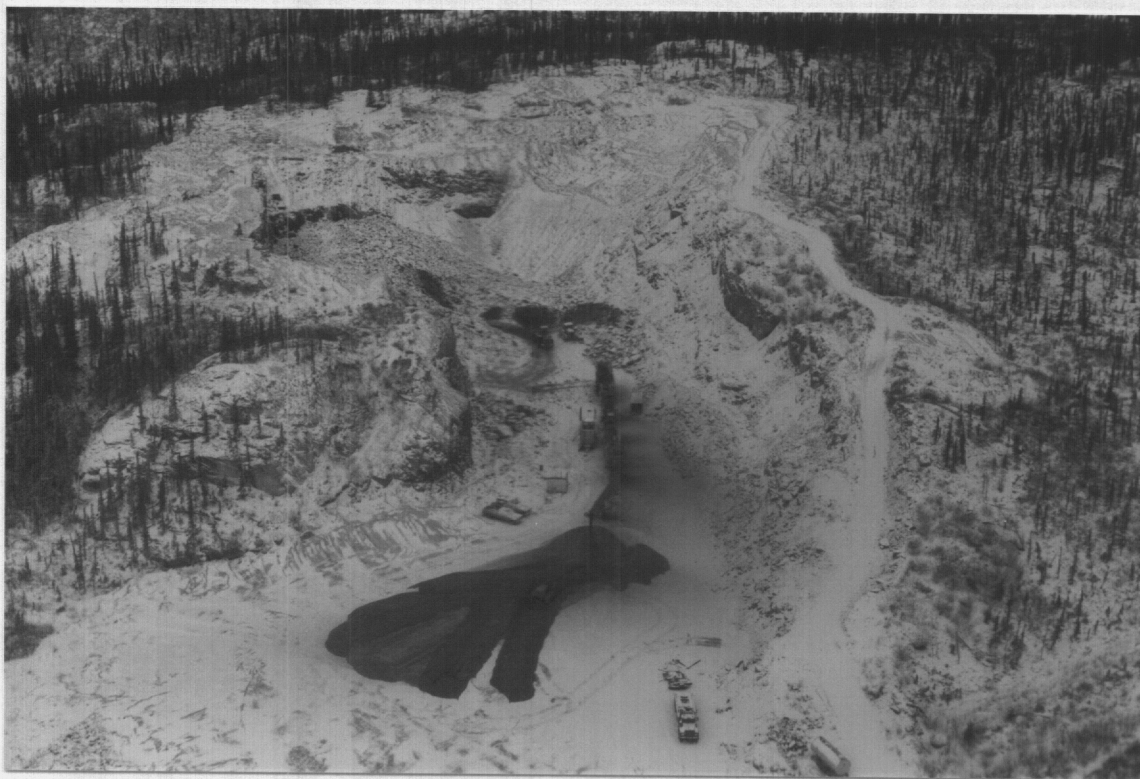
PHOTOGRAPH 17: AERIAL VIEW OF EXISTING CAMPBELL QUARRY LOOKING SW

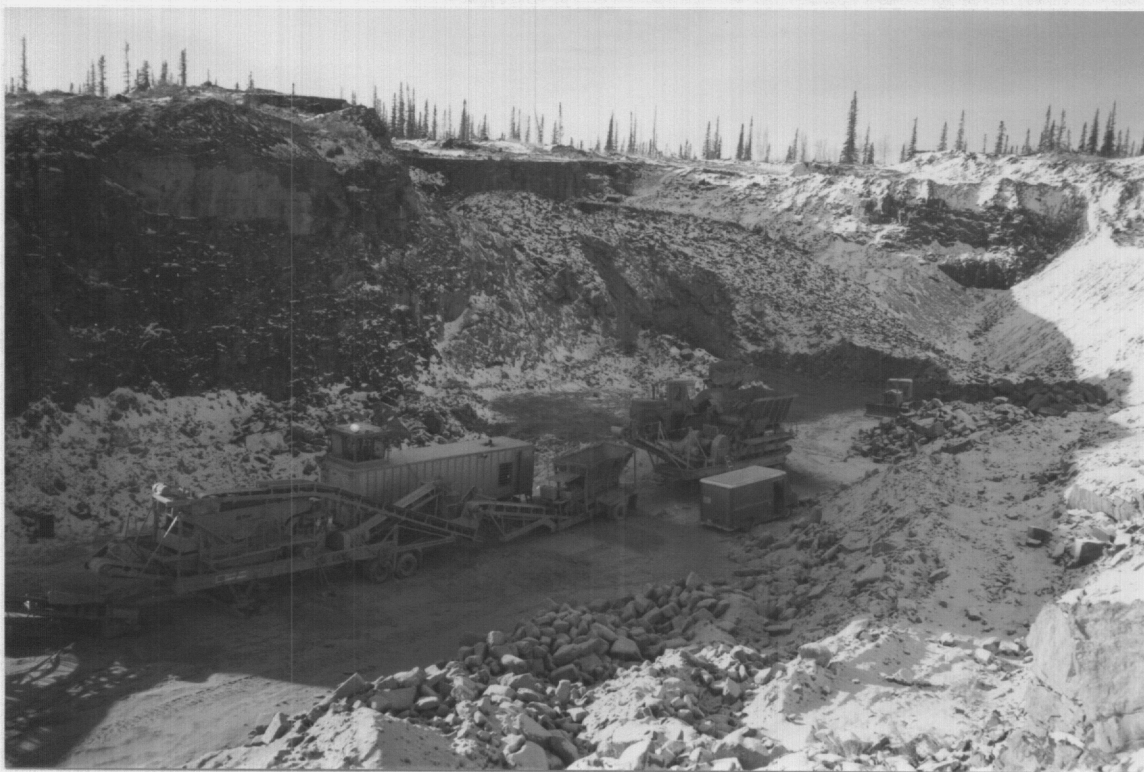
PHOTOGRAPH 18: GROUND VIEW OF EXISTING CAMPBELL QUARRY LOOKING S
