MACKENZIE HIGHWAY GEOTECHNICAL EVALUATION

VOLUME XVI
TSINTU RIVER CROSSING
MILE 711.2
MACKENZIE HIGHWAY

**MACKENZIE HIGHWAY
GEOTECHNICAL EVALUATION
VOLUME XVI
TSINTU RIVER CROSSING - MILE 711.2
MACKENZIE HIGHWAY**

**GOVERNMENT OF CANADA
DEPARTMENT OF PUBLIC WORKS
CONTRACT NUMBER A10/73
FILE NUMBER 9305-52-307**

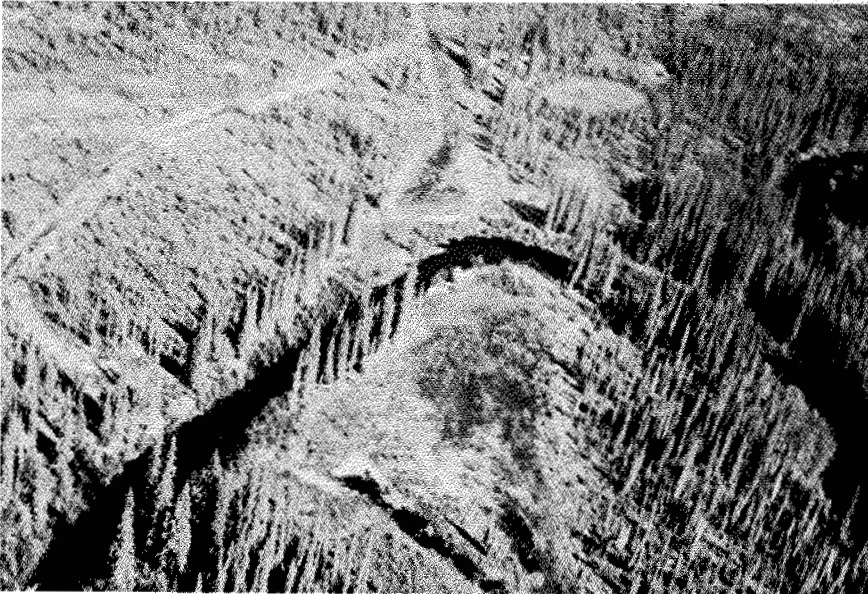
PLATE No. 1

Tsintu River Crossing
North is to the top of
the plate. The proposed
crossing is on the main
north-south cutline.

The proposed Mackenzie Highway crosses the Tsintu River at Mile 711.2, approximately 10 miles south of Fort Good Hope, N.W.T.. Drawing A-1, Appendix A, is a Key Plan of the Tsintu River area and Drawing No. A-2, Appendix A, presents a detailed Site Plan. Plates No. 1, and No. 2, Drawing No. A-3, Appendix A, show the crossing from the air in June, 1973,

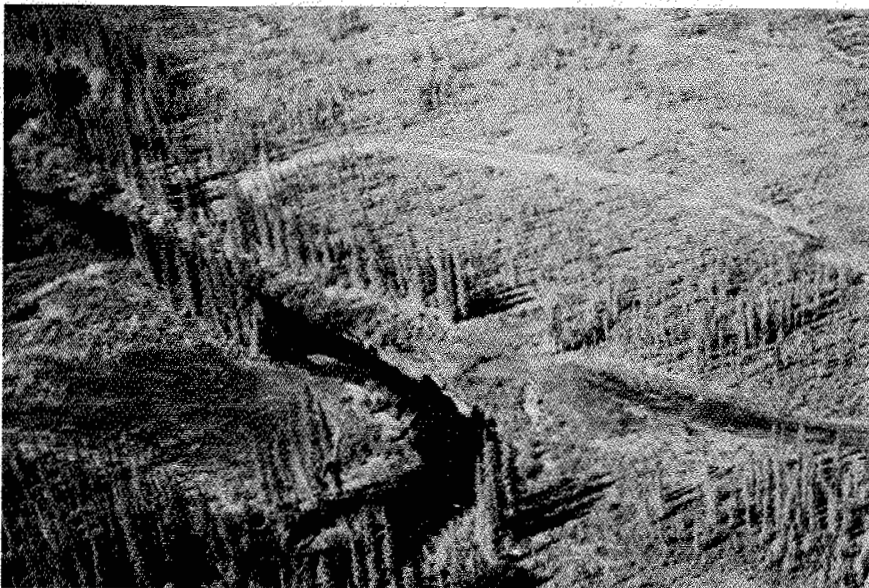
PLATE No. 2

Tsintu River Crossing
North is to the right
of the plate.
