1975 PIPELINE BORROW INVESTIGATIONS YUKON COASTAL PLAIN

Prepared for Canadian Arctic Gas Study Limited

By
Northern Engineering Services Company Limited
Calgary, Alberta

May, 1976

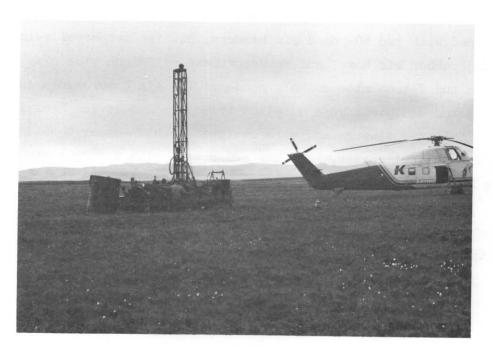
Photo 3.1.1 View of Kenting Big Indian Heli-Drill drilling by means of airflush to prove out depth of granular materials deposit on the Yukon coastal plain.

The Kenting Big Indian Heli-Drill was used to drill test holes in selected borrow sites. The Heli-Drill is a helicopter-transportable Mayhew 200 drilling rig mounted on a detachable base which can be levelled by means of three hydraulic jacks. The power units for the drill and air compressor consist of two Wisconsin VH4D 30-horsepower air-cooled gasoline engines which operate independently of each other. The Heli-Drill is usually transported as two packages. The first package consists of the drill frame, rotary table, draw works, mast assembly, and one power unit, and the second package consists of the drill base upon which the air compressor and the second power unit are mounted. Each of these two components weighs approximately 3400 pounds and is equipped with custom slinging cables to ensure a properly balanced load for transportation by helicopter.

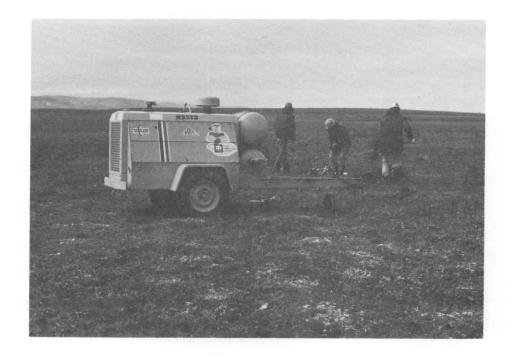
Photo 3.1.2

Test pit crew beginning to excavate a test pit on the Yukon coastal plain. An air compressor outfitted with jackhammers is located on site for use in excavating into the permafrost.

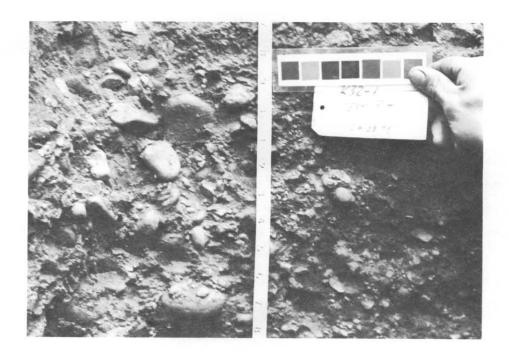
$$\operatorname{Photo}\ 3.1.3$$ Typical view of a test pit side wall at deposit N75-117A-B12 on the Yukon coastal plain.

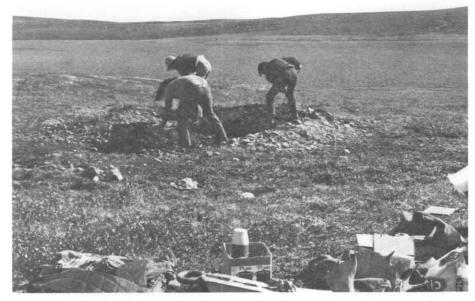
Photo 3.1.4
Test pit crew filling in a test pit after the soil was logged, samples were collected, and photographs were taken on the Yukon coastal plain.

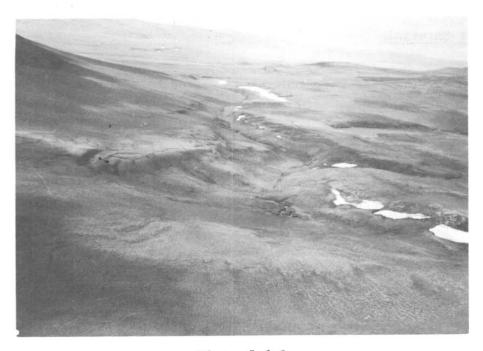
$$\operatorname{Photo}\ 5.6.1$ Aerial view of a kame terrace located 2 miles west of the Firth River on the Yukon coastal plain numbered as Deposit N75-117D-B3.

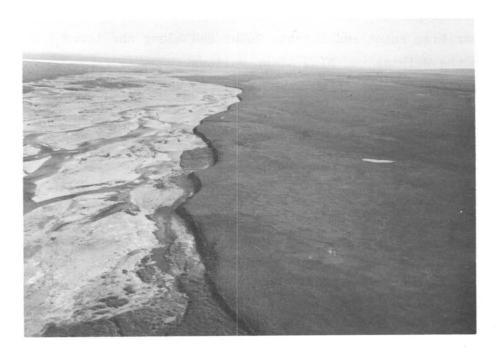
Photo 5.6.2 Aerial view of a fluvial terrace on the east side of the Firth River on the Yukon coastal plain numbered as Deposit N75-117D-B5.

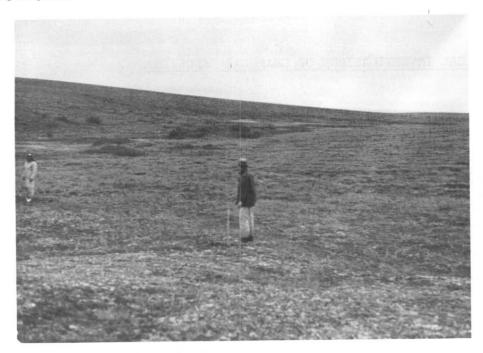
Photo 6.1.1 Geophysics crew taking geophysical readings on the Yukon coastal plain.

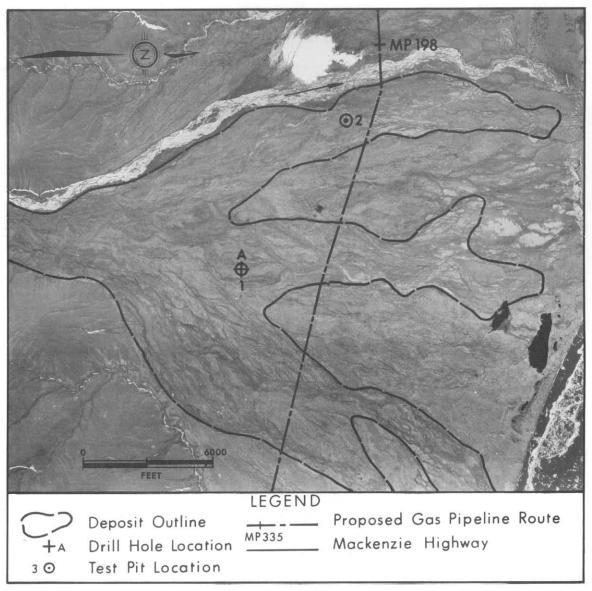
Airphoto No.

A13138-153

A site airphoto and synoptic page introduces each individual site report. The physical outline of the borrow source, location of test pits and/or test holes, and the proposed pipeline route are noted on the site airphoto. A brief summary outlining the Physical Setting, Volume, and Assessment for each individual site is denoted on the airphoto page.
