1975 PIPELINE BORROW INVESTIGATIONS

RICHARDS ISLAND TO FORT GOOD HOPE, N.W.T.

VOLUME II
1975 PIPELINE BORROW INVESTIGATIONS -
RICHARDS ISLAND TO FORT GOOD HOPE, N.W.T.

Prepared For
Canadian Arctic Gas Study Limited

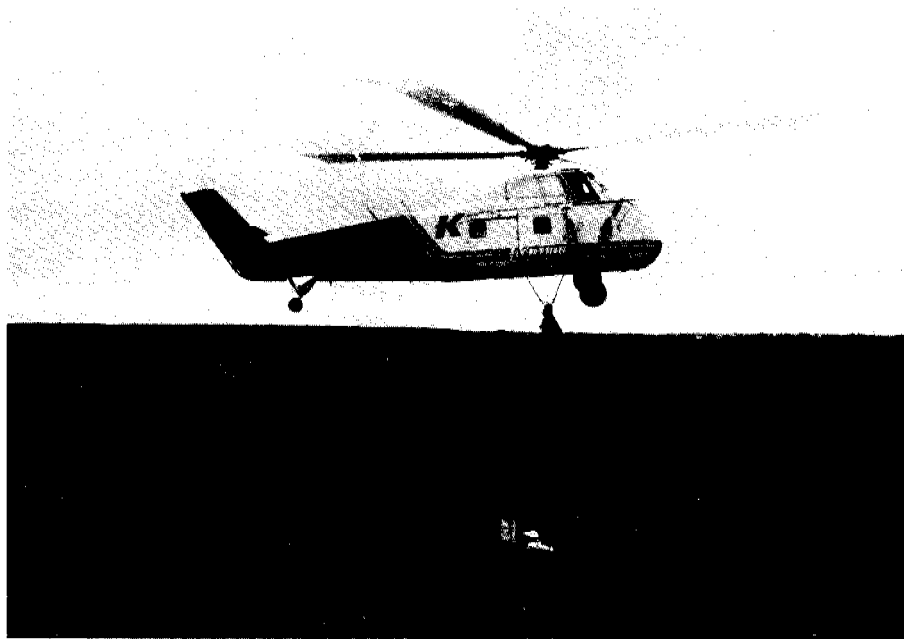
Photo 3.1.3

Kenting Aviation Ltd. Sikorsky S58E helicopter hooking up to transport the Heli-Drill.

A Sikorsky S58E gasoline-powered helicopter provided by Kenting Aviation Ltd., with a maximum rated sling load lifting capacity of 4000 pounds, was selected to transport the Heli-Drill components,

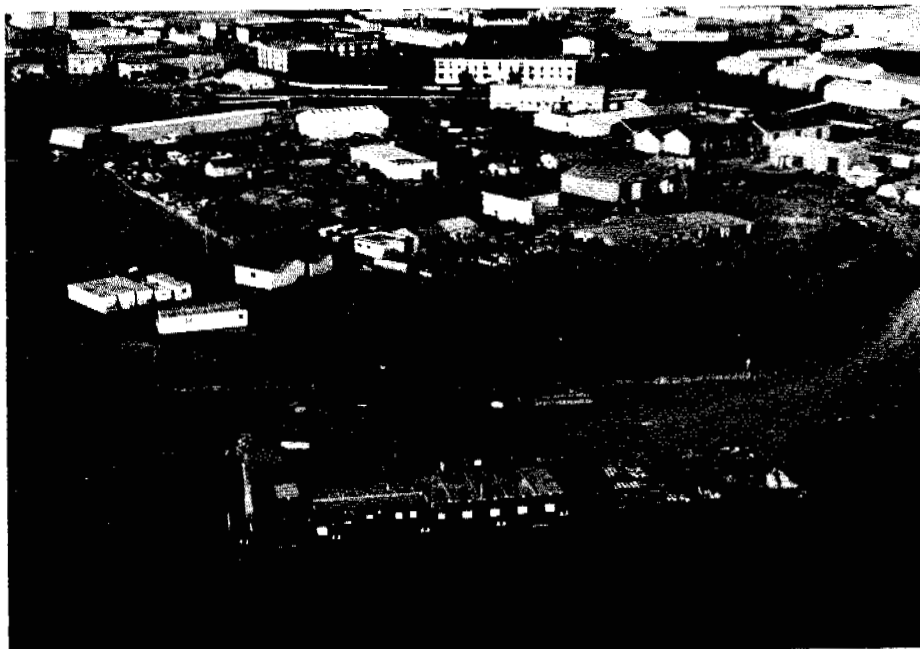
Photo 3.1.4

NTCL Barge Camp along with the fuel barge at Inuvik N.W.T.

The 24-man barge camp, 150-ton supply barge, Mark II Jetboat and casual tugboat charter were provided by Northern Transportation Company Limited (NTCL). The 24-man camp was specifically built and equipped to be mounted on a 300-ton river barge and contained sleeping quarters, kitchen, dinette, recreation area, radio room, washroom, laundry facilities, power plant, and general shop.

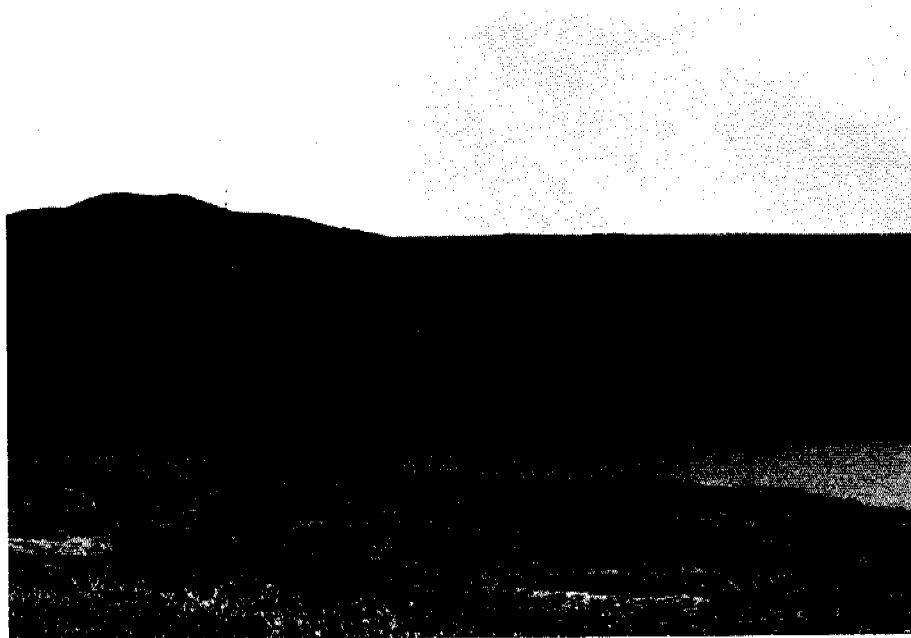
Photo 5.3.1

Potential borrow deposit located in the tundra area near Parsons Lake N.W.T.

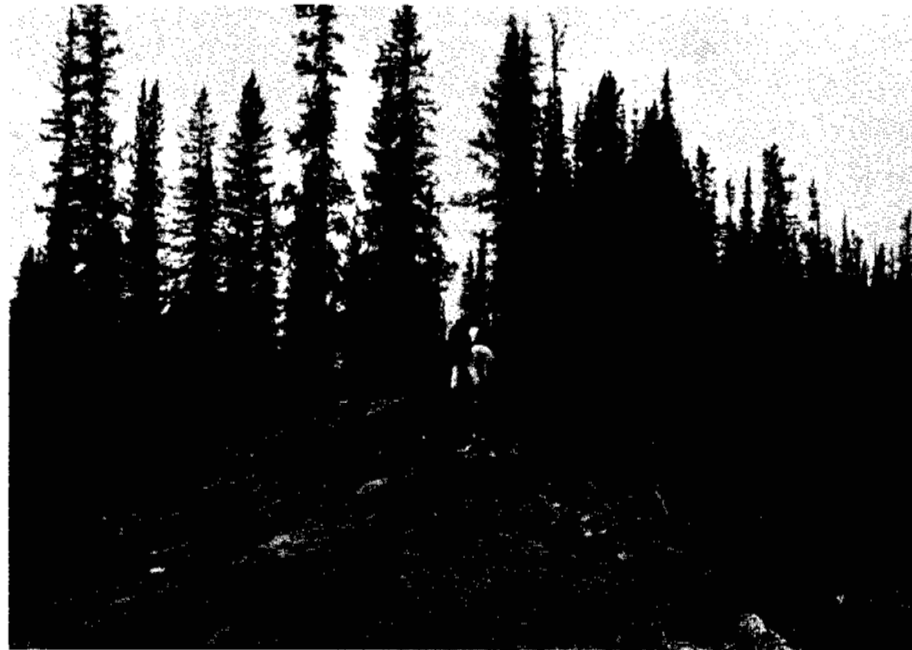
Photo 5.3.2

Potential borrow deposit located in the forested area north of Fort Good Hope.

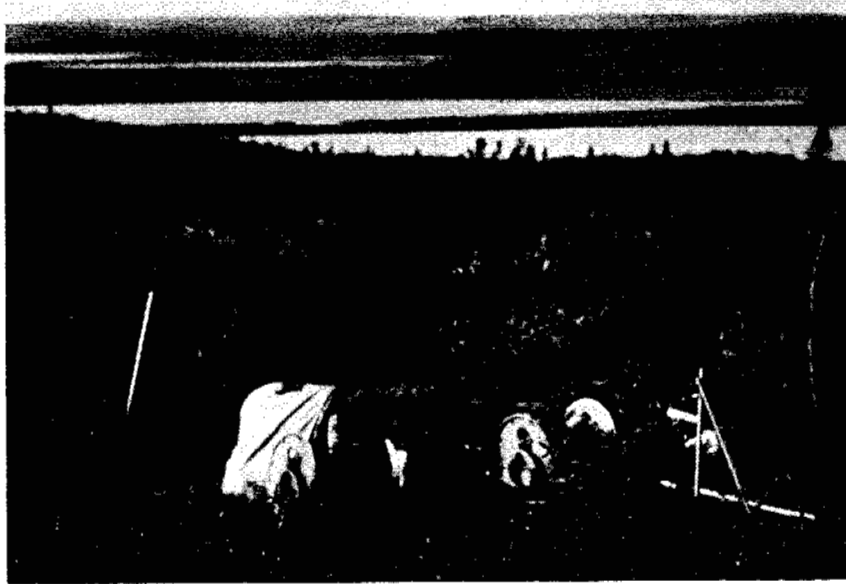
Photo 6.1.1

Geophysical resistivity instruments set up at a potential borrow deposit in the Noell Lake area just north of Inuvik N.W.T.

Resistivity surveys, particularly in the Arctic, require electromagnetic rather than electrical methods. In electrical methods, the contact resistance of probes inserted in the ground has to be kept low. Establishing low contact resistance is difficult on permafrost. Also very small lateral variation in depth of active layer can have very large effects on electrical resistivity measurements. Electromagnetic methods have significant advantages over electrical methods in resistivity surveying in the Arctic. Electromagnetic methods for shallow exploration (~ 30 ft) were still under development at the time of the borrow program. Non-contact electromagnetic methods for shallow exploration became available shortly after the conclusion of the borrow investigation.

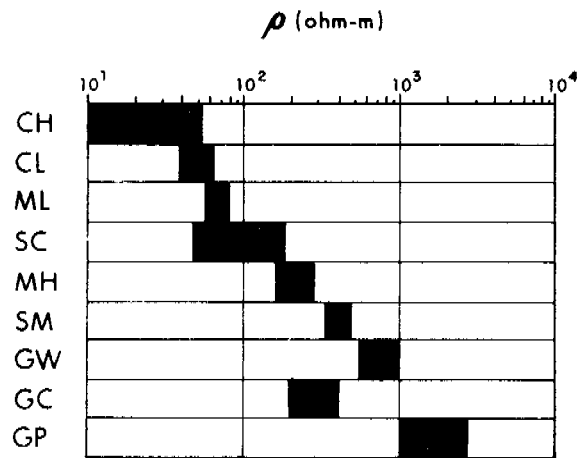
FIGURE 6.4.1
 THE RANGES IN RESISTIVITY ASSOCIATED WITH THE SOIL
 TYPES OF UNIFIED ENGINEERING CLASSIFICATION SYSTEM.
 (CH - FAT CLAY; ML - SILTY CLAY; SC - SANDY CLAY; MH - SILT;
 S - SAND; GW - WELL SORTED GRAVEL; GC - GRAVEL WITH
 CLAY; GP - POORLY SORTED GRAVEL).

The relatively simple situation, shown in Figure 6.4.1, becomes considerably more complex in permafrost regions. Figure 6.4.2 shows the variation in resistivity with temperature for several soil types; when the ground freezes the resistivity increases; and for gravels, this increase is sudden. The trend of a resistivity increase, in going from clay to silt to gravel, is maintained when the ground is in the frozen state. However, in addition to temperature the ice content of the ground influences resistivity, as is illustrated in Figure 6.4.3. High resistivity (> 5000 ohm-m) in permafrost regions can, therefore, be due to low ground temperatures, high ice content and frozen gravel.

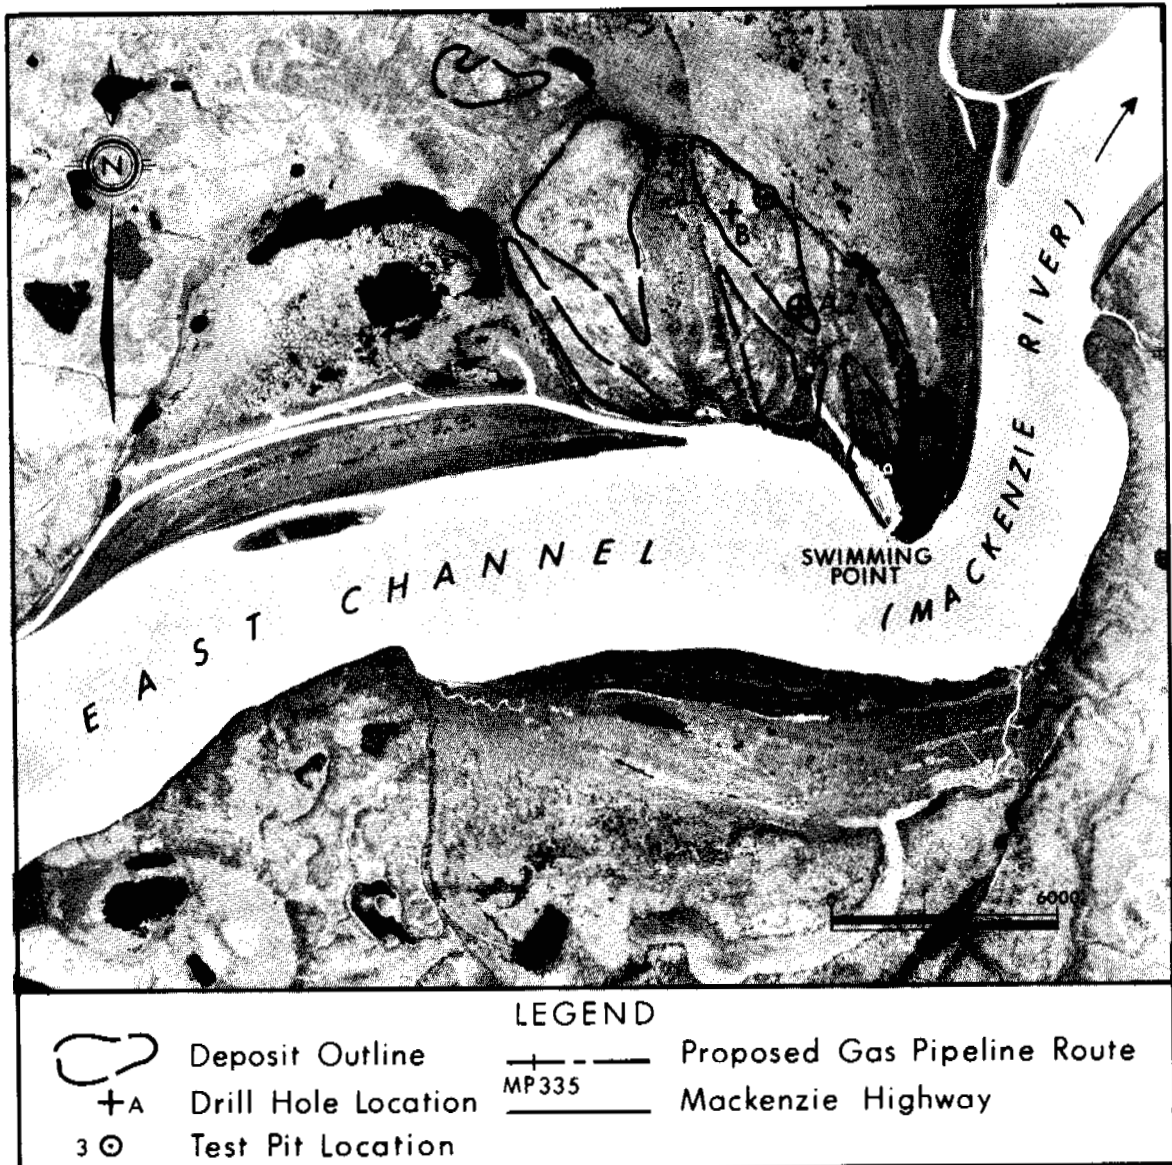
Airphoto No. A23476-128

Assessment: Deposit 107C-B1 is a source of fair quality granular material suitable for general fill and backfill.

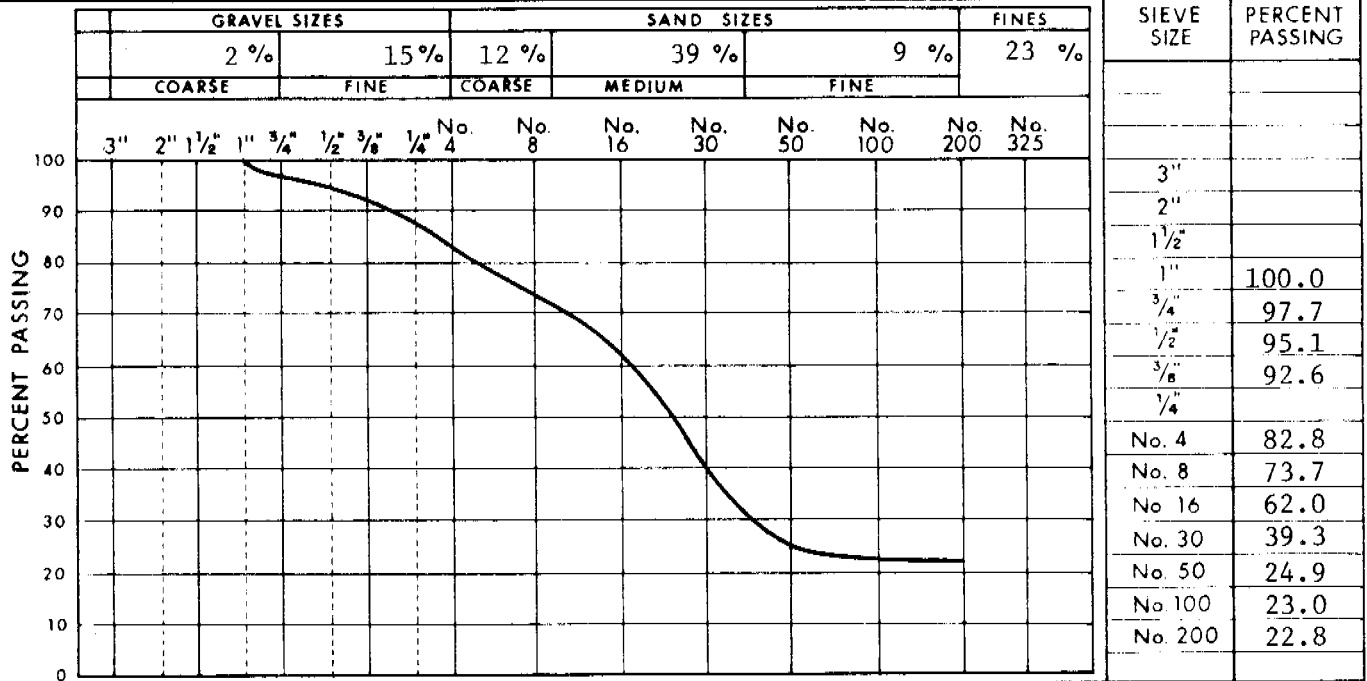
SAMPLE N75-107C-B1-2 DEPTH 3.0-4.0 R.M.HARDY REPORT NUMBER 59
 DATE SAMPLED August 8, 1975 SAMPLED BY NESCL

COMMENTS Moisture content of 3.2% OVERSIZE (>3") = 0.0%

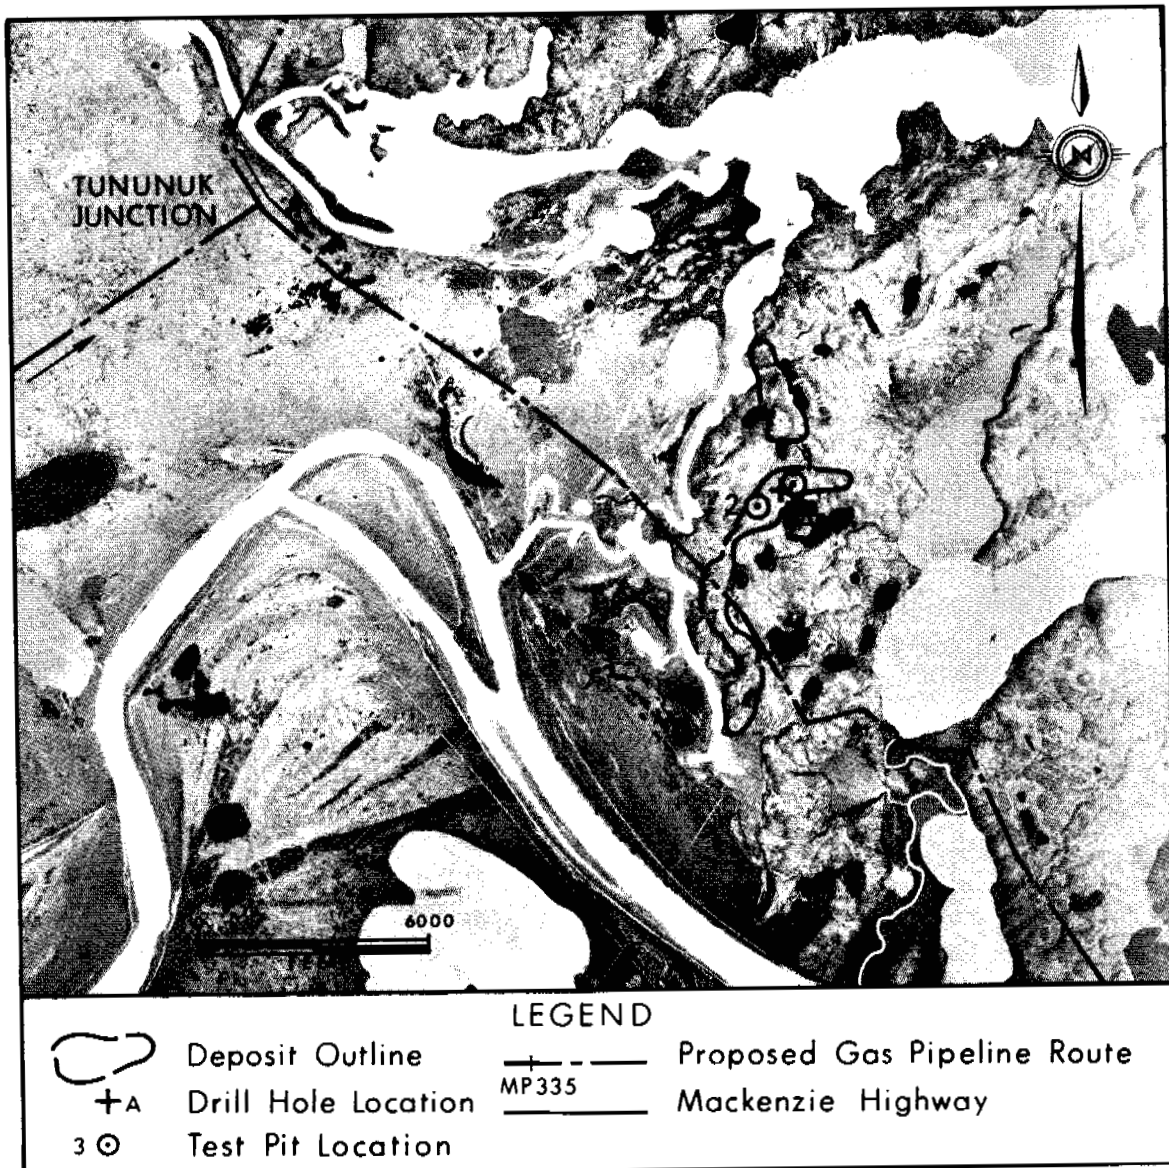
Airphoto No. A23476-131
Approximate Scale: 1" = 5000'

Assessment: Deposit 107C-B2 is a source of good quality material suitable for general fill, backfill, and building pads. Haul distances would be short as the deposit is crossed by the right of way.

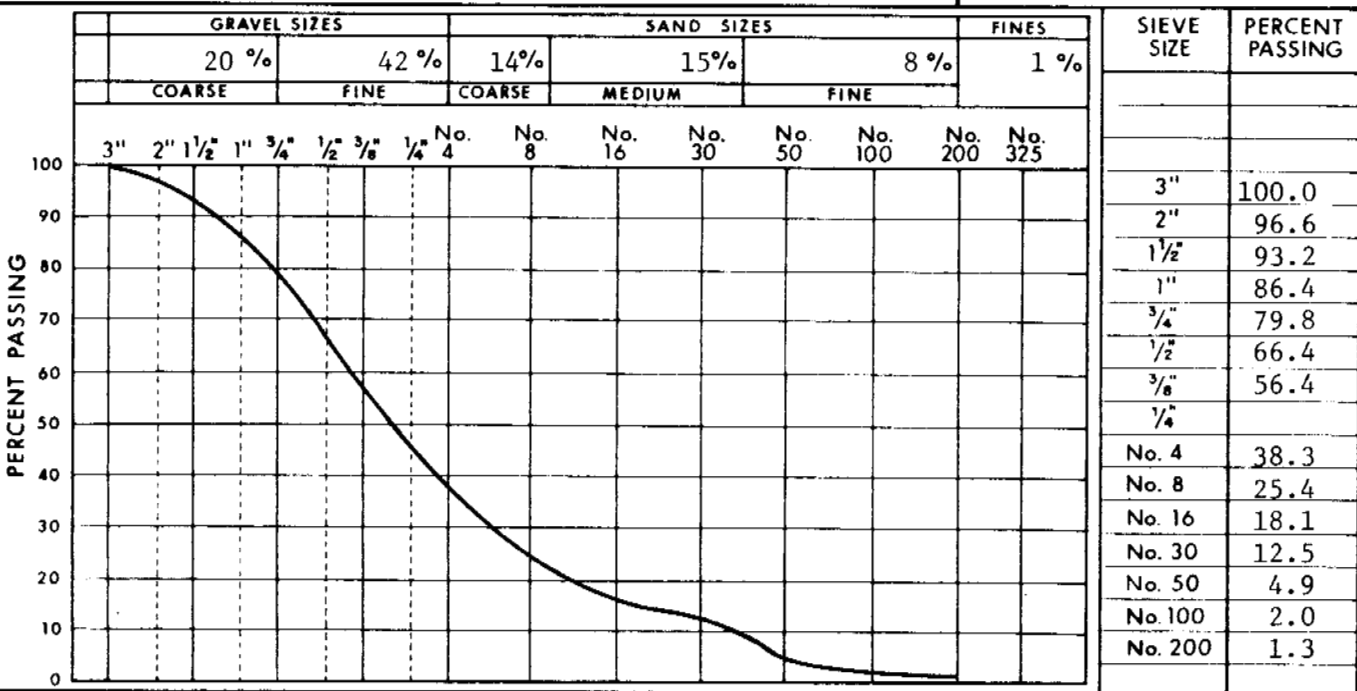
SAMPLE N75-107C-B2-2 DEPTH 1.0-3.0 R.M.HARDY REPORT NUMBER
 DATE SAMPLED August 8, 1975 SAMPLED BY NESCL 62

COMMENTS OVERSIZE (>3") = 0.0 %
 Moisture contents range from 1.6% to 2.0%

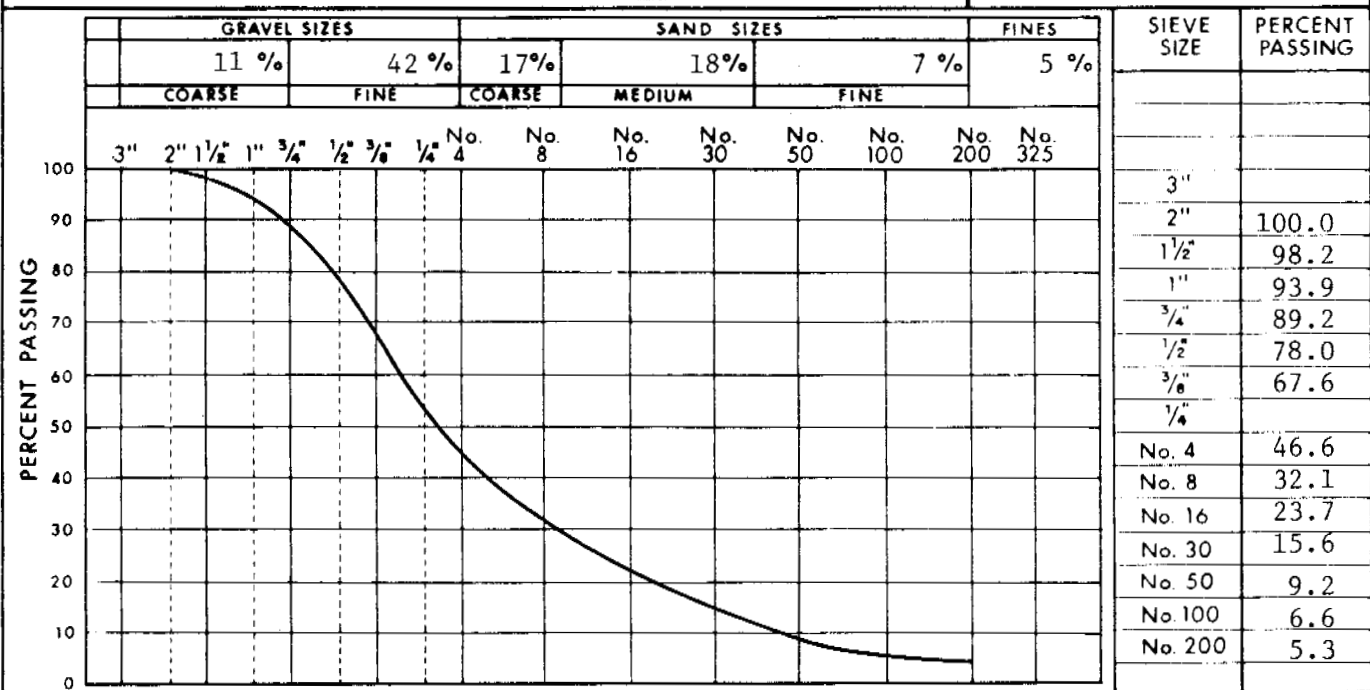
SAMPLE N75-107C-B2-2 DEPTH 3.0-5.0 R.M.HARDY REPORT NUMBER
 DATE SAMPLED August 8, 1975 SAMPLED BY NESCL 63

COMMENTS Moisture content from 2.9% to 5.5% OVERSIZE (>3") = 0.0%

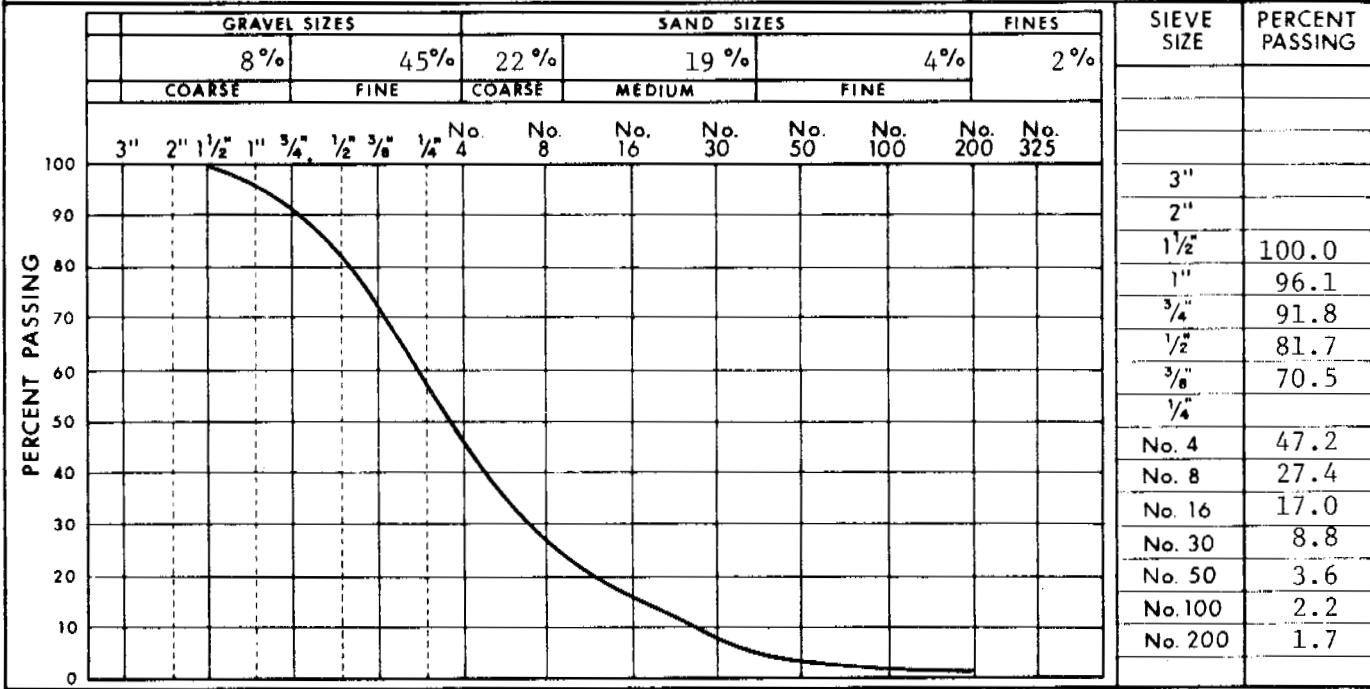
SAMPLE N75-107C-B2-2 DEPTH 5.0-8.0 R.M.HARDY REPORT NUMBER
 DATE SAMPLED August 8, 1975 SAMPLED BY NESCL 64

COMMENTS Moisture content from 3.3% to 4.3% OVERSIZE (>3") = 4.9%

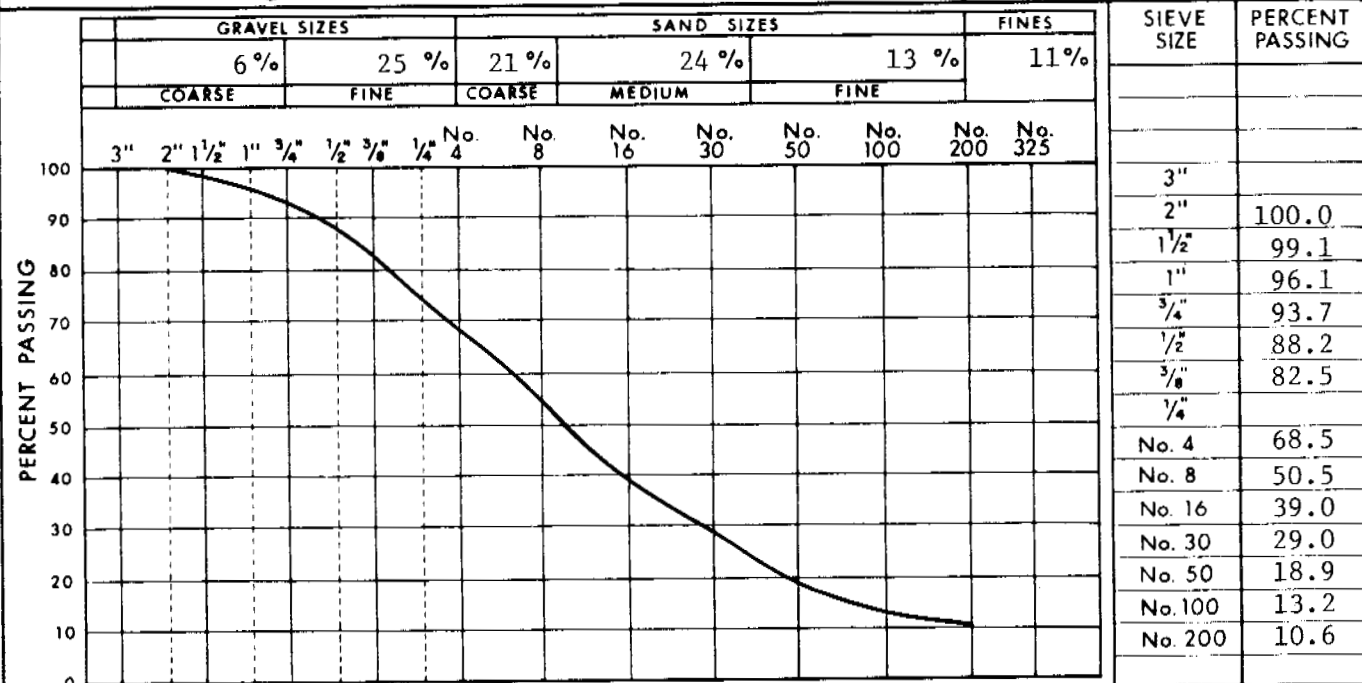
SAMPLE N75-107B-B1-4 DEPTH 2.0-7.0 R.M.HARDY REPORT NUMBER
 DATE SAMPLED August 9, 1975 SAMPLED BY NESCL 89

COMMENTS OVERSIZE (>3") = 0.0%
 Moisture contents range from 2.2% to 6.2%

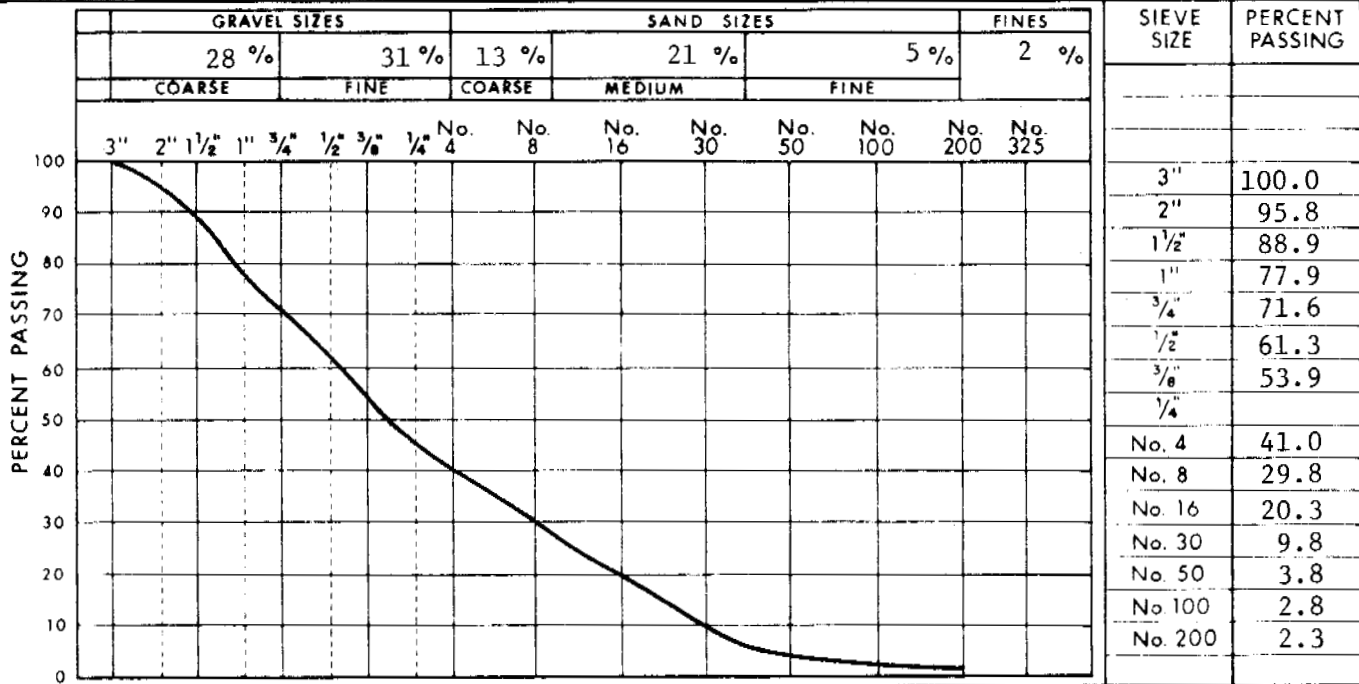
SAMPLE N75-1060-B1-1 DEPTH 1.0-3.0 R.M.HARDY REPORT NUMBER 47
 DATE SAMPLED August 21, 1975 SAMPLED BY NESCL

COMMENTS Moisture contents range from 3.0% to 4.0% OVERSIZE (>3") = 0.0%

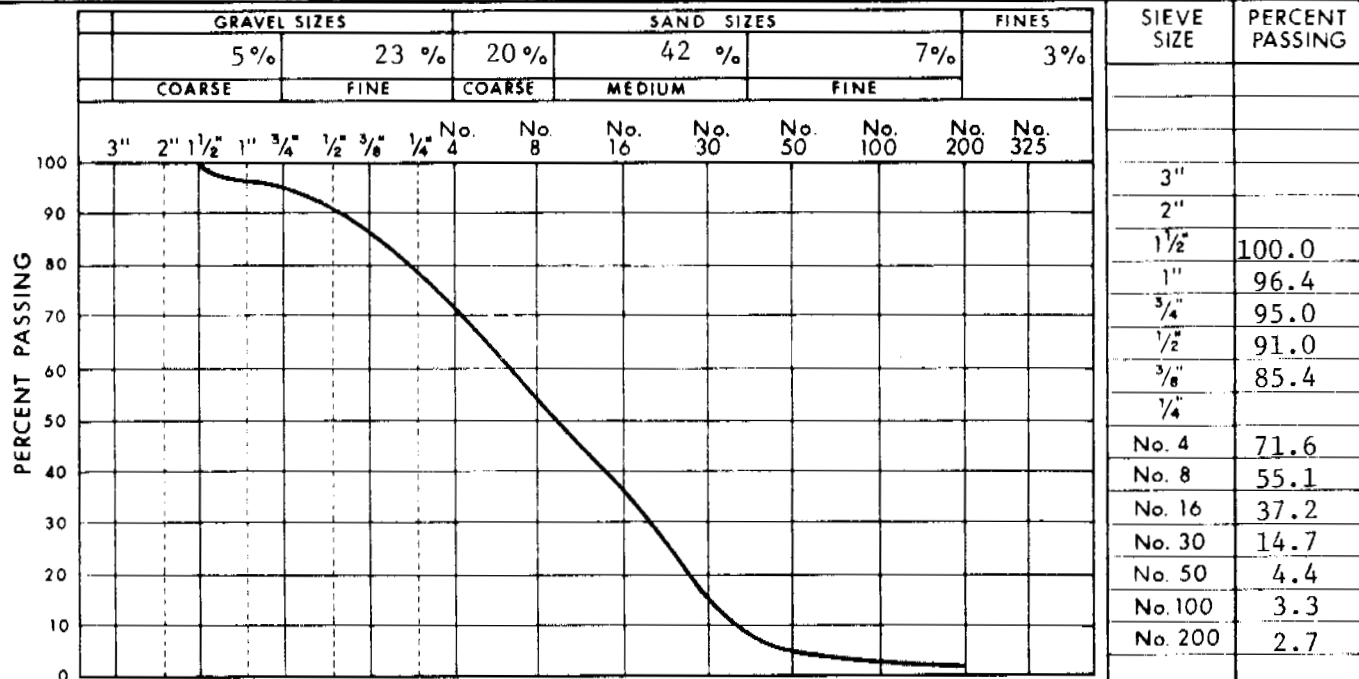
SAMPLE N75-1060-B1-1 DEPTH 3.0-4.0 R.M.HARDY REPORT NUMBER 46
 DATE SAMPLED August 21, 1975 SAMPLED BY NESCL

COMMENTS Moisture content is 3.8% OVERSIZE (>3") = 0.0%

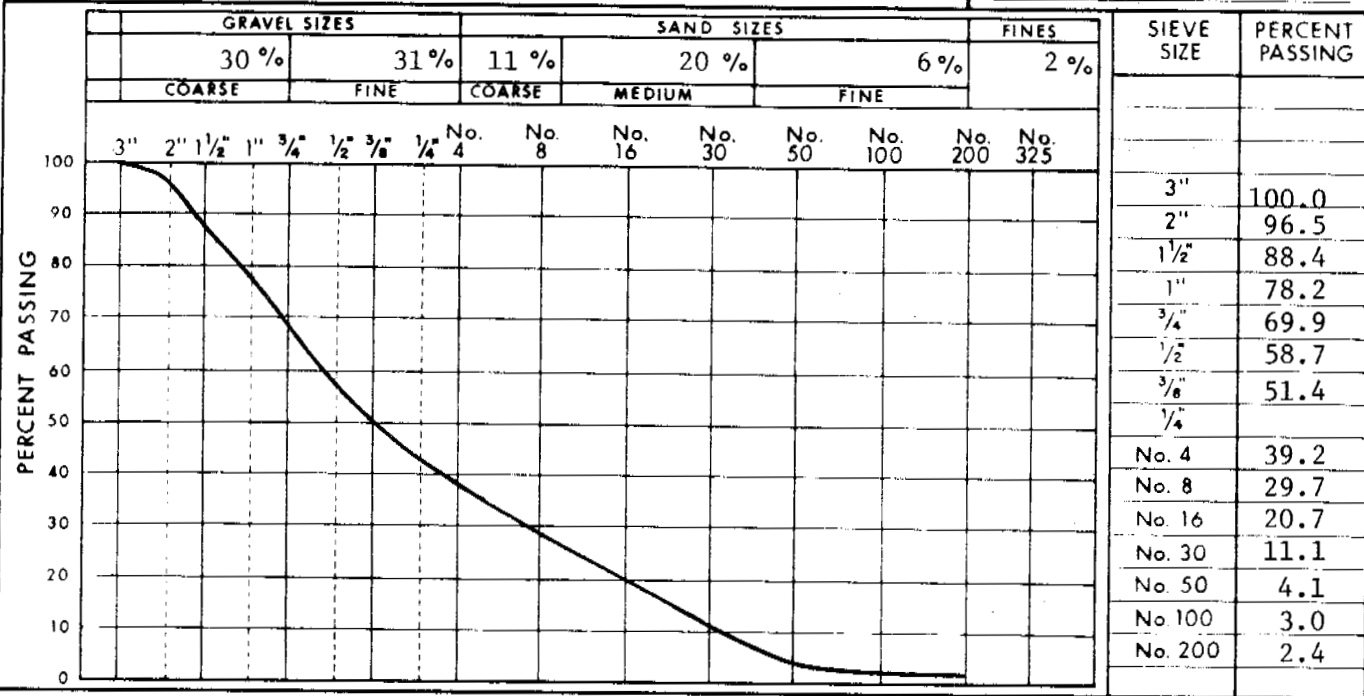
SAMPLE N75-1060-B1-2 DEPTH 1.0-4.0 R.M.HARDY REPORT NUMBER
 DATE SAMPLED August 20, 1975 SAMPLED BY NESCL 45

COMMENTS Moisture content ranges from 3.5% to 4.3% OVERSIZE (>3") = 0.0%

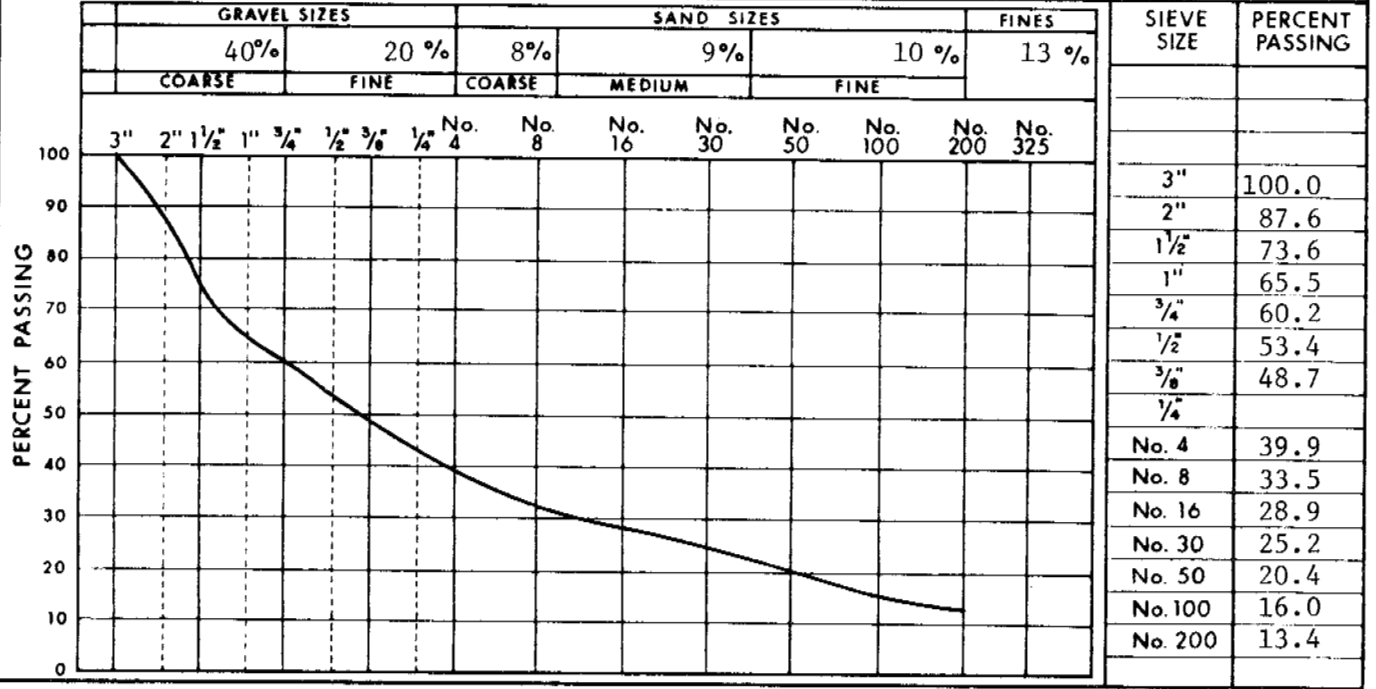
SAMPLE N75-1060-B2-2 DEPTH 1.0-6.0 R.M.HARDY REPORT NUMBER
 DATE SAMPLED August 21, 1975 SAMPLED BY NESCL 53

COMMENTS Moisture contents range from 3.5% to 8.3% OVERSIZE (>3") = 0.0%

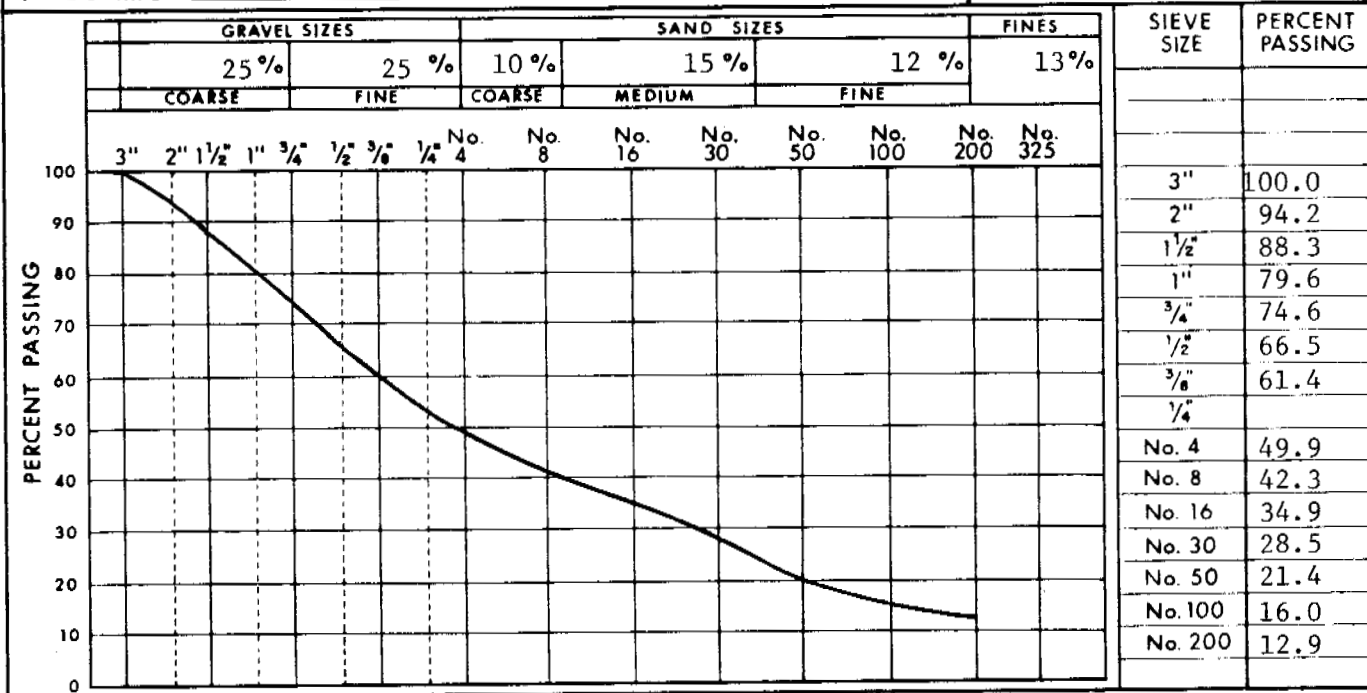
SAMPLE N75-1060-B3-2 DEPTH 2.0-5.0 R.M.HARDY REPORT NUMBER
 DATE SAMPLED August 22, 1975 SAMPLED BY NESCL 43

COMMENTS OVERSIZE (>3") = 21.8 %
 Moisture contents range from 3.9% to 11.3%.

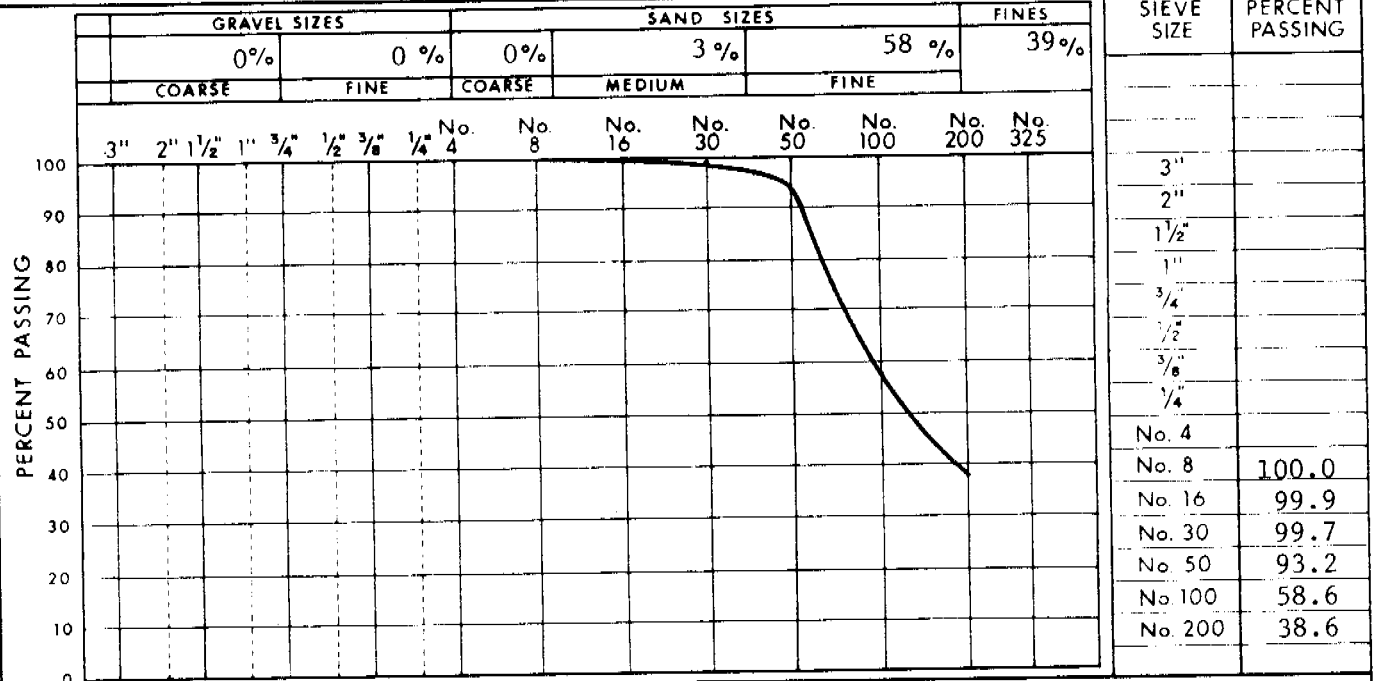
SAMPLE N75-1060-B4-1 DEPTH 0.5-4.5 R.M.HARDY REPORT NUMBER 44
 DATE SAMPLED August 24, 1975 SAMPLED BY NESCL

COMMENTS Moisture contents range from 7.7% to 20.0% OVERSIZE (>3") = 0.0%

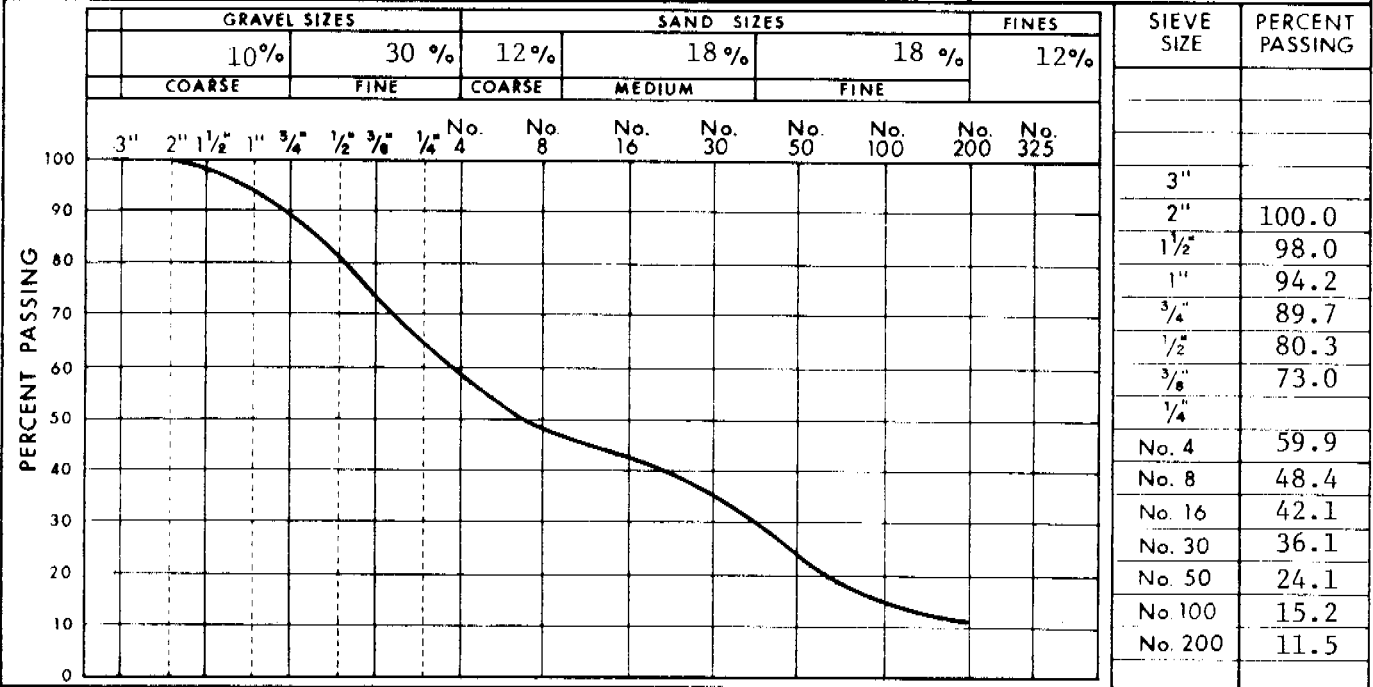
SAMPLE N75-1060-B5-1 DEPTH 0.0-1.0 R.M.HARDY REPORT NUMBER 72
 DATE SAMPLED August 23, 1975 SAMPLED BY NESCL

COMMENTS Moisture content of 5.3% OVERSIZE (>3") = 0.0%

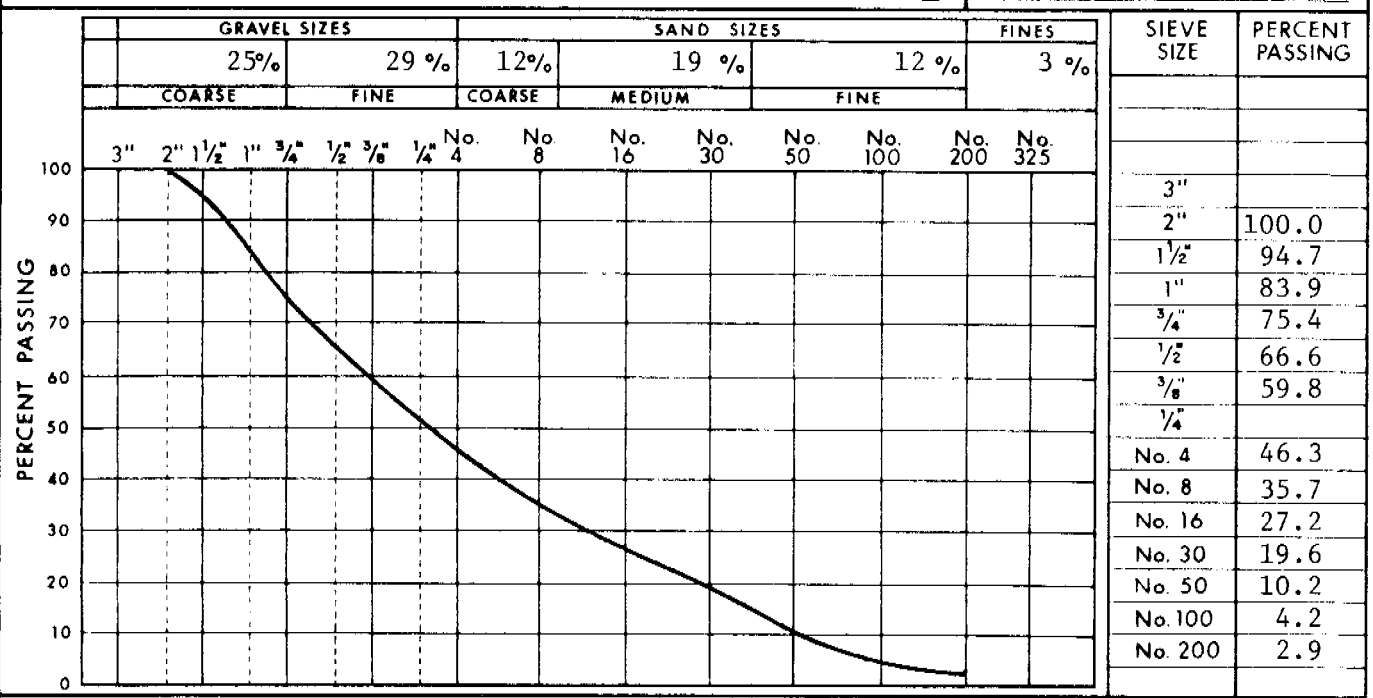
SAMPLE N75-1060-B5-1 DEPTH 2.0-3.0 R.M.HARDY REPORT NUMBER 73
 DATE SAMPLED August 23, 1975 SAMPLED BY NESCL

COMMENTS Moisture content of 2.8% OVERSIZE (>3") = 0.0%

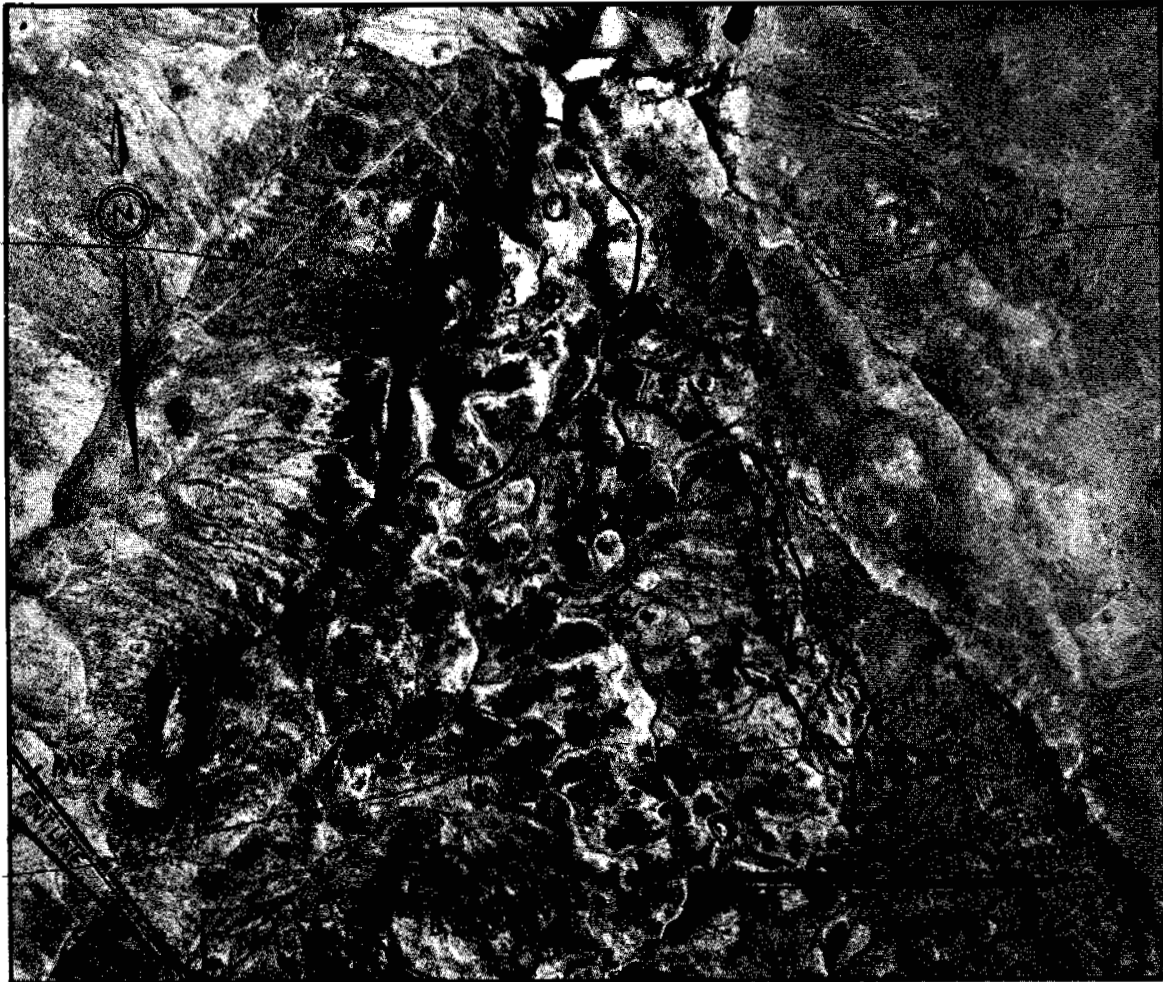
LEGEND	
	Deposit Outline
	Drill Hole Location
	Test Pit Location
	Proposed Gas Pipeline Route
	Mackenzie Highway

Airphoto No. A22859-174
Approximate Scale: 1" = 3200'

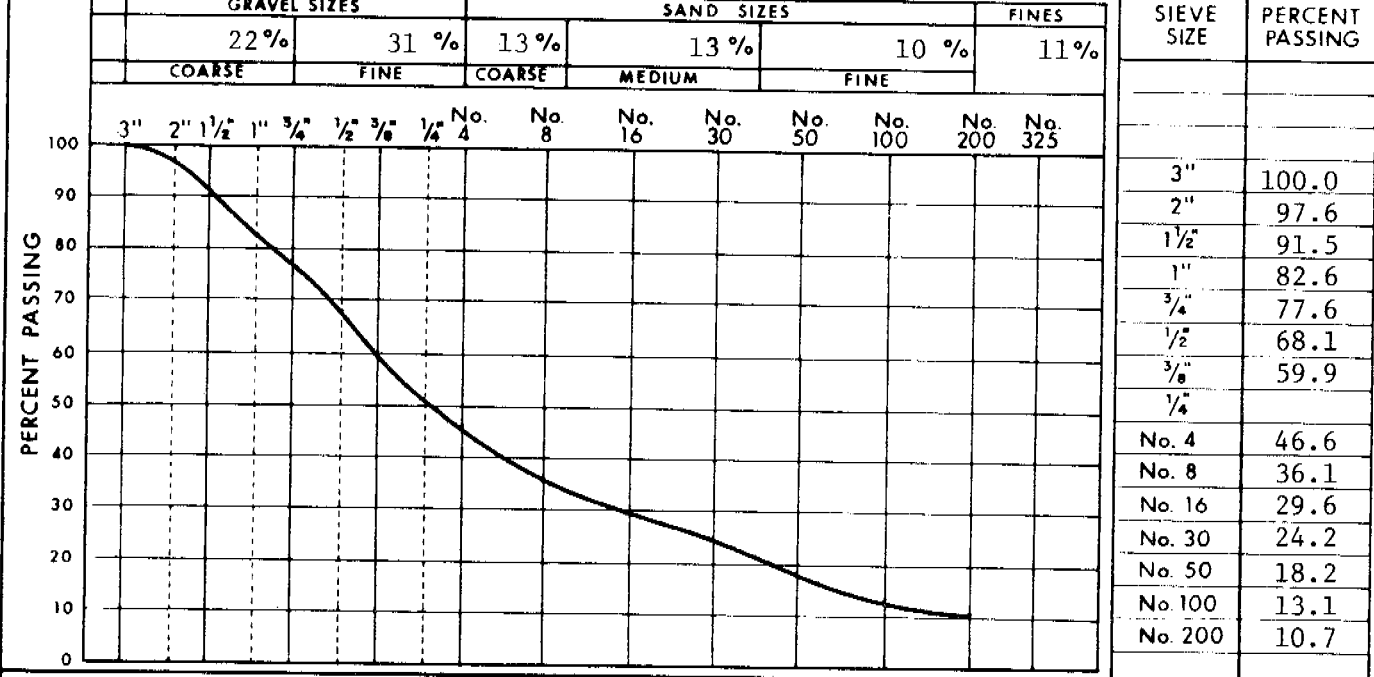
SAMPLE N75-1060-B7-3 DEPTH 1.0-5.0 R.M.HARDY REPORT NUMBER
 DATE SAMPLED August 25, 1975 SAMPLED BY NESCL 19

COMMENTS Moisture content range from 4.2% to 7.8% OVERSIZE (>3") = 0.0%

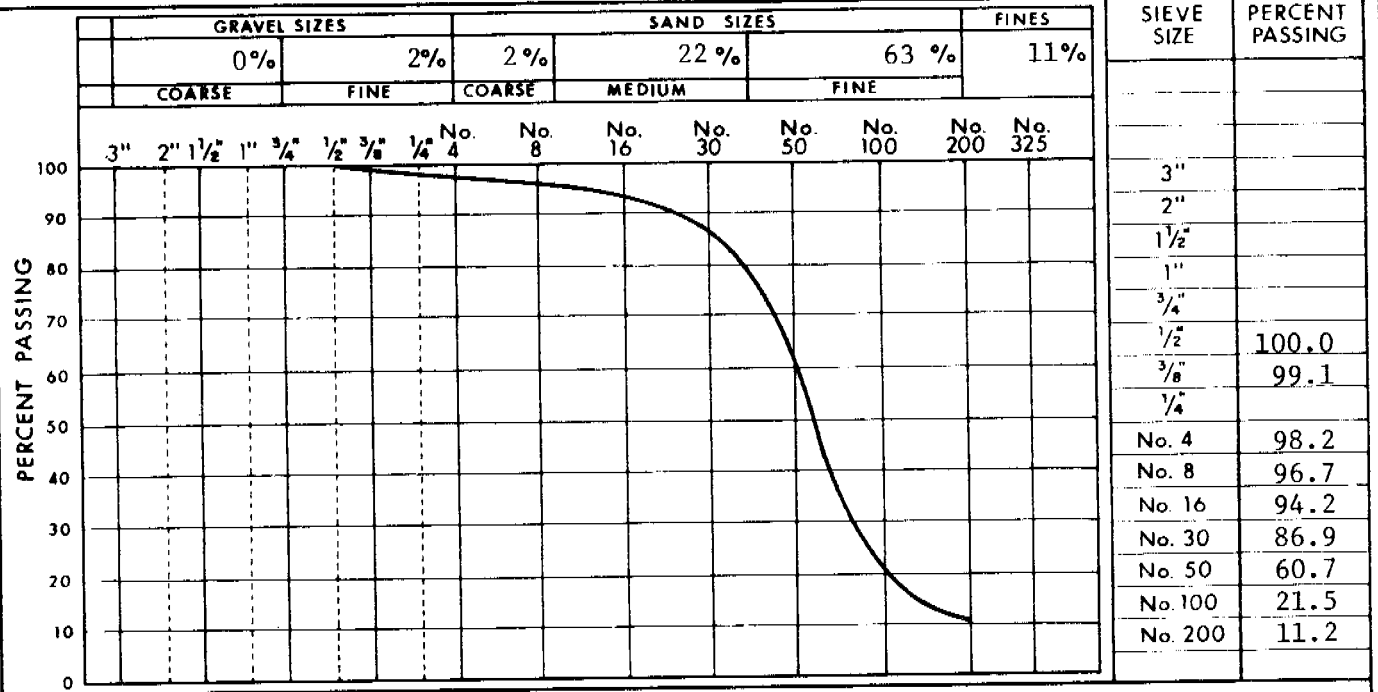
SAMPLE N75-106P-B1-1 DEPTH 2.0-6.0 R.M.HARDY REPORT NUMBER 1
 DATE SAMPLED August 25, 1975 SAMPLED BY NESCL

COMMENTS Moisture contents range from 4.6% to 5.6% OVERSIZE (>3") = 0.0%
