1975 PIPELINE BORROW INVESTIGATIONS

RICHARDS ISLAND TO FORT GOOD HOPE, N.W.T.

VOLUME II
1975 PIPELINE BORROW INVESTIGATIONS -
RICHARDS ISLAND TO FORT GOOD HOPE, N.W.T.

Prepared For
Canadian Arctic Gas Study Limited

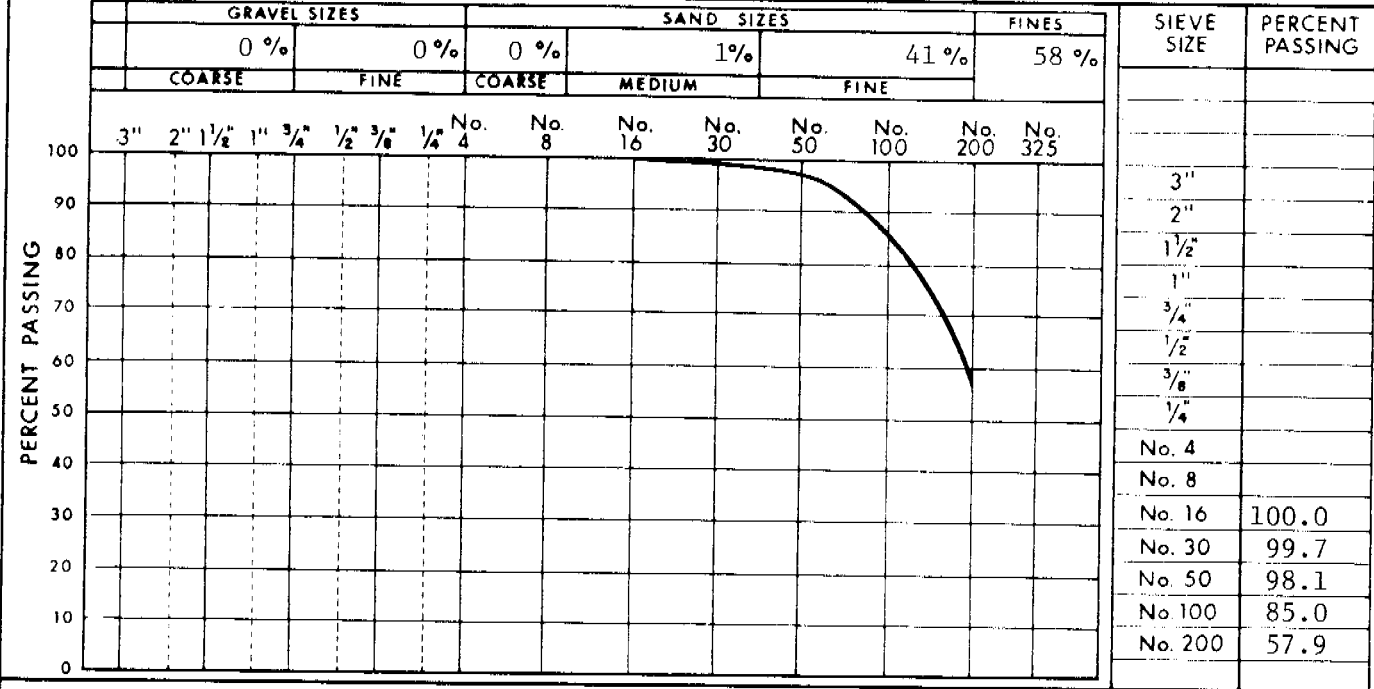
SAMPLE N75-106P-B3-1 DEPTH 1.0-3.0 R.M.HARDY REPORT NUMBER 26
 DATE SAMPLED August 26, 1975 SAMPLED BY NESCL

COMMENTS Moisture content from 10.4% to 20.7% OVERSIZE (>3") = 0.0 %

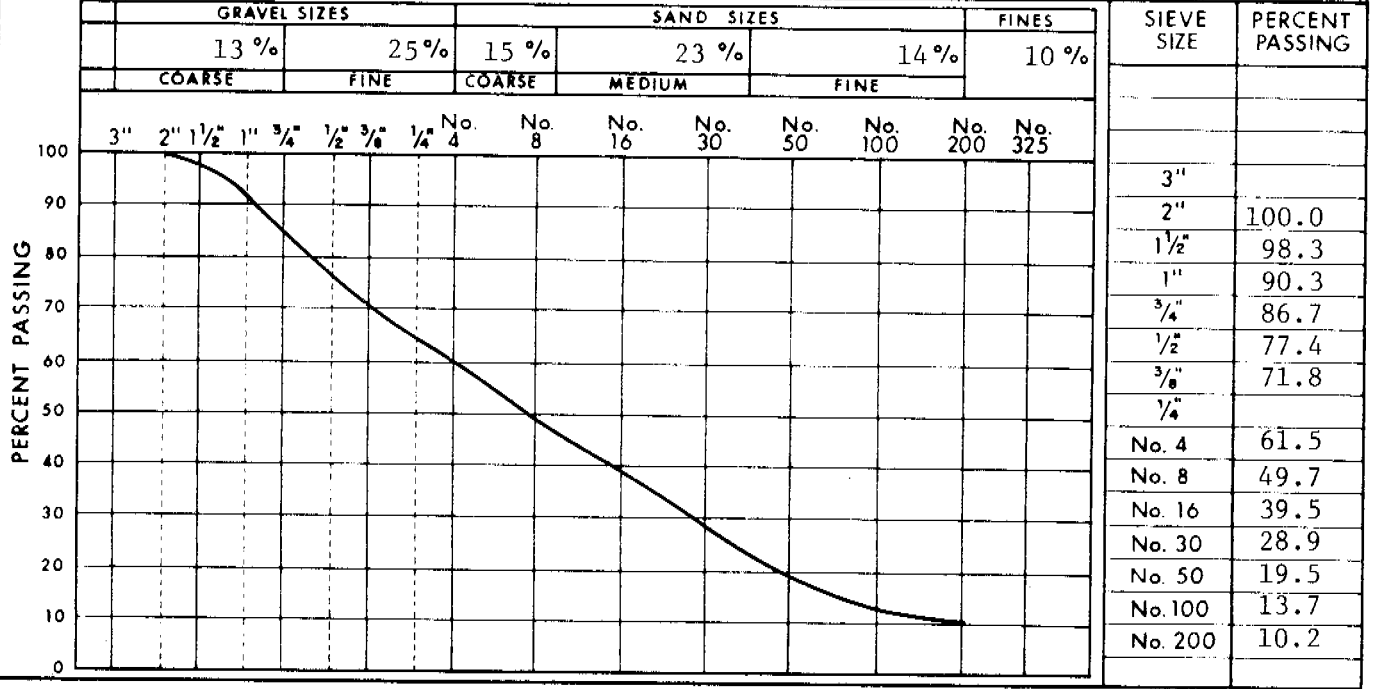
SAMPLE N75-106P-B3-1 DEPTH 3.0-6.0 R.M.HARDY REPORT NUMBER 25
 DATE SAMPLED August 26, 1975 SAMPLED BY NESCL

COMMENTS Moisture content from 2.5% to 3.9% OVERSIZE (>3") = 0.0 %

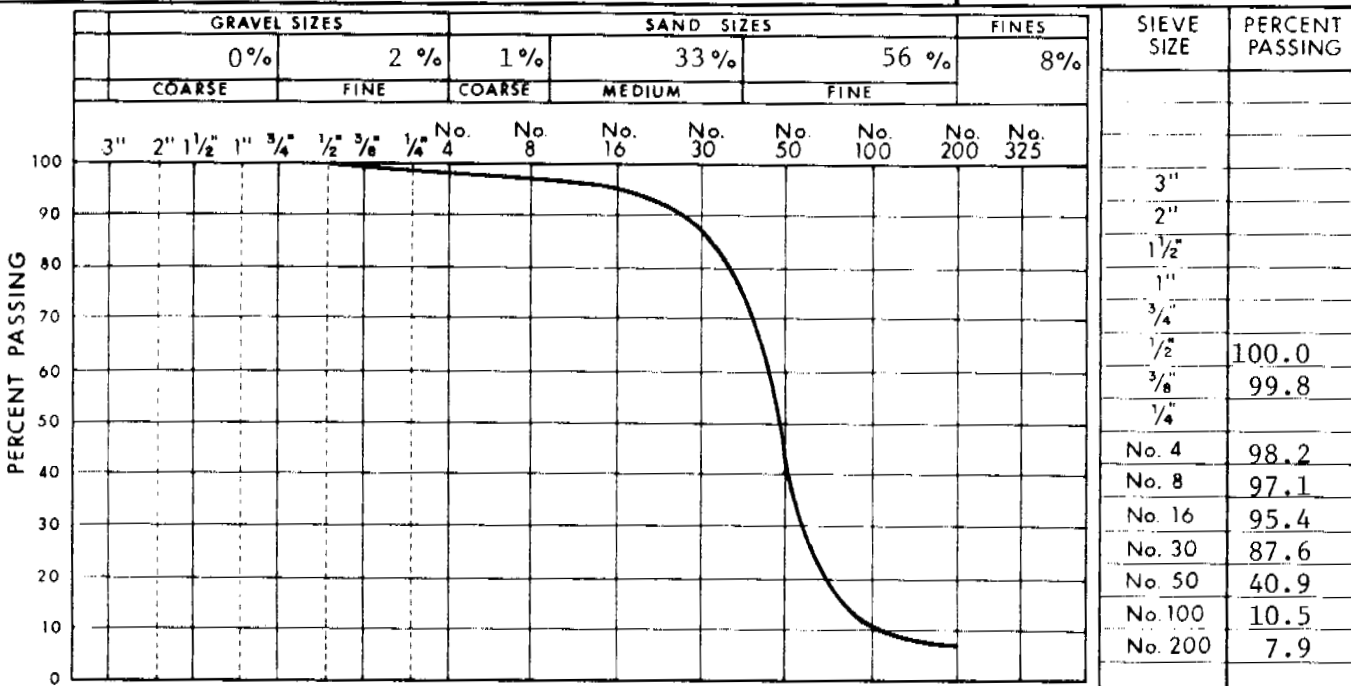
SAMPLE N75-106I-B2-2 DEPTH 1.0-4.0 R.M.HARDY REPORT NUMBER
 DATE SAMPLED August 28, 1975 SAMPLED BY NESCL 168

COMMENTS Moisture contents range from 4.3% to 12.2% OVERSIZE (>3") = 0.0 %

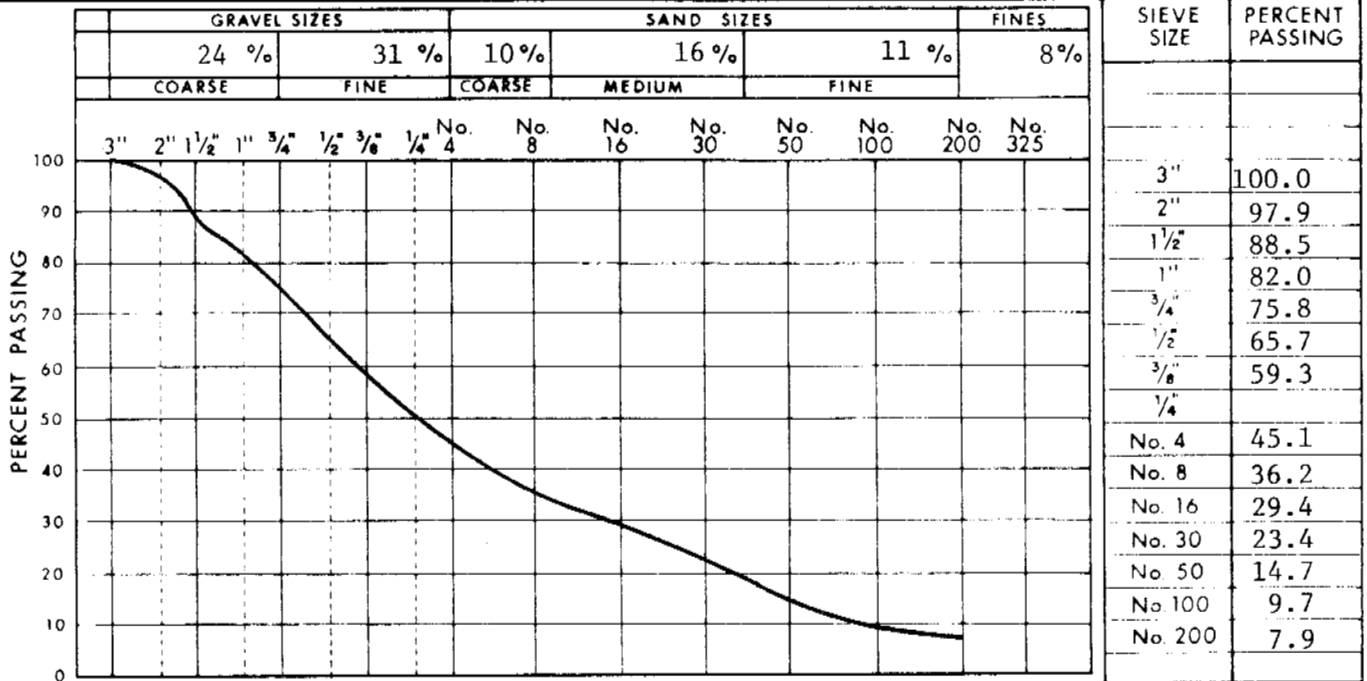
SAMPLE N75-106I-B3-6 DEPTH 1.0-3.0 R.M.HARDY REPORT NUMBER
 DATE SAMPLED August 29, 1975 SAMPLED BY NESCL 193

COMMENTS Moisture contents range from 3.4% to 6.0% OVERSIZE (>3") = 6.9 %

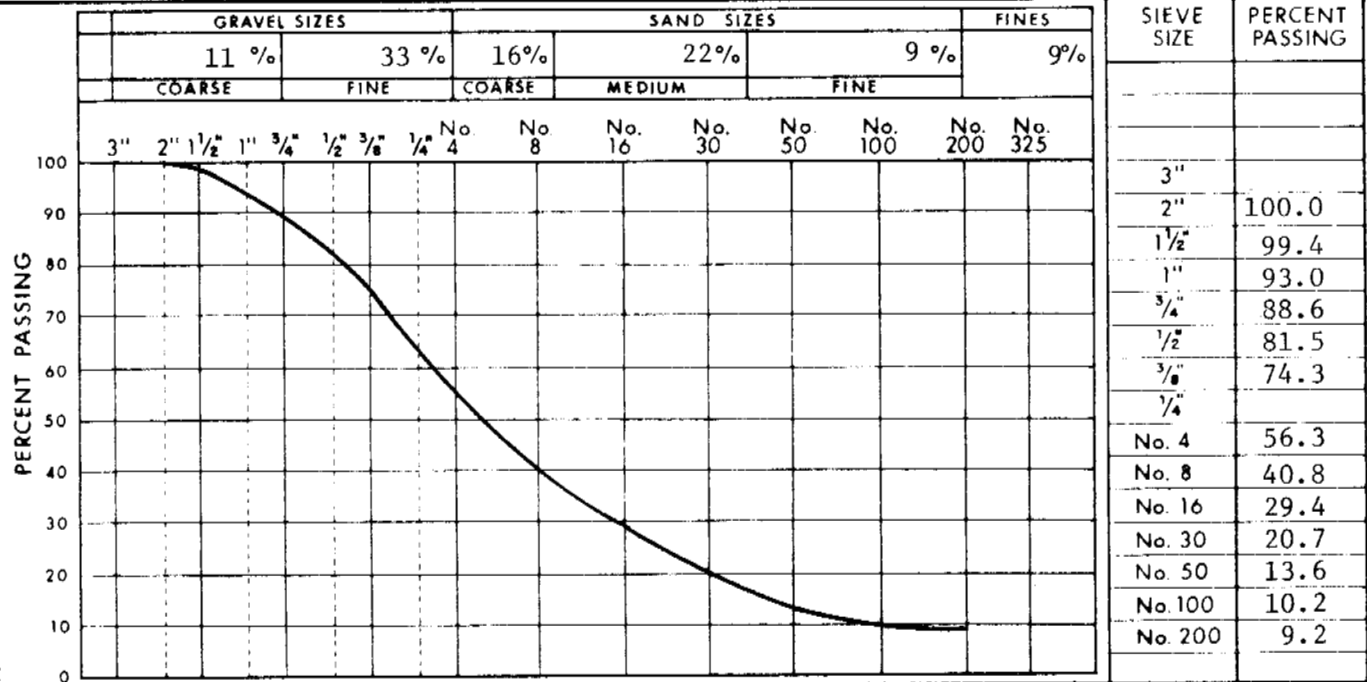
SAMPLE N75-106I-B3-6 DEPTH 3.0-6.0 R.M.HARDY REPORT NUMBER
 DATE SAMPLED August 29, 1975 SAMPLED BY NESCL 194

COMMENTS Moisture contents range from 5.1% to 7.4% OVERSIZE (>3") = 6.8 %

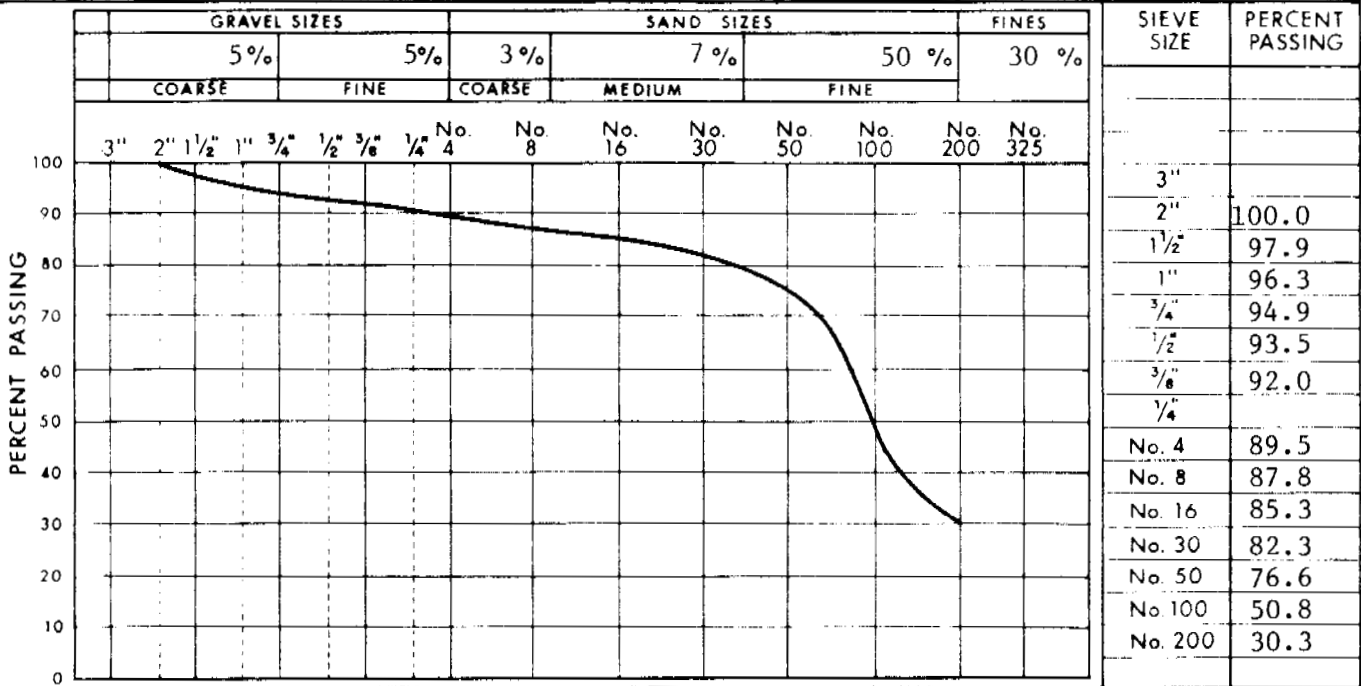
SAMPLE N75-106I-B3-7 DEPTH 1.0-6.0 R.M.HARDY REPORT NUMBER
 DATE SAMPLED August 28, 1975 SAMPLED BY NESCL 165

COMMENTS Moisture contents range from 4.8% to 10.6% OVERSIZE (>3") = 0.0 %

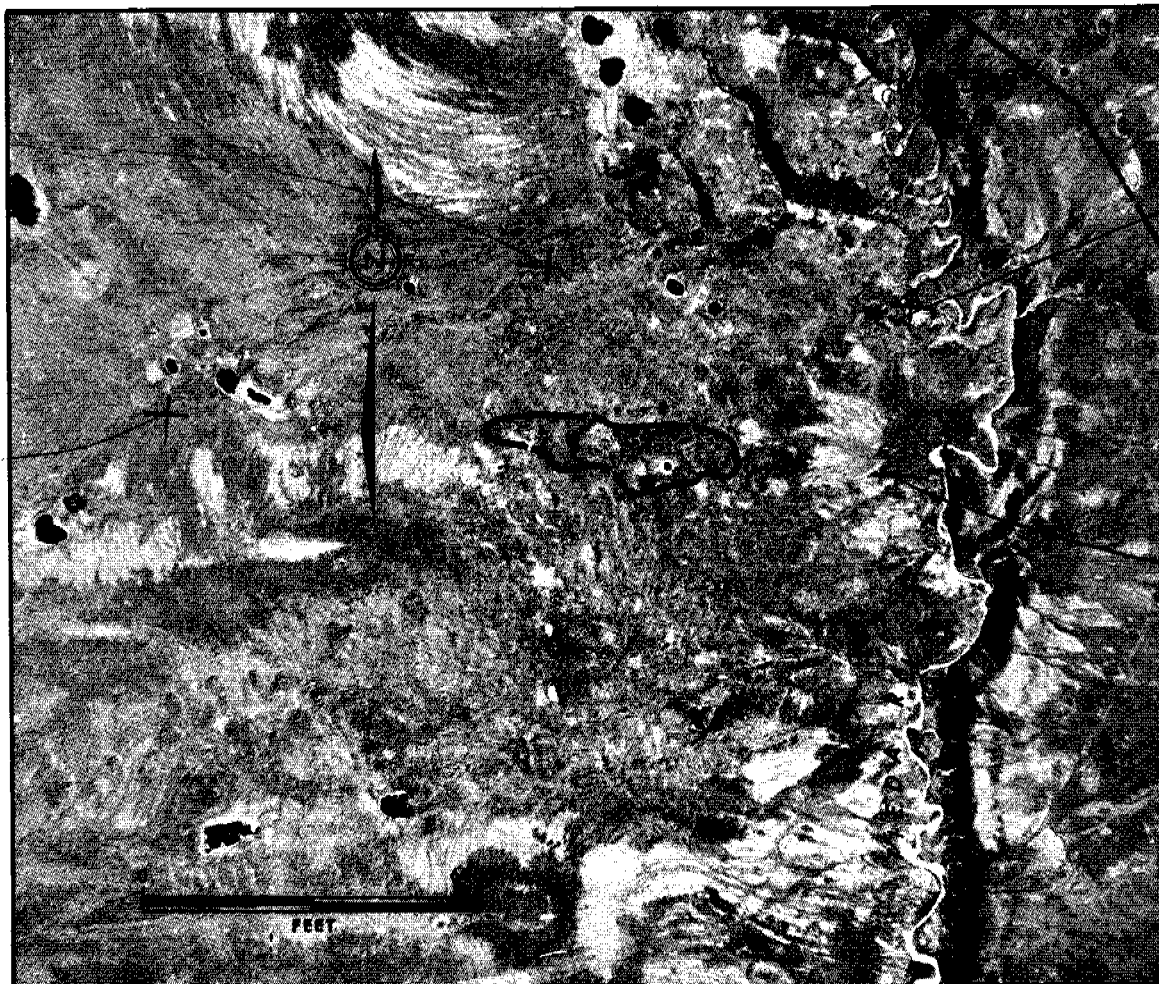
LEGEND	
	Deposit Outline
	Drill Hole Location
	Test Pit Location
	Proposed Gas Pipeline Route
	Mackenzie Highway

Airphoto No. A13306-101
Approximate Scale: 1" = 3400'
