# GRANULAR MATERIALS EVALUATION DEPOSITS 168 & 211 TUKTOYAKTUK AREA, N.W.T.

**MAY 1983**

BBT GEOTECHNICAL CONSULTANTS LTD. GVM GEOLOGICAL CONSULTANTS LTD. and TERRAIN ANALYSIS AND MAPPING SERVICES LTD.

PROJECT NO. A83-613

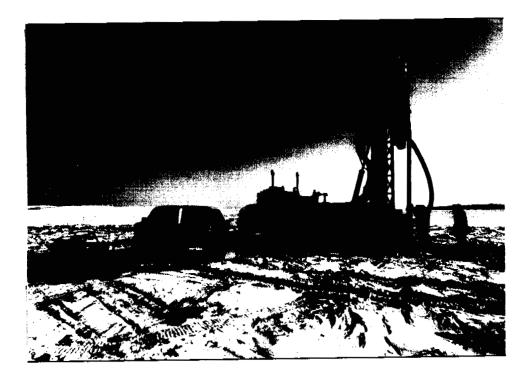
PHOTO 3: Drilling and sampling in progress at location of Test Hole 211-3, looking south

The very cold temperatures encountered required that the main engines of the truck and tractor be run continually. However, delays were still experienced each morning in warming the drill rig's hydraulic systems and the diesel hammer. Once the rig was operational, the test holes could be drilled and sampled relatively quickly. An 8 m to 9 m deep hole in gravel took from forty-five minutes to one hour to complete from set-up to rig-down. Photo 3 in Appendix C shows the drill rig in operation on Deposit 211.

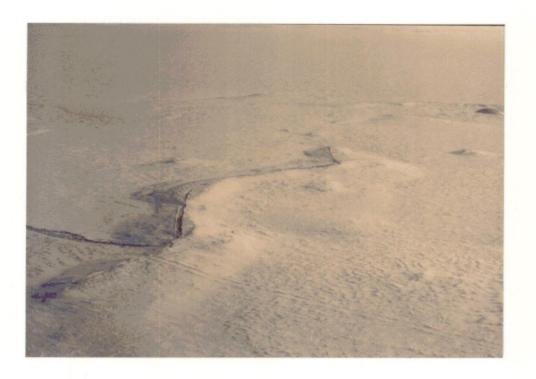
PHOTO 1: Aerial view of the main body of Deposit 168, looking south

Photo 1 in Appendix C presents an oblique aerial view of the deposit.

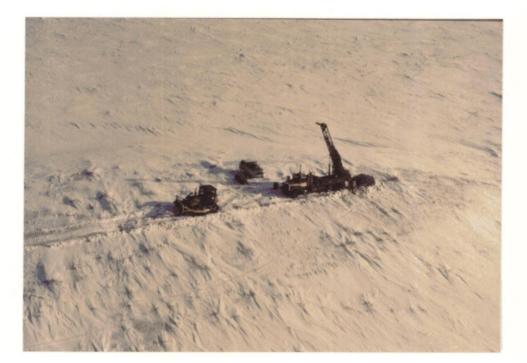
PHOTO 2: Rig setting up at location of Test Hole 168-8
