INVENTORY OF EXISTING GRAVEL PITS
ALONG MAJOR HWYS. & COMMUNITIES
IN THE YUKON TERRITORY

LABERGE - Y.T. Hwy #1

D003309

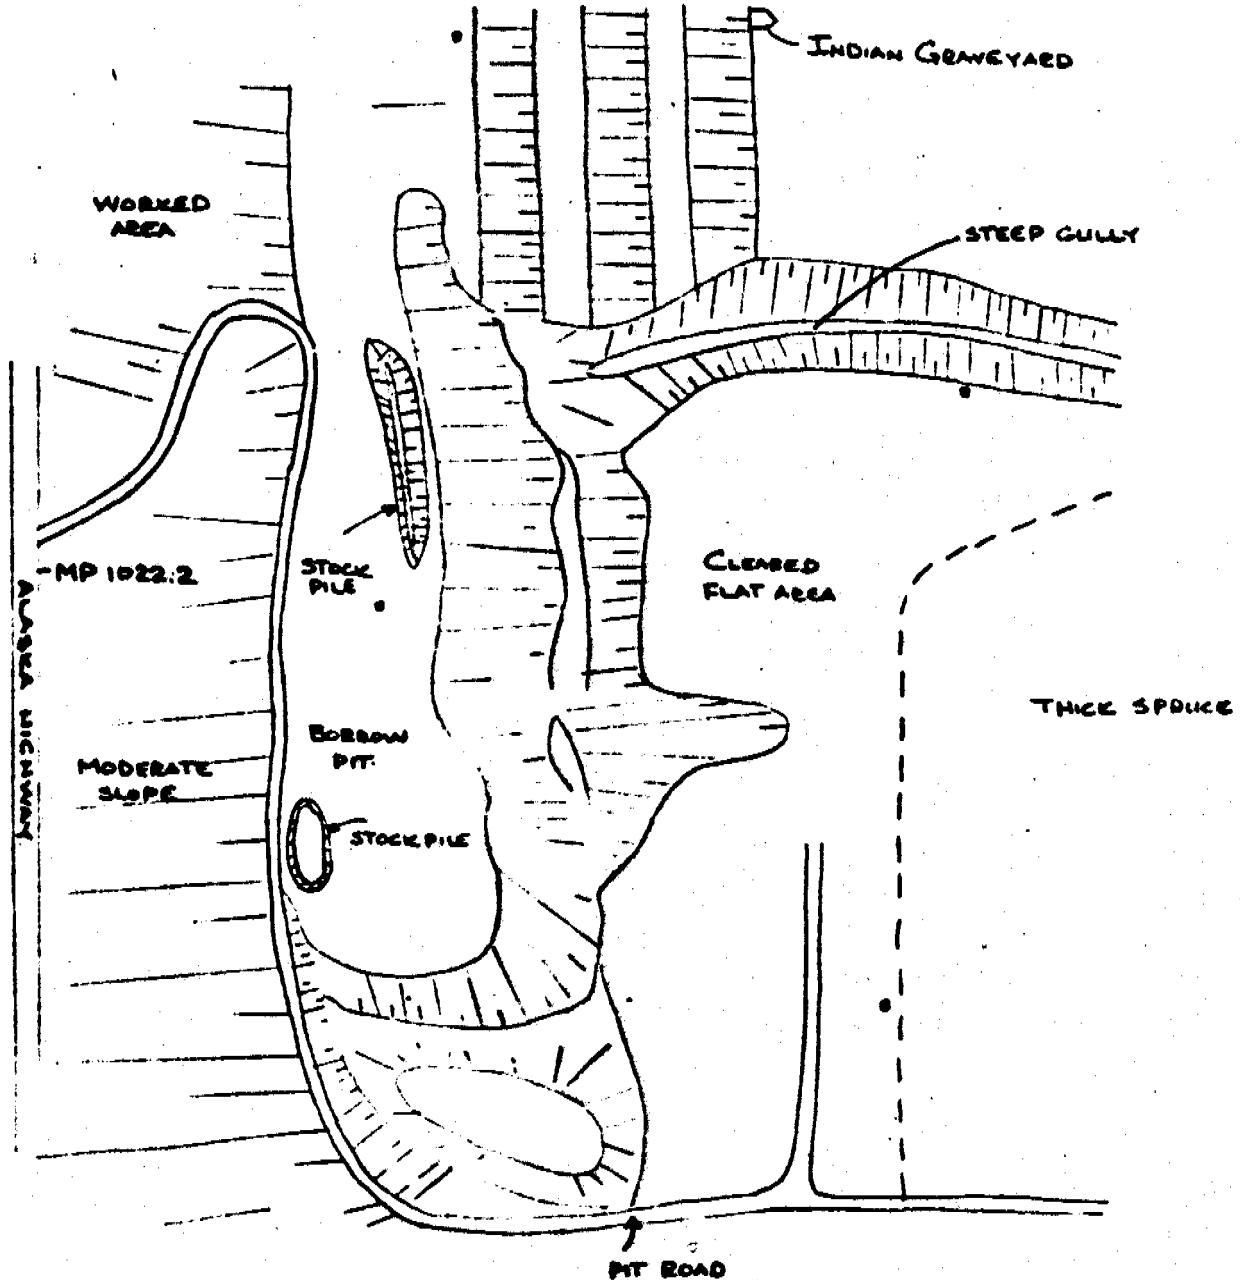
SITE NO 65
KLUANE R.M.A.
TEST AREA
ALASKA HIGHWAY MP 1022 2 RHS

K.M. Area:	Kluane	Borrow or Test Site No:	65
Location:	Highway No: 1	Side: R <input checked="" type="checkbox"/> L <input type="checkbox"/>	Distance: 0.2 mi
MP 1022.2	KP [] Highway Name: Alaska	Access	Excellent
Tenure: Gravel Pit Reserve Appl Plan Yes [] No [x]		Current Status: Active

STOCKPILE SITE TYPE HISTORY	Date: May/77	Crush	Amount: ± 750 Cu.Yds.
	Description: Moderate Sidehill	Tree Cover: Thick Spruce, Popl	
	Material: Gravel	Deposit:	
	Past Use: Borrow - Surfacing	Date:	Performance Rating:
Remarks:		Amount Used:

TEST SUMMARY	Augered <input type="checkbox"/>	Pitted <input checked="" type="checkbox"/>	Trenched <input type="checkbox"/>	Not Indicated <input type="checkbox"/>
	Lab. Test <input type="checkbox"/>	Sketch (Plan) <input checked="" type="checkbox"/>	Crushed: <input type="checkbox"/>	
Date: July/69		Sites Sampled: 4 Pits		
SUBSURFACE TEST RESULTS	Depth	Max.	Min.	Average
	Overburden	1'	0	
	Material	15 $\frac{1}{2}$ '	14'	
Quantity:(CuYds) Estimated		Proven		
Remarks: Some calcite coating gravel.

LAB. TEST RESULTS	Los Angeles Abrasion Z Loss: 17.3	Crush Count:
Other Tests:	Petrographic Analysis - Quartzite - 50%; Granite - 20%; Limestone - 15%; Porphyry - 5%; Others - 10%

Grain Size Analysis		Z Passing Sieve Size									
Hole No.	Depth	1-1/2"	3/4"	3/8"	No. 4	No. 10	No. 40	No. 200	LL	PI	
Av.-4 Pits		88	66	50	39	31	14	3	--	NP	
Crush-1" 1 Pit		100	85	55	41	30	14	4	--	NP	
Crush-1 Pit 3/4"		100	98	69	46	32	15	3	--	NP

Potential Conflicts:	Environmental: Indian Grave, Scenic Viewpoint
Land Use:

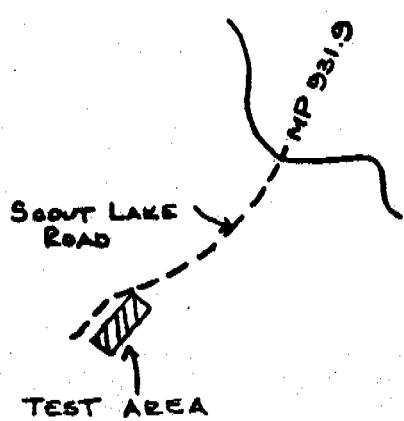
MP 931.9

STOCKPILE	Date:	Amount:	Cu.Yds.
	Description:	Tree Cover: Old burn	
SITE	Material: Gravel	Deposit: Glacial meltwater	
	Past Use:	Date:	
TYPE	Performance Rating:	Amount Used:	
	Remarks:

TEST SUMMARY	Augered	<input type="checkbox"/>	Pitted	<input checked="" type="checkbox"/>	Trenched	<input type="checkbox"/>	Not Indicated	<input type="checkbox"/>
	Lab. Test	<input checked="" type="checkbox"/>	Sketch (Plan)	<input checked="" type="checkbox"/>	Crushed:	<input type="checkbox"/>		
Date: Dec/74-Jan/75		Sites Sampled: 16 pits						
SUBSURFACE TEST RESULTS	Depth	Max.		Min.		Average		
	Overburden	1'		0				
	Material	11'		2				
Quantity(CuYds) Estimated				Proven				
Remarks: Permafrost at 6 ft in 2 pits. Dirty gravel - overall average of test results 10% passing #200 sieve.

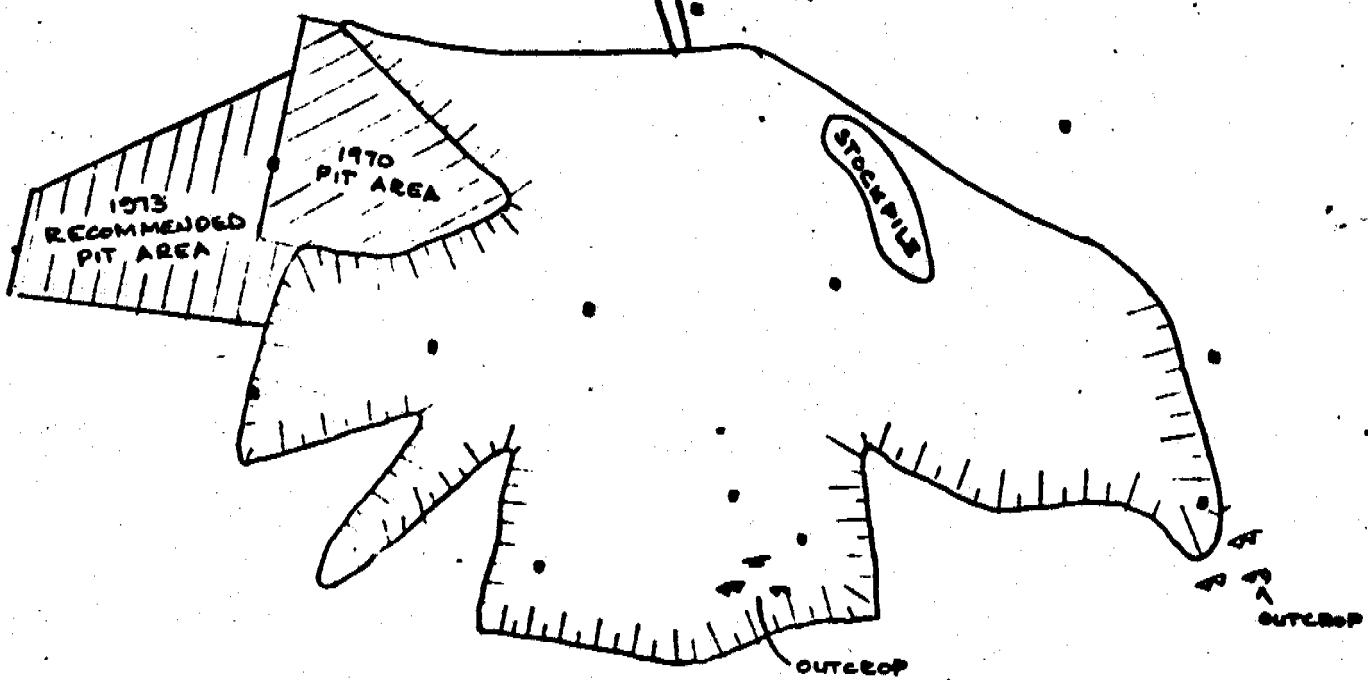
SITE NO 22

STOCKPILE SITE TYPE HISTORY	Date: May/77	Crush	Amount: + 10,000 Cu.Yds.
	Description: Steepsided terrace	Tree Cover: Old burn	
	Material: Gravel	Deposit:	
	Past Use: Surfacing MP 938-948	Date: 1970	
Performance Rating: Fair		Amount Used:	
Remarks:

ACCESS ROAD - 1 MI TO MP
944.2 ALASKA
HIGHWAY

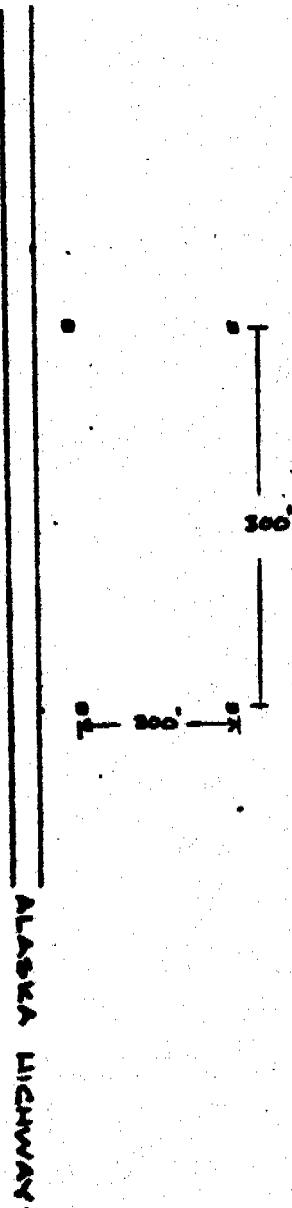
SITE NO. 40
LABERGE RMA

TEST AREA
ALASKA HIGHWAY MP 954.0 RHS

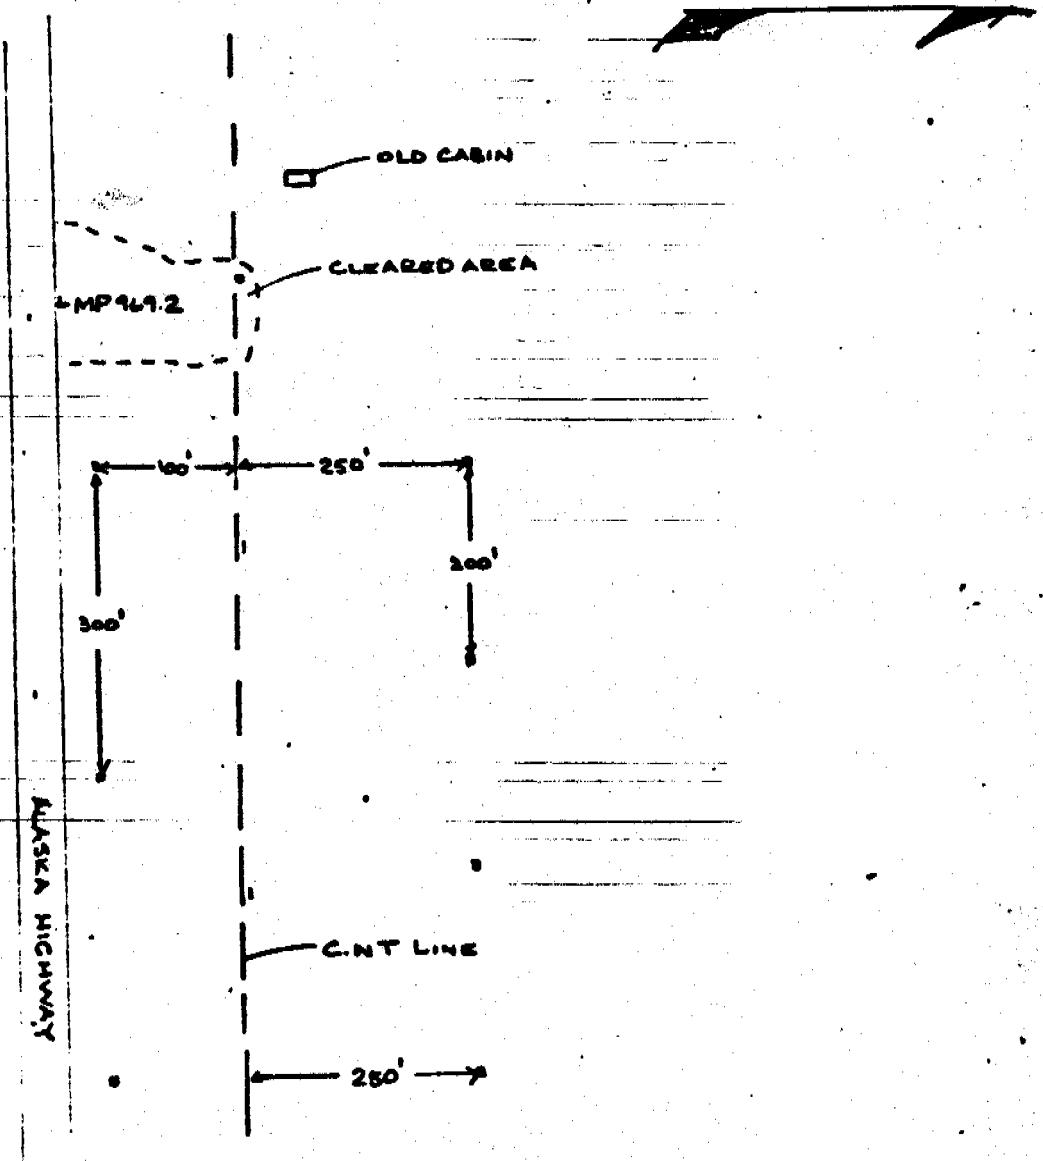
SITE NO 66
LABERGE RMA.

Permafrost about 7 ft. below ground level.

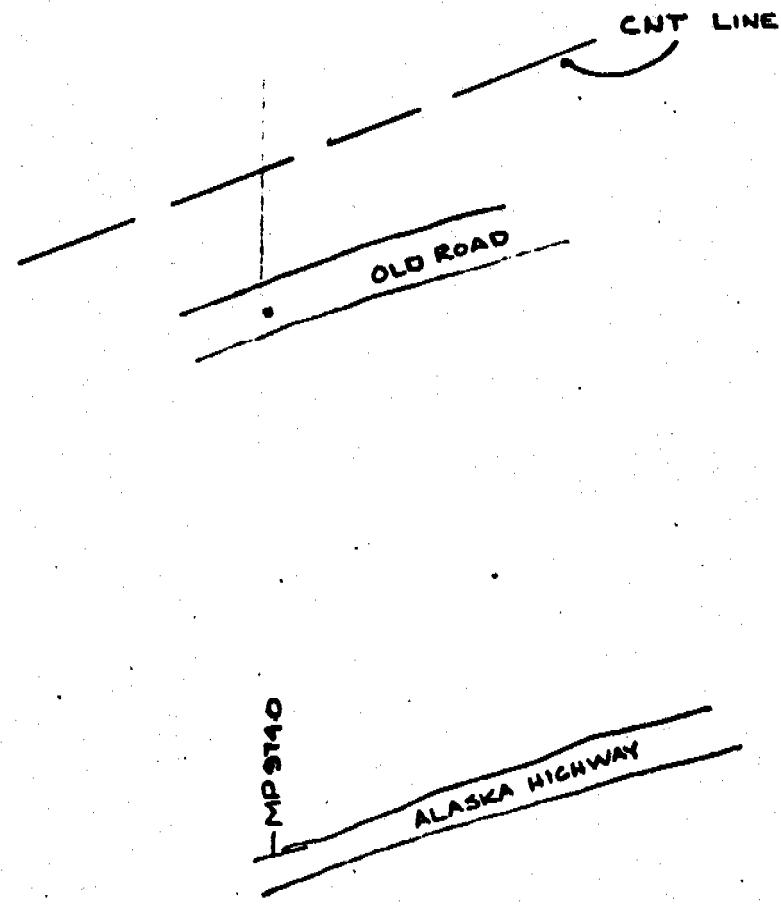
SITE NO 88
LABERGE R.M.A.

TEST AREA
ALASKA HIGHWAY MP 974.0 RHS
1 M. 200 FT
8 TEST PITS
