GRANULAR MATERIALS INVENTORY

HAINES ROAD AND HAINES KLUANE SECTION
OF THE
ALASKA HIGHWAY, YUKON TERRITORY

[JANUARY 1978]

Volume I

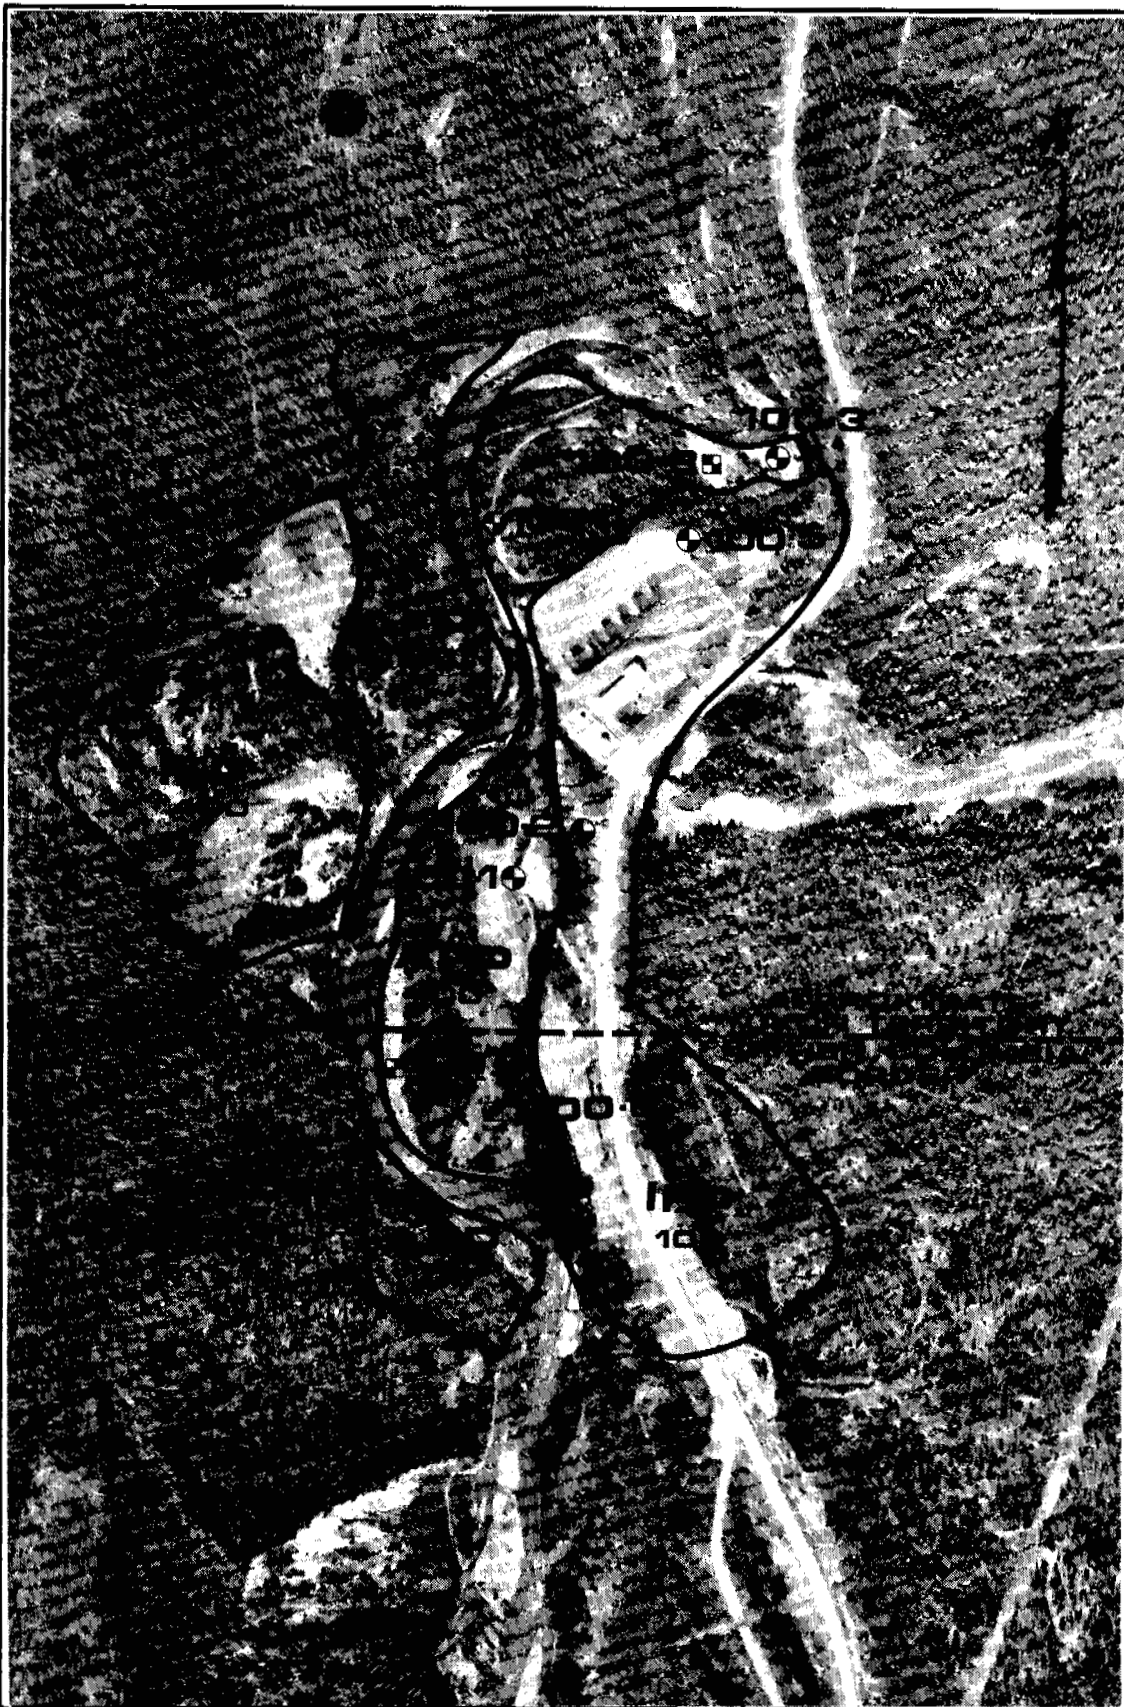
Source No. 100

Airphoto No. A24177-122

The source is not recommended for large scale development because of unavoidable disturbance to fish populations and the special interest of the British Columbia/Yukon boundary to tourists. Some material could be removed from the inactive flood plain areas located away from the river. Full utilization of the inactive flood plain deposits on the east side of the river would necessitate the dismantling of the abandoned pump station.

Material suitable for both asphalt aggregate, bases and sub-bases is available within the source. Some crushing would be required for asphalt aggregate. Local deposits with high sand content could be used for blending. Weathered rock types make up a small percentage of total material. The relatively high slate content precludes the use of these materials for concrete aggregate.

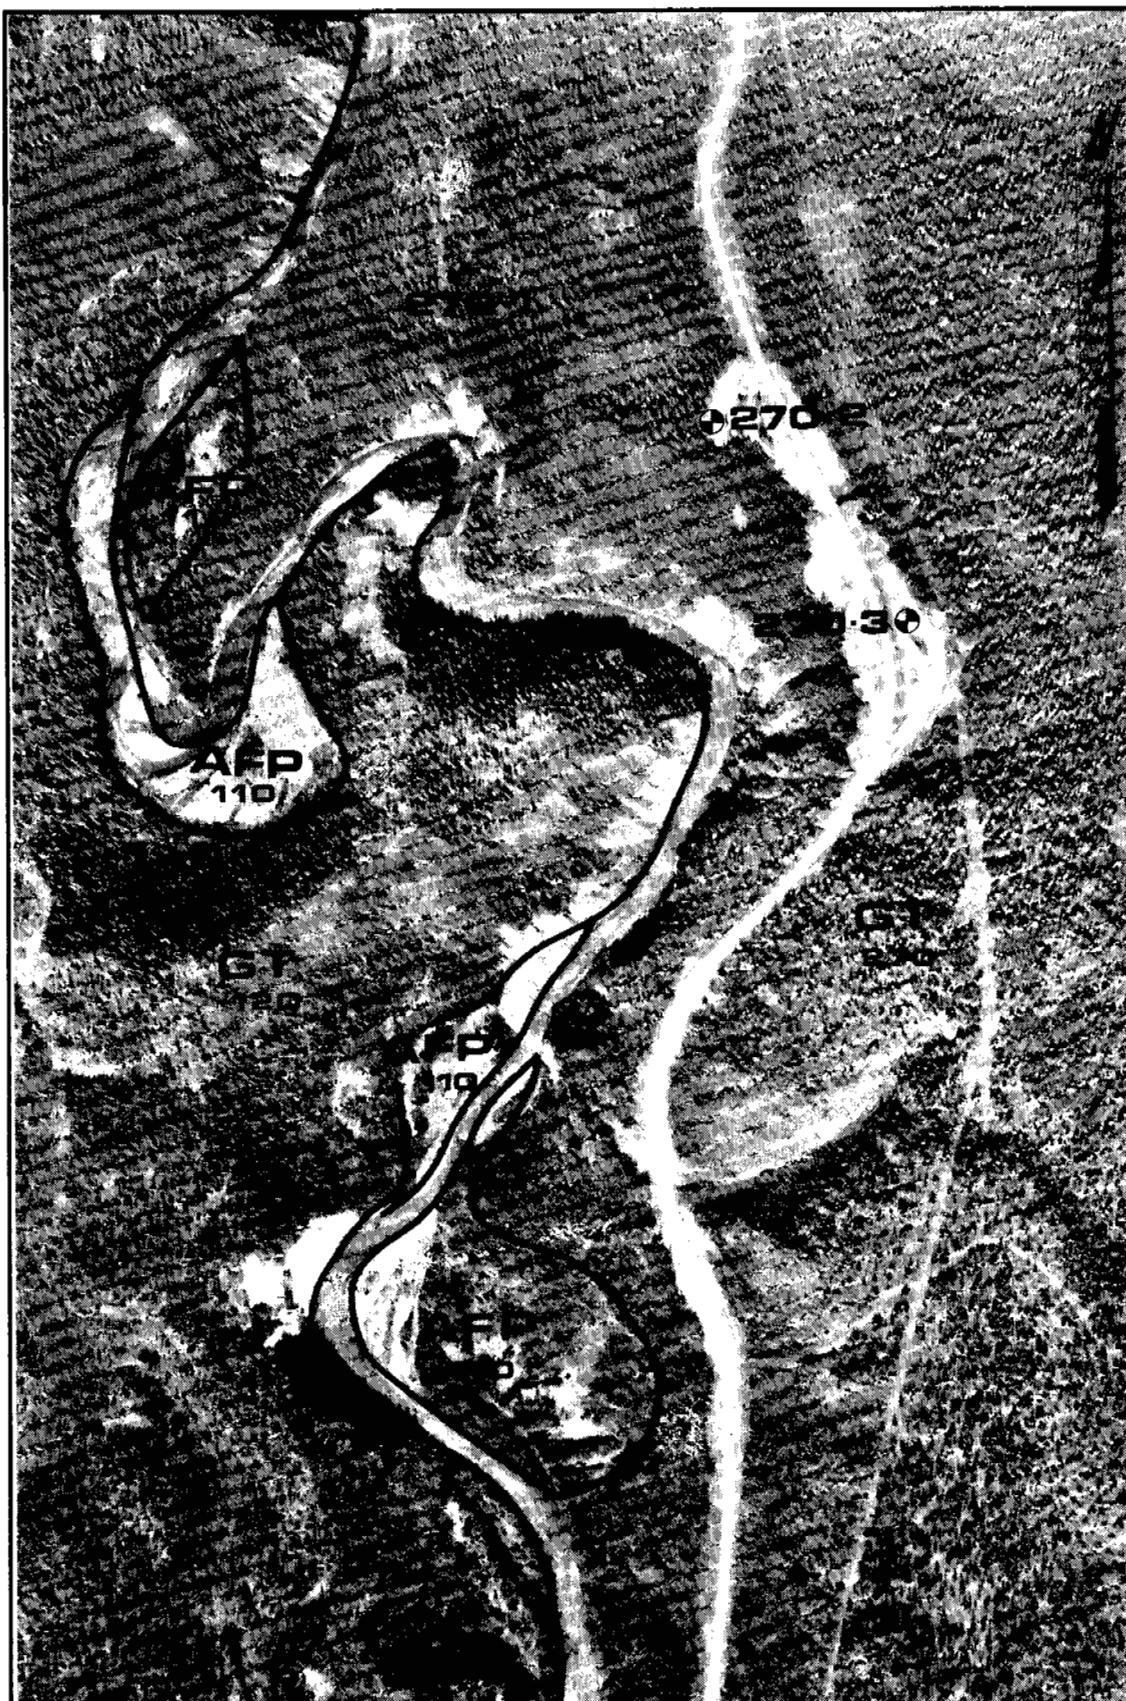
Source Nos. 110, 120 and 270

Airphoto No. A24177-122

Difficult access will be the main deterrent to development of Source No. 110. The volume of materials available probably will not justify the expenditures that would be necessary to construct a suitable access road. Disturbance of fisheries is also a negative factor with respect to development. It is expected that the material uses and material handling requirements would be the same as Source No. 100.

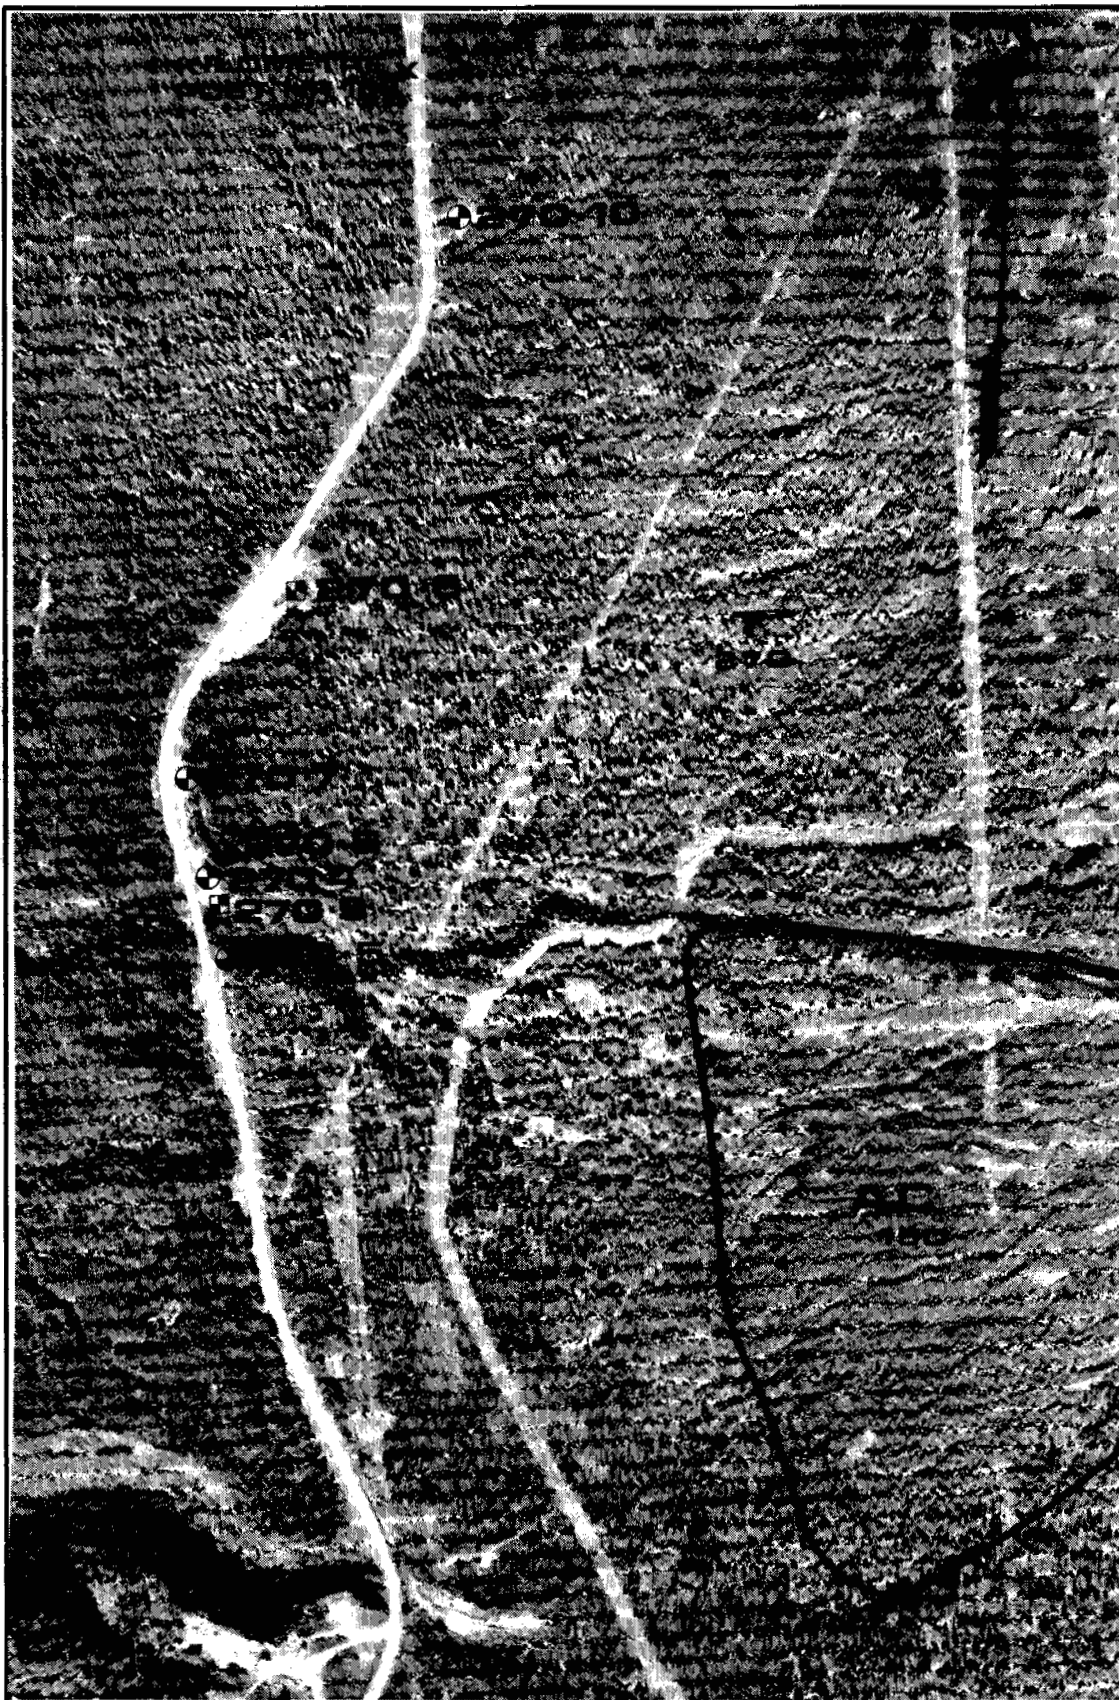
Source Nos. 150 and 270

Airphoto No. A24177-118

Suitability of the granular materials in these sources is difficult to assess without sampling. It is expected that some processing would be required if the materials were to be used for any purpose except general fill. Environmental concerns do not appear to be limiting. The expense of constructing access roads may be a major deterrent to development.

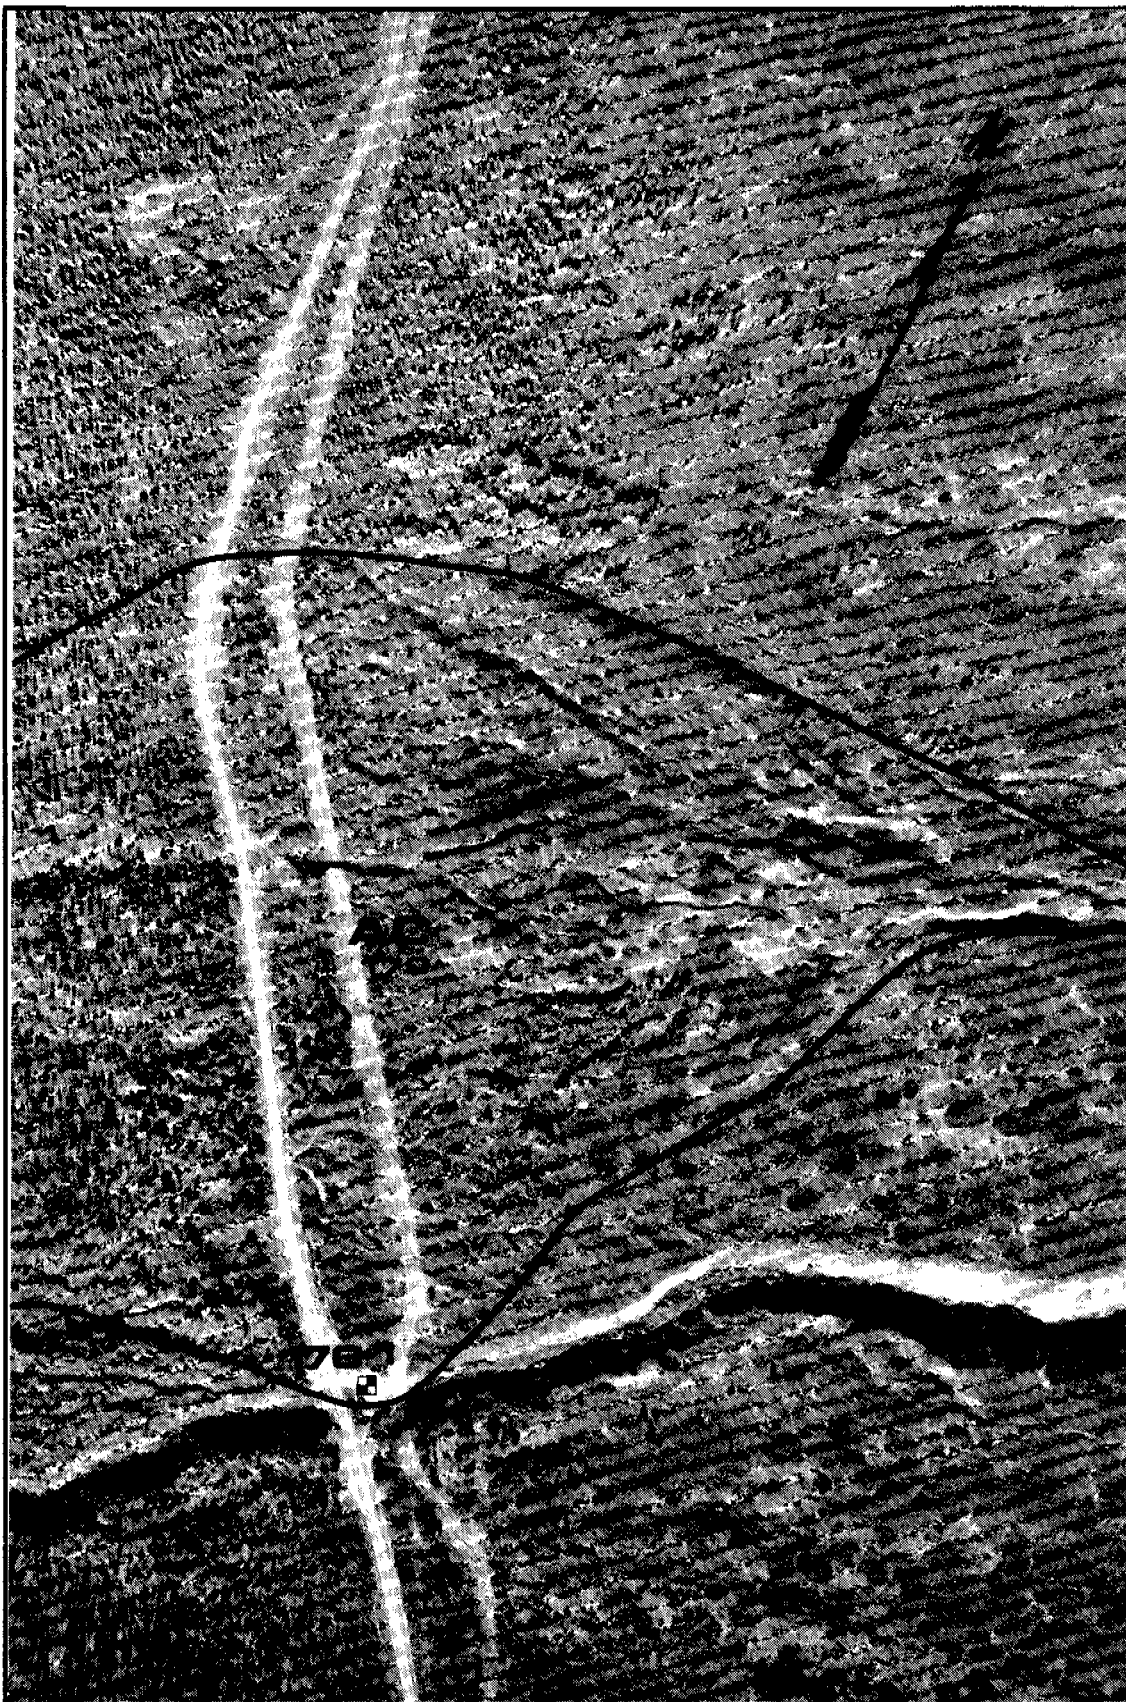
Source No. 170

Airphoto No. A24177-114

Analysis of Sample 170-1 indicates that the deposit at this location consists of boulders in a matrix of sand with some gravel and silt. Material with this grading requires extensive processing, although it is not known to what extent this single sample reflects the grain size distribution of the entire deposit. Useful aggregate could be developed using crushing and blending procedures. A two stage crushing operation would be required to process the boulders.

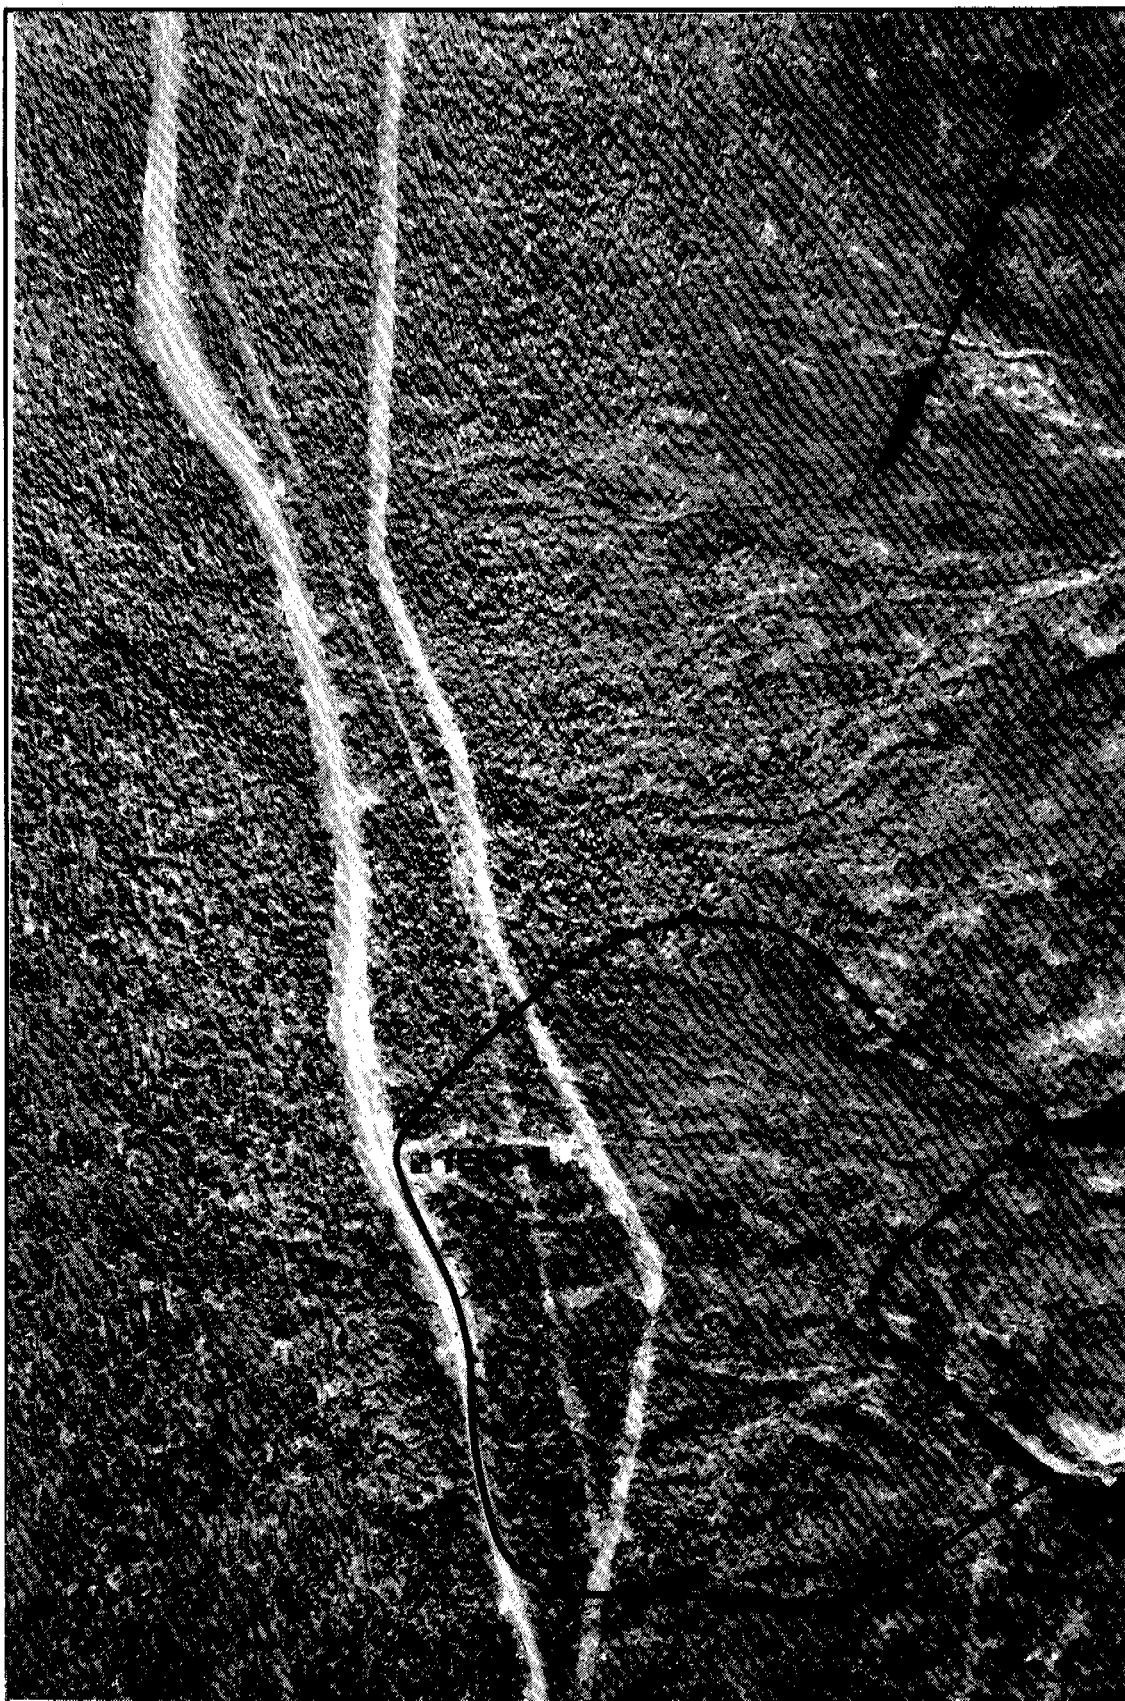
Airphoto No. A24177-112

The sand and gravel gradation in Source No. 180 is suitable as a sub-base course, and may also be marginally acceptable as a base course. Cobbles and boulders may have to be scalped or culled out. Washing, screening and blending may produce acceptable concrete aggregates, but it is expected that the deposit would produce only marginal asphalt due to the high silt contents.

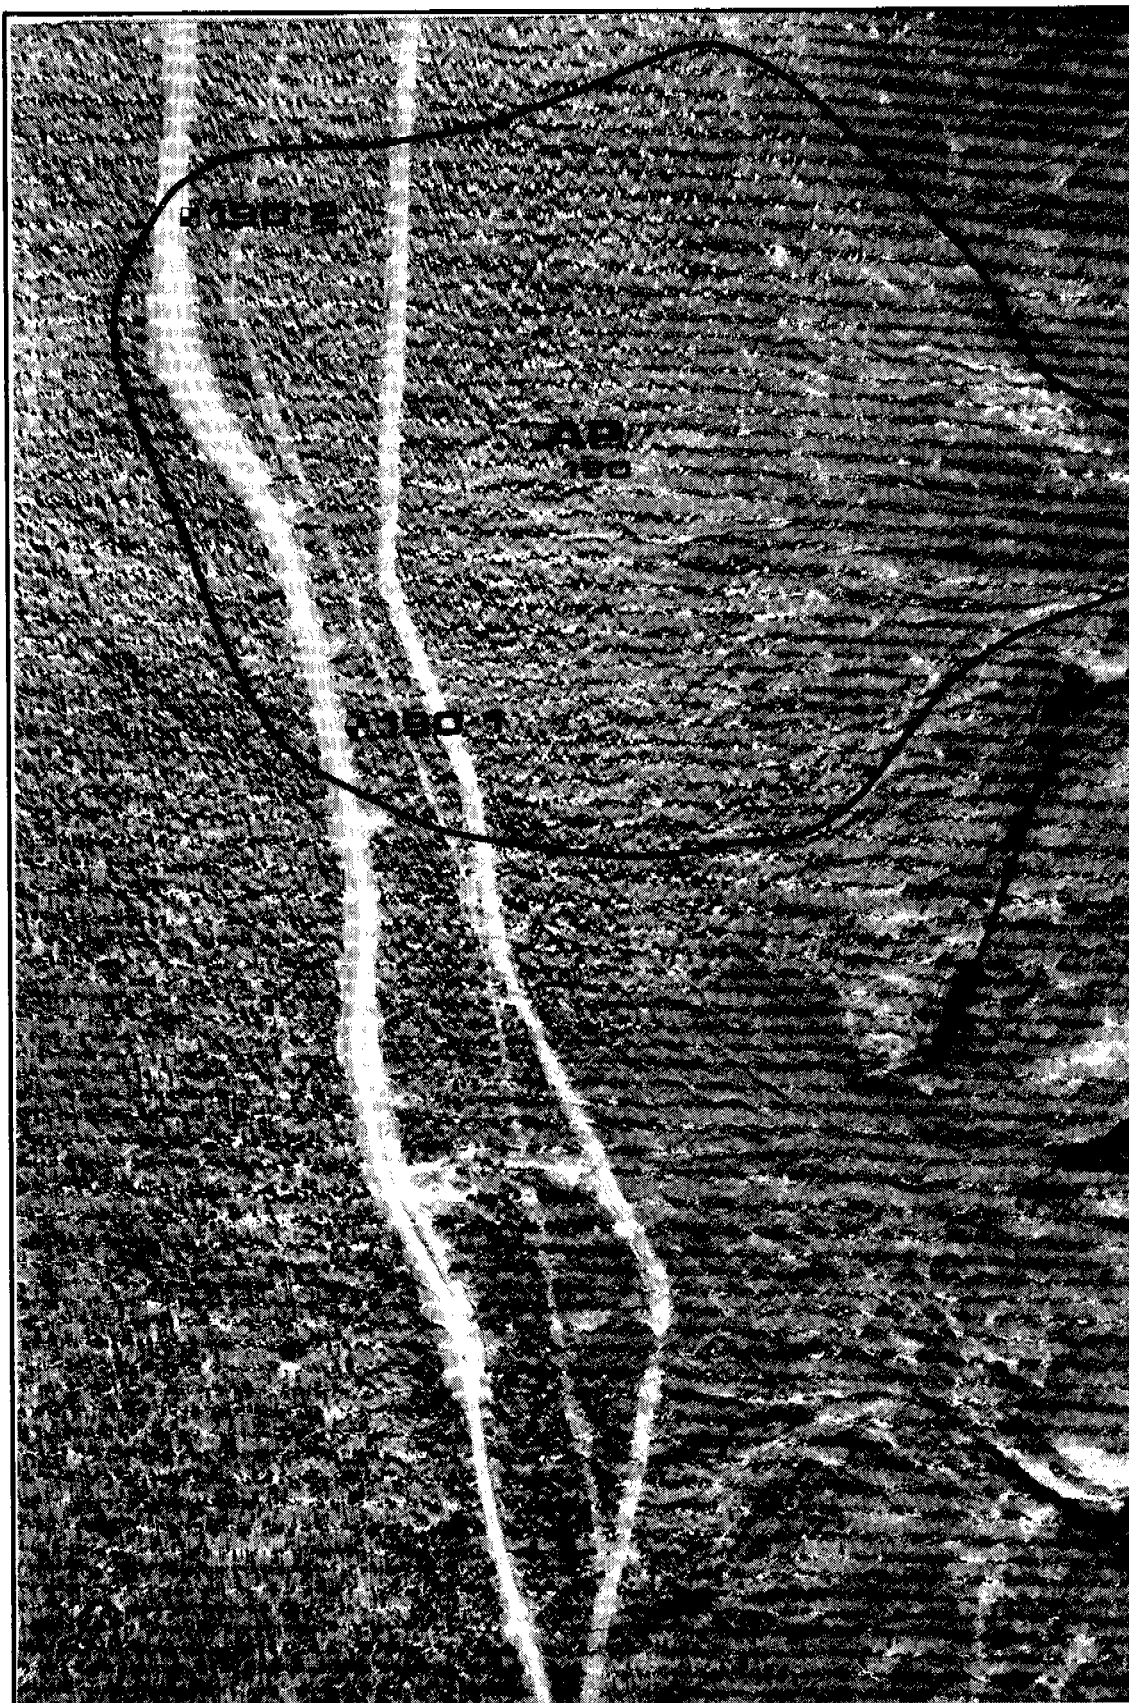
Source No. 190

Airphoto No. A24177-112

According to sample 190-2, this source is only suitable for general fill. More detailed investigation would be necessary to determine whether better material is available elsewhere in the deposit. Environmental concerns are not serious and development could be carried out if soil conditions warranted further assessment.

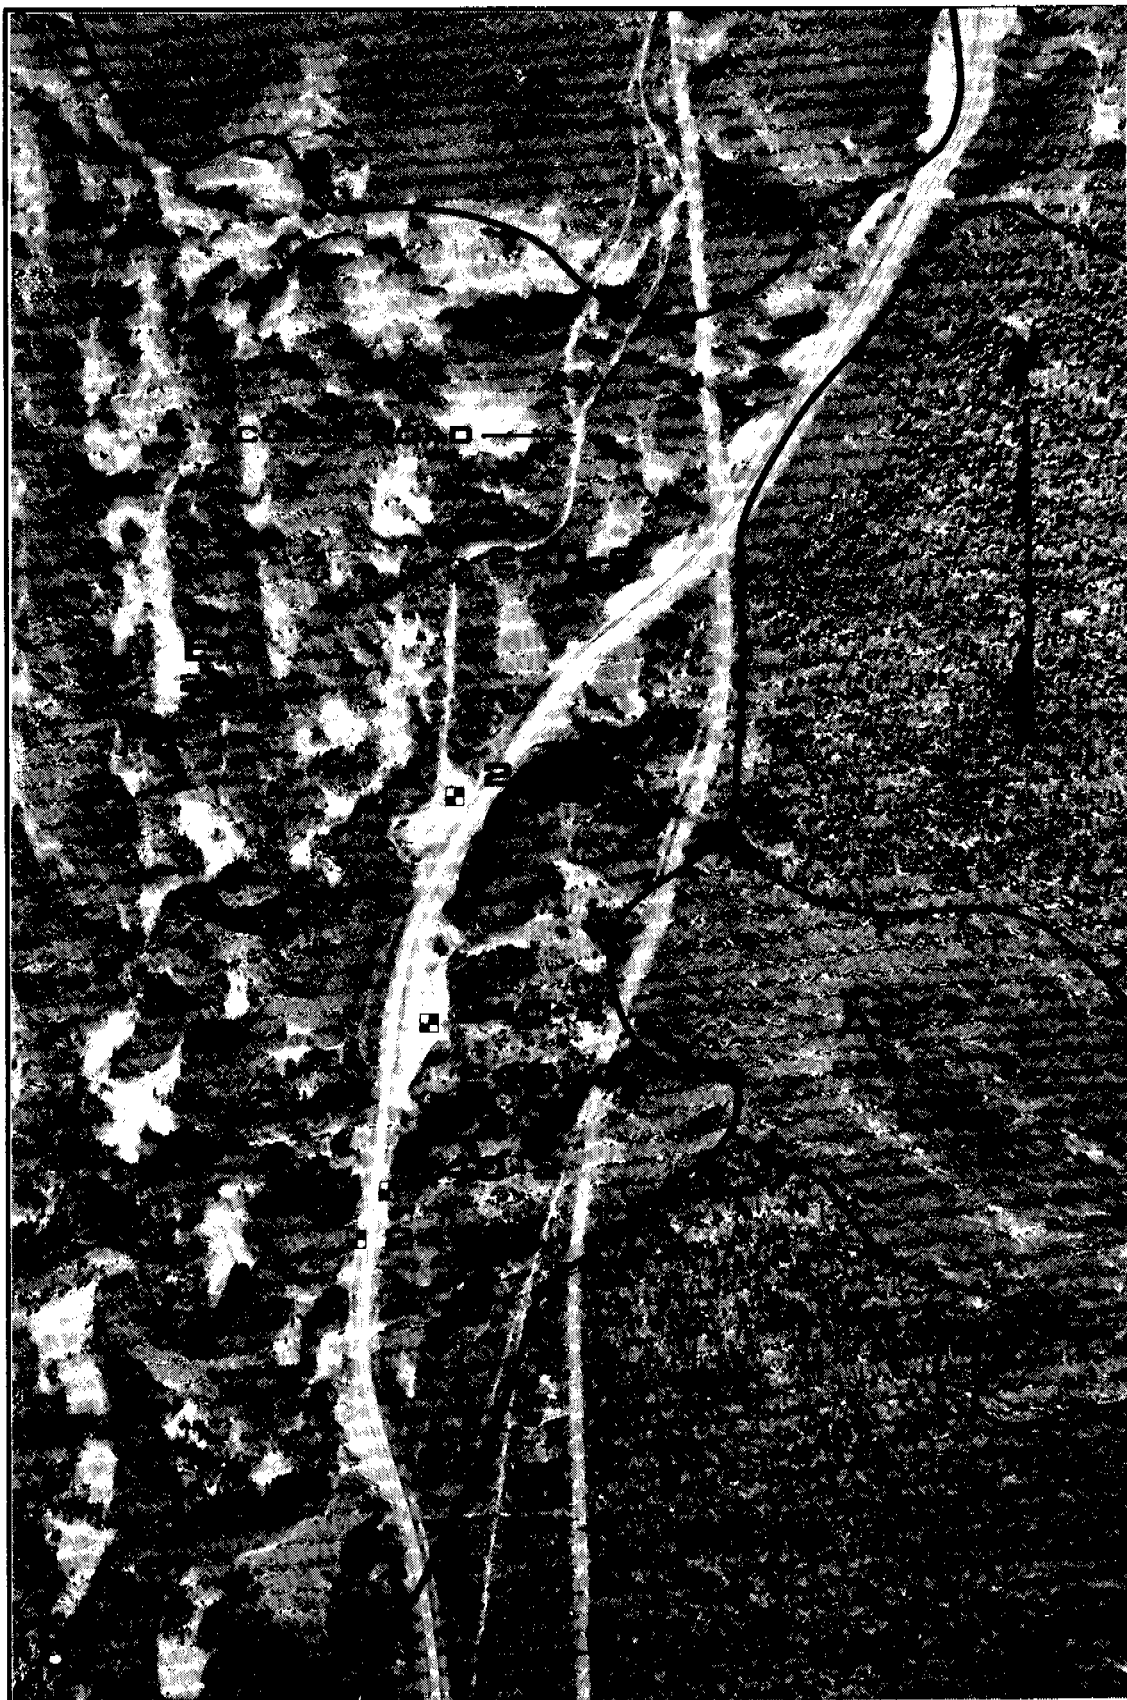
Source Nos. 220, 240

Airphoto No. A24177-107

Source No. 220 requires a sampling program to evaluate the possible utilization of the granular materials. Until further work is done, these materials should be considered to be of the same quality as Source No. 210 and therefore useful only as general fill. Environmental concerns in the source area were not directly evaluated but are not expected to be limiting based on examination of similar sites in the area. Road access costs should not be high.

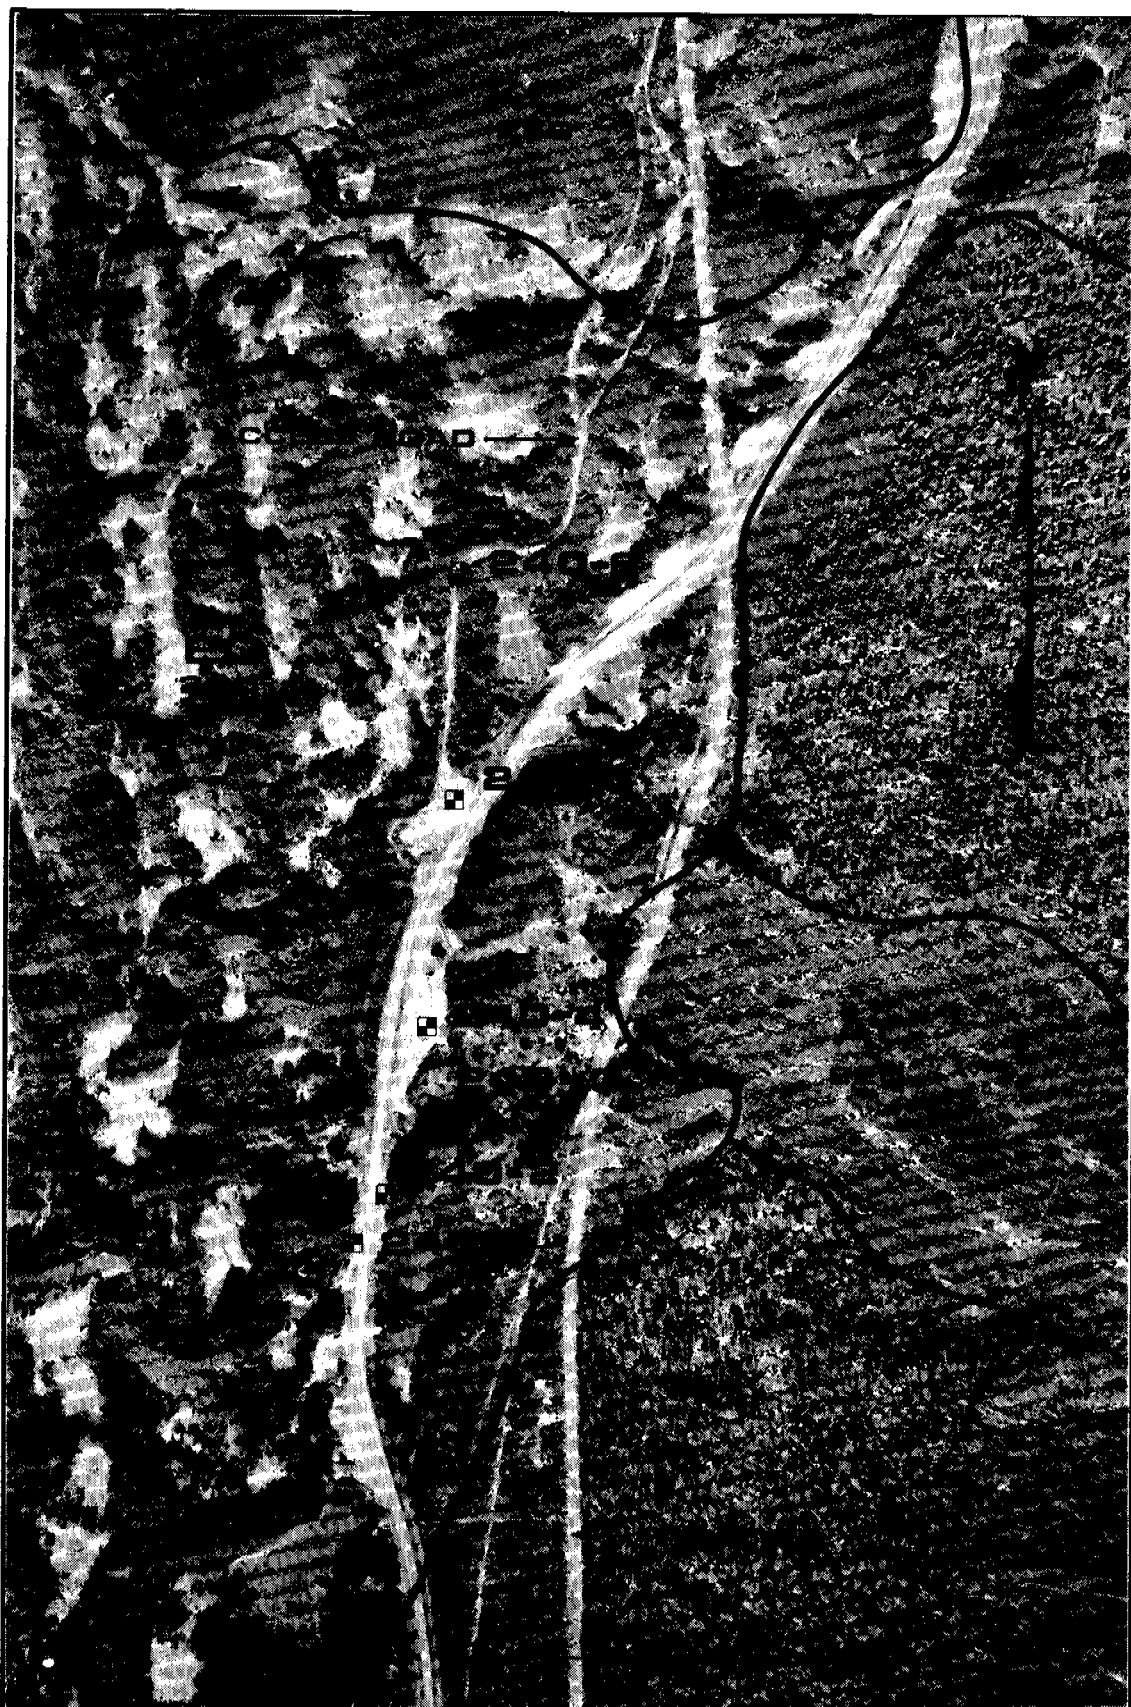
Source Nos. 220, 240

Airphoto No. A24177-107

The field investigation revealed that each esker, and in some cases certain parts of the same esker, has a characteristic grain size distribution. Some samples contained excellent material for concrete and asphalt aggregates, base courses and sub-bases while others contained sands suitable only for general fill or for blending with coarser materials. In general cobbles and boulders were present only in trace amounts. The quantity of deleterious substance (slate and weathered materials) ranged from 3 to 17 percent. Material handling processes anticipated for this source include some screening and blending. Environmental concerns for the source area are moderate but not necessarily limiting. Careful planning of gravel removal should be possible while maintaining habitat and recreational values.

The esker complex has excellent potential as a source of granular material, especially if development is carried out as a large scale operation. It is recommended that further sampling be done in order to accurately outline areas in which specific granular material can be exploited.

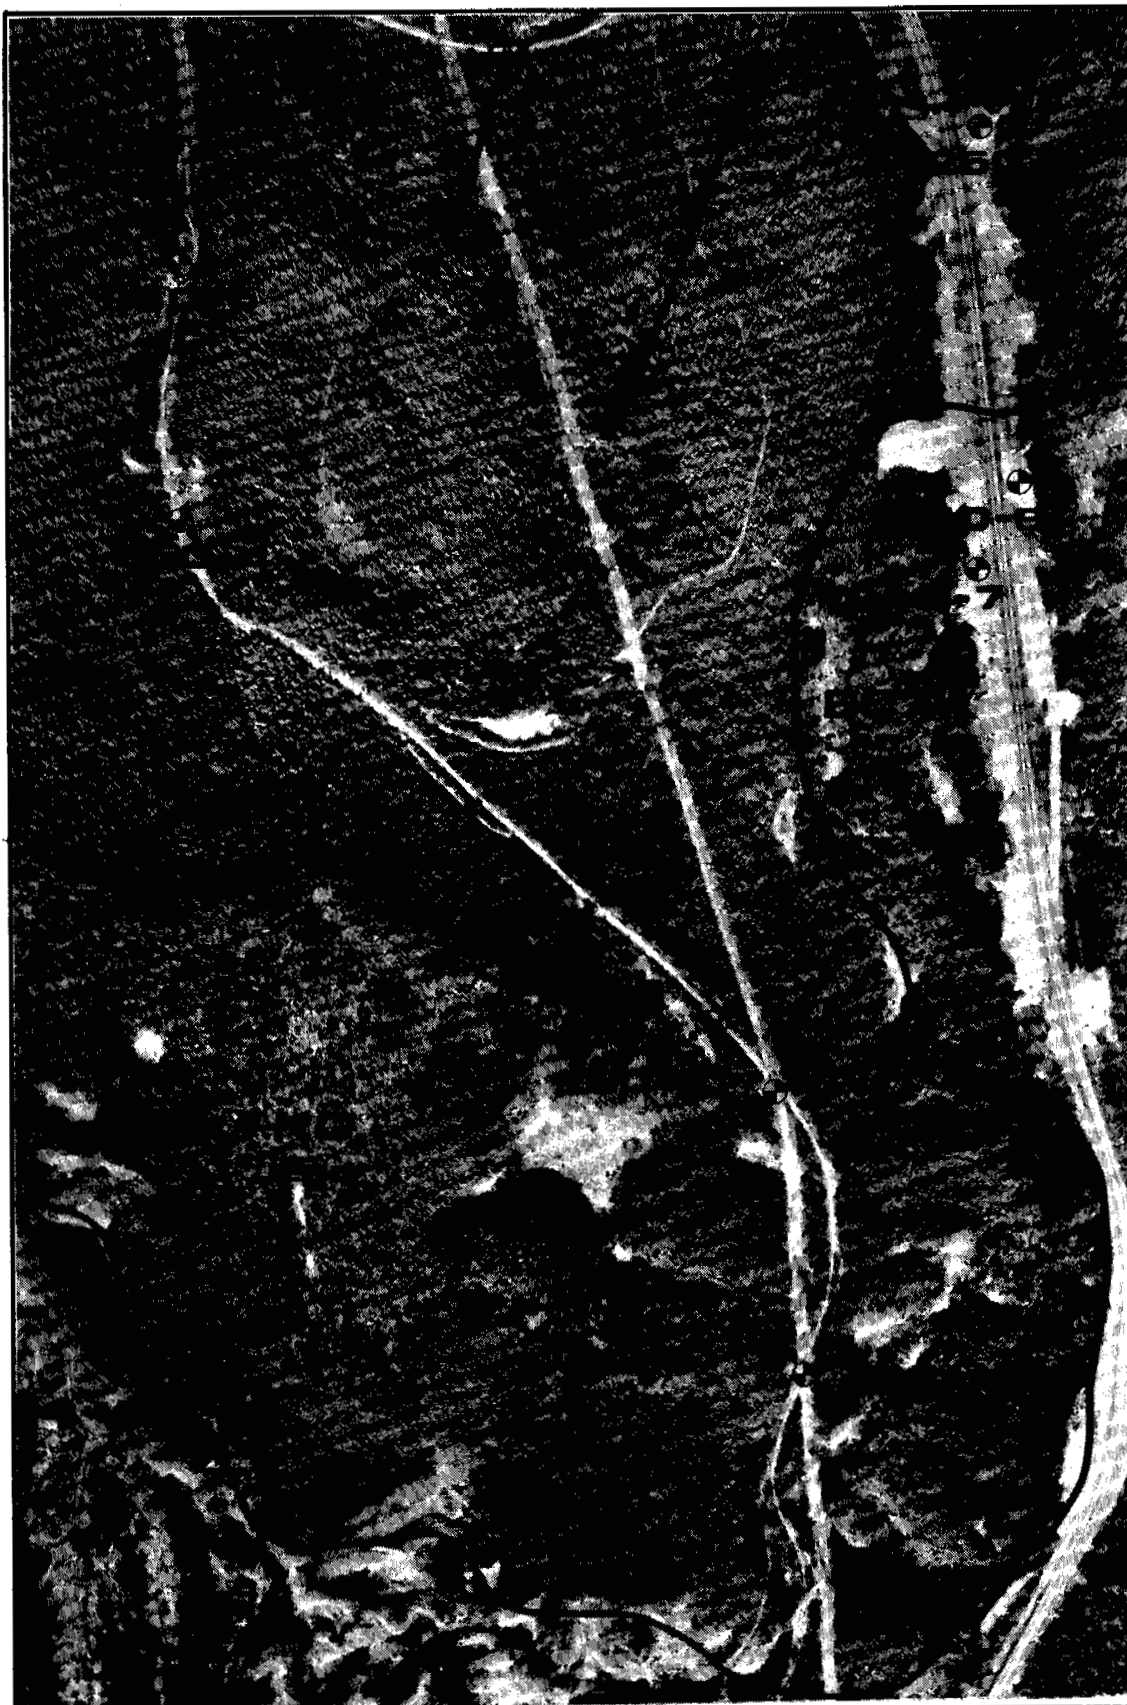
Airphoto No. A24177-106

Source No. 250 may be utilized for general fill. Isolated areas with better grade granular materials may be present but it is not expected that their limited volumes would justify the expense of development.

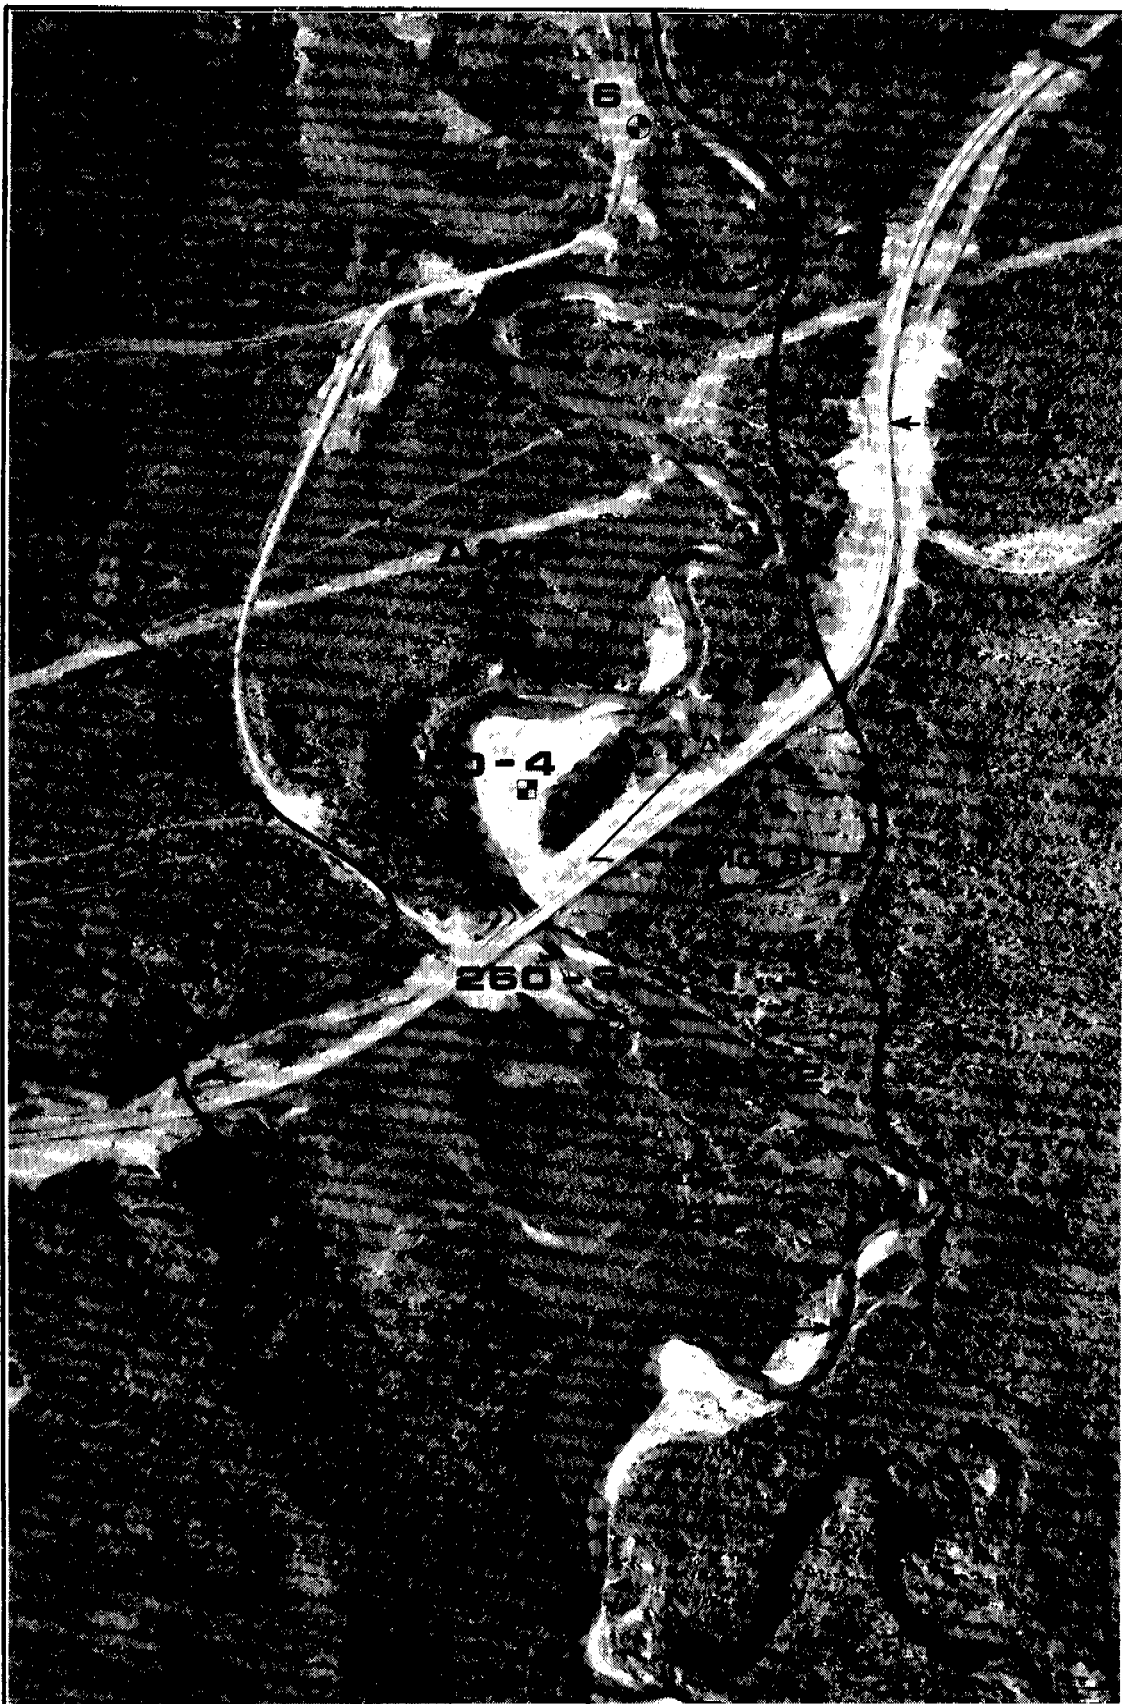
Source No. 260

Airphoto No. A24177-104

Although this deposit contains some coarse gravelly material which would be suitable as concrete aggregate, negative factors such as the present land-use (camping, picnicing) are limiting factors. The potential impact of development on fishery resources and the proximity of alternate granular resources in Source No. 240 make development of this source undesirable at the present time.
