GRANULAR MATERIALS INVENTORY

HAINES ROAD AND HAINES KLUANE SECTION
OF THE
ALASKA HIGHWAY, YUKON TERRITORY

Volume 2

SOURCE ASSESSMENT SUMMARIES

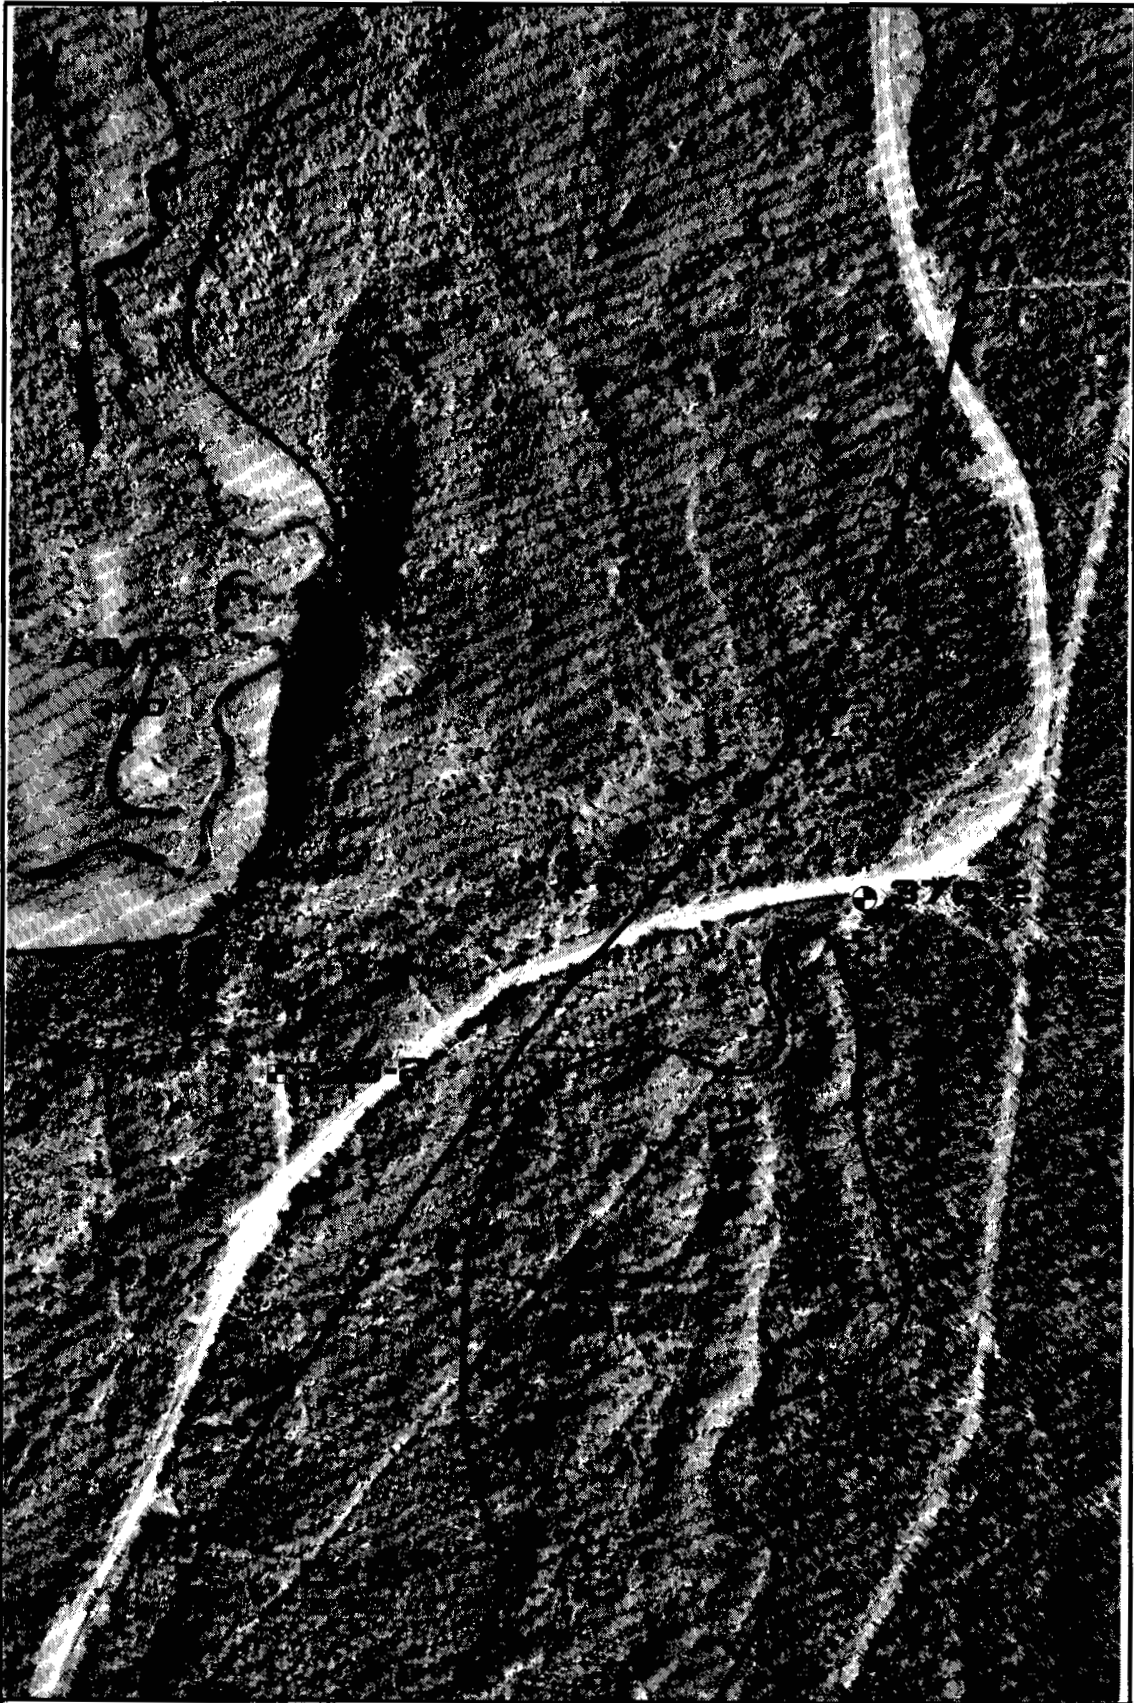
Airphoto No. A24177-53

Source Nos. 320, 330 and 370
