**A TEST OF GROUND PROBING RADAR
FOR EVALUATING SUBSURFACE CONDITIONS
IN PERMAFROST TERRAIN**

TUKTOYAKTUK COASTLANDS AREA, N.W.T.

Prepared for
INDIAN AND NORTHERN AFFAIRS CANADA

Prepared by
FRANK THOMPSON
November, 1994

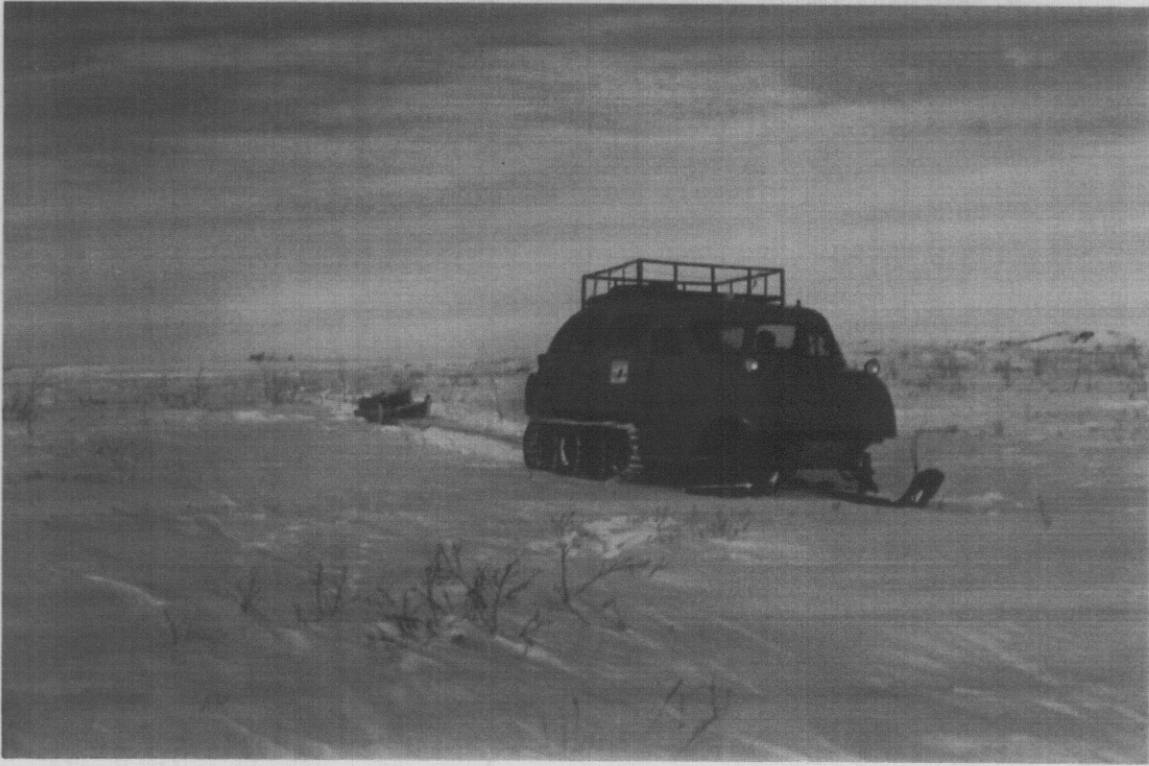
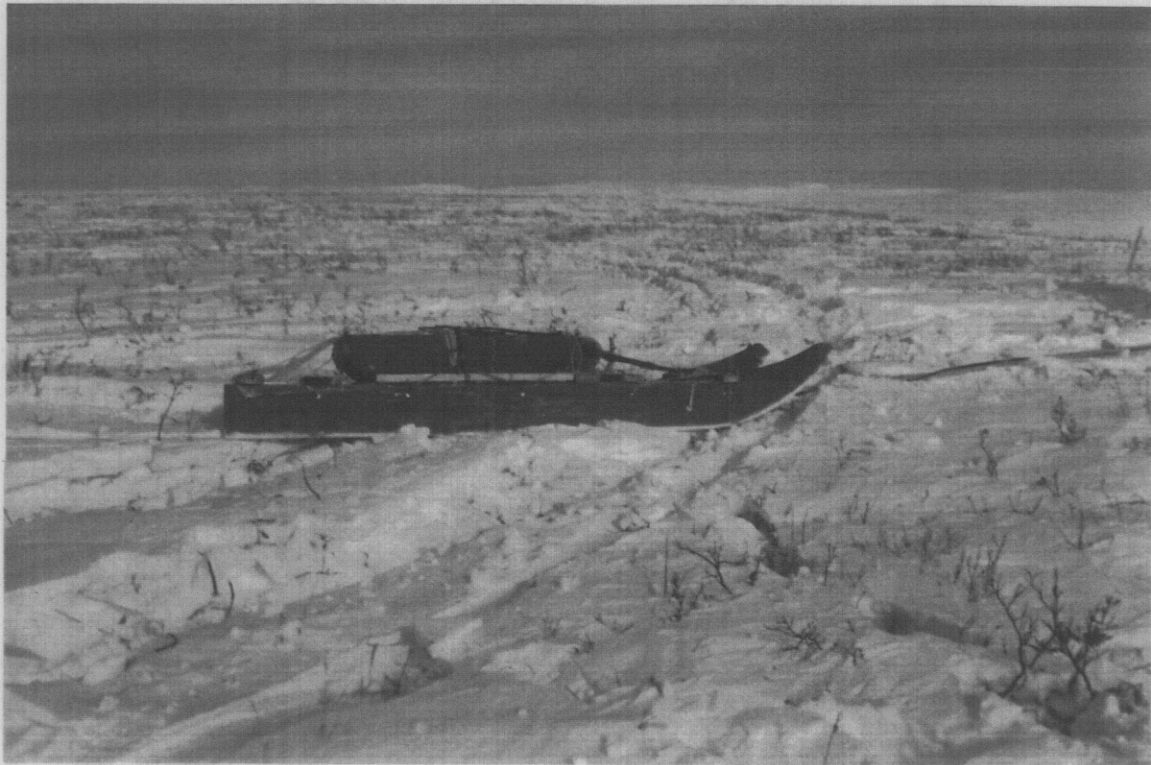
Illustration 1. Photographs of bombardier and the transducer under tow.

The GPR profiling was done by Jim Greer of North-South Consultants, Egremont, Alberta. The recording instruments were mounted inside a Bombardier and the transducer/receiver towed behind on a sled (see photographs in Illustration 1, Appendix A). The profiler was a PR 8300 with a 120 MHz (3020) sea ice transducer. Frank Thompson, consulting geologist of Ottawa, Ontario, selected and laid out the survey lines and provided on-site supervision of the study.
