# EVALUATION OF SIX GRANULAR BORROW PROSPECTS IN THE MACKENZIE DELTA AREA PHASE 1: ASSESSMENT OF INVESTIGATION PROGRAM REQUIREMENTS

Kiggiak-EBA Project No.:KE1002EBA Project No.:1100018

**DECEMBER 2002**

# INUVIALUIT LAND ADMINISTRATION INUVIK, NT

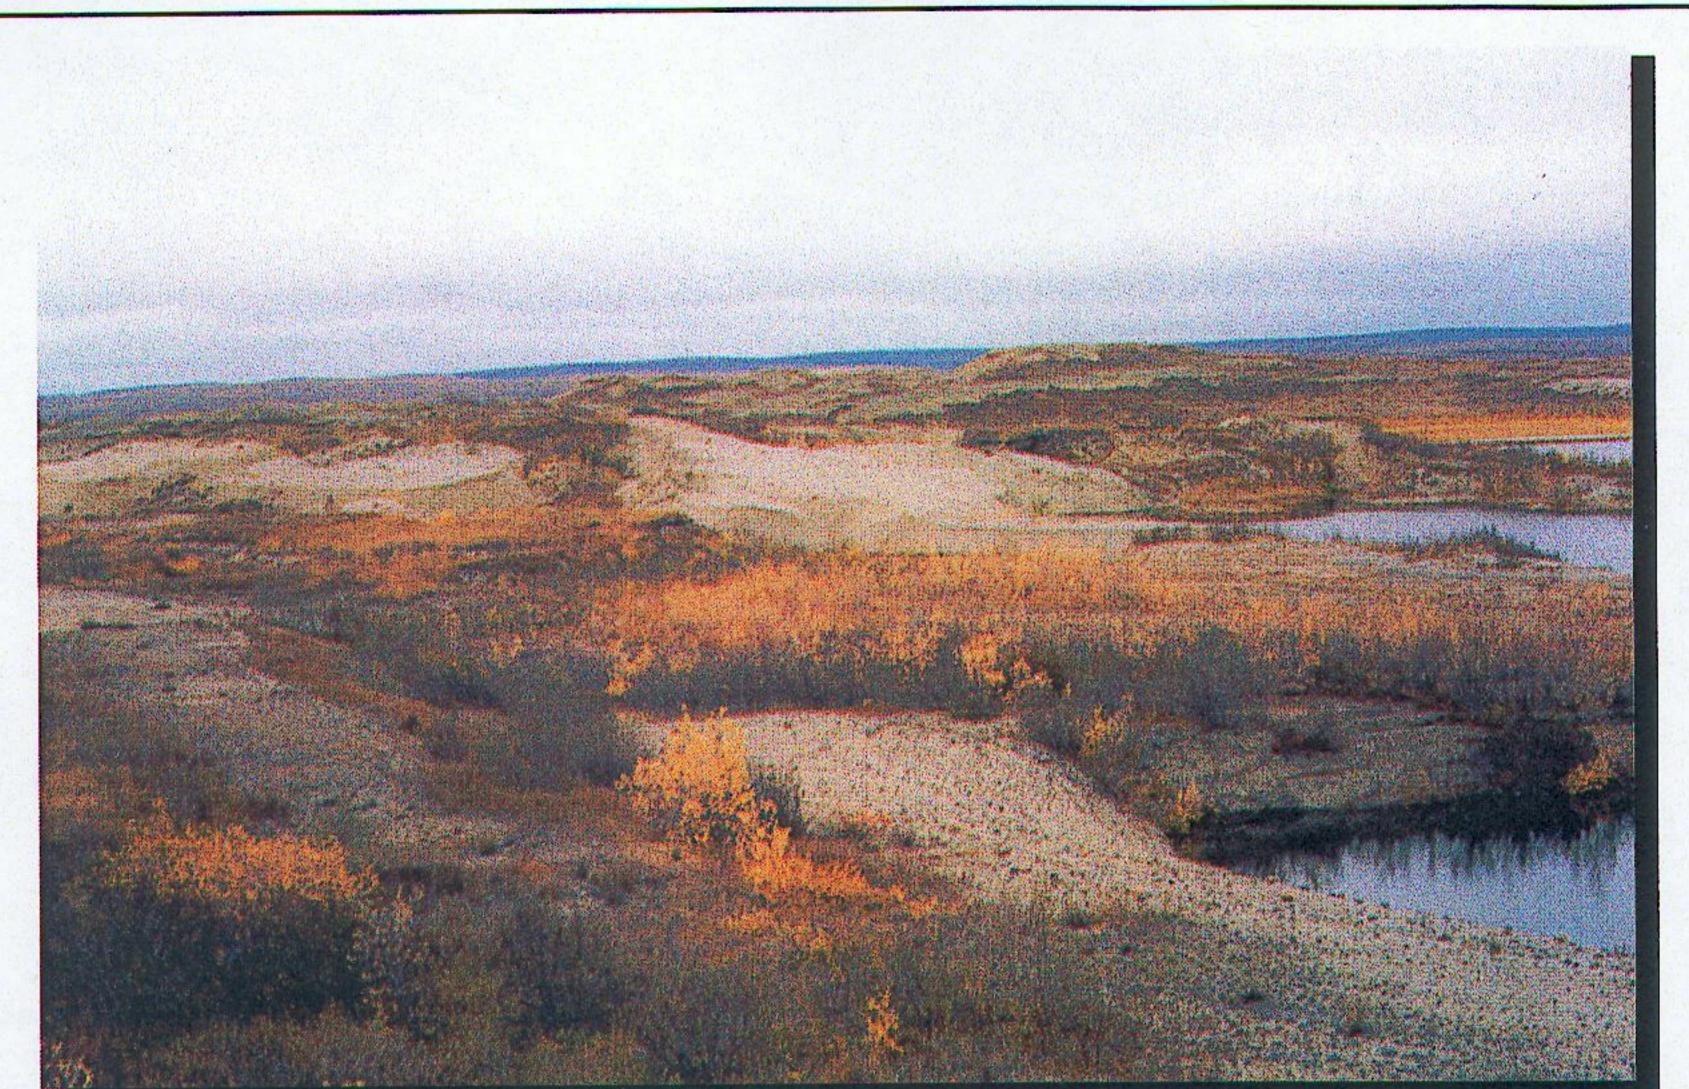
# Photo 1 Previously worked area in the central part of the Yaya Deposit.

The physical relief of the central part of the deposit will provide a challenge for any site assessment program. Photos 1 and 2 (from near GPS Waypoint 69° 05.843'N 1340 42.508'W) show the steep sided isolated ridges of gravel with some ponds in the central part of the western previously developed area. These ridges will necessitate advance planning of access routes and the incorporation of

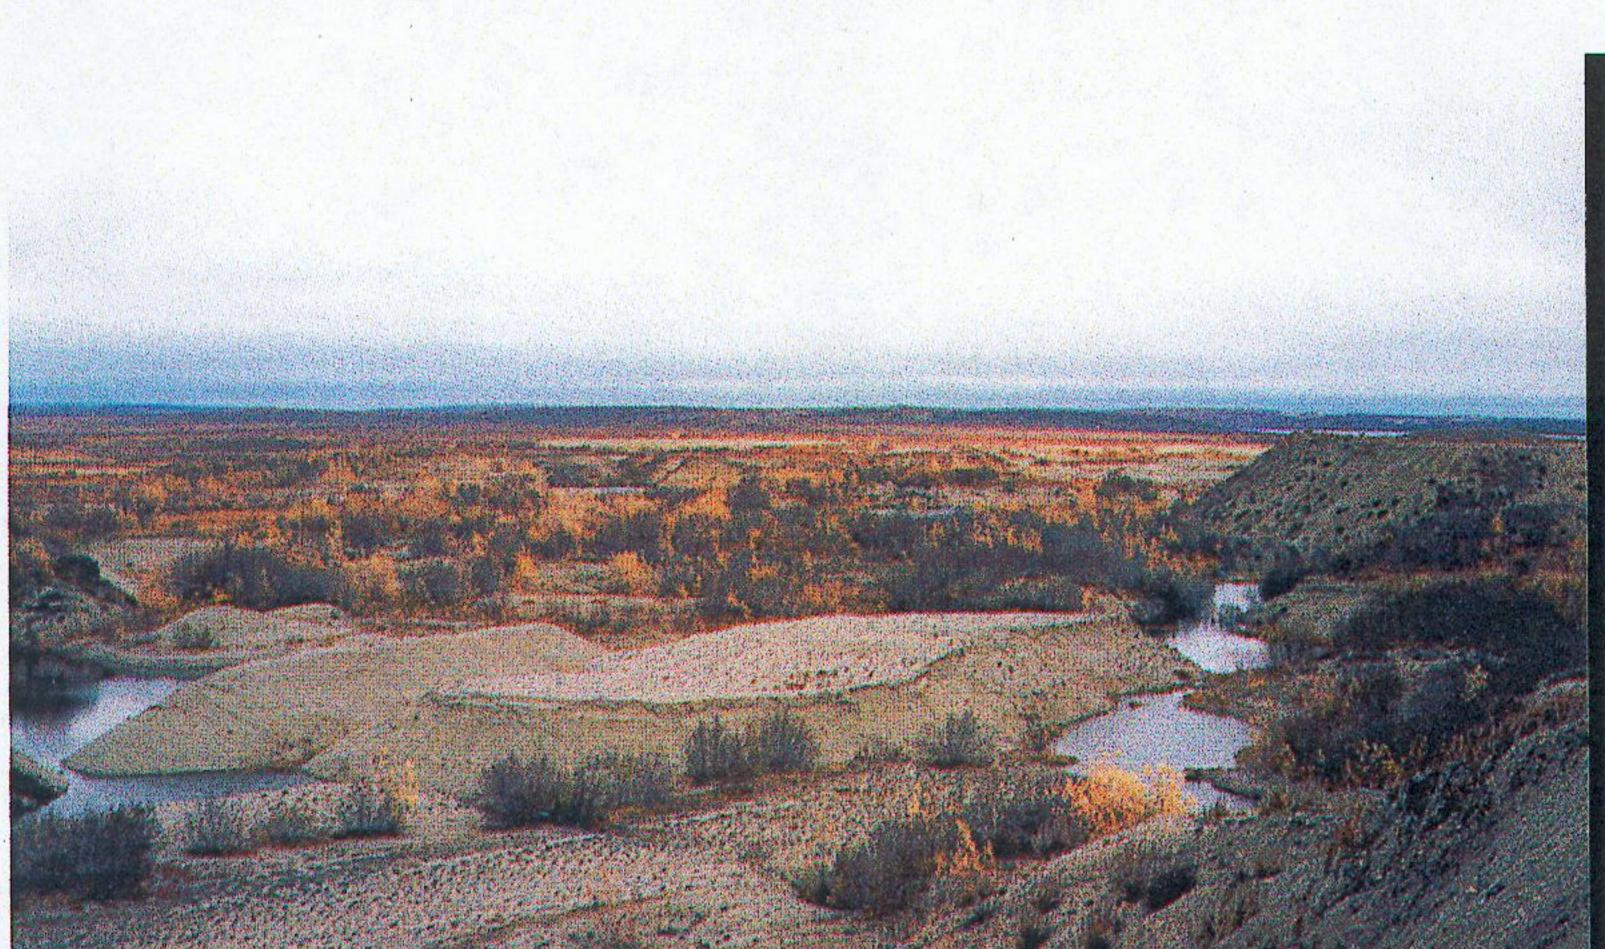
## Photo 2 Steep sided, isolated gravel ridges on knobs separated by thaw ponds in central part of the Yaya Deposit.

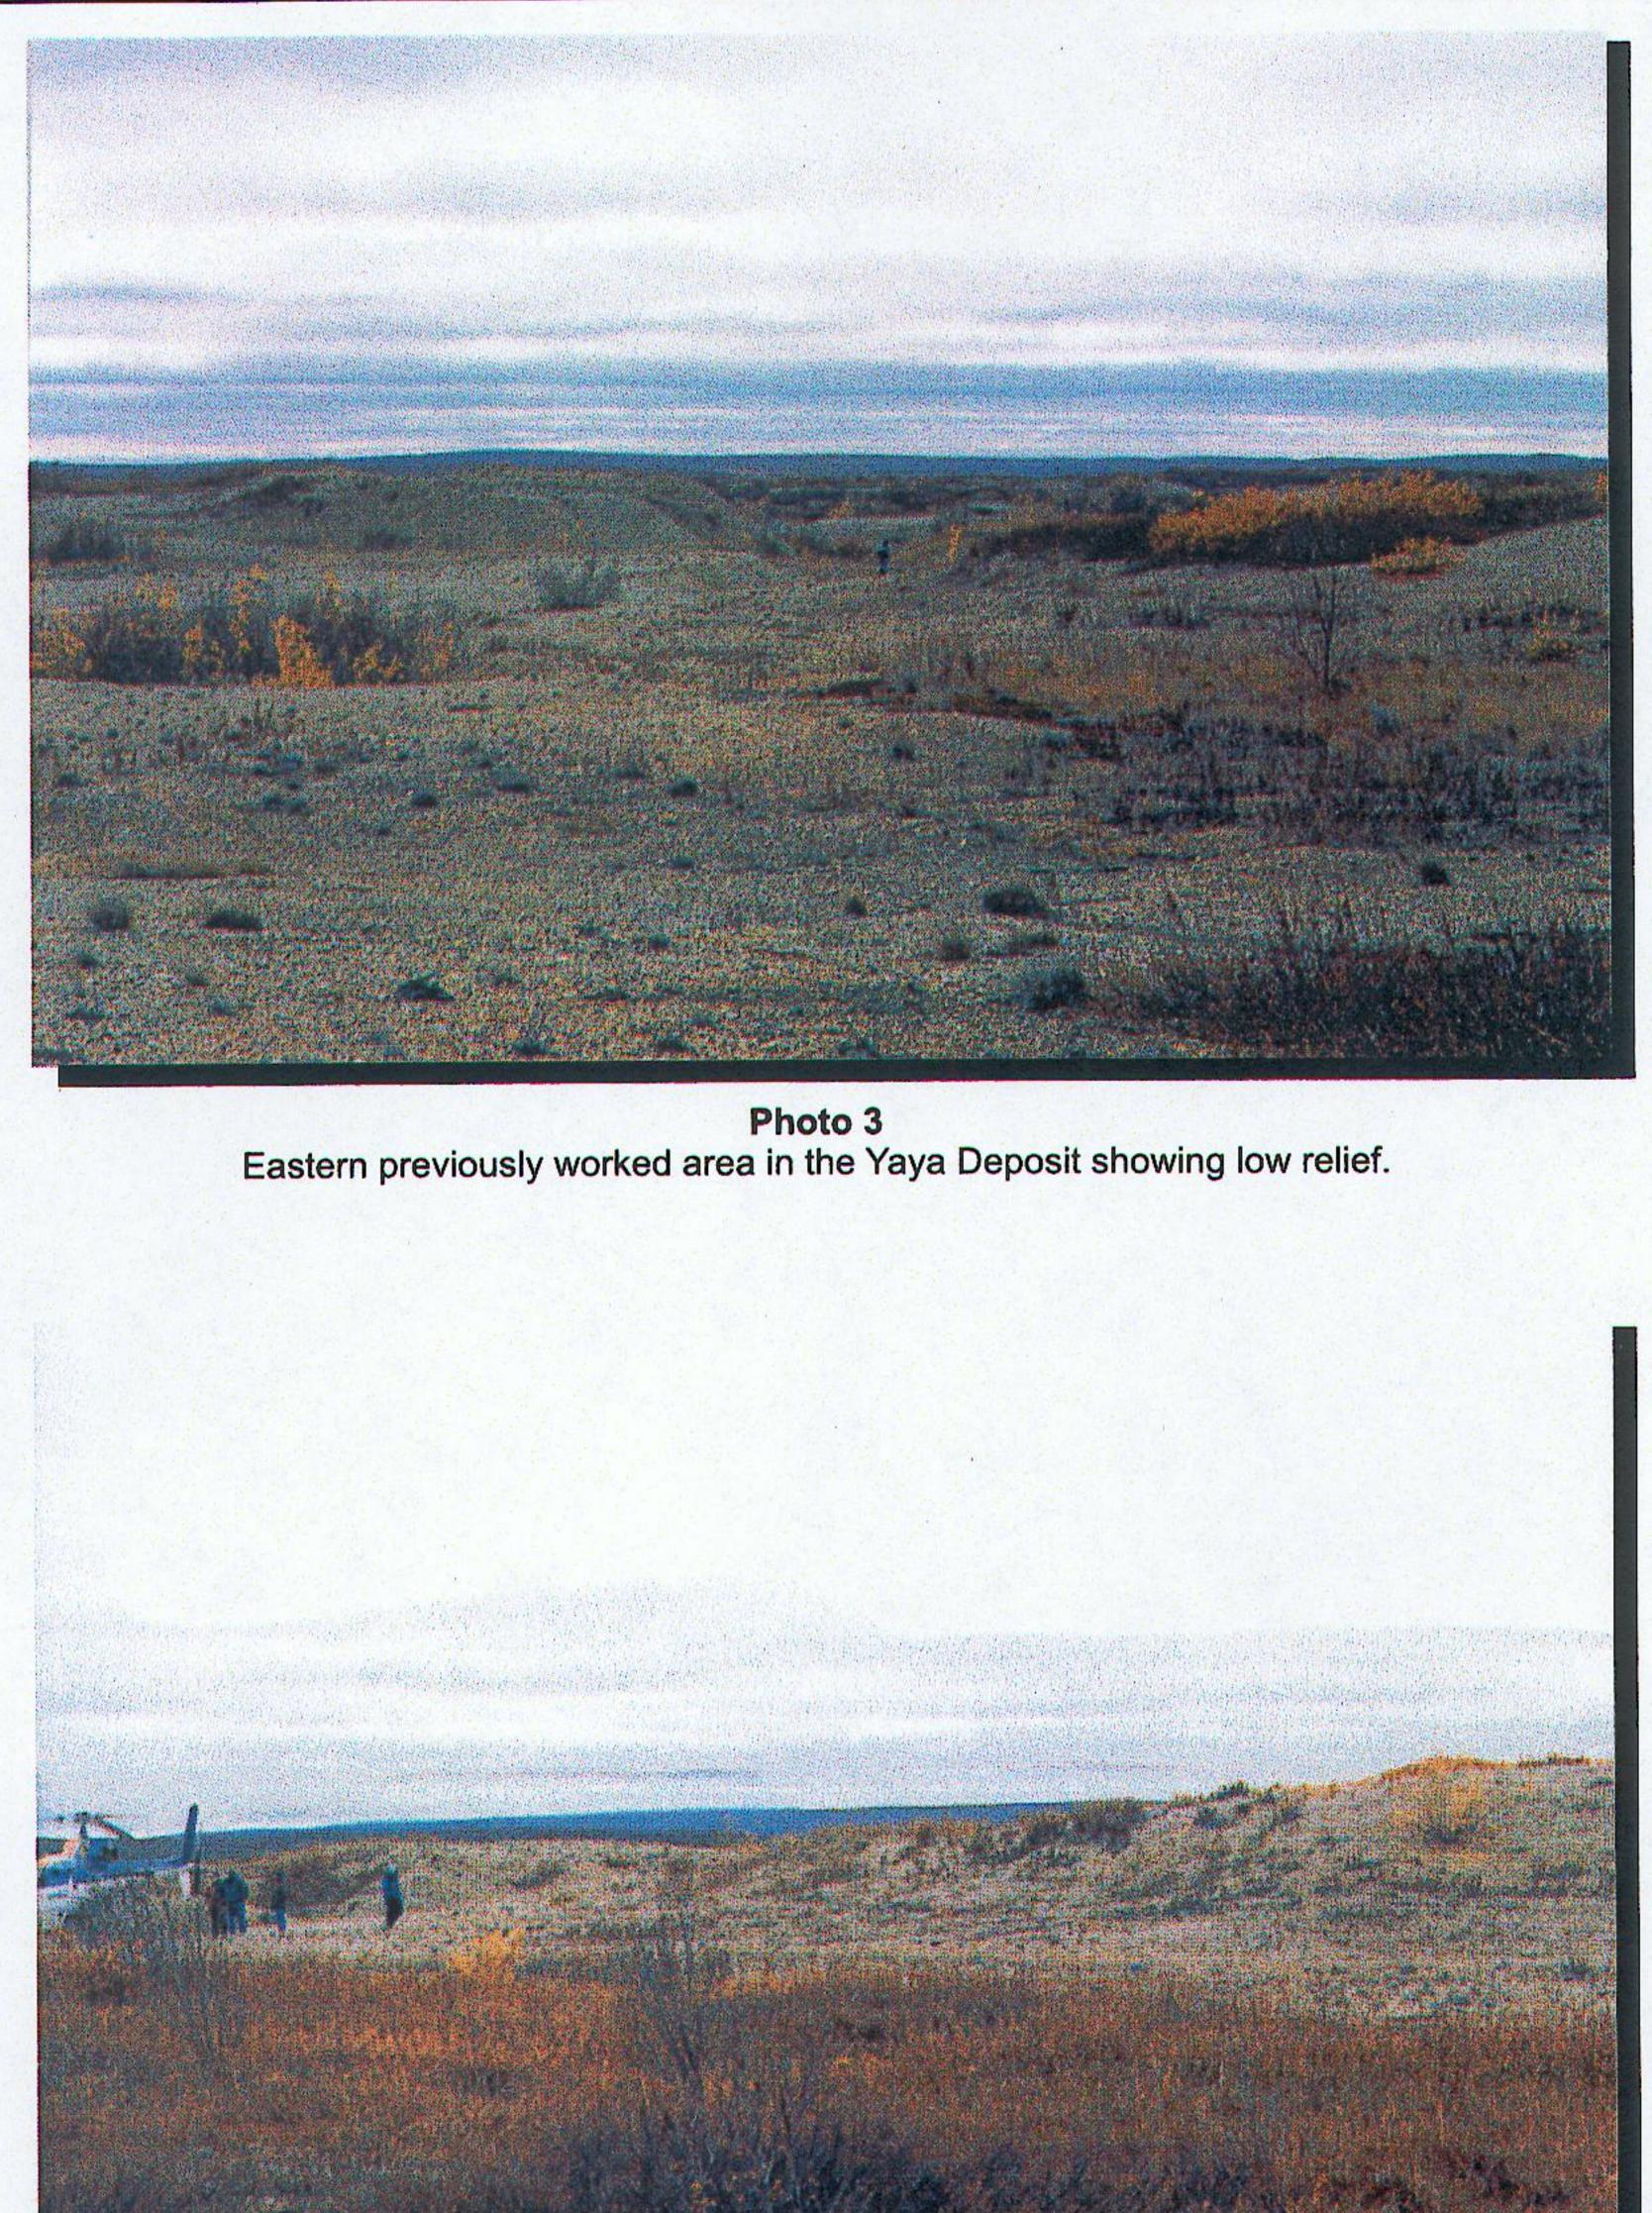
#### **Photo 4** Gravelly sand ridge is along the edge of previously leased workings in eastern part of the Yaya Deposit.

appropriate models for the interpretation of geophysical profiles. Photos 3 and 4 from the eastern stripped area (near GPS Waypoint 69° 06.408'N 1340 36.436'W) show terrain which has lower relief and is typical of this area.

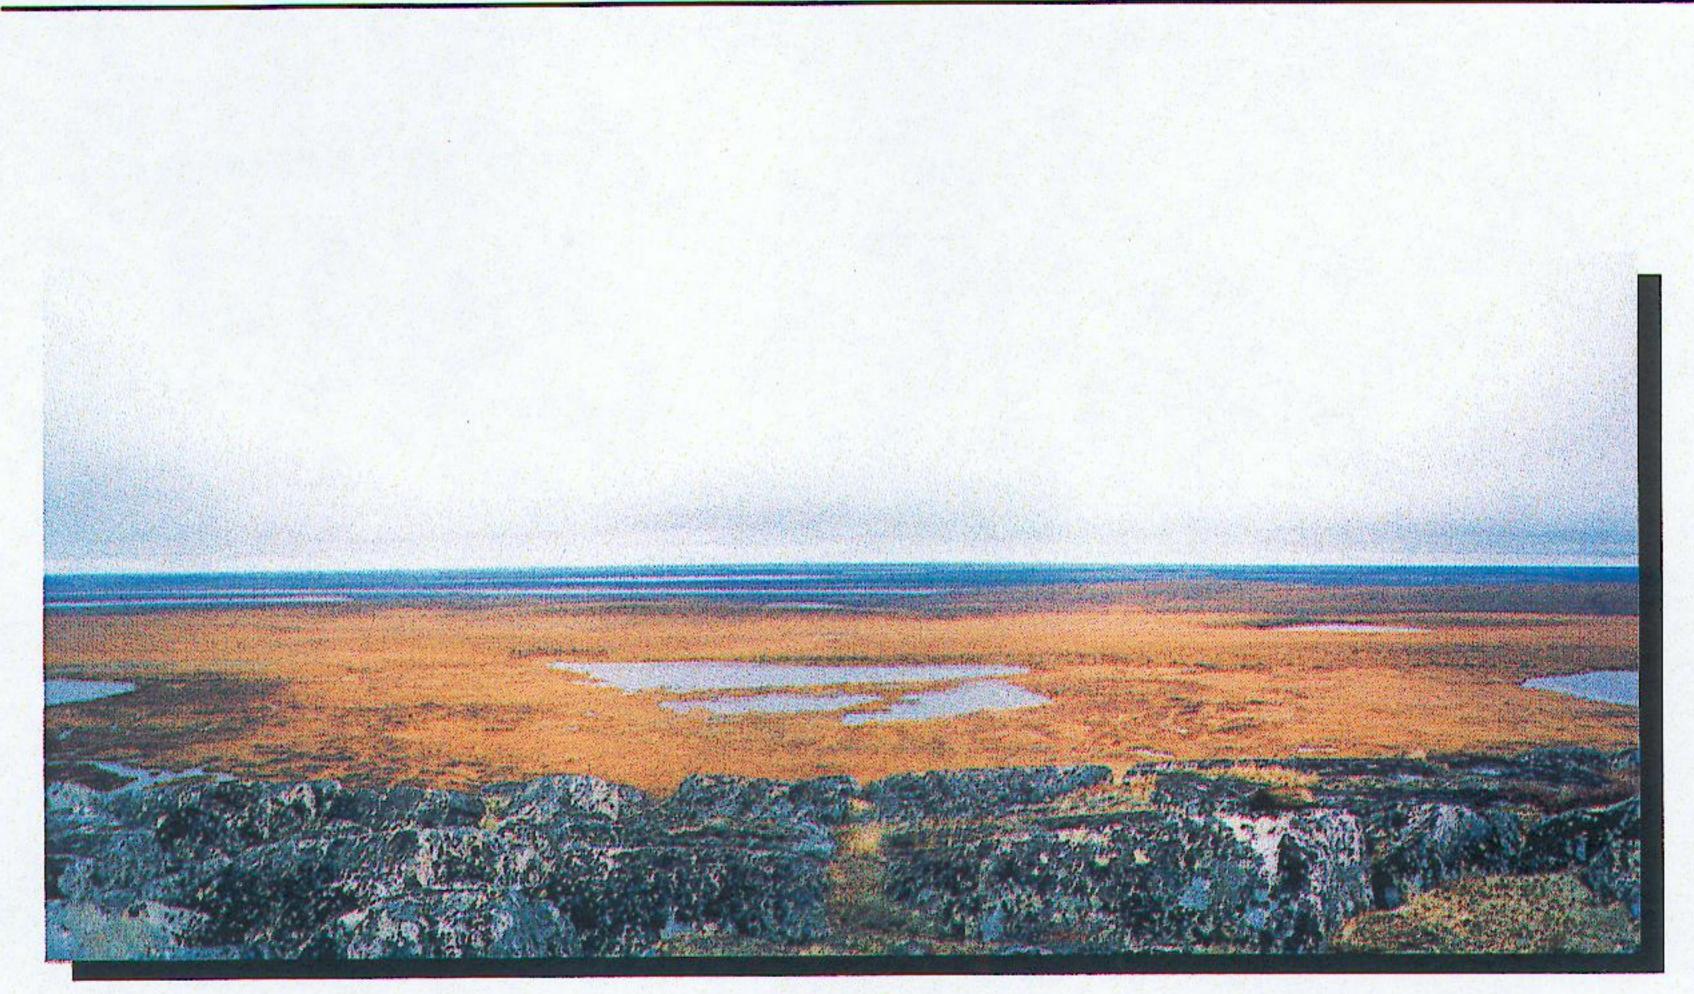
Photo 5 View to the river from the top of Site 464-SE.

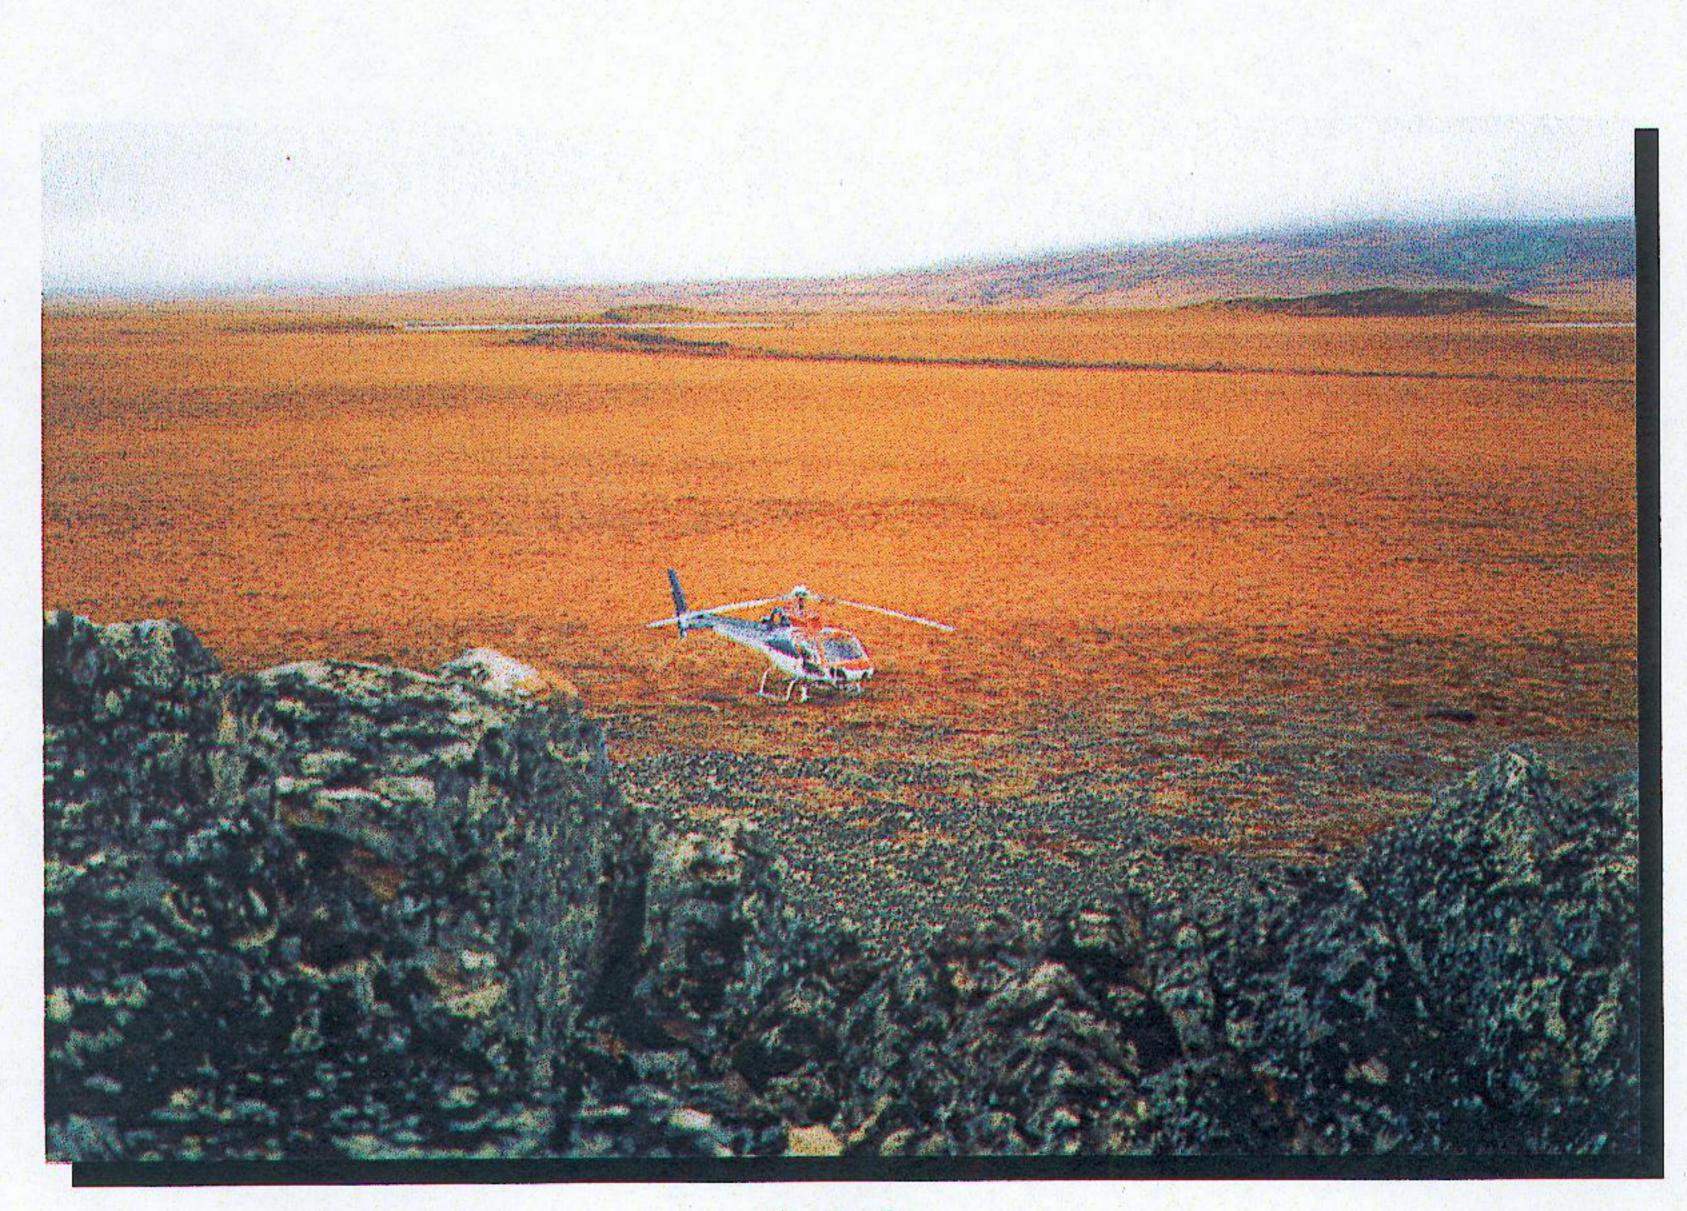
## Photo 6 View off the west side of Site 464-SE.

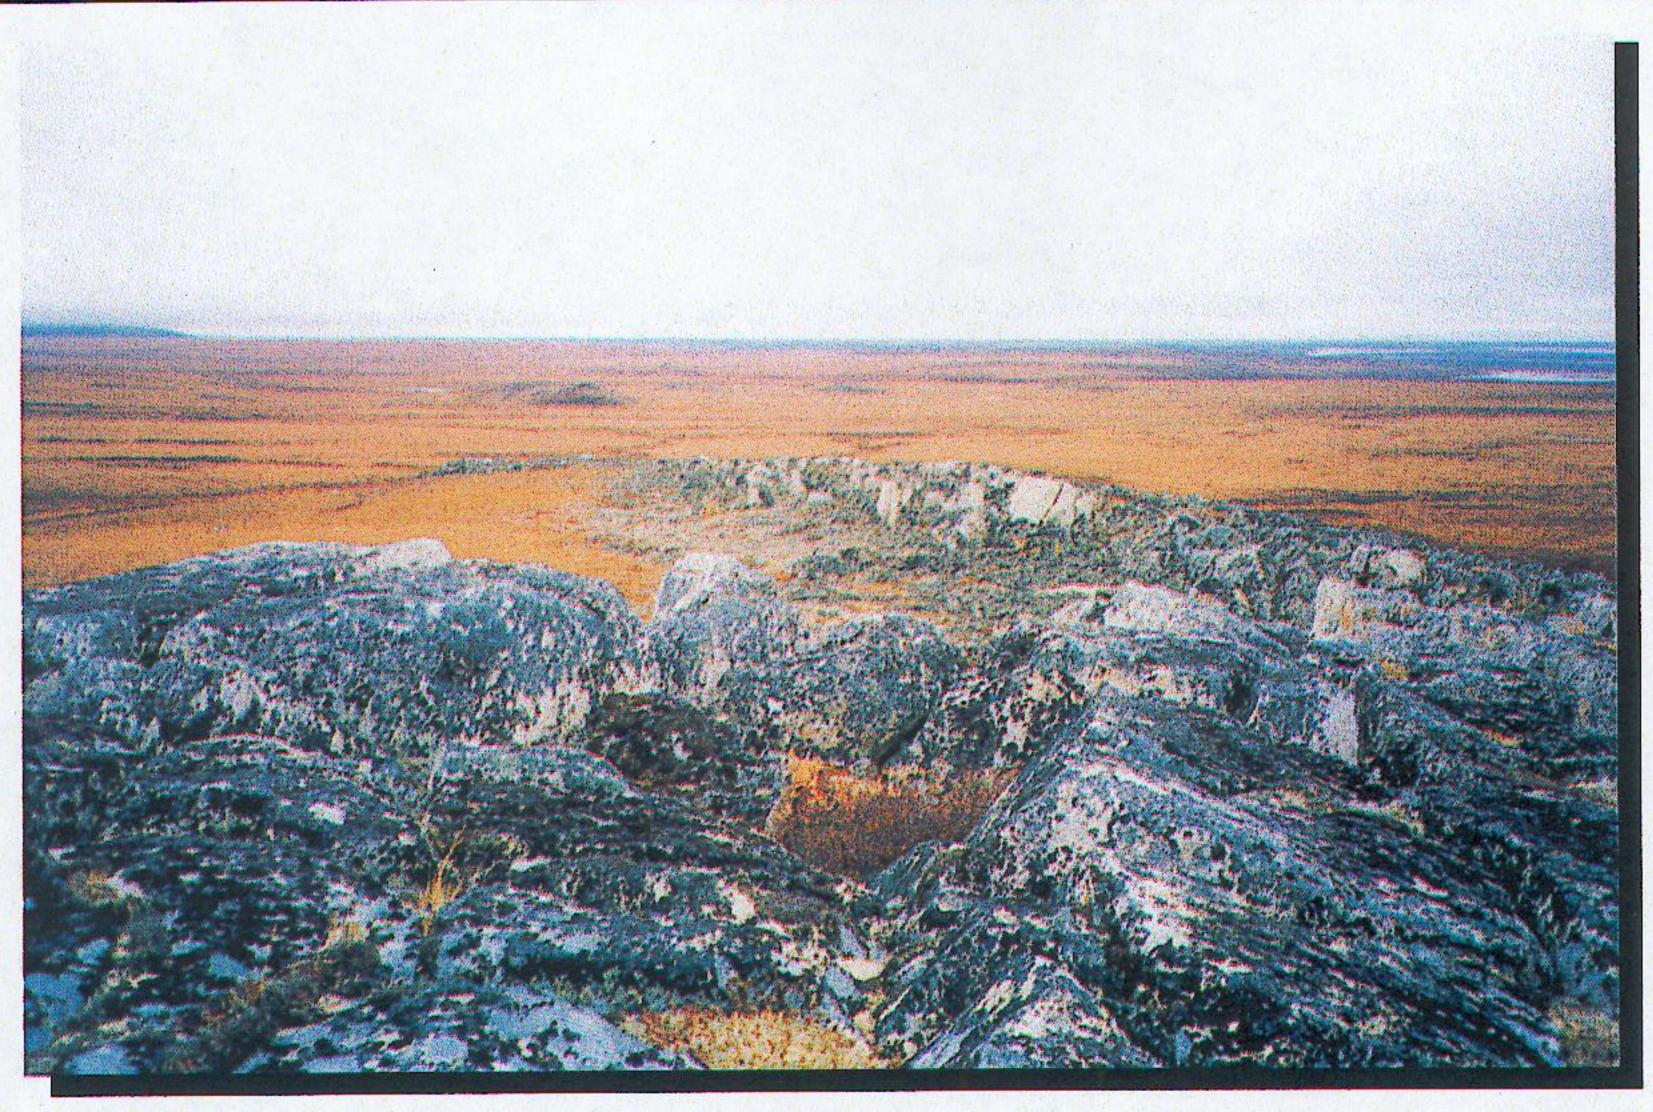
The central portion of the deposit is about 20 m high on the back (west) side and about 45 m high on the river (east) side. The deposit extends for about a kilometer but the most likely area for a quarry is estimated to be only about 250 m long. The width of the outcrop is estimated to be 150 m at the base. The volume of recoverable rock is estimated to be about 625,000 m<sup>3</sup>. A proper survey is required to reliably define the dimensions. Photo 7 shows the lower ridge tailing northward from the central part of the site.

# Photo 7 North end of Site 464-SE showing lower ridge tailing towards the northwest.

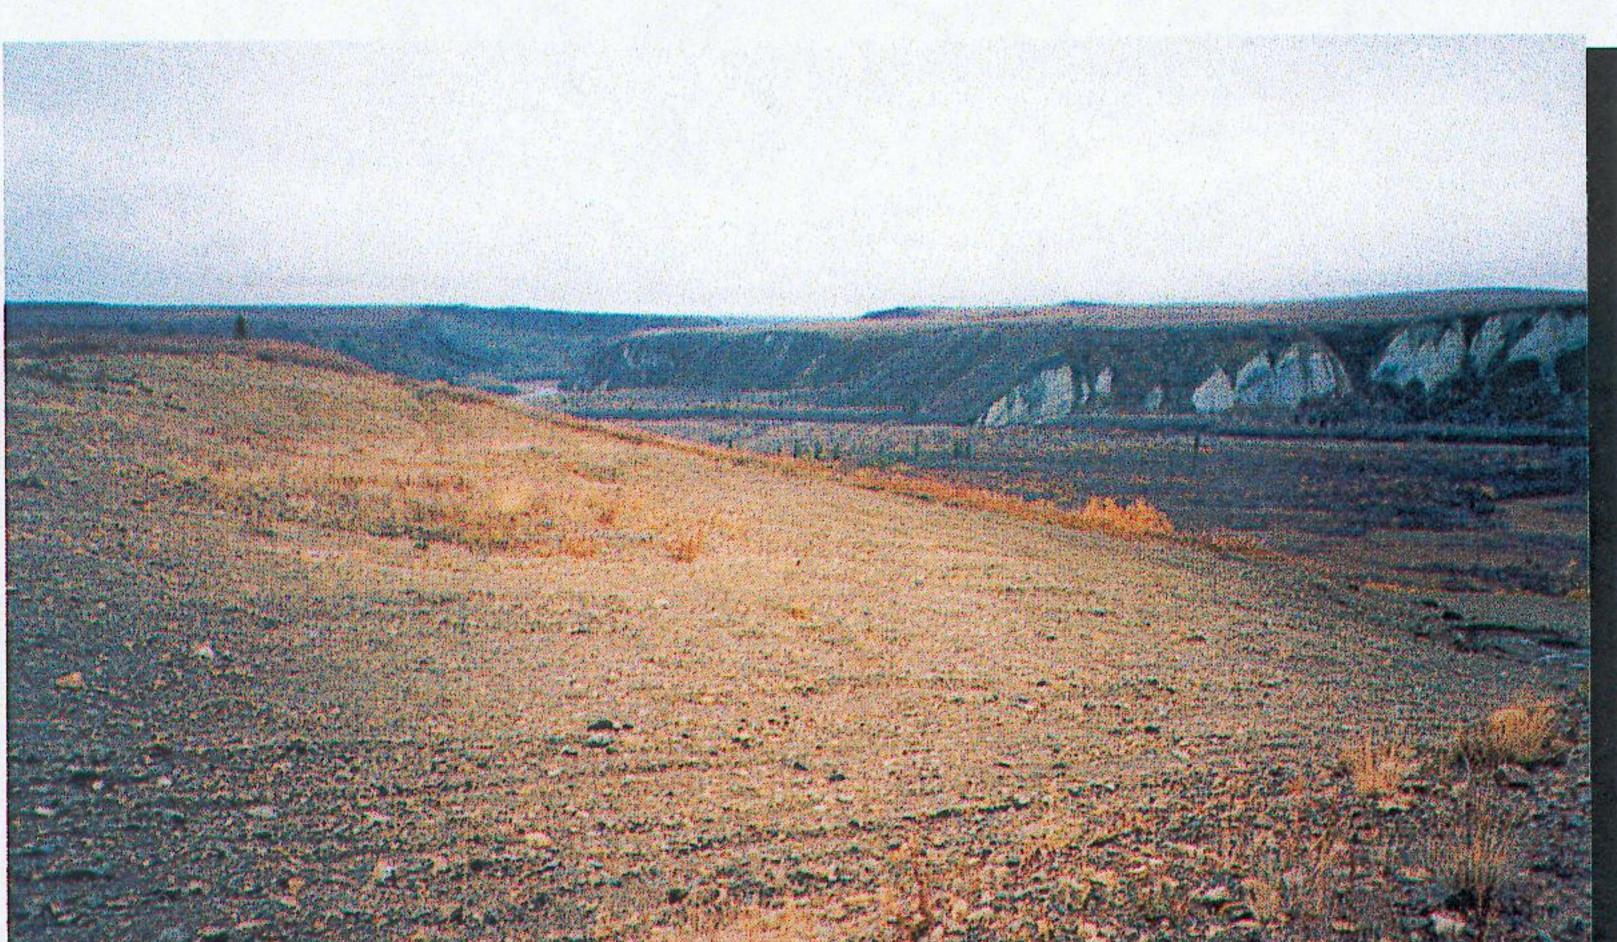
The material exposed on the pit face was typically sandy gravel with occasional rounded cobbles. At the end of summer the material was loose and dry. There were few signs of collapse areas or small slumps that would suggest ice rich zones had thawed during the past summer. At the toe of the deposit, there were signs of a modest level of drainage runoff cutting into the haul road and over it onto the slope below. The overburden cover at the level of the upland plateau was very thin. Photo 8 shows the east end of the pit face and in the background the Lower Canyon can also be seen.

## Photo 8 The face of the Willow River Pit appears in the foreground and the Lower Canyon appears in the background.

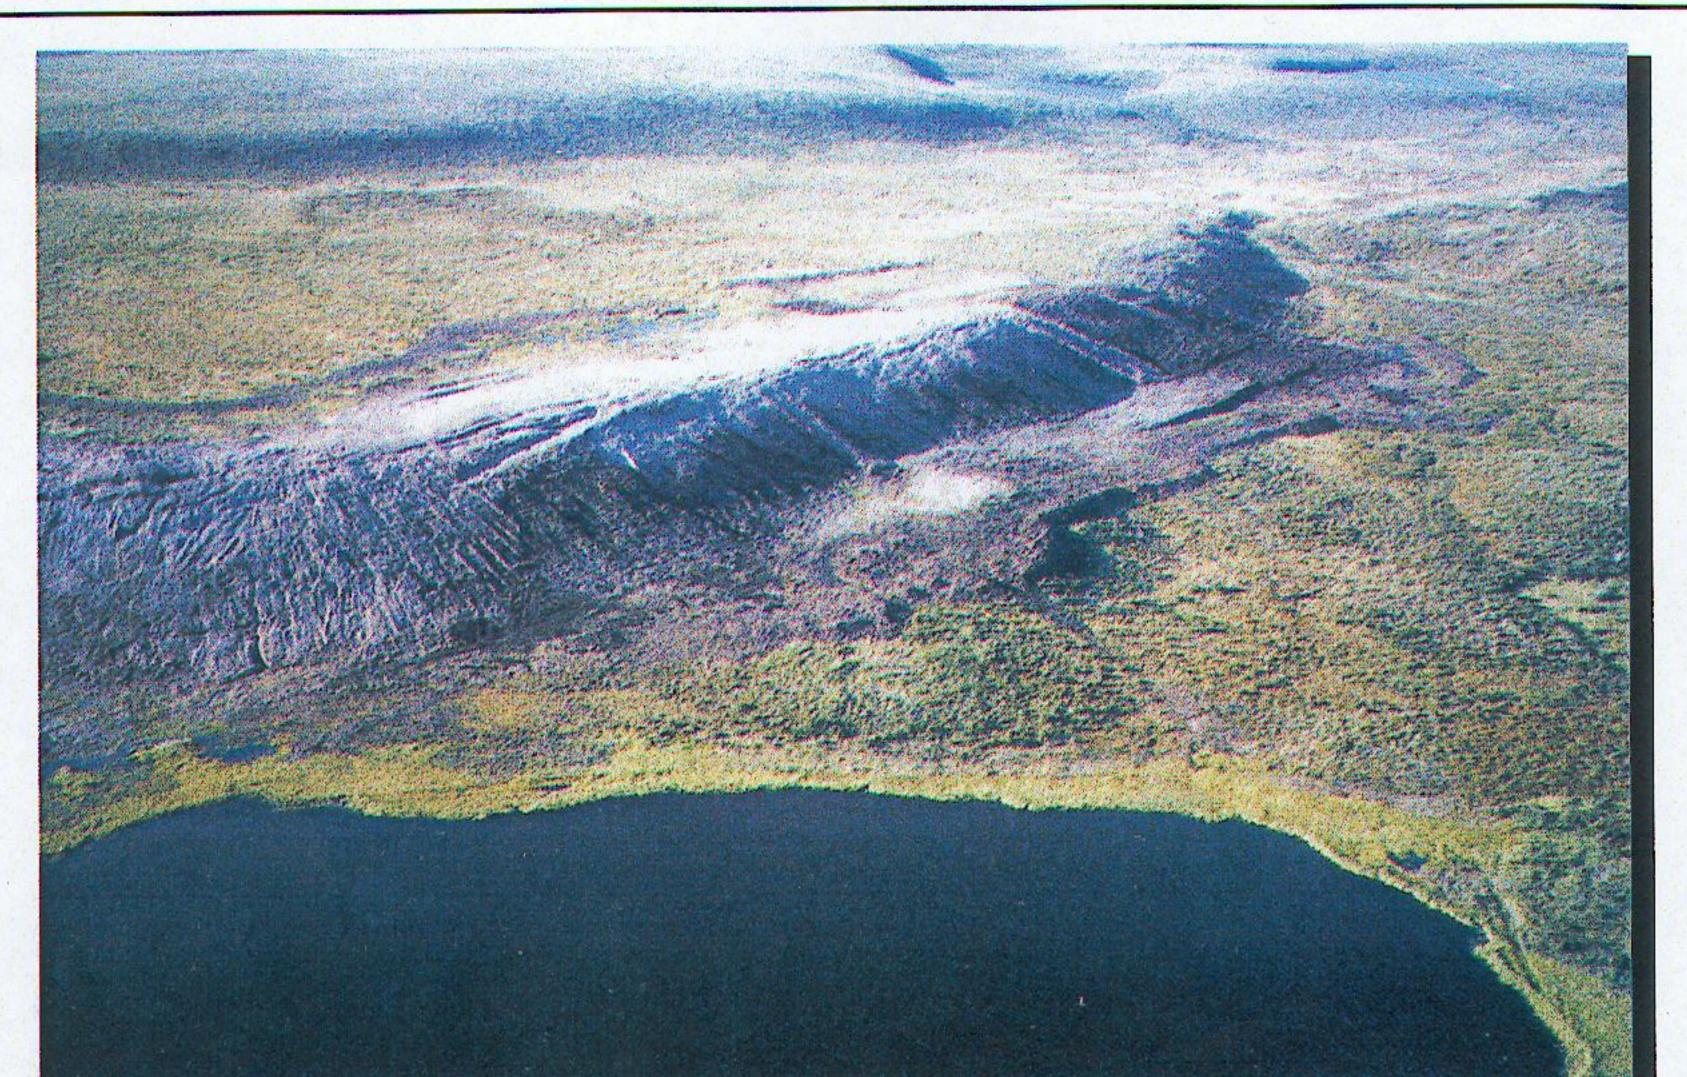
## Photo 9

Photo 9 (from September 2001) shows that the main deposit is located on the crest of a hill approximately 25 m above the tundra level to the north. The best materials appear to be confined to a narrow ridge along the hill crest. Typically, it is comprised of gravelly sand to sand with some gravel (top-size about 150 mm). There are also some silt, occasional isolated boulders and rafted sandstone blocks. The ends of the deposit appear to be of finer gradation than the central region. In several areas there are thaw slumping features that suggest the deposit contains ice rich zones (see Photo 10, also from September 2001).

Tuk Pit 177 in September 2001. Stripped area visible is about 350 m long. (View to the southwest)

The PWC borehole logs provide enough data for a relatively complete assessment of the northern-most gravel ridge where material has been excavated in recent years. However, there are records for only two testpits in the other areas of the deposit. It appears prudent to evaluate the others areas more thoroughly. First, a geophysical survey using GPR techniques should be completed. GPR should be able to map the extent of coarse sand, such as are found in the northern ridge, and would be able to map massive ice or very ice rich zones. Conductivity measurements made during the reconnaissance visit ranged from 2.2 to 8 mSiemens/m on the gravel ridge and were about 5.4 mSiemens/m on the surrounding tundra. Therefore, resistivity techniques are not recommended.

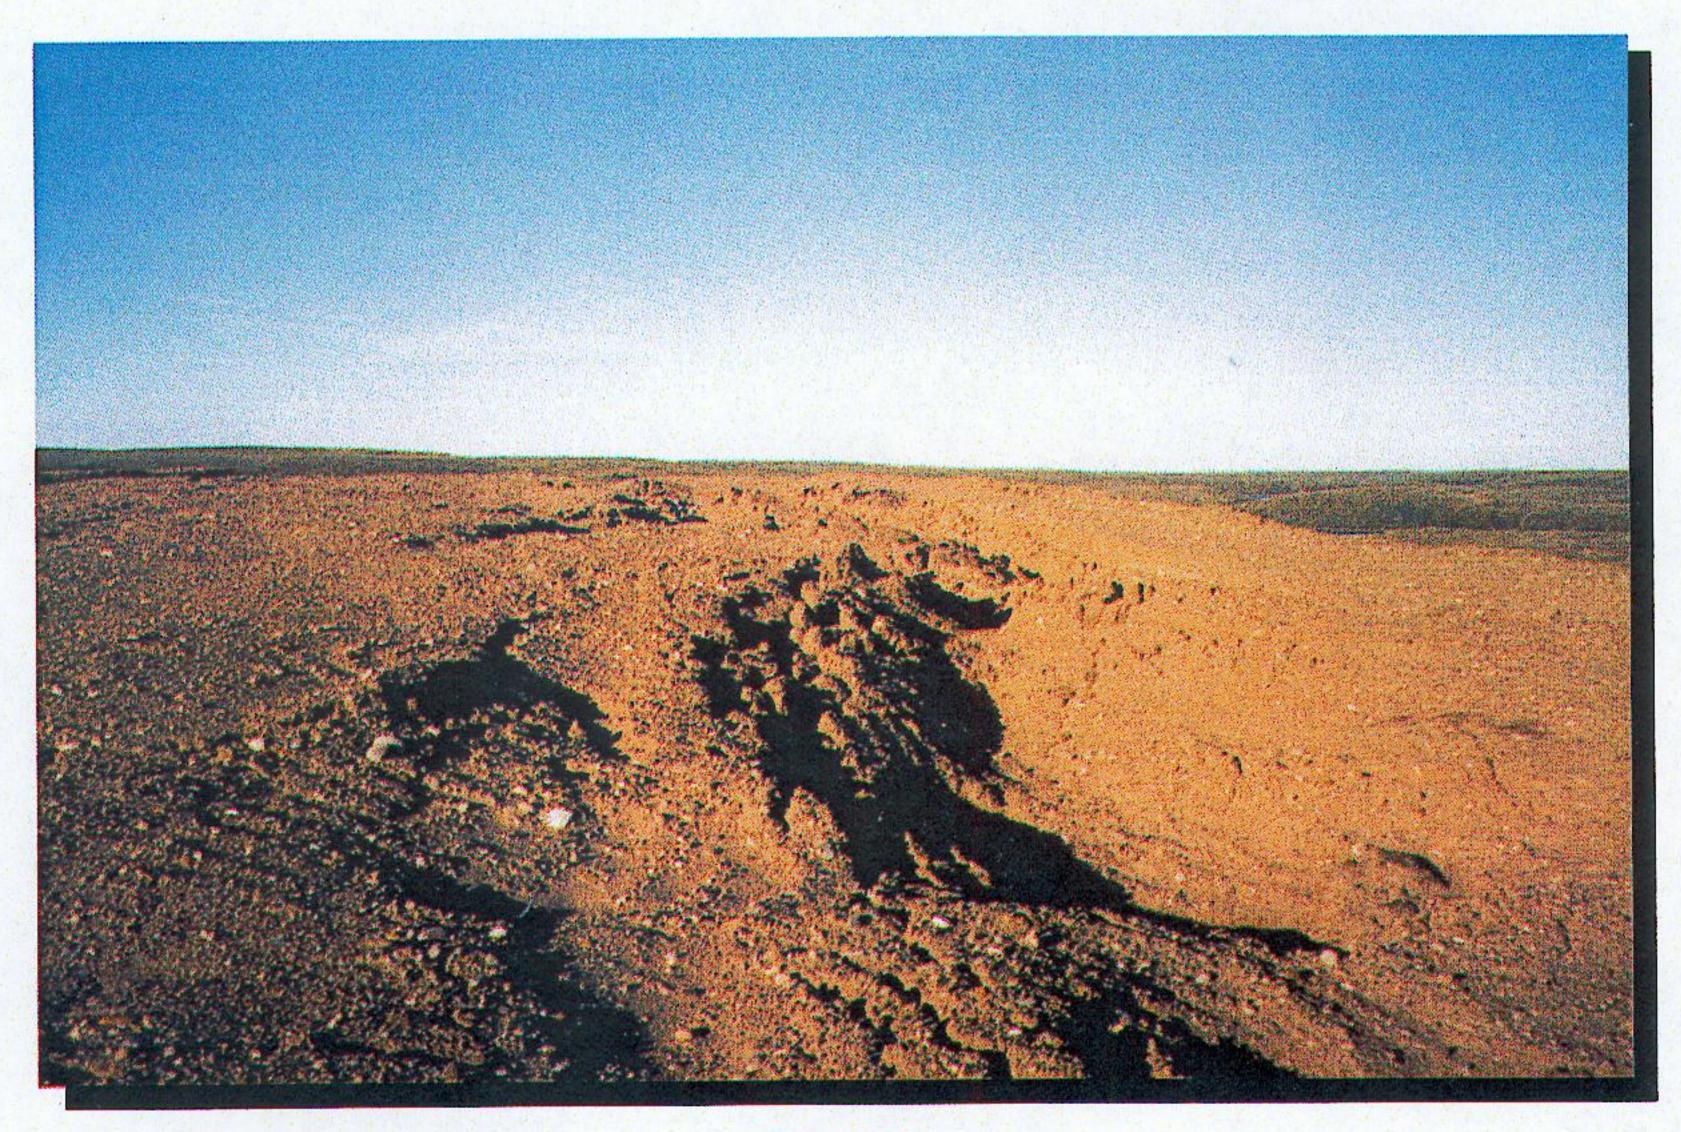
## Photo 10 Tuk Pit 177 (view to west) in September 2001. Top of ridge with ground-ice melt out cracks and minor slumps.
