TESTS TO DEFINE LEVELS  
OF TERRAIN DAMAGE  
BY TRACKED VEHICLES OPERATING  
ON TUNDRA

A Report submitted to  
The Department of Indian Affairs  
and Northern Development  
Government of Canada

MUSKEG RESEARCH INSTITUTE  
UNIVERSITY OF NEW BRUNSWICK

December 1970

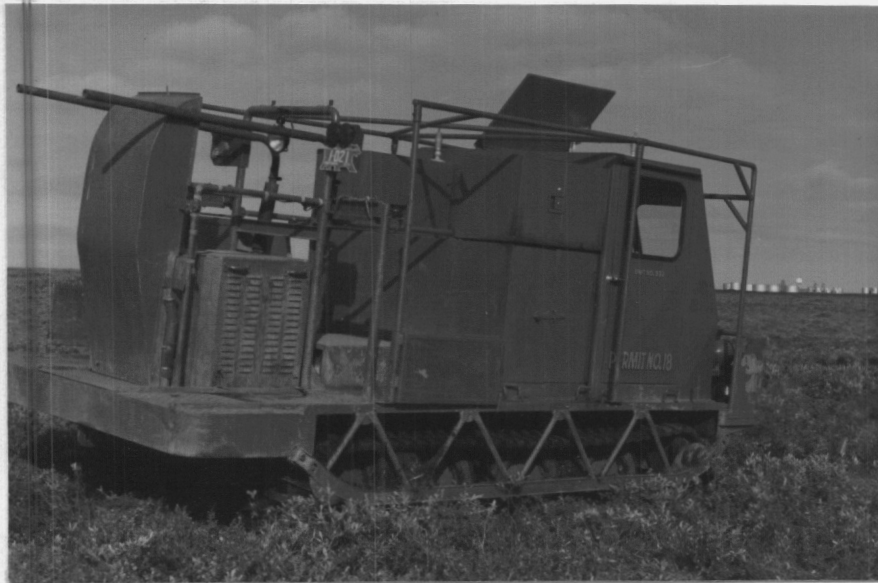
Fig. 5. Light tracked carrier.

Phase I tests were performed at Tununuk, in four sites. Vehicles used included a light tracked carrier (Fig.5), a light-medium four tracked carrier, a medium tracked carrier, and a

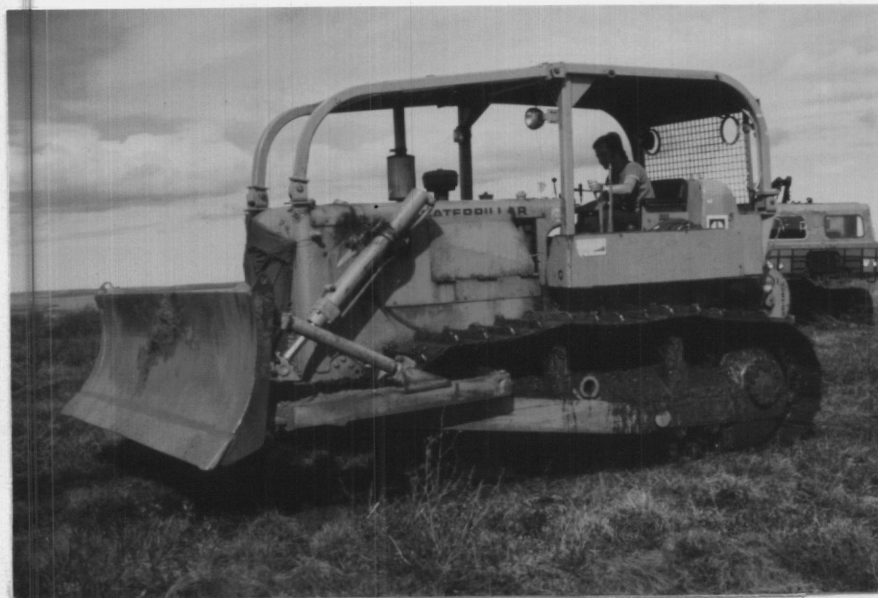
Fig. 6. Medium tracked bulldozer.

medium tracked bulldozer (Fig.6). At each site, test lanes at least 100 ft. in length were laid out and one vehicle was driven back and forth in each lane. Photographs of the tracks were taken after one, five, ten, twenty, forty, sixty, eighty and one hundred passes (it was previously determined that one hundred passes is a typical number in some vehicle operations). The vegetative cover, depth to frost, surface profile, slope and ground temperature were noted at each site, and soil and vegetation samples were taken for later analysis. An attempt was also made at one site to measure drawbar pull of some vehicles and simultaneously photograph the ground immediately behind the vehicle tracks during the test. In this way it was hoped that it would be possible to correlate vehicle weight and track design, drawbar pull and terrain surface disturbance.

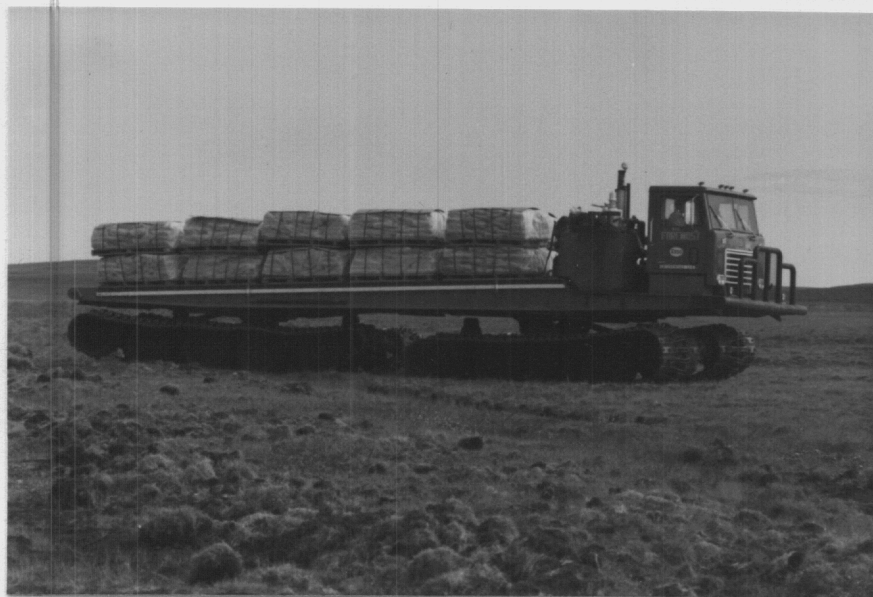
Fig. 7. Heavy 4 tracked carrier.

The tests carried out at each site depended on the vehicles available at the particular location. Phase II was carried out during two different periods of time as a part of an attempt to assess the effects of seasonal climatic variations on terrain conditions. The first series of tests was performed during the latter half of August. At Tuktoyaktuk, test vehicles included a medium tracked carrier fitted with a seismic drill, a light tracked carrier loaded with a magazine and cement, and a heavy four tracked carrier loaded with 30 tons of cement (Fig.7).

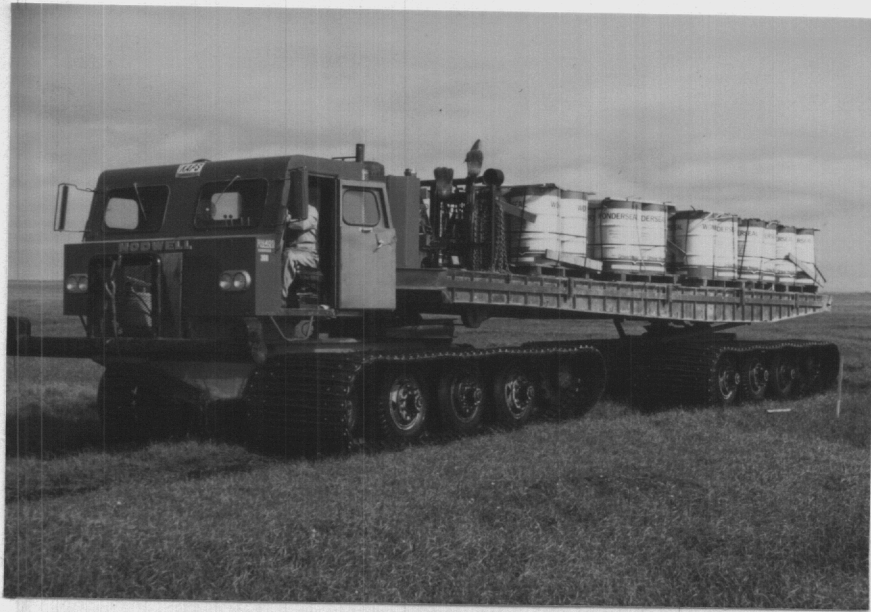
Fig. 8. Four track 20 ton carrier - Prudhoe Bay

Finally, as a supplement to the main program, similar tests in northern Alaska near Prudhoe Bay were observed. A four-tracked twenty-ton carrier (Fig. 8) and a two-tracked 8 ton carrier (Fig. 9) were operated over test lanes 1000 ft. in length (Fig. 10). After each pass was completed, the vehicle turned around outside the test lane and travelled back over the same path. This was repeated for a total of either 10 or 20 passes depending on the extent to which the terrain became disturbed.

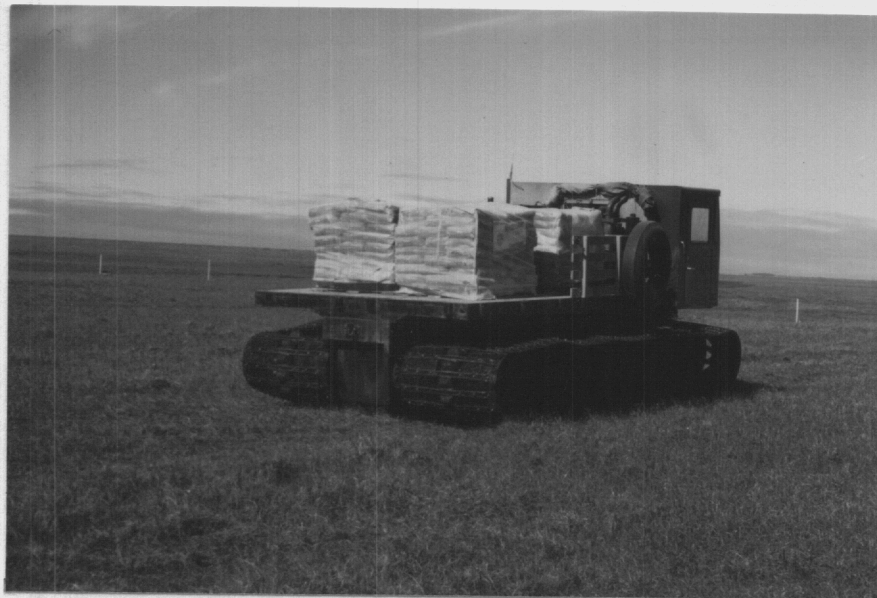
Fig. 9. Eight ton tracked carrier

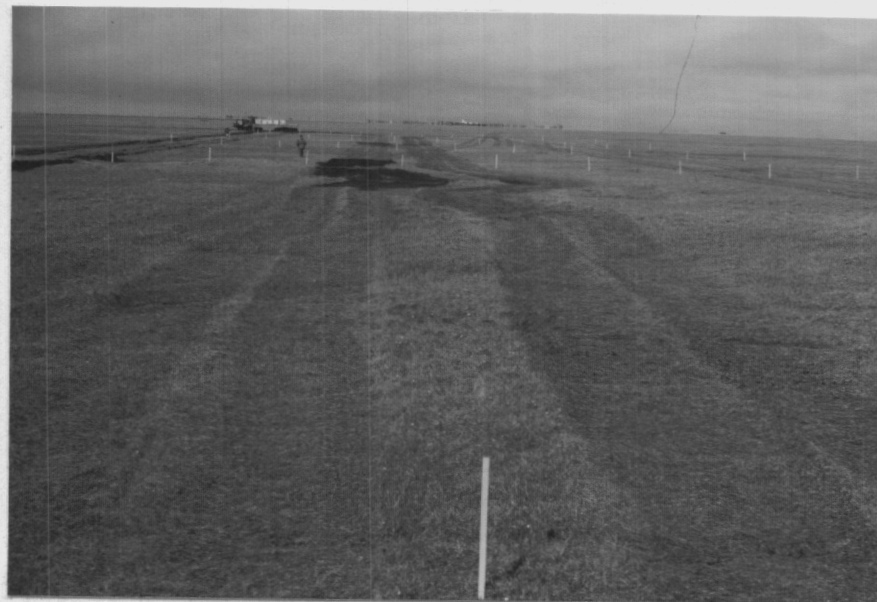
Fig. 10. Test site in Alaska near Prudhoe Bay

As compared with the Mackenzie Delta sites, the test area in Alaska near Prudhoe Bay was unique. Viewed at ground level the flatness of the landscape was striking, and from the air the boundaries of the depressed centre polygons were clearly defined. Vegetation consisted of sedges and a very few shrubs all of very low stature, as well as moss cover (Fig. 10).

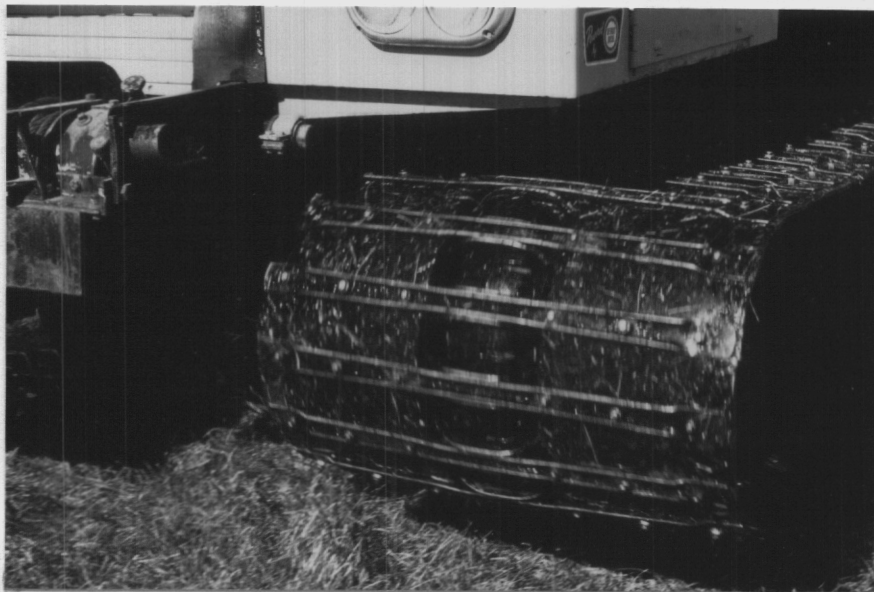
Fig. 19. Flat track on eight ton carrier in Alaska

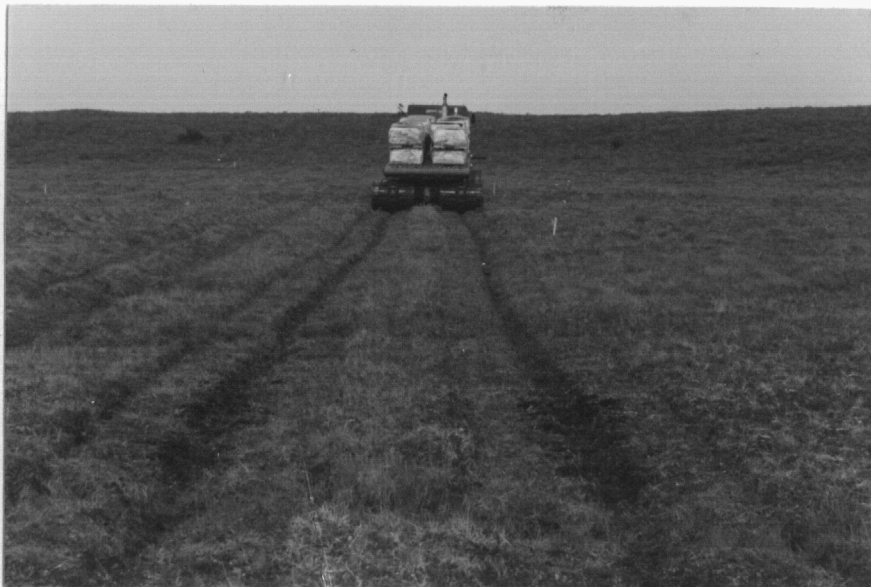
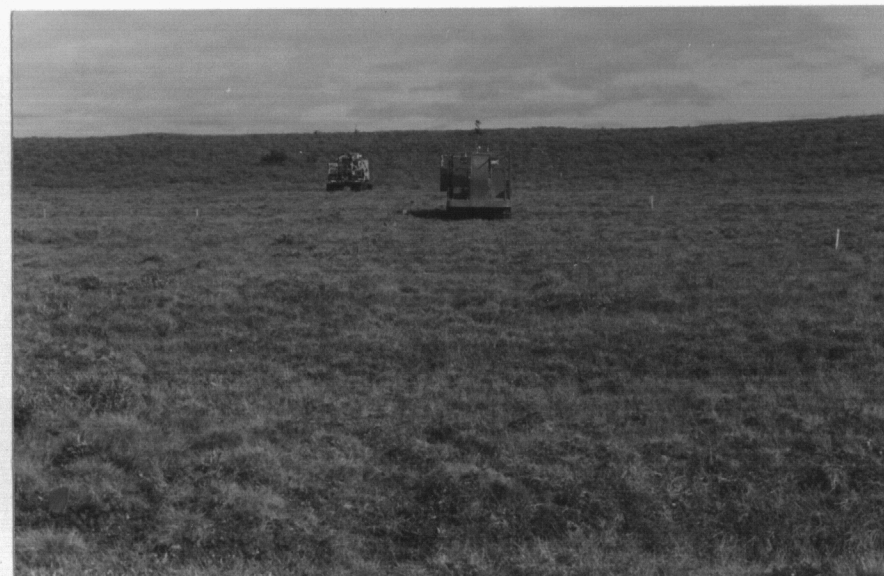
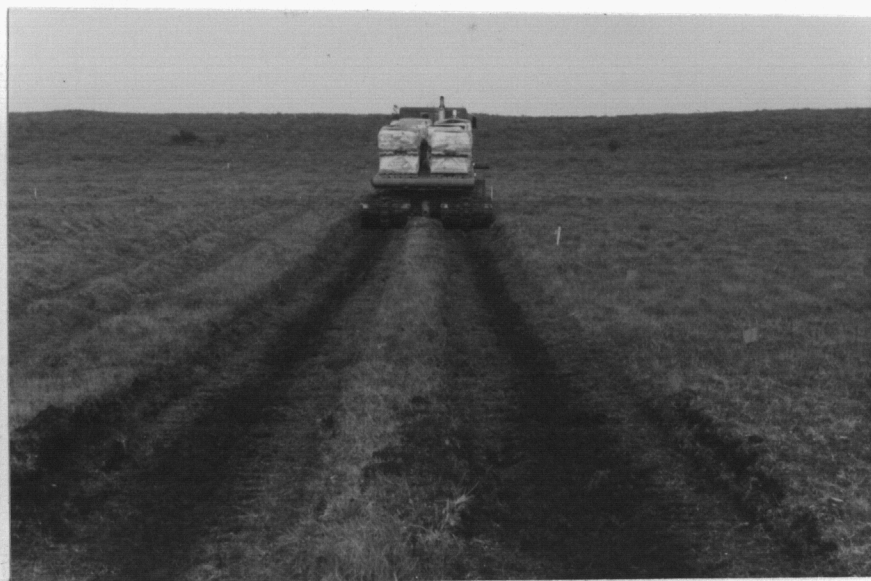
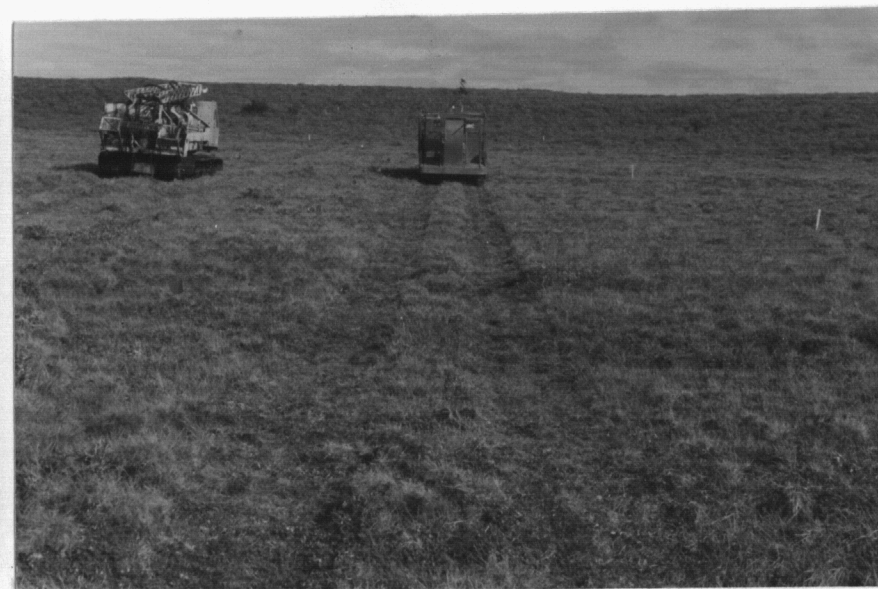
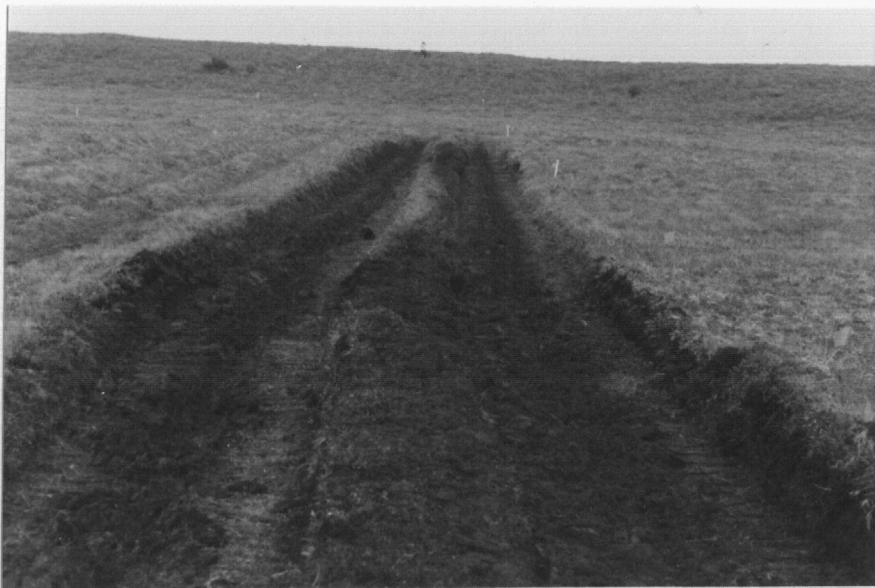
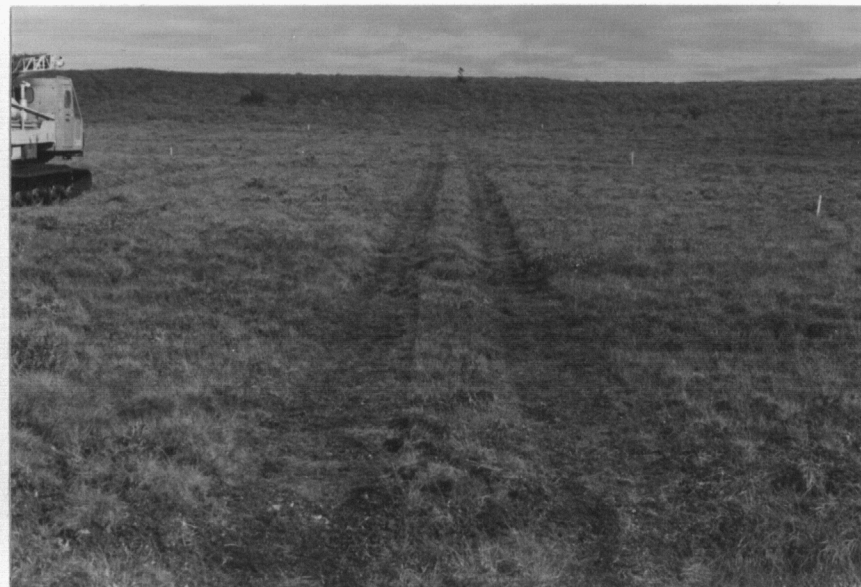
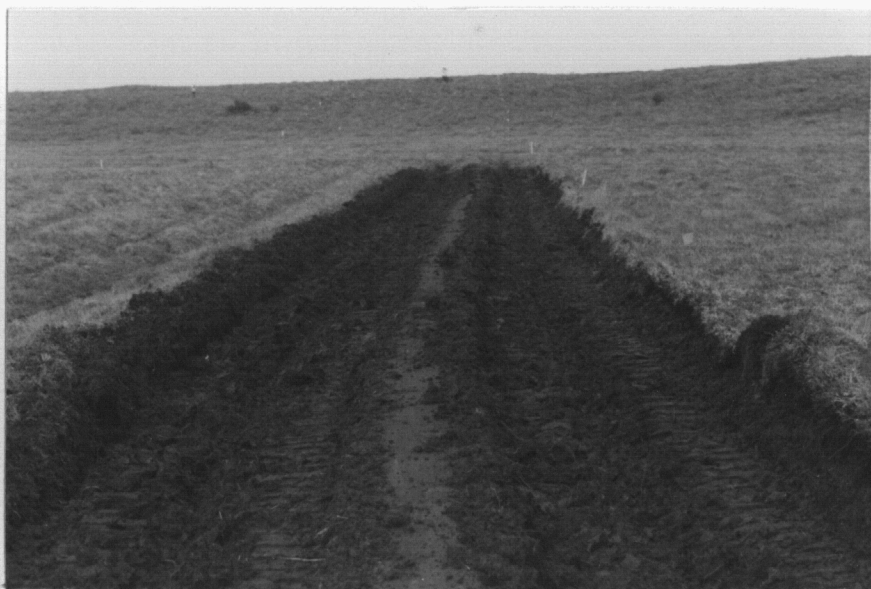
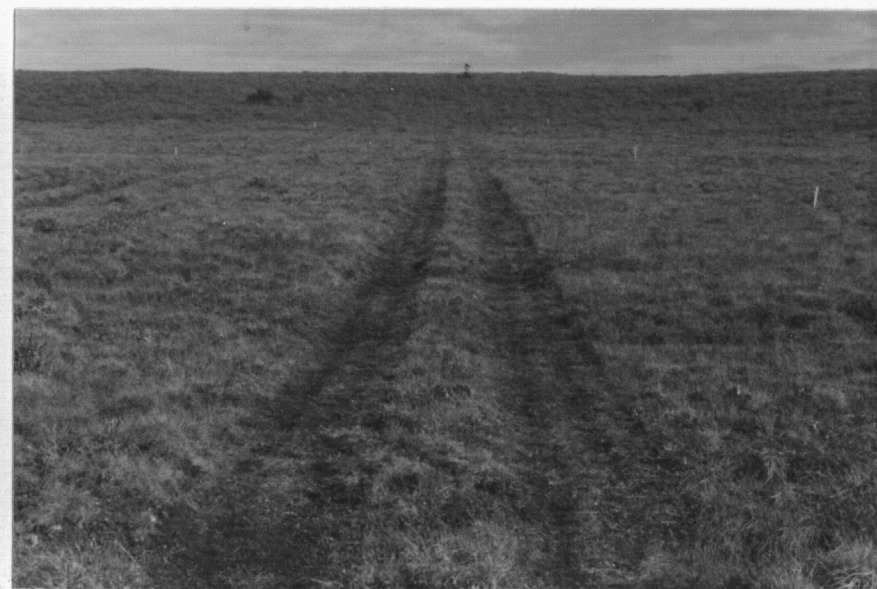
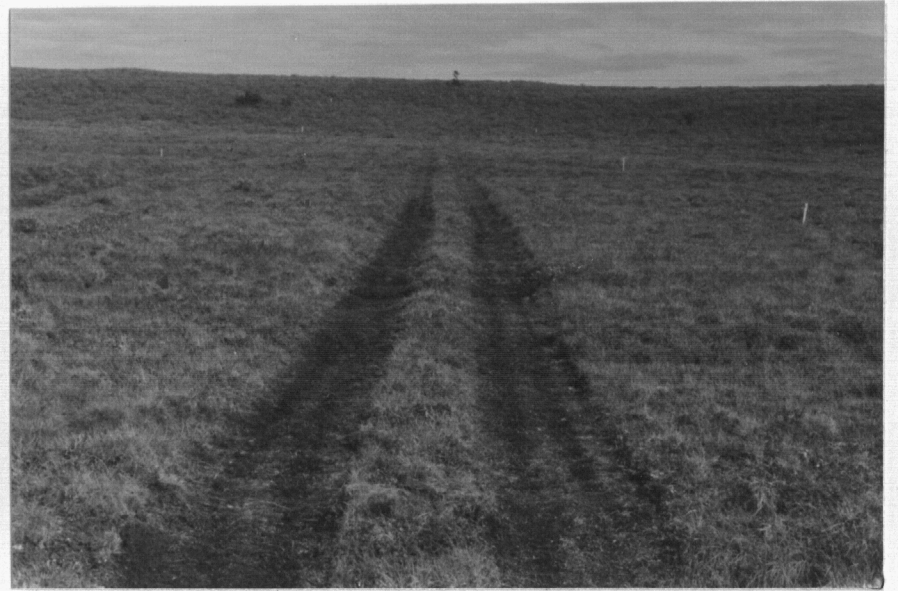
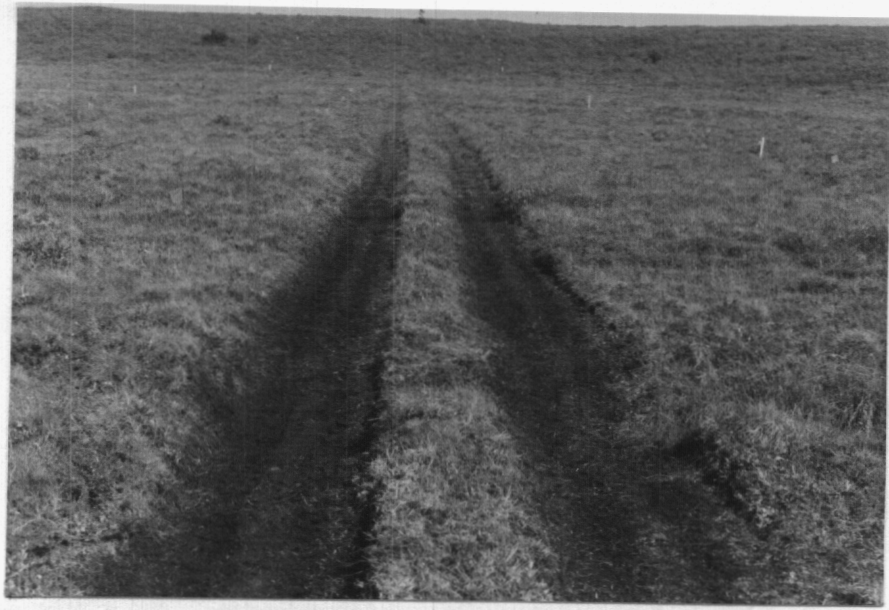
Fig. 20. Tuktoyaktuk, site 1, heavy vehicle 1 pass

Fig. 21. Tuktoyaktuk, site 1, light vehicle 1 pass

Fig. 22. Heavy vehicle 5 pass

Fig. 23. Light vehicle 5 pass

Fig. 24. Heavy Vehicle 10 pass

Fig. 25. Light Vehicle 10 pass

Fig. 26. Heavy Vehicle 20 pass

Fig. 27. Light Vehicle 20 pass

Fig. 29. Light Vehicle 40 pass

Fig. 32. Light Vehicle 100 pass

Figures 33 to 40 show ruts from a similar light vehicle in a very wet area (Shingle Point Site I). If a comparison is made between figures 21 and 33, 23 and 34, 25 and 35, 27 and 36, 29 and 37, 30 and 38, 31 and 39, and 32 and 40, it will be seen that the high ground moisture content at the Shingle Point site has a profound effect on rate of terrain disturbance.

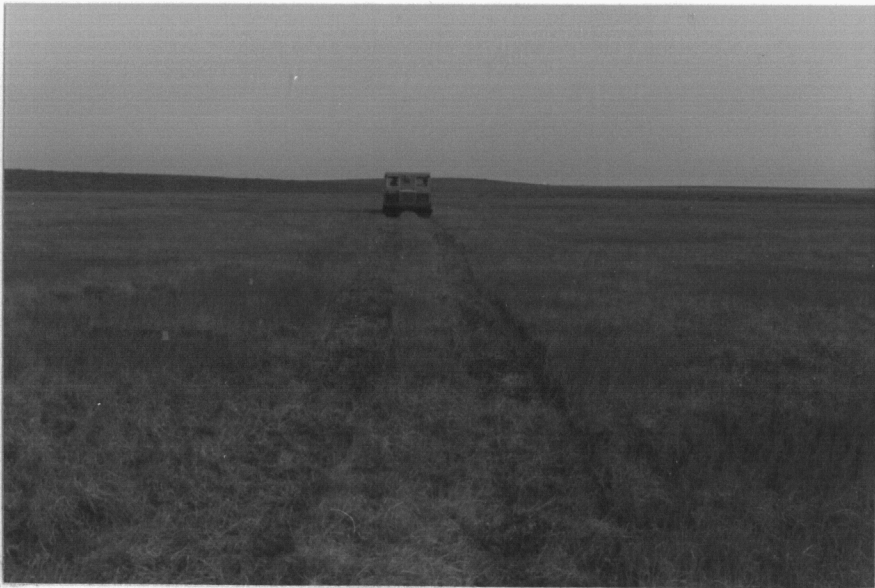
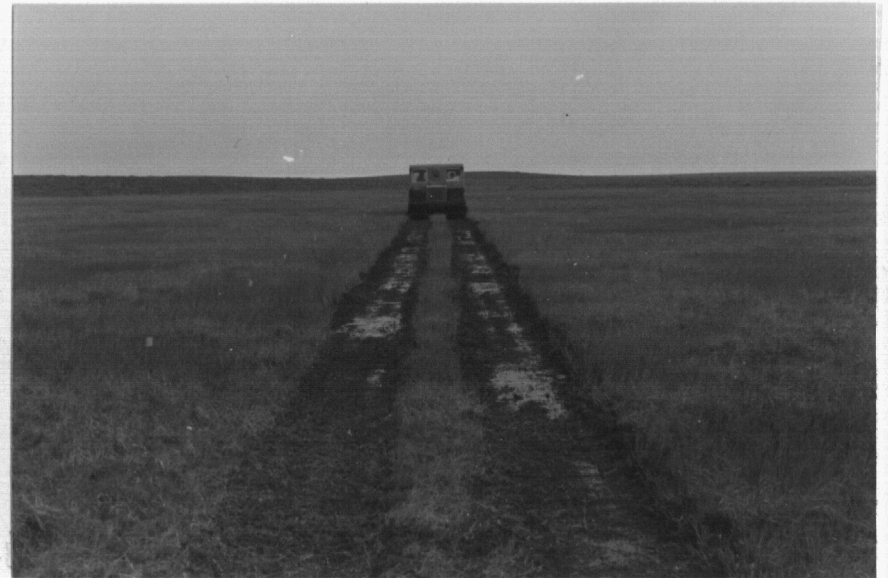
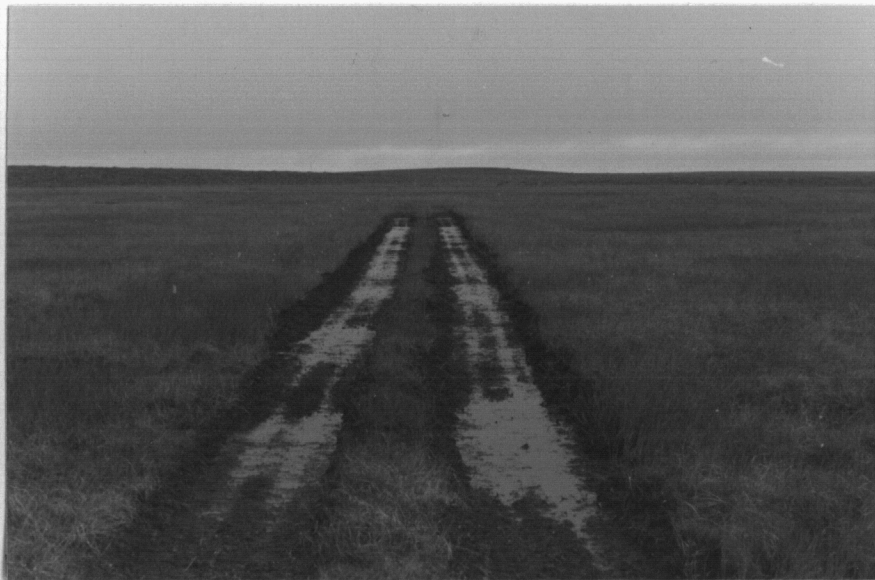
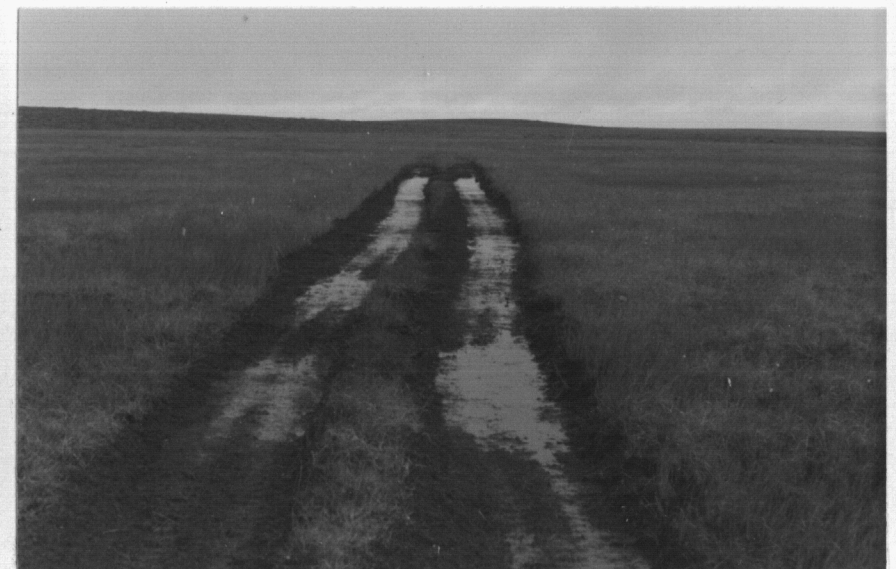
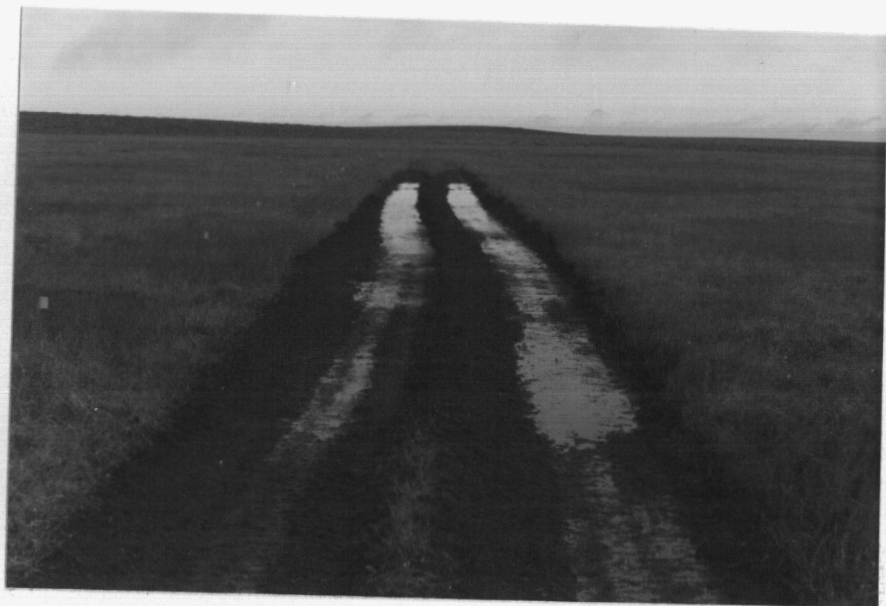
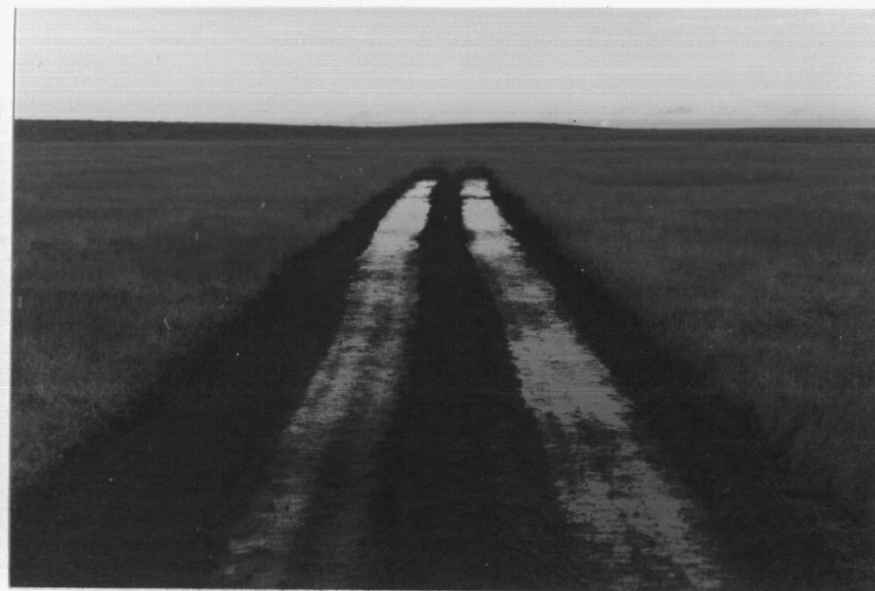
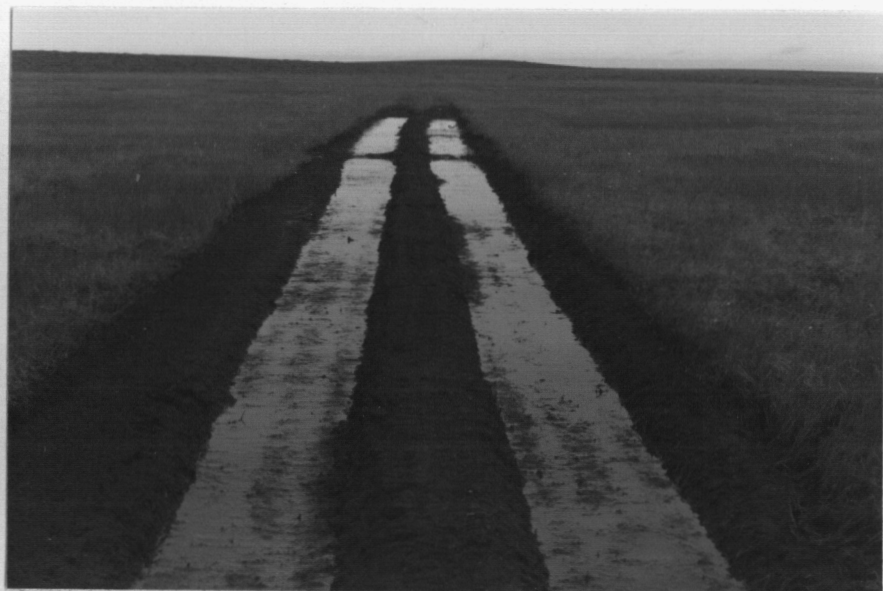
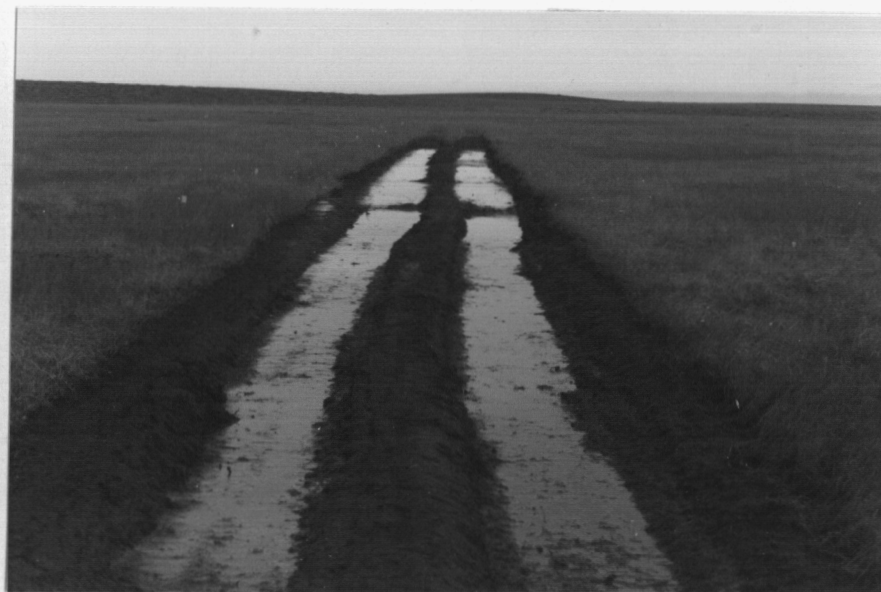
Fig. 33. Shingle Point, site 1,  
Light Vehicle 1 pass

Fig. 34. 5 pass

Fig. 35. 10 pass

Fig. 36. 20 pass

Fig. 37. 40 pass

Fig. 38. 60 pass

Fig. 39. 80 pass

Fig. 40. 100 pass

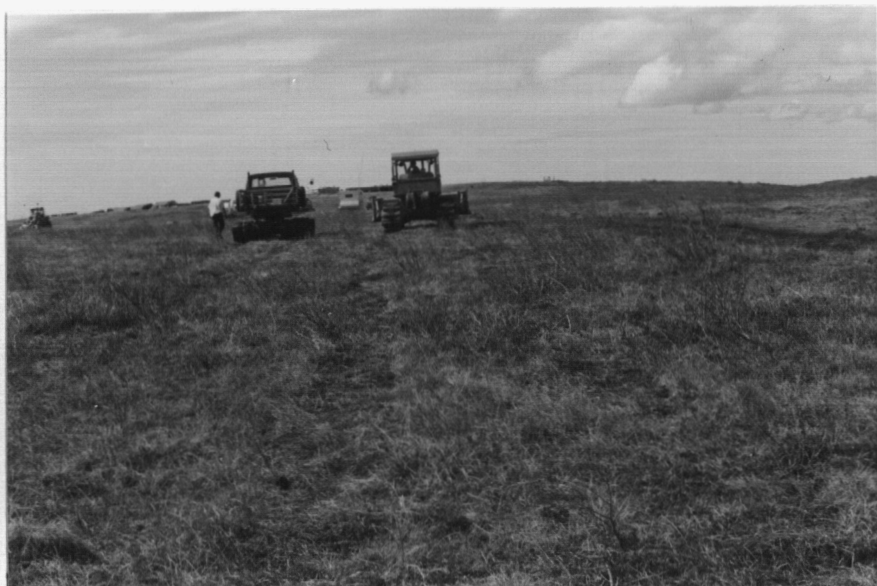
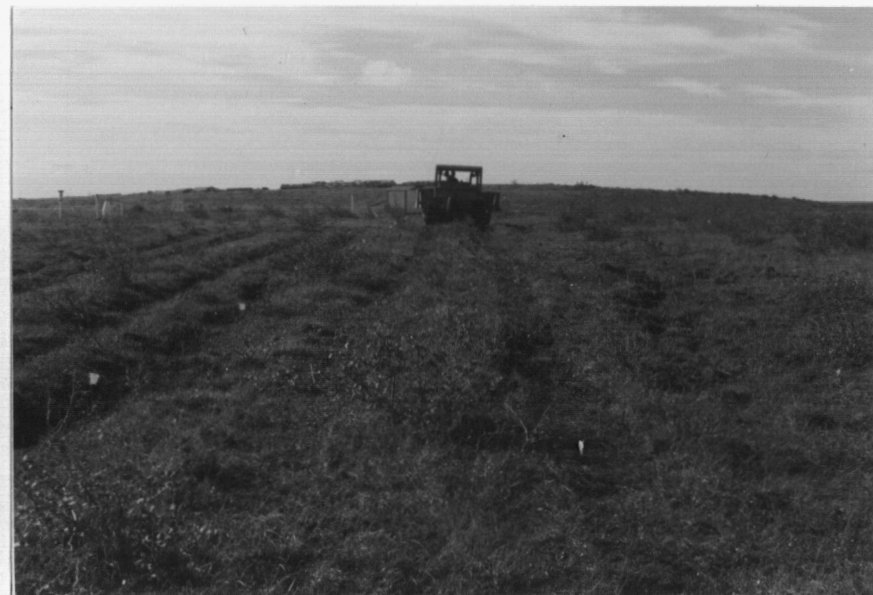
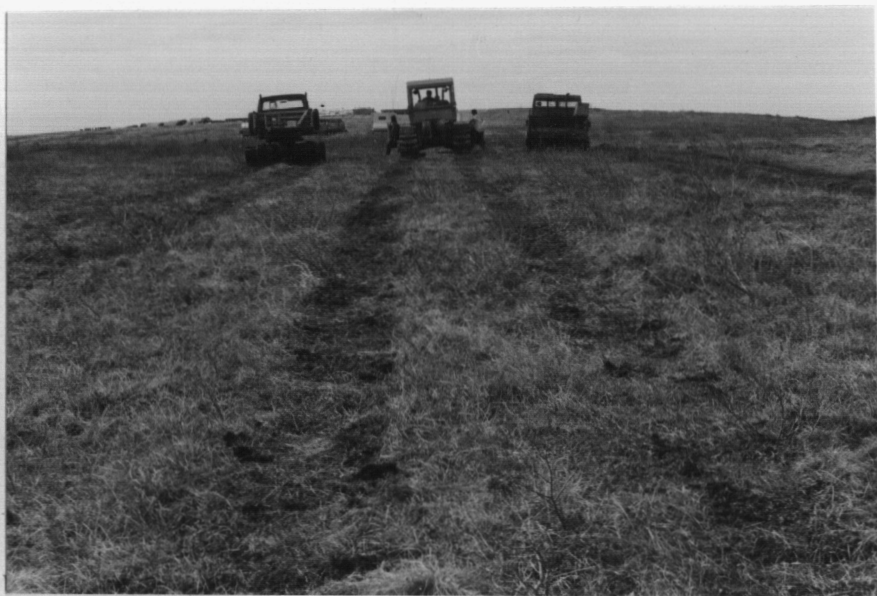
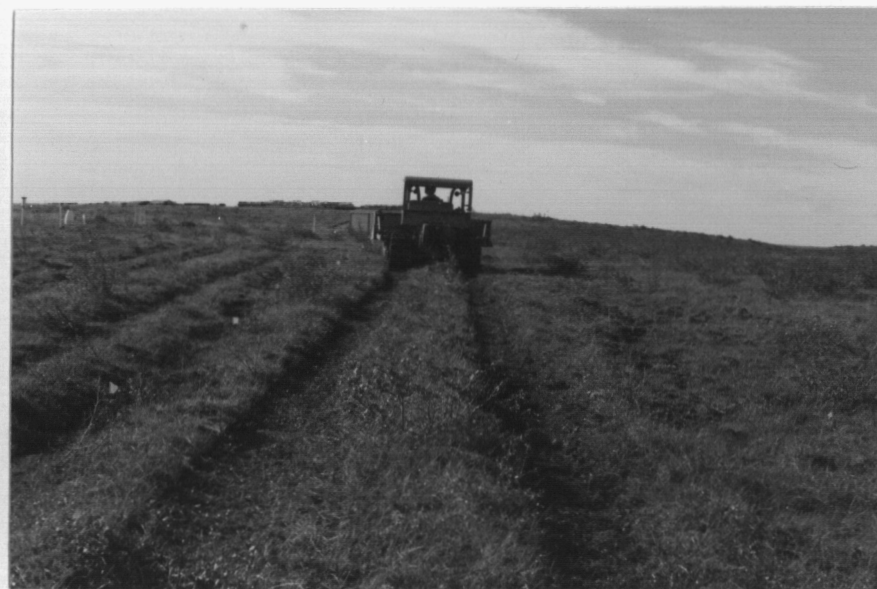
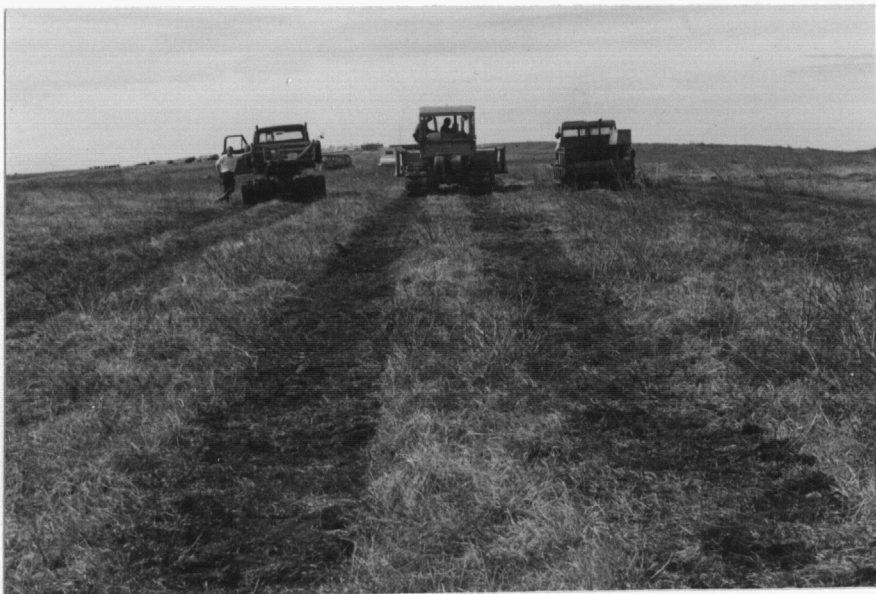
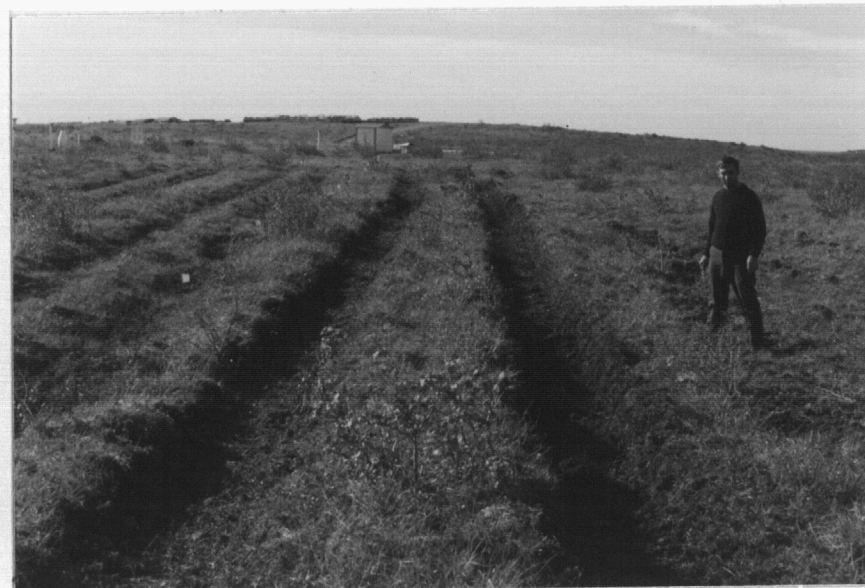
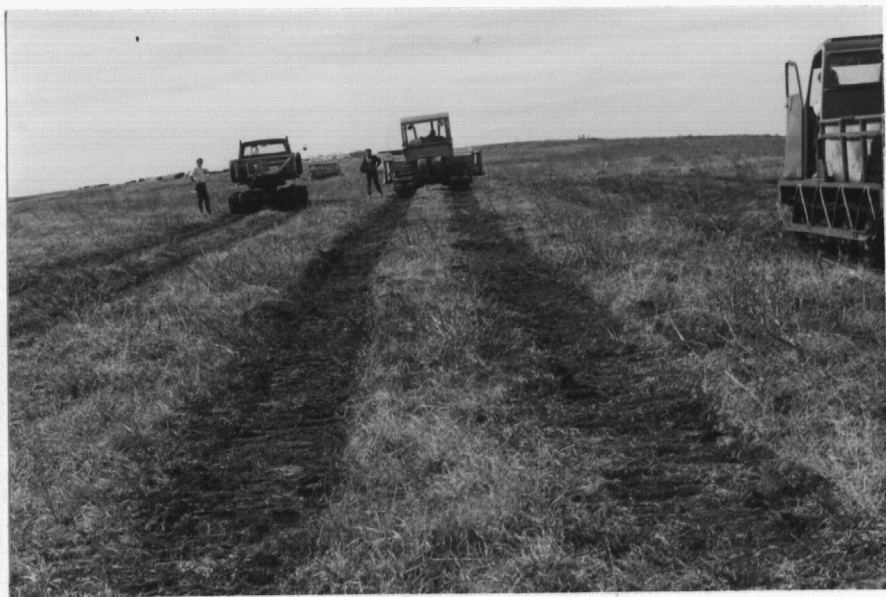
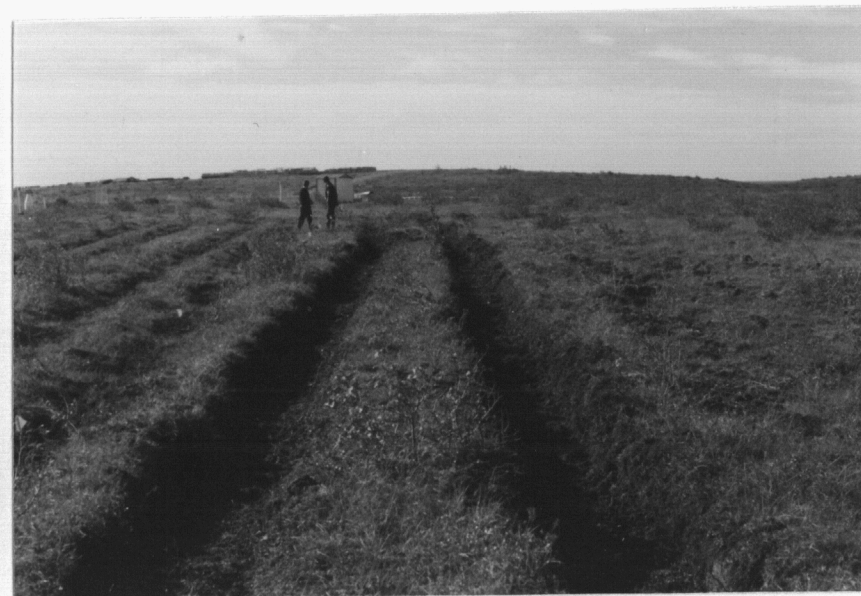
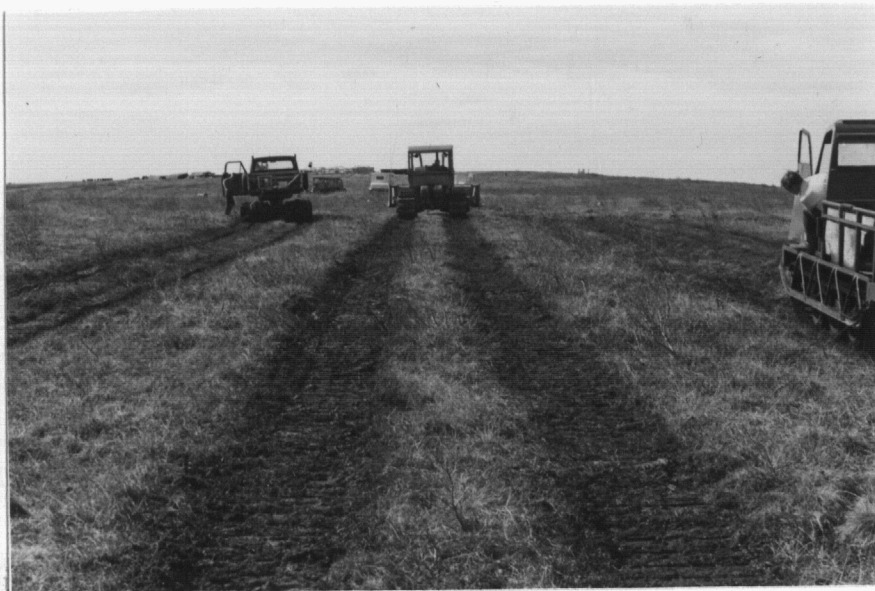
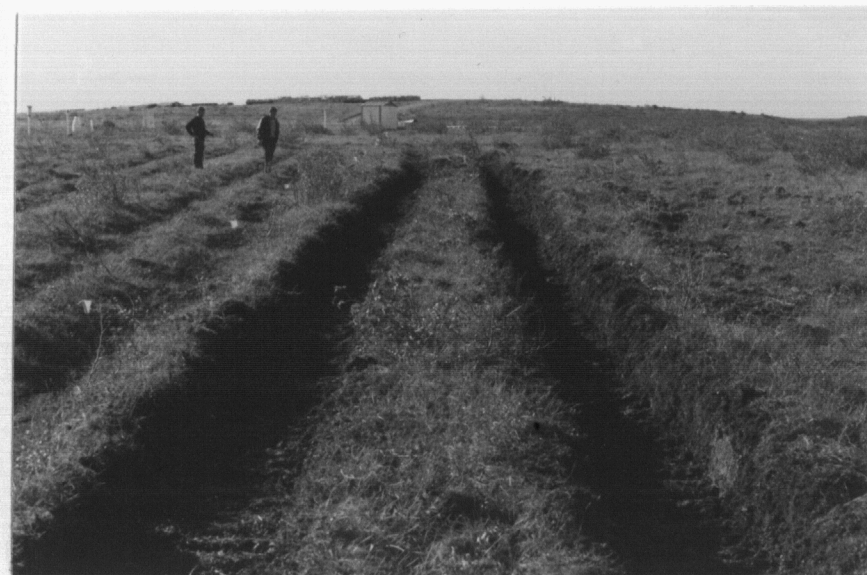
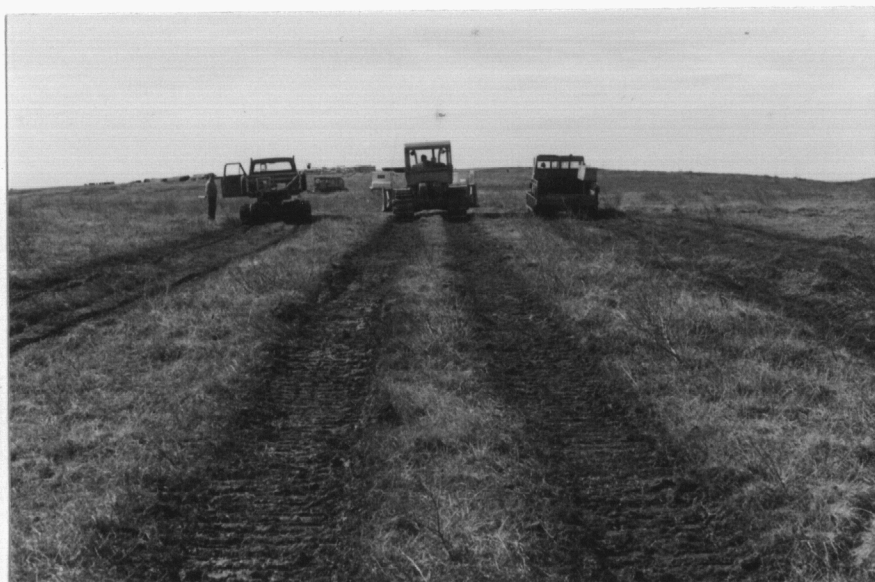
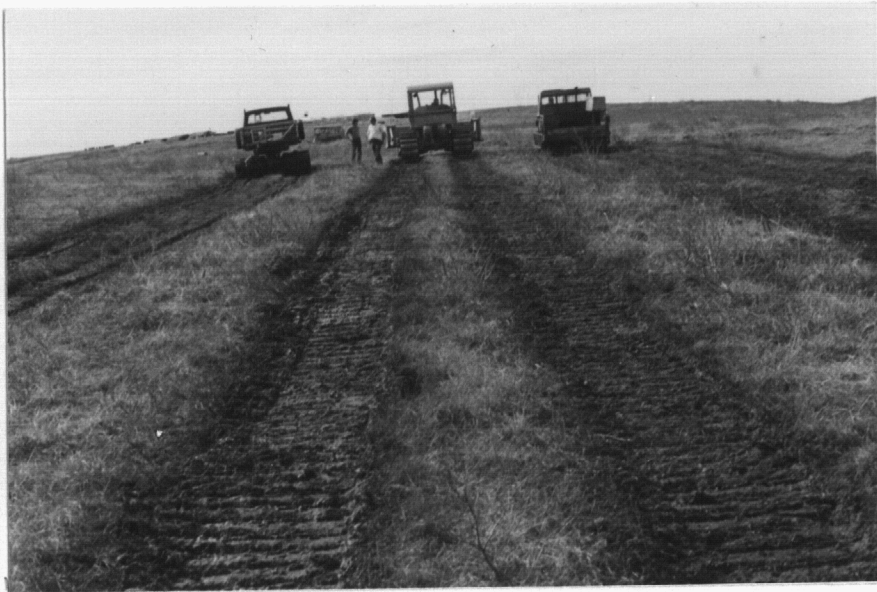
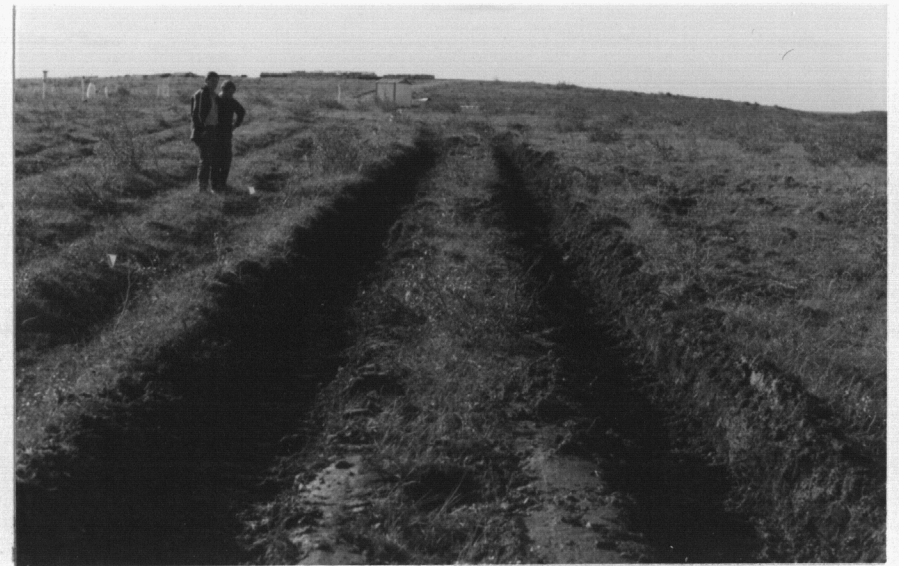
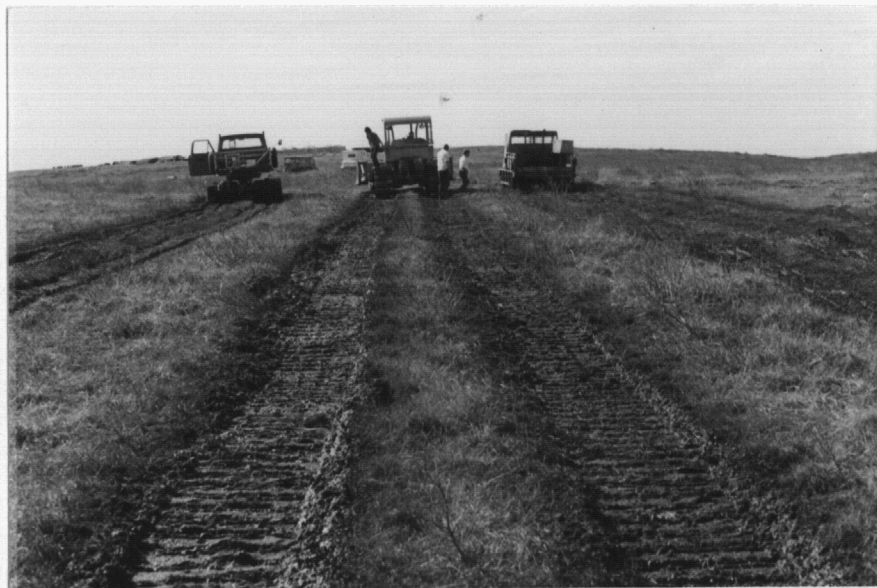
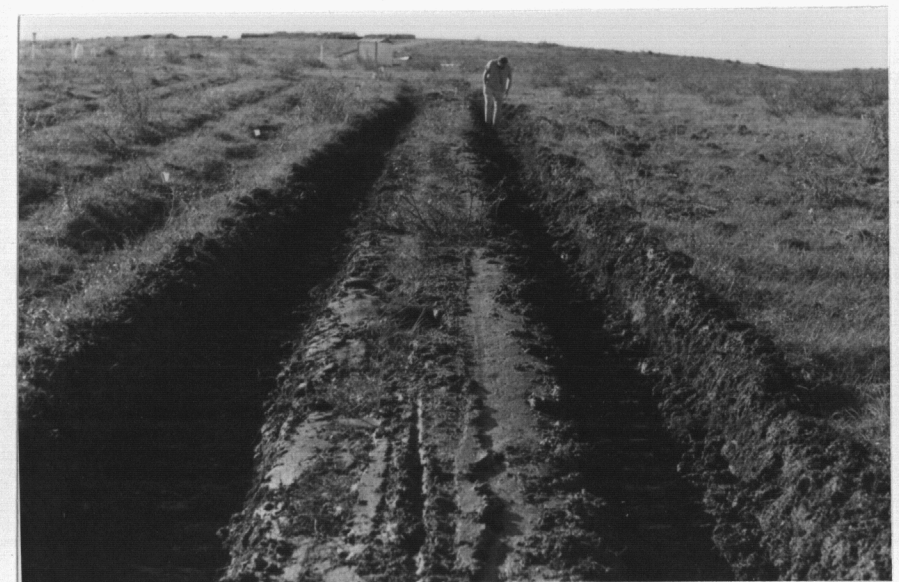
Fig. 41. Tununuk, site 1, June,  
Bulldozer 1 pass

Fig. 42. Tununuk, Site 1, August,  
Bulldozer 1 pass

Fig. 43. June, 5 pass

Fig. 44. August, 5 pass

Fig. 45. June, 10 pass

Fig. 46. August, 10 pass

Fig. 47. June, 20 pass

Fig. 48. August, 20 pass

Fig. 49. June, 40 pass

Fig. 50. August, 40 pass

Fig. 51. June, 60 pass

Fig. 53. June, 80 pass

Fig. 54. August, 80 pass

Fig. 55. June. 100 pass

Fig. 56. August, 100 pass

By conducting tests at three different times during the summer it was possible to assess, to a certain extent, the effect of season on terrain sensitivity. As one example, a bulldozer was operated (blade up) at Tununuk, site 1 at the end of June and again at the end of August. From Table I, average depth to permafrost at this site in June was 8.44 cm while by the end of August it had reached to 35.2 cm. The effect of this recession appears in a comparison of bulldozer ruts formed at each of these times as shown in figures 41 to 56. In June the permafrost near the surface combined with the deep grouser bars on the bulldozer tracks to carry most of the vehicle's weight. Rut depth could not grow to a very large value. In August, however, the soft ground surface allowed the vehicle to sink rapidly until it reached the permafrost after about 60 passes.

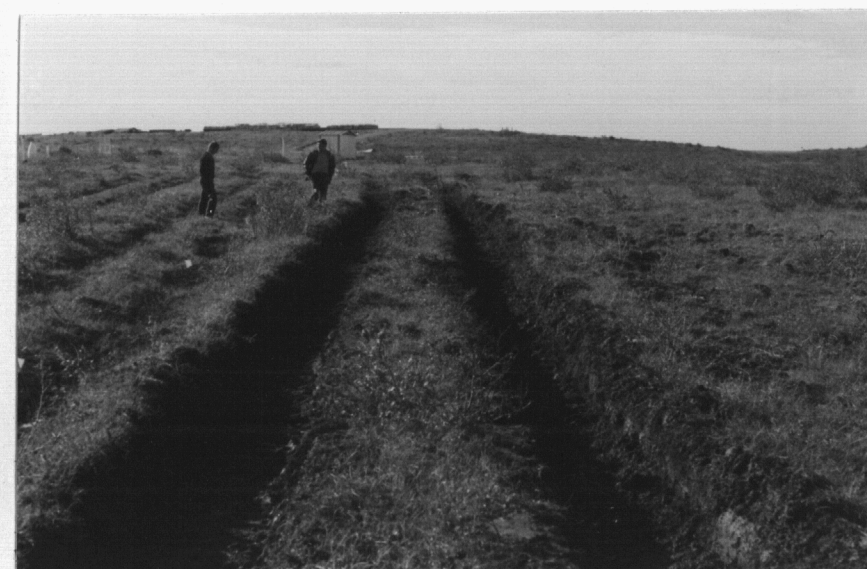
Fig. 52. August, 60 pass
