TESTS TO DEFINE LEVELS  
OF TERRAIN DAMAGE  
BY TRACKED VEHICLES OPERATING  
ON TUNDRA

A Report submitted to  
The Department of Indian Affairs  
and Northern Development  
Government of Canada

MUSKEG RESEARCH INSTITUTE  
UNIVERSITY OF NEW BRUNSWICK

December 1970

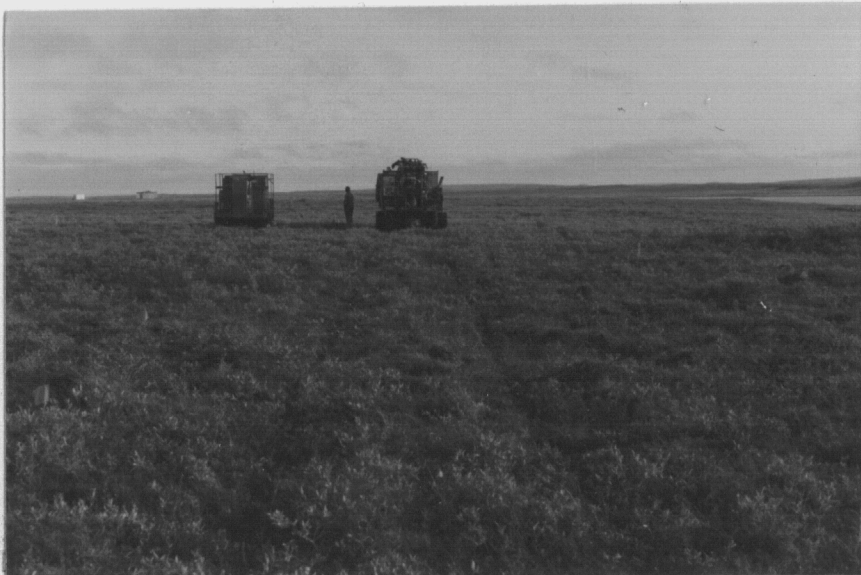
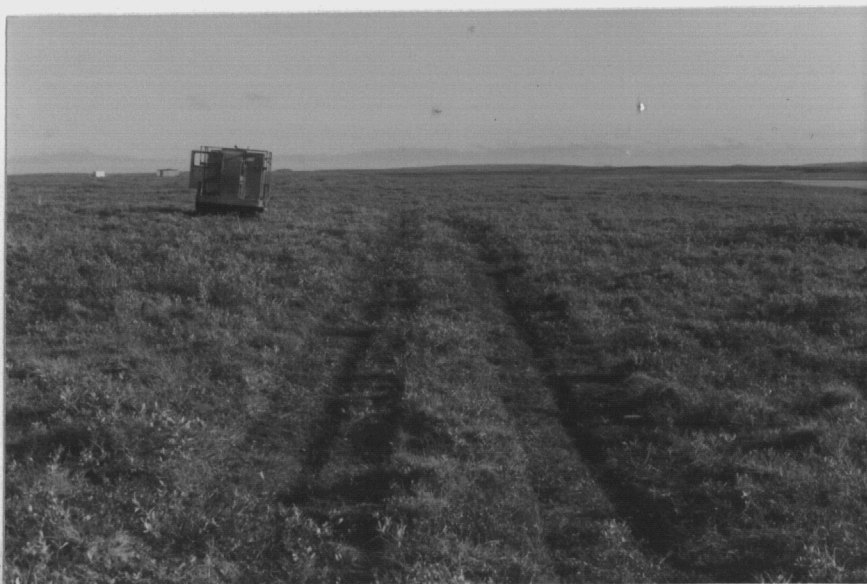
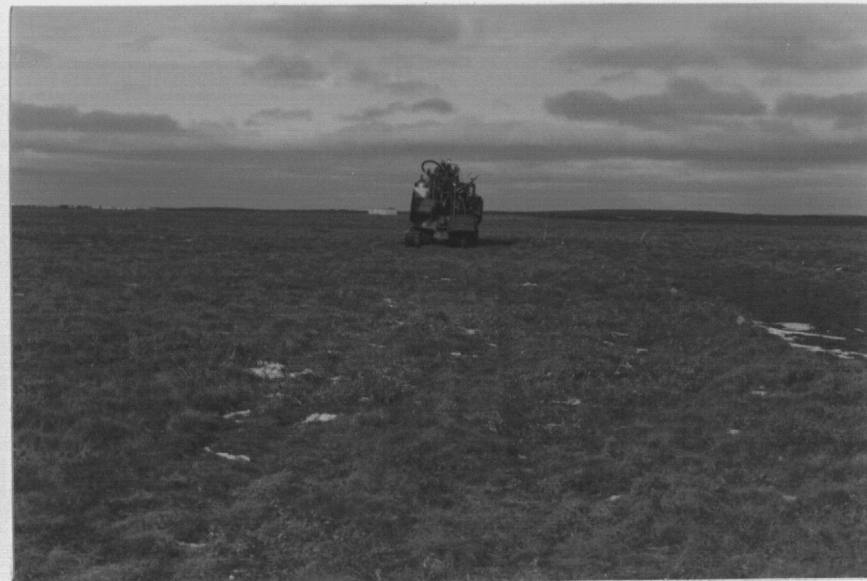
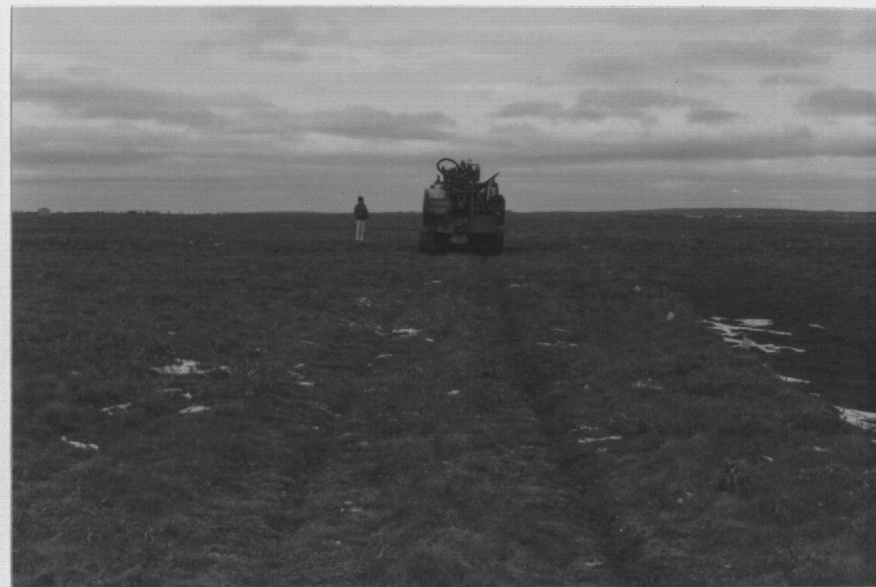
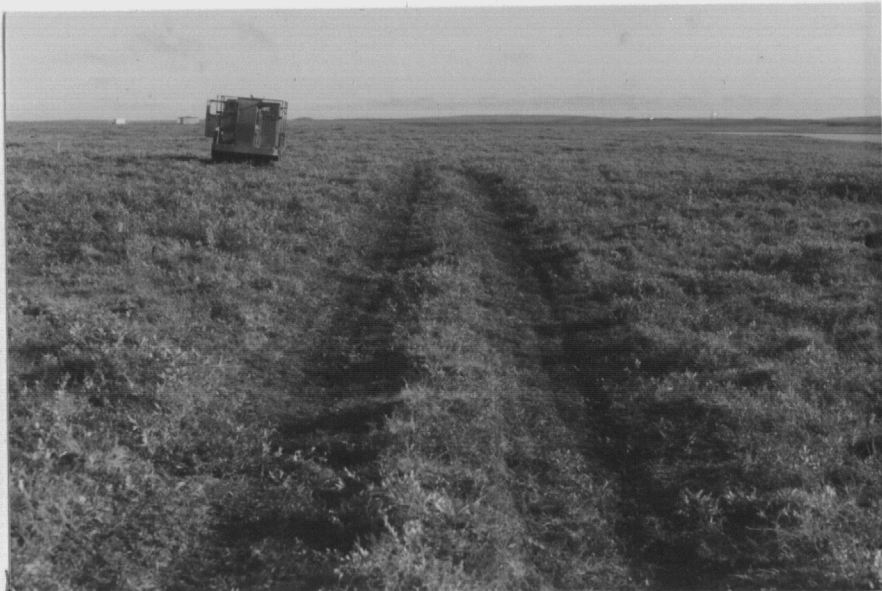
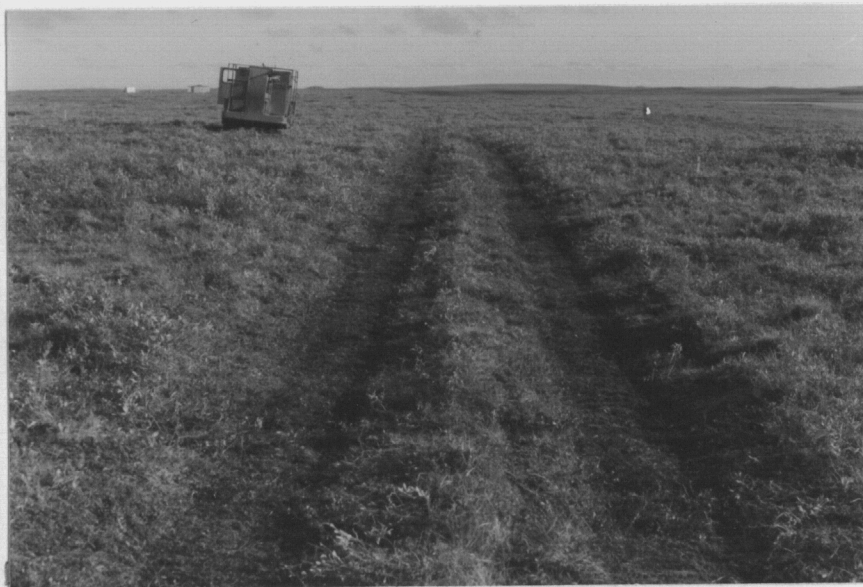
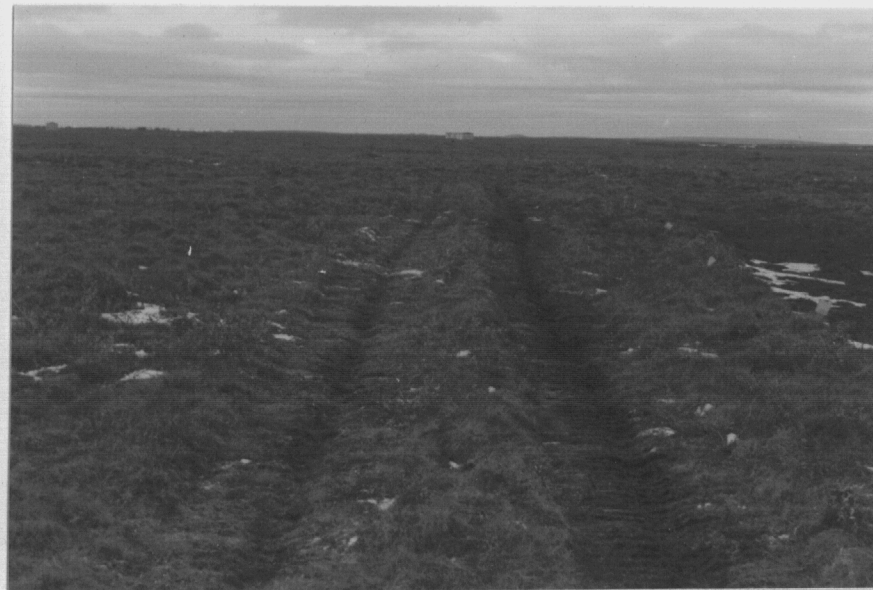
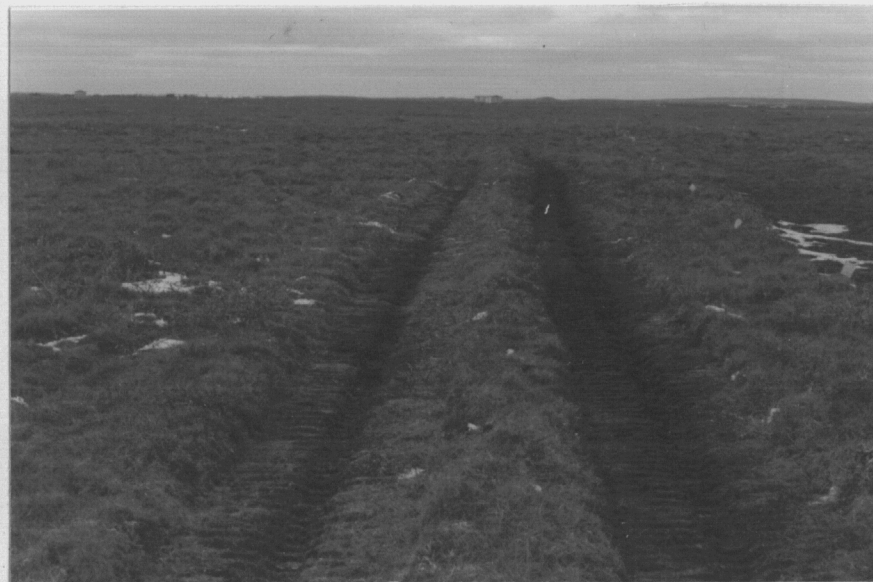
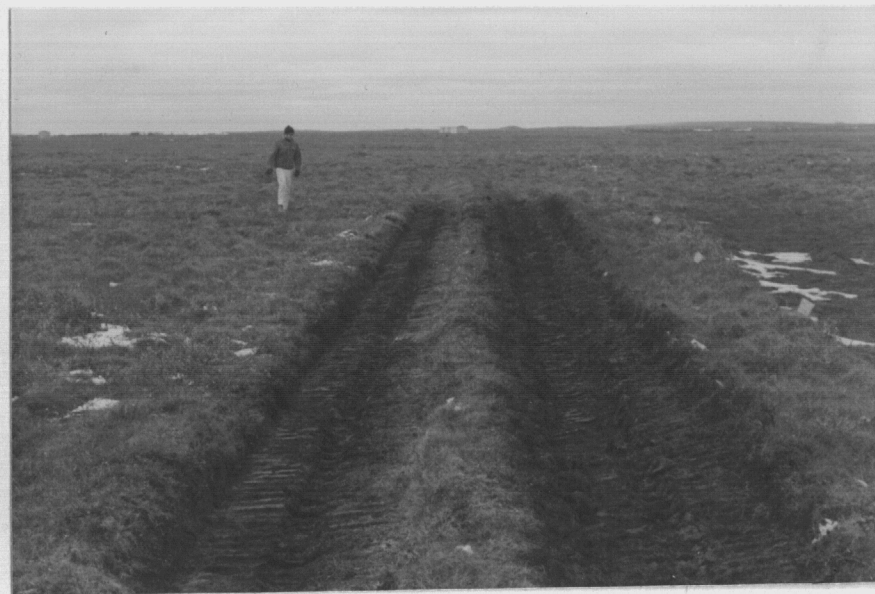
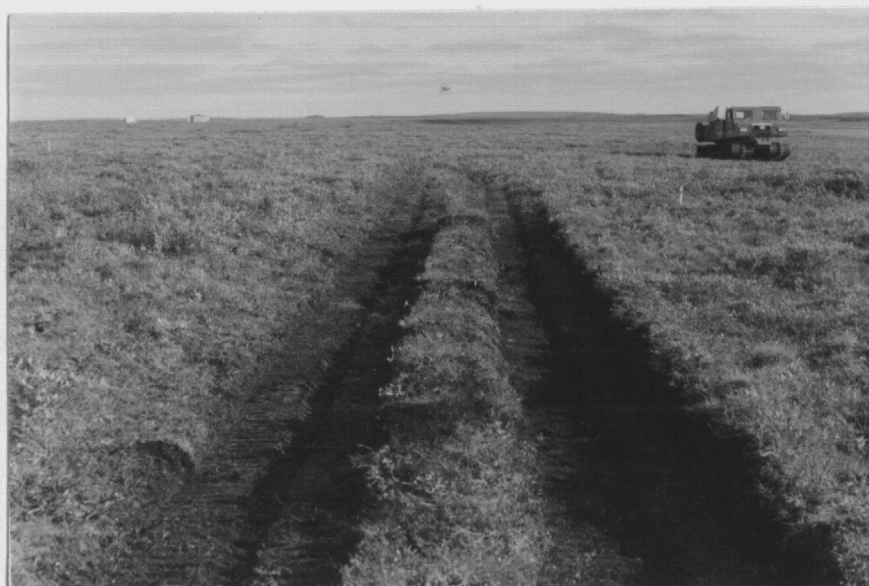
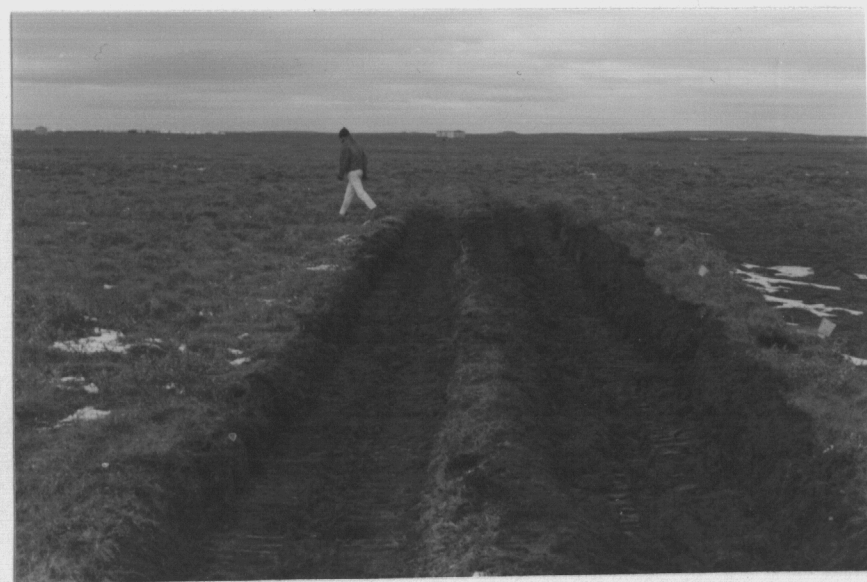
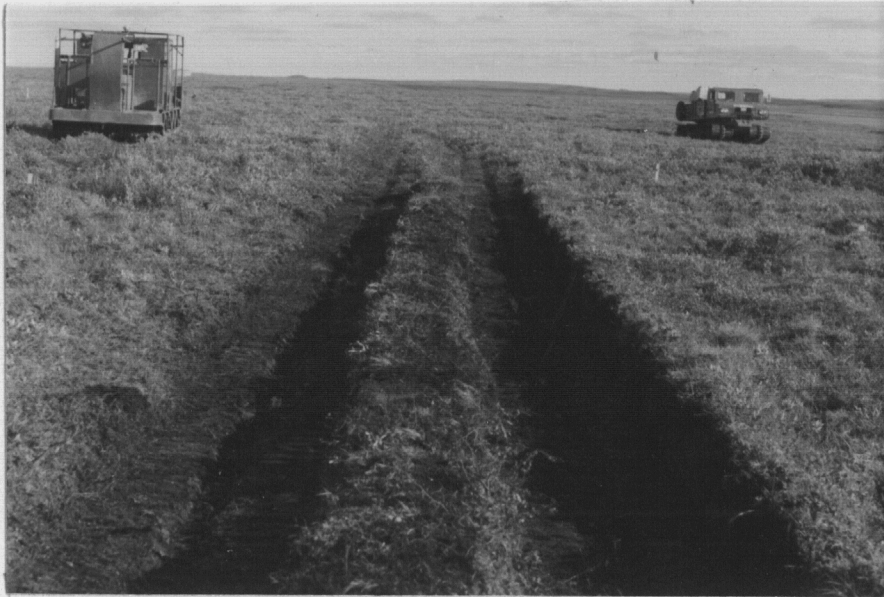
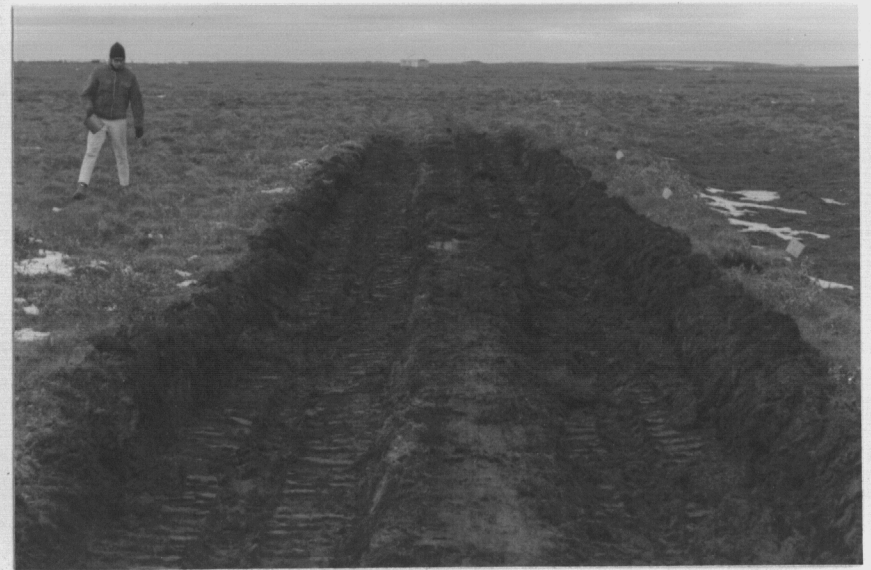
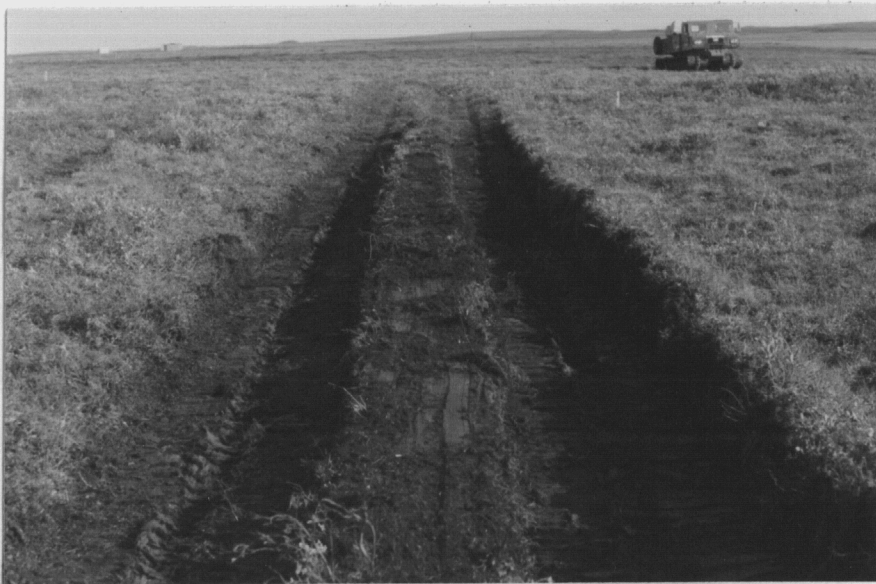
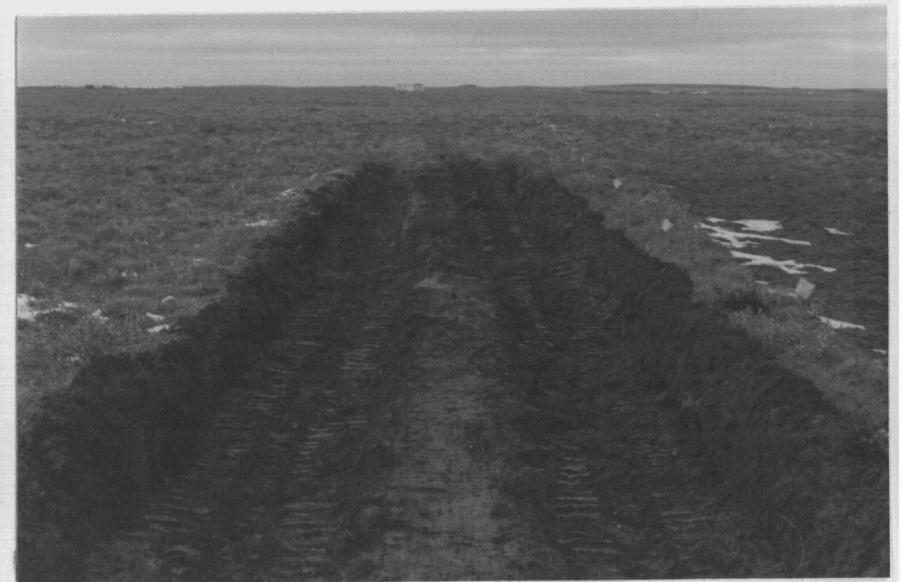
Fig. 57. 46,000 lb. vehicle  
Tuktoyaktuk site 3, August 1 pass

Fig. 59. August 5 pass

Fig. 58. 46,000 lb. vehicle  
Tuktoyaktuk site 3, September 1 pass

Fig. 60. September 5 pass

Fig. 61. August, 10 pass

Fig. 63. August, 20 pass

Fig. 62. September, 10 pass

Fig. 64. September, 20 pass

Fig. 66. September, 40 pass

Fig. 67. August, 60 pass

Fig. 68. September, 60 pass

Fig. 69. August, 80 pass

Fig. 70. September, 80 pass

Fig. 71. August, 100 pass

Fig. 72. September, 100 pass

The next set of photographs demonstrates another thermal effect of seasonal change on terrain response. Tests were run with a seismic drill vehicle weighing about 46,000 lb. at Tuktoyaktuk site 3 at the end of August and again at the end of September. Depth to permafrost was about 40 cm. in August and 30 cm. in September, but in September there was also a frozen surface crust varying in thickness from 5 to 10 cm. This crust inhibited the September disturbance until about 30 passes had been completed. Once this point was reached, the disturbance rate proceeded at about the same rate as it had in August. Figures 57 to 72 illustrate this phenomenon.

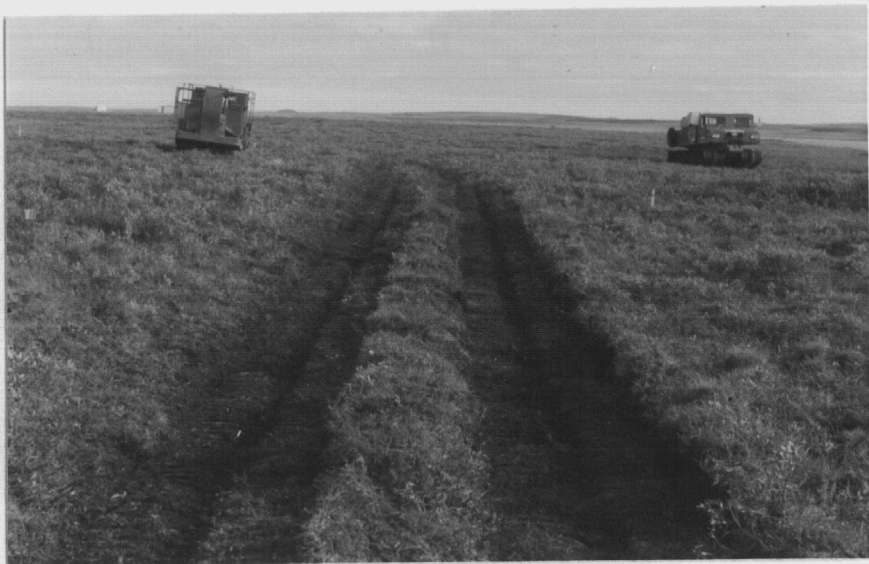
Fig. 65. August, 40 pass

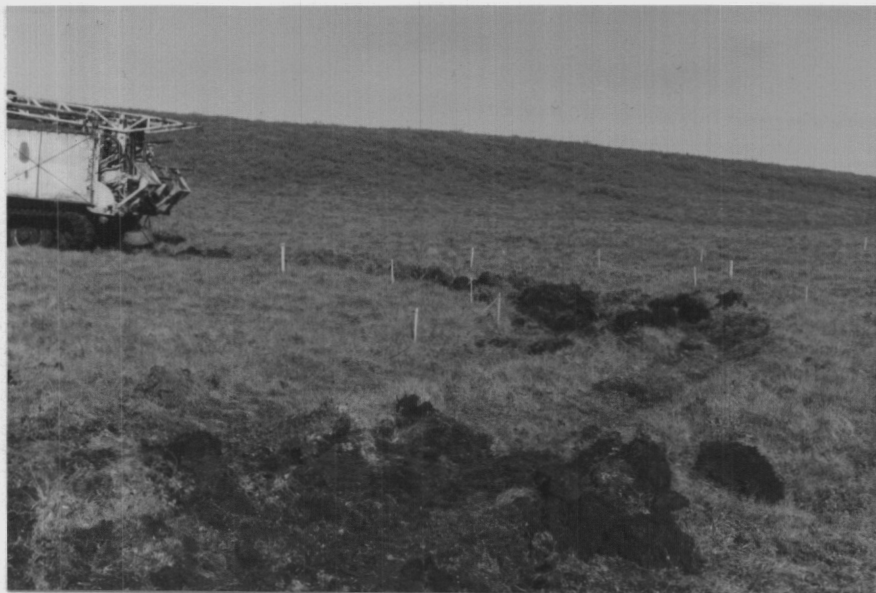
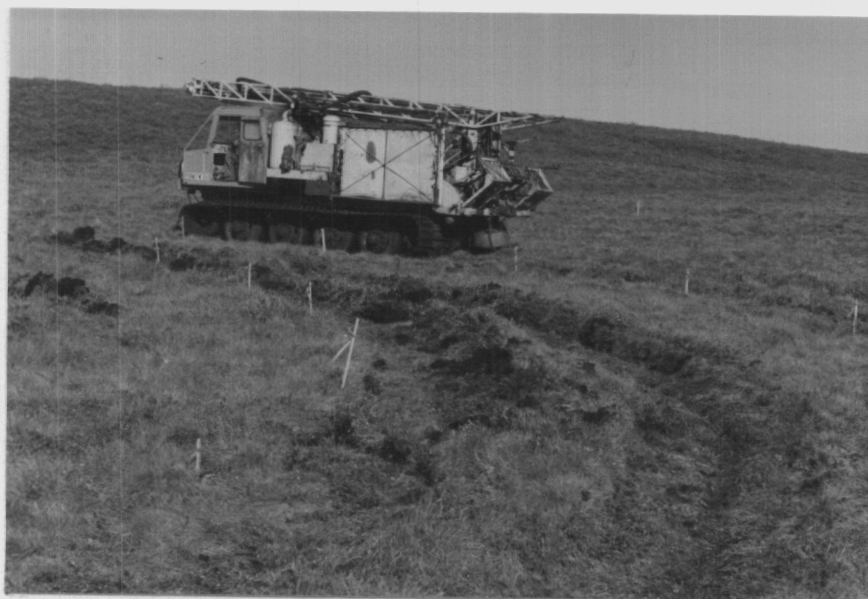
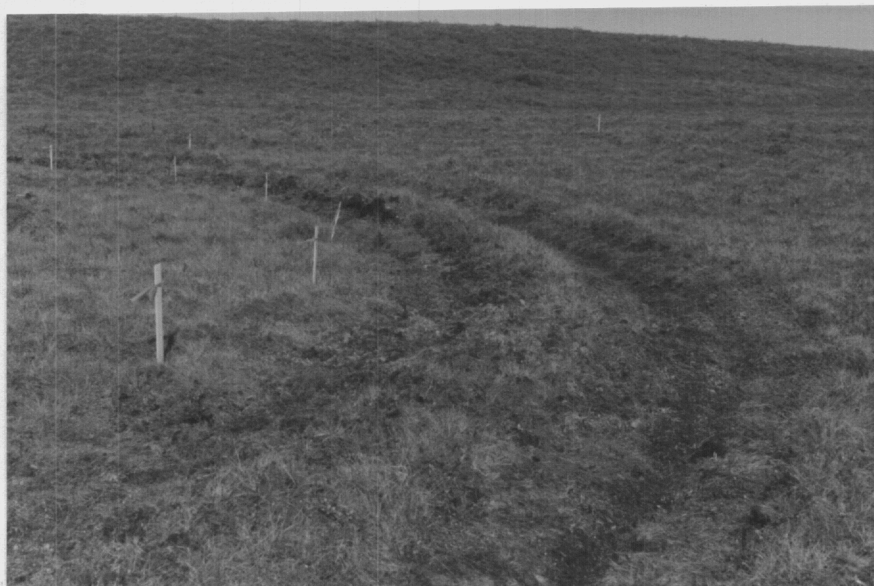
Fig. 76. Turn test, 20 ft. radius

Fig. 77. Turn test, 40 ft. radius

Fig. 78. Turn test, 60 ft. radius

The test vehicle executed the 40 ft. and 60 ft. radius turns without difficulty. On the 20 ft. radius turn, the inside track frequently slipped on its sprocket, steering effort by the vehicle operator was high, and tussocks were torn from the ground surface.

Terrain surface disturbance appeared to be at or below level 4 in a turn with a 60 ft. radius. This is suggested to be a reasonable minimum turning radius for a vehicle of this size and weight. Operations with smaller vehicles would probably not be inconvenienced by restricting turns to a minimum radius of 60 ft., and larger vehicles normally probably have their minimum turning radius mechanically limited to a value greater than 60 ft. In areas more sensitive than site 1, Tuktoyaktuk, it is perhaps possible that this 60 ft. minimum is too generous. In the writer's judgement, however, such sensitive areas would tolerate almost no traffic before level 4 disturbance was produced (c.f. Shingle Point Site 1). Analysis of Table IV has shown this to be a reasonable tentative assumption.

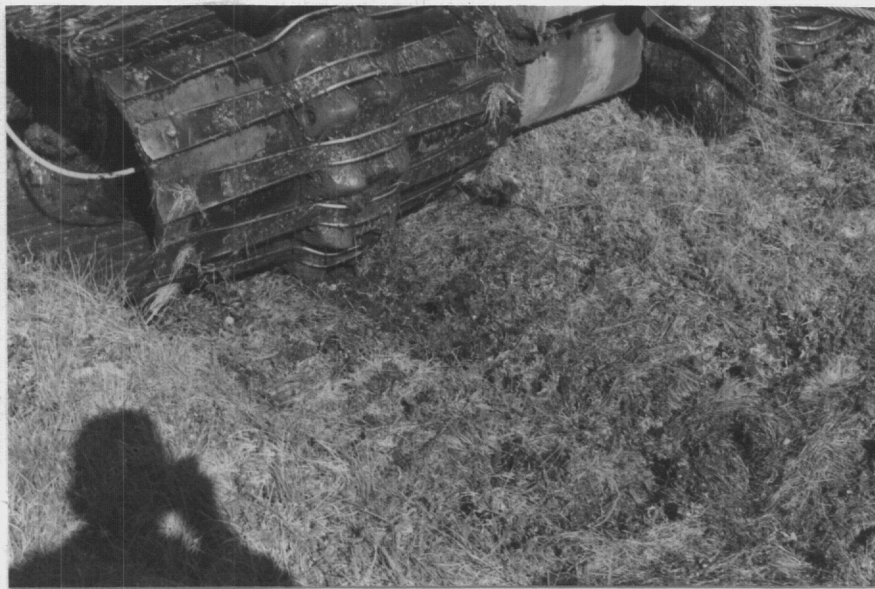
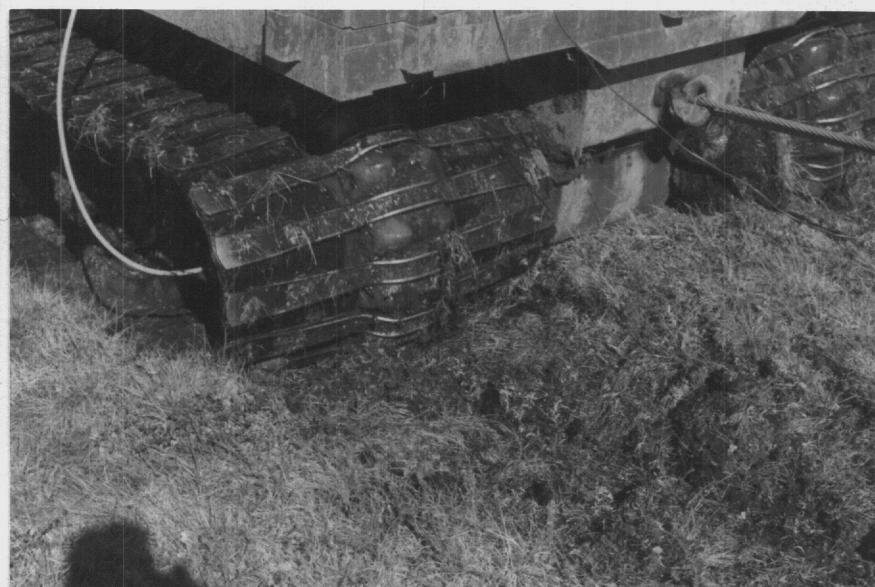
Fig. 79. Drawbar pull test  
19.7% slip

Fig. 80. Drawbar pull test  
100% slip

The type of results derived from the drawbar pull tests conducted at Tuktoyaktuk in August is shown in figures 79 and 80. These photographs were taken in Test Site 3 and show the effects of 19.7% slip and 100% slip (100% slip being the condition in which the vehicle is not moving but its tracks are spinning). Analysis of this and other tests has shown that maximum tractive effort was developed at close to 20% slip and that this effort was virtually sustained up to 100% slip. Terrain disturbance was well within level 4 at 20% slip and in site 1 at Tuktoyaktuk approached level 5 in places (permanent ruts just starting to form). This level of disturbance was reached in one pass under drawbar load conditions whereas it had been reached in between 5 and 15 passes in the multipass tests. Drawbar pulls at 20% slip varied between 30% and 45% of the vehicle's weight.

It would appear that in operating tracked vehicles as tractors towing loads or as carriers climbing slopes, slip should be less than 20% to limit terrain disturbance to level 4. This amount of slip is consistent with net tractive effort amounting to 30% to 45% of the vehicle's gross weight.

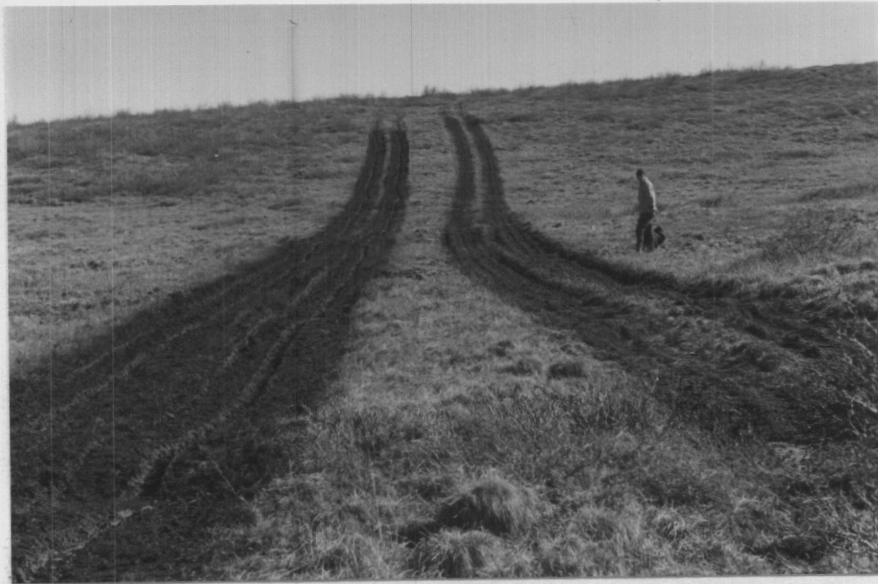
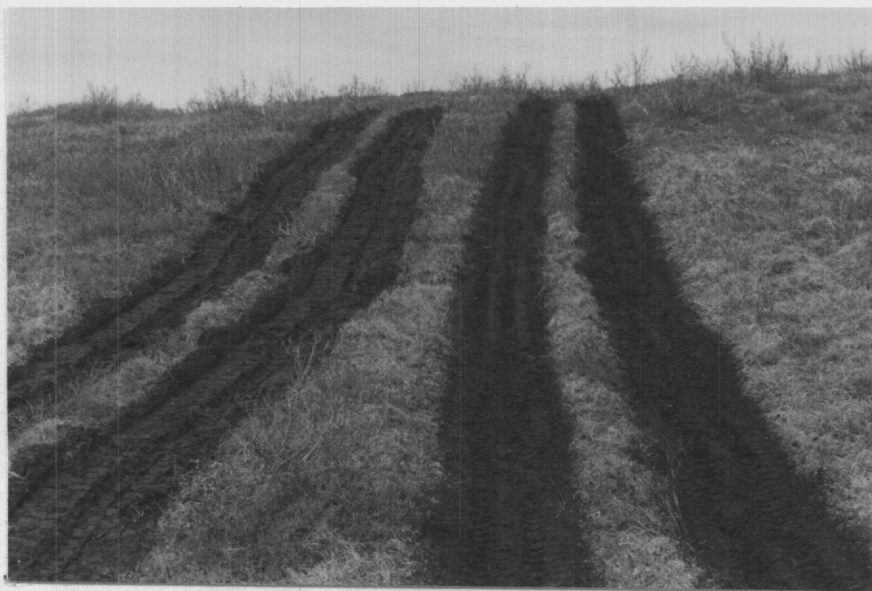
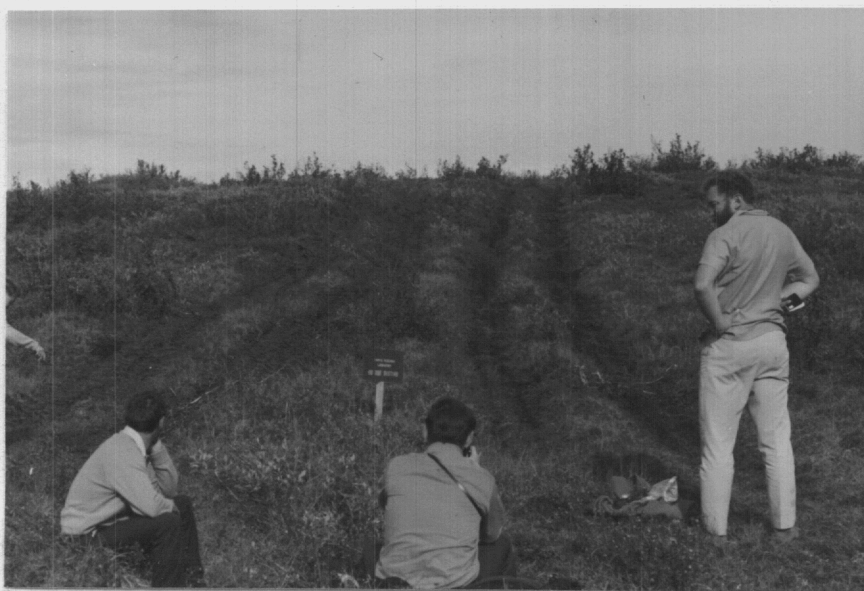
Fig. 81. Tununuk test site 2  
June, 60 passes

Fig. 83. Tununuk test site 4  
June, 100 passes

Fig. 84. Tununuk test site 4  
August

At Tununuk it was possible to inspect in August the sites where multipass tests had been conducted two months previously. Figure 81 shows test site 2 following completion of 60 passes by two light vehicles in June. Figure 82 is the same view of this area in August. Considerable growth of vegetation in the ruts is visible. Figures 83 and 84 show Tununuk site 4 in June and August respectively. One hundred passes of the same vehicle were completed in this site.

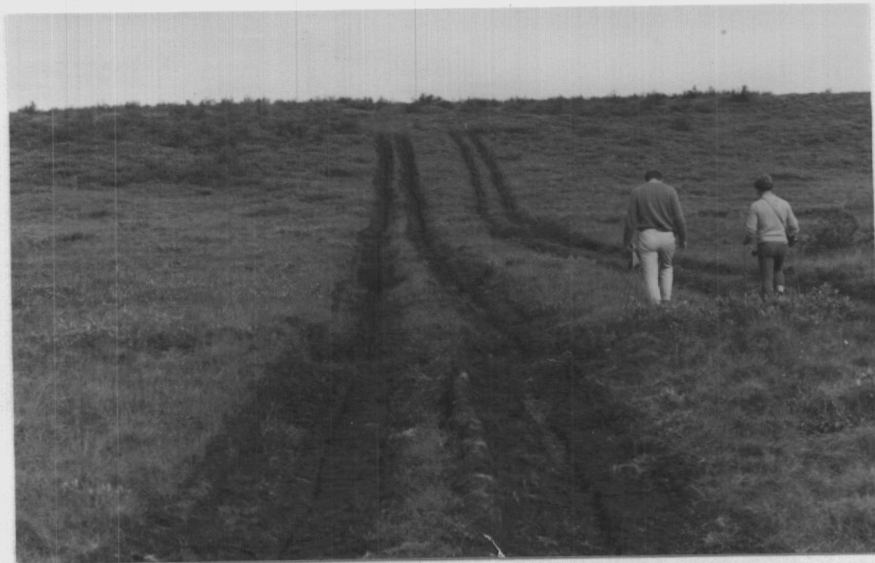
Fig. 82. Tununuk test site 2  
August
