PUBLIC WORKS CANADA  
HYDROLOGY AND HYDRAULICS  
MUSKEG RIVER BRIDGE  
KILOMETRE 207.9, LIARD HIGHWAY  
DECEMBER, 1978  
PREPARED BY BOLTER PARISH TRIMBLE LTD.

PUBLIC WORKS CANADA  
HYDROLOGY AND HYDRAULICS  
MUSKEG RIVER BRIDGE  
KILOMETRE 207.9, LIARD HIGHWAY  
December 1978

Re: Liard Highway - Muskeg River Bridge,  
Kilometre 207.9

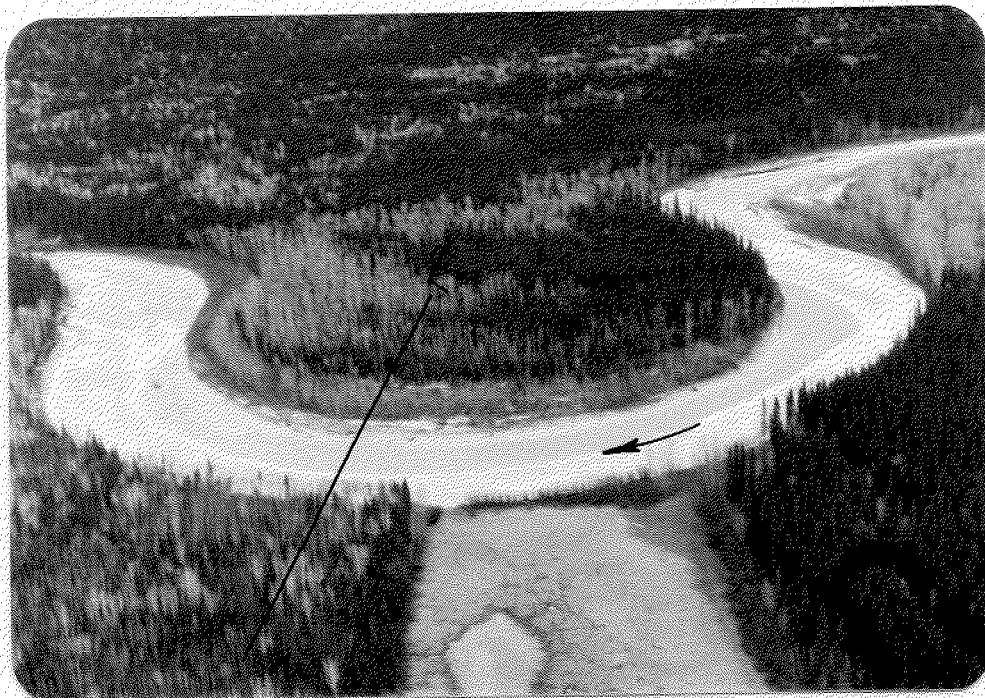
PHOTOGRAPH 1. Muskeg River - looking northeast. Flow is right to left. October 30, 1978.

The recommended location is the 1978 A line (Figure 1, Drawing 115-19-1, Photographs 1 to 4). This crossing is on a moderate bend in the river and the outside of the bend, the south bank, is gradually receding. An examination of the 1947, 1968, 1973 and 1978 aerial photographs and 1970 on-the-ground photographs confirms that the bank is receding, but the actual rate of recession is difficult to assess owing to scale problems and the clarity of the photographs. However, we estimate that the total bank recession at the proposed crossing location is less than four metres since 1949.

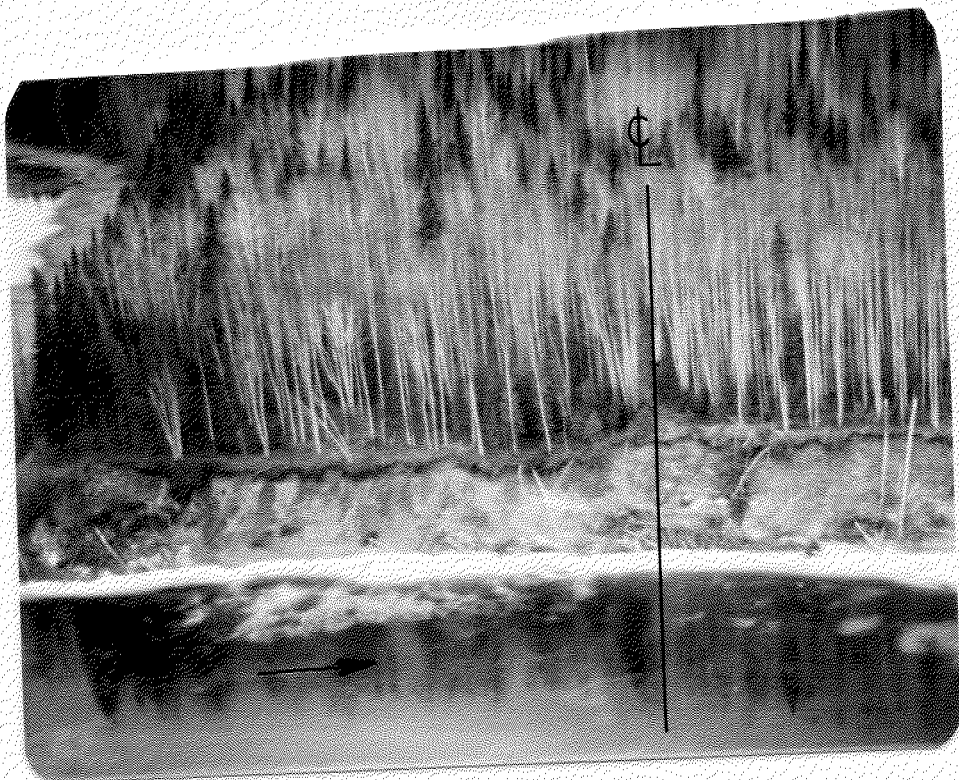
PHOTOGRAPH 3. Muskeg River - looking at high south bank.  
Flow is left to right. October 30, 1978.

It is proposed that the south bank near the bridge be protected with heavy rock riprap of gradation specified as Class II R.T.A.C. An apron toe of riprap will be required at the base of the south bank slope with the top elevation at the current low water level, elevation 203.4. The apron toe should extend out from the edge of water 1.5 metres and the existing bank should be cut back an additional 1.5 metres, yielding a 3.0 metre wide apron toe. The apron toe would contain approximately 6.0 m<sup>3</sup> of rock per metre of length along the bank. A layer of rock riprap 0.6 metres thick would extend up the south bank at a slope of 2:1 to elevation 209.4, which is 1.0 metre above the highest water level anticipated.

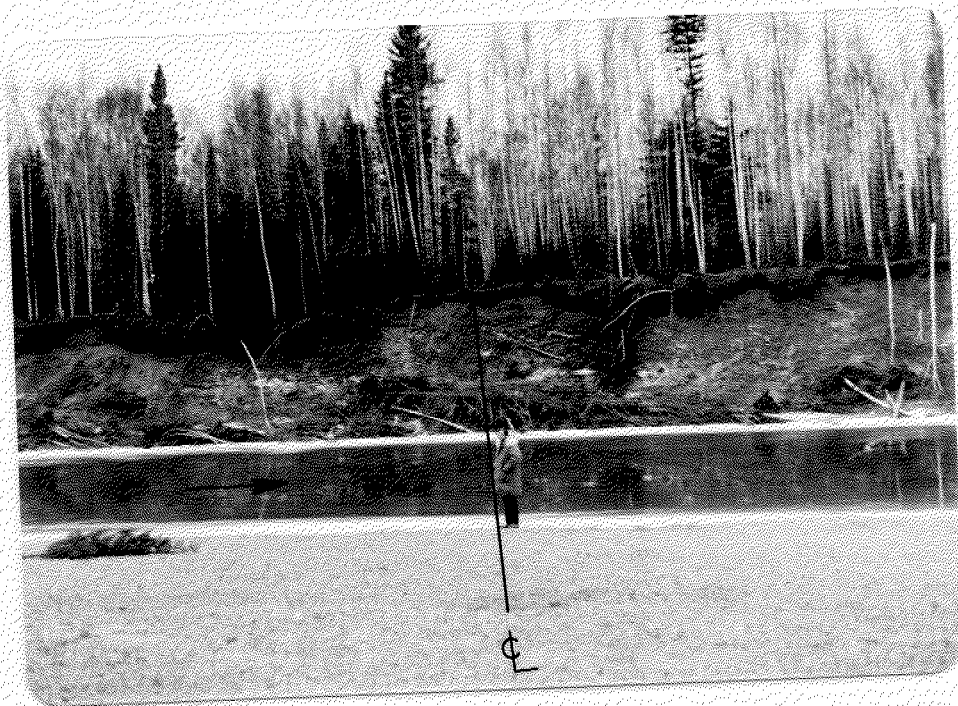
PHOTOGRAPH 4. Muskeg River - looking south to high bank  
on centre line. October 30, 1978.

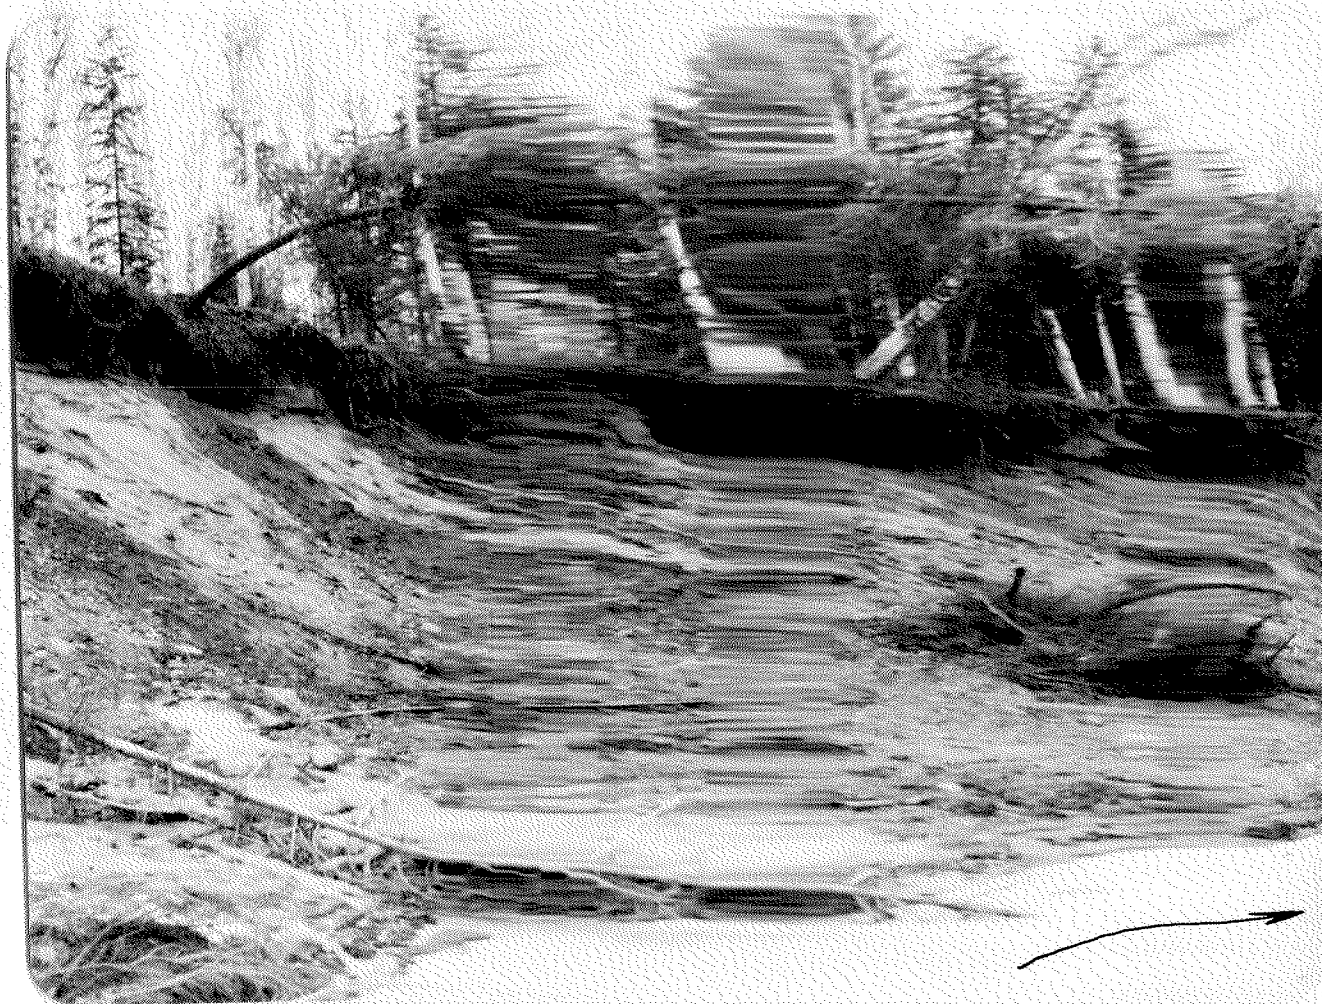
PHOTOGRAPH 5. Muskeg River - looking at high south bank approximately 30 metres upstream of centre line. October 30, 1978.

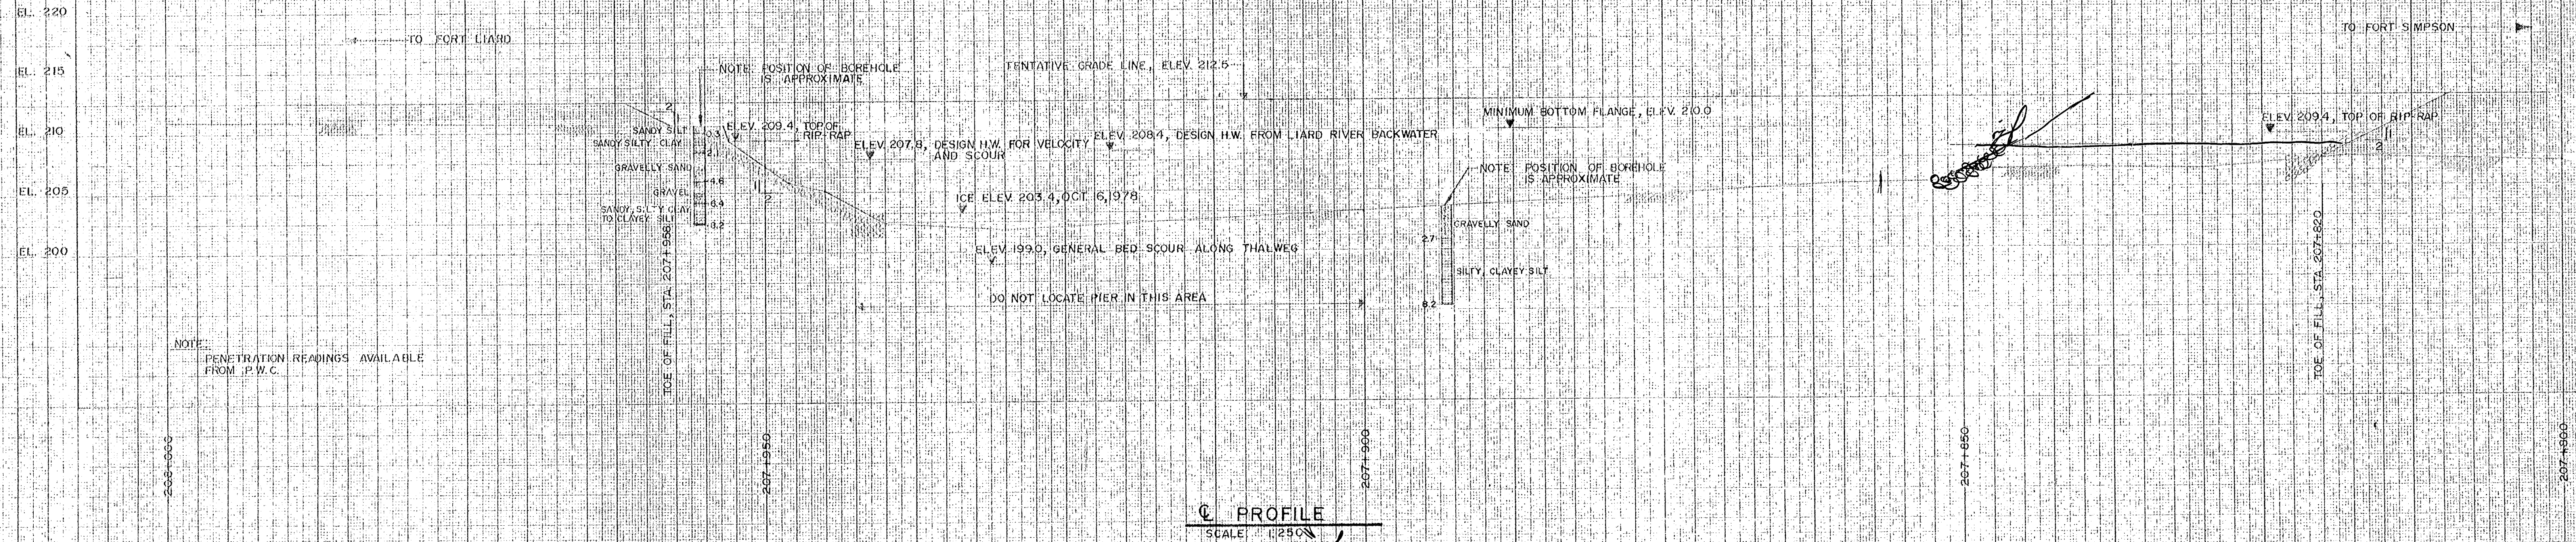
22"  
Out to Out of Fills  $\approx 152$  meters.

A grade line has not been set at this stage of investigation; therefore, the recommended out to out of fills can only be approximated. If the grade line were set at elevation 212.5, however, the out to out would be approximately 152 metres.
