**AGGREGATE SURVEY
TALTON HYDRO FACILITY, NT**

Project No. 0701-01-15333

December, 2001

EBA ENGINEERING CONSULTANTS LTD.
YELLOWKNIFE, NT

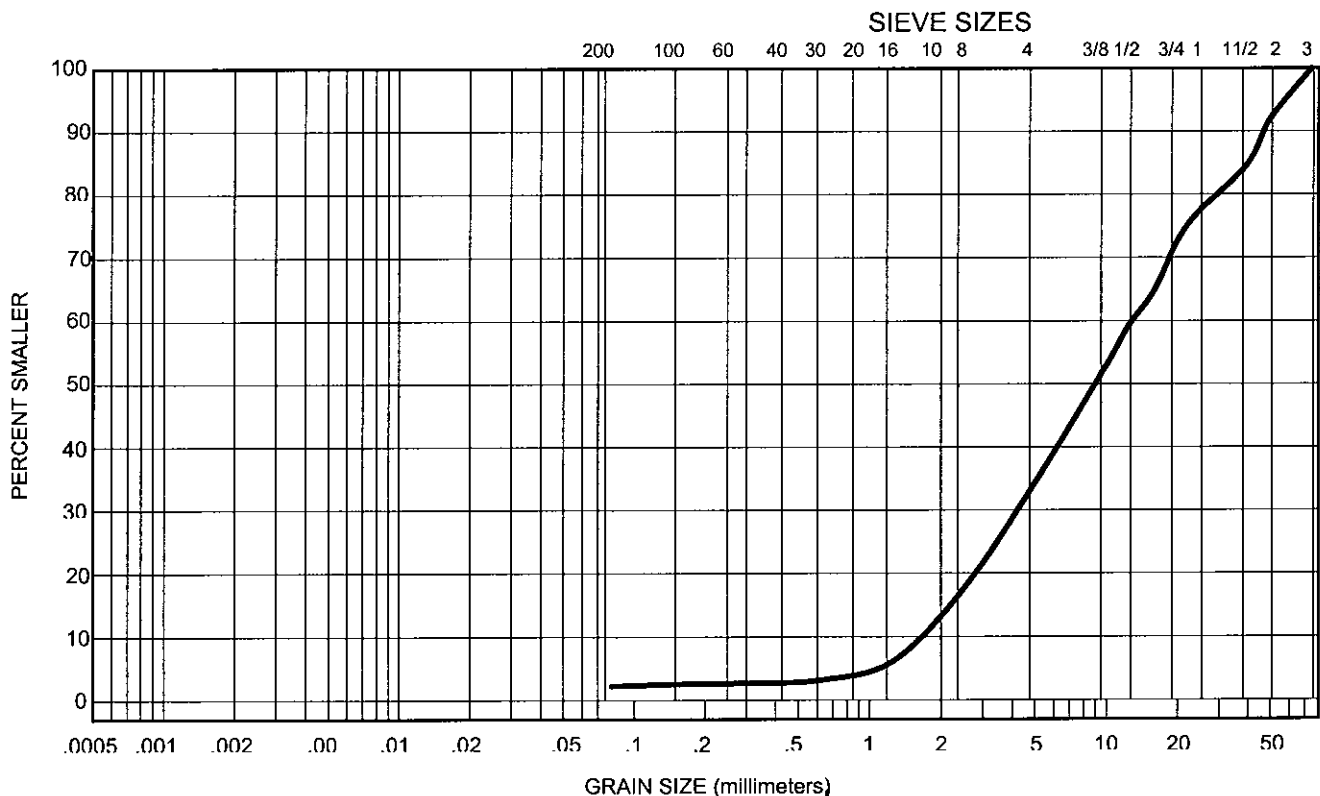
Project: Talston Aggregate Survey
 Project Number: 0701-01-15333
 Client: NTPC
 Attention: Greg Haist, P.Eng.
 Date Tested: October 6, 2001
 Test Pit Number: Gertrude Pit
 Depth, m surface
 Lab Number: 2722-4
 Soil Description: Sandy GRAVEL, trace silt
 Natural Moisture Content: _____
 Remarks: _____

SIEVE	PERCENTAGE PASSING
40	85
25	77
20	72
16	65
12.5	59
10	53
5	34
2.5	18
1.25	6
0.63	3
0.315	3
0.16	3
0.08	2

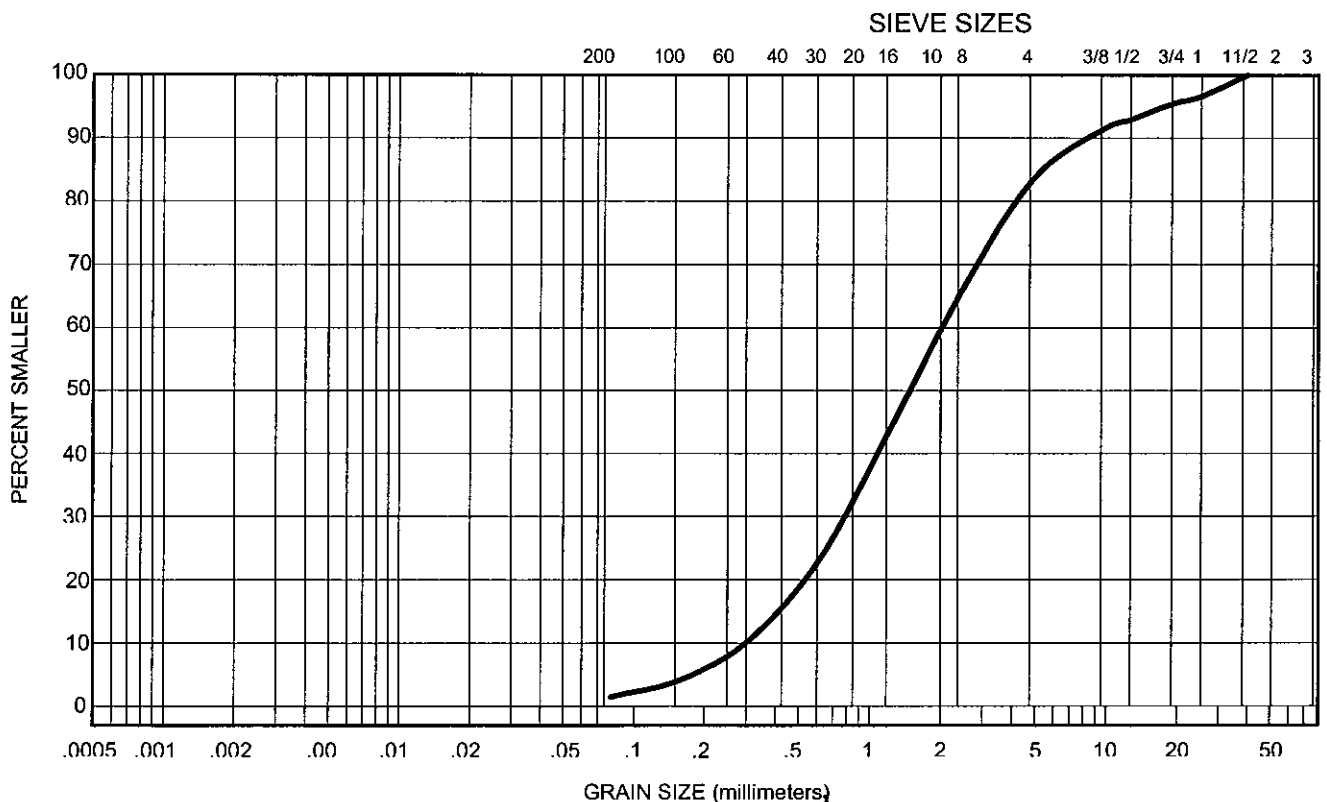
Project: Talston Aggregate Survey
 Project Number: 0701-01-15333
 Client: NTPC
 Attention: Greg Haist, P.Eng.
 Date Tested: October 6, 2001
 Test Pit Number: Pit Da
 Depth, m surface
 Lab Number: 2722-7
 Soil Description: Gravelly SAND, trace silt
 Natural Moisture Content: _____
 Remarks: _____

SIEVE	PERCENTAGE PASSING
40	100
25	97
20	96
16	94
12.5	93
10	92
5	84
2.5	66
1.25	44
0.63	24
0.315	11
0.16	4
0.08	1

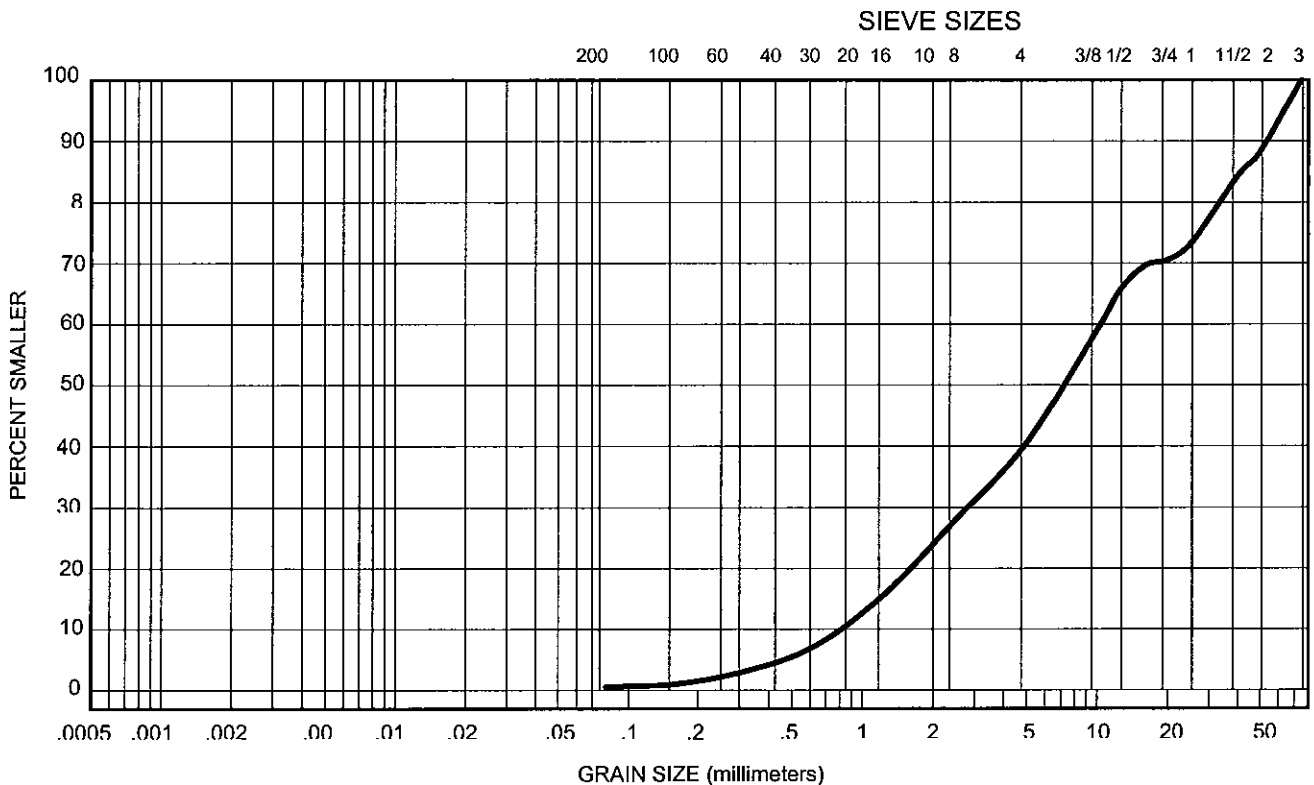
Project: Talston Aggregate Survey
 Project Number: 0701-01-15333
 Client: NTPC
 Attention: Greg Haist, P.Eng.
 Date Tested: October 6, 2001
 Test Pit Number: Pit Xa
 Depth, m surface
 Lab Number: 2722-9
 Soil Description: GRAVEL & SAND, trace silt
 Natural Moisture Content: _____
 Remarks: _____

SIEVE	PERCENTAGE PASSING
40	84
25	73
20	71
16	70
12.5	65
10	59
5	40
2.5	28
1.25	16
0.63	7
0.315	3
0.16	1
0.08	1

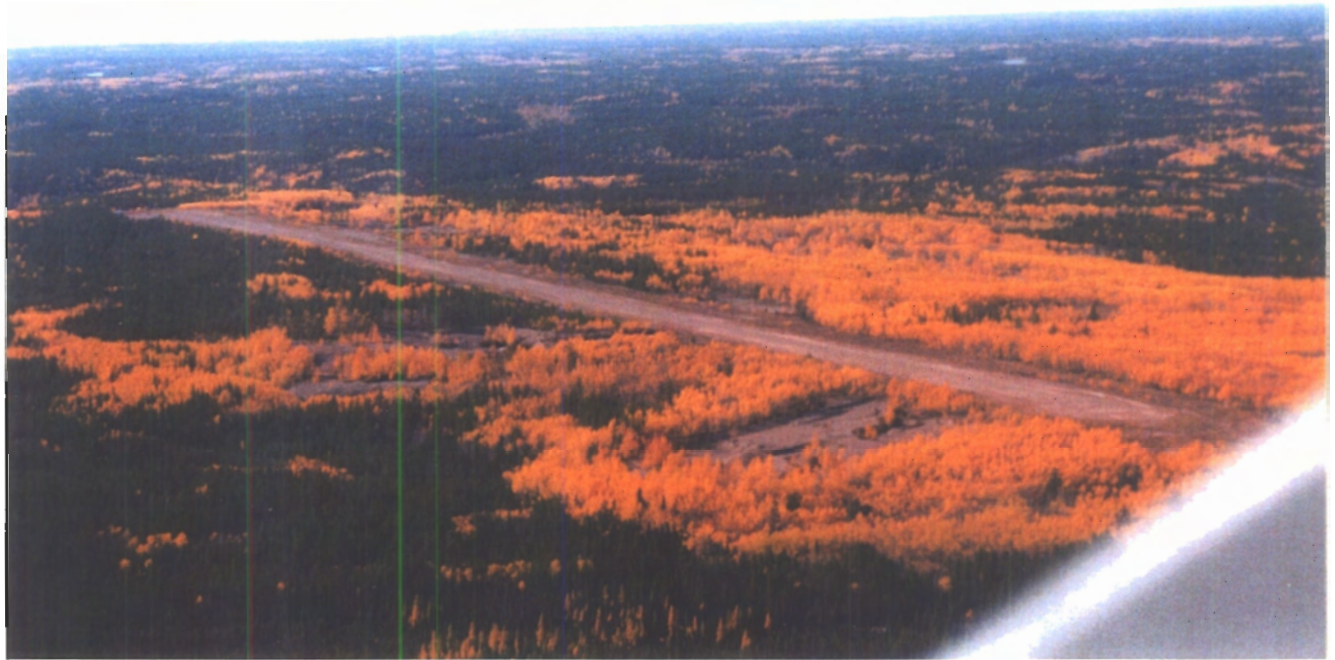
Photo 1

Aerial view of airstrip looking NW. Pits Y & Z in foreground. Pits V & W opposite at far end runway.

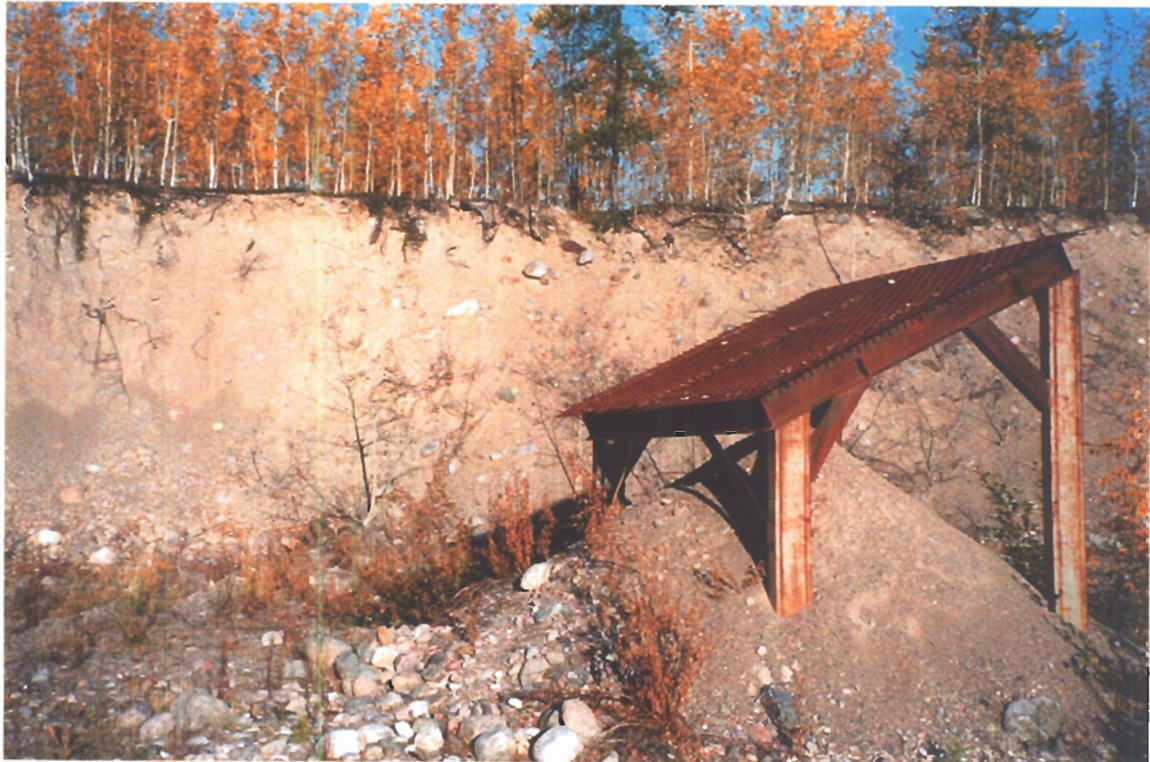
Photo 2

Grizzly screen set up in Pit W.

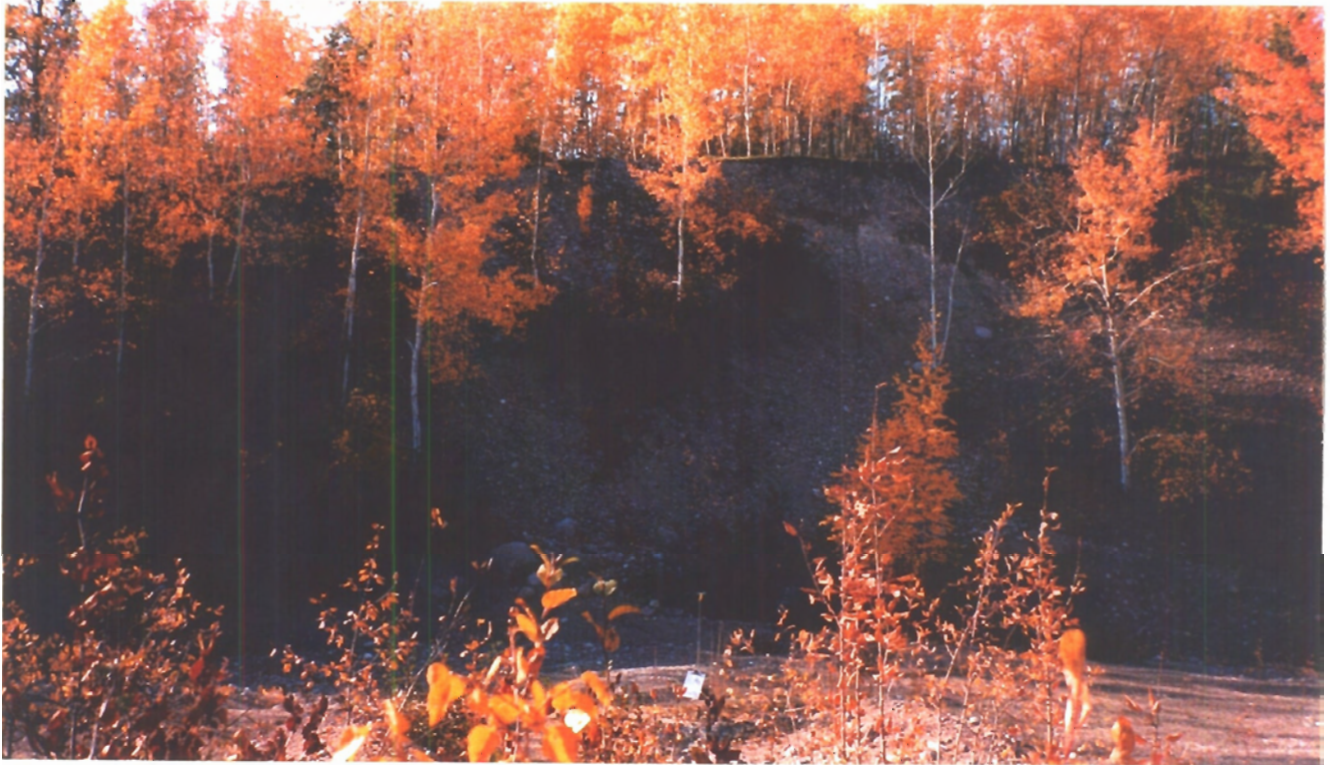
Photo 3

Central portion of Lake Pit along north side of Spillway road. Pit is partly overgrown.

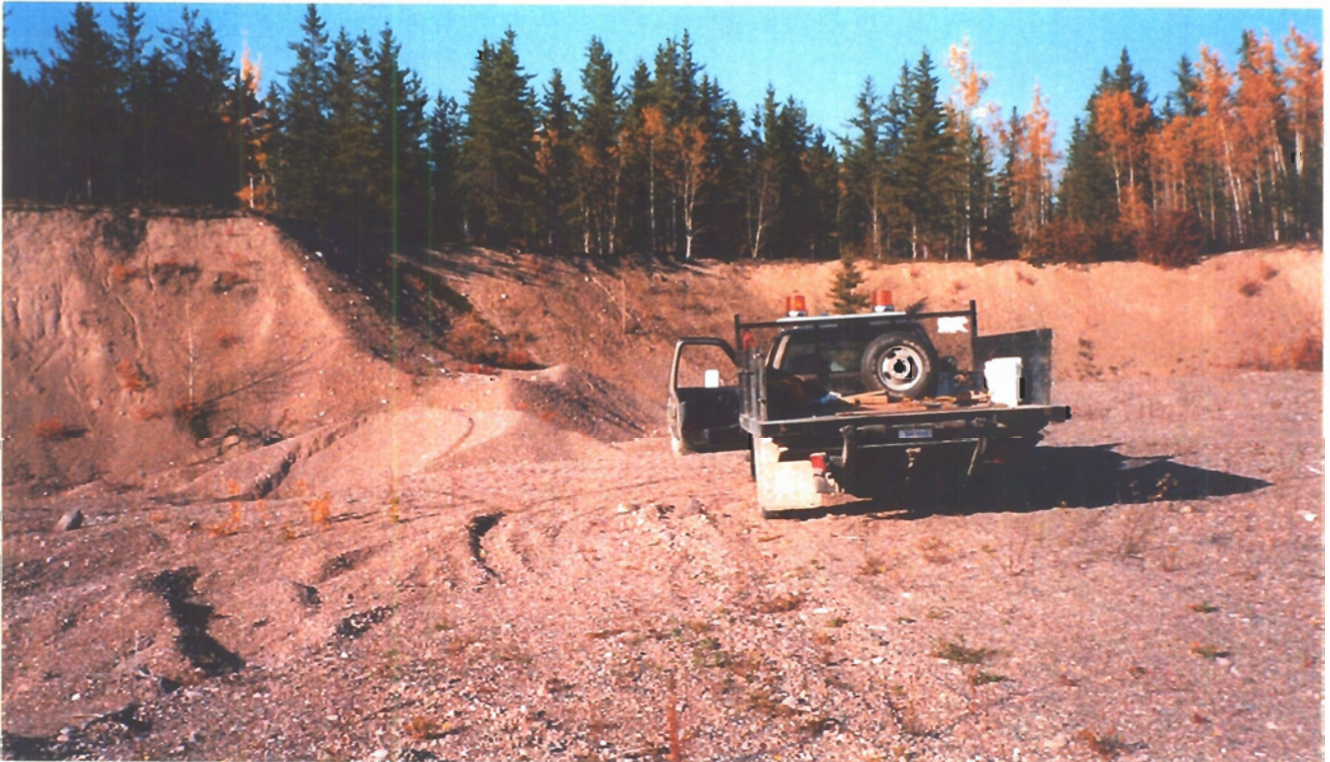
Photo 4

View of east portion of Middle Pit along north side of Spillway road. Coarse concrete aggregate is obtained from floor of pit at left hand side.

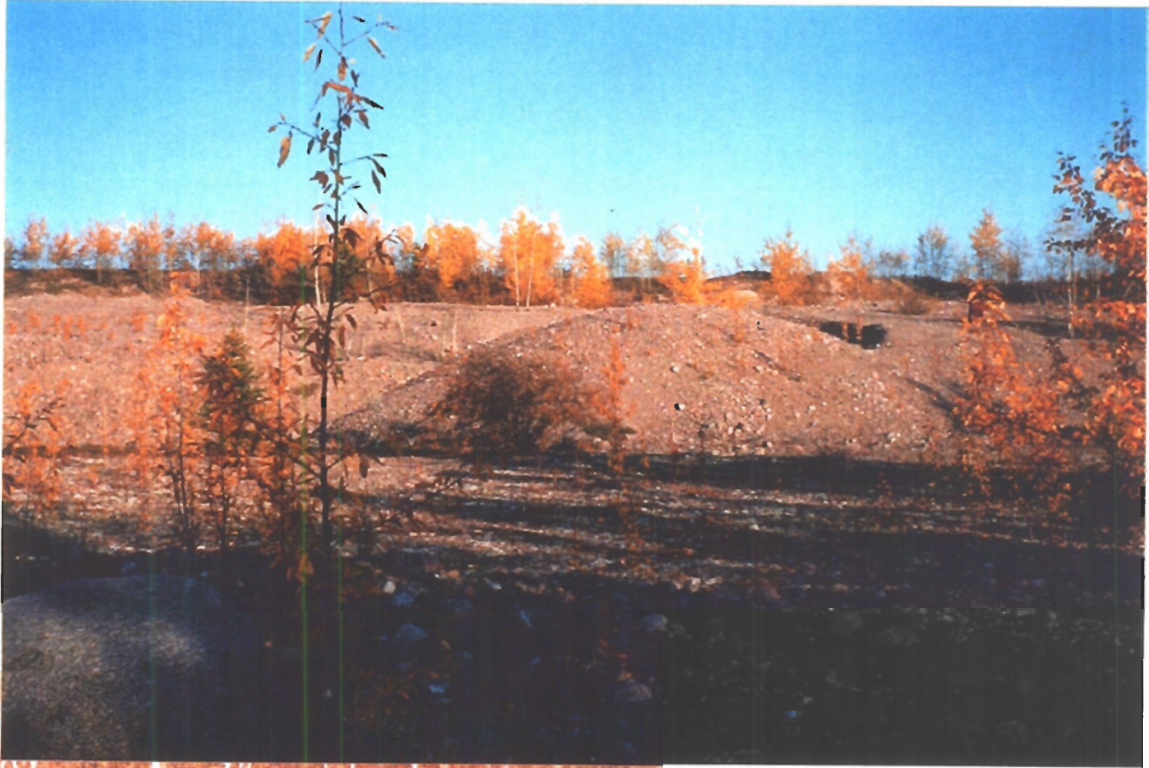
Photo 5

Pit Z looking north from southern edge of pit. Airstrip is behind trees.

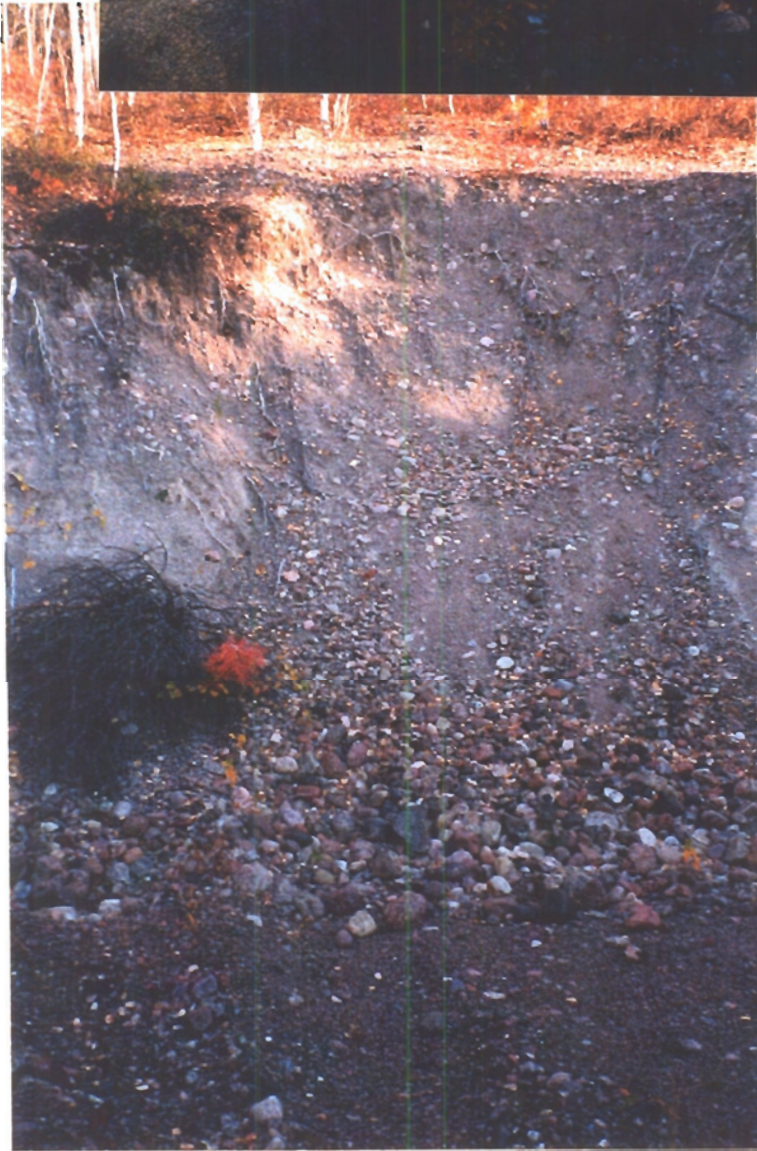
Photo 6

Close up of aggregate in Pit Z – some cobbles, mostly sand and gravel.

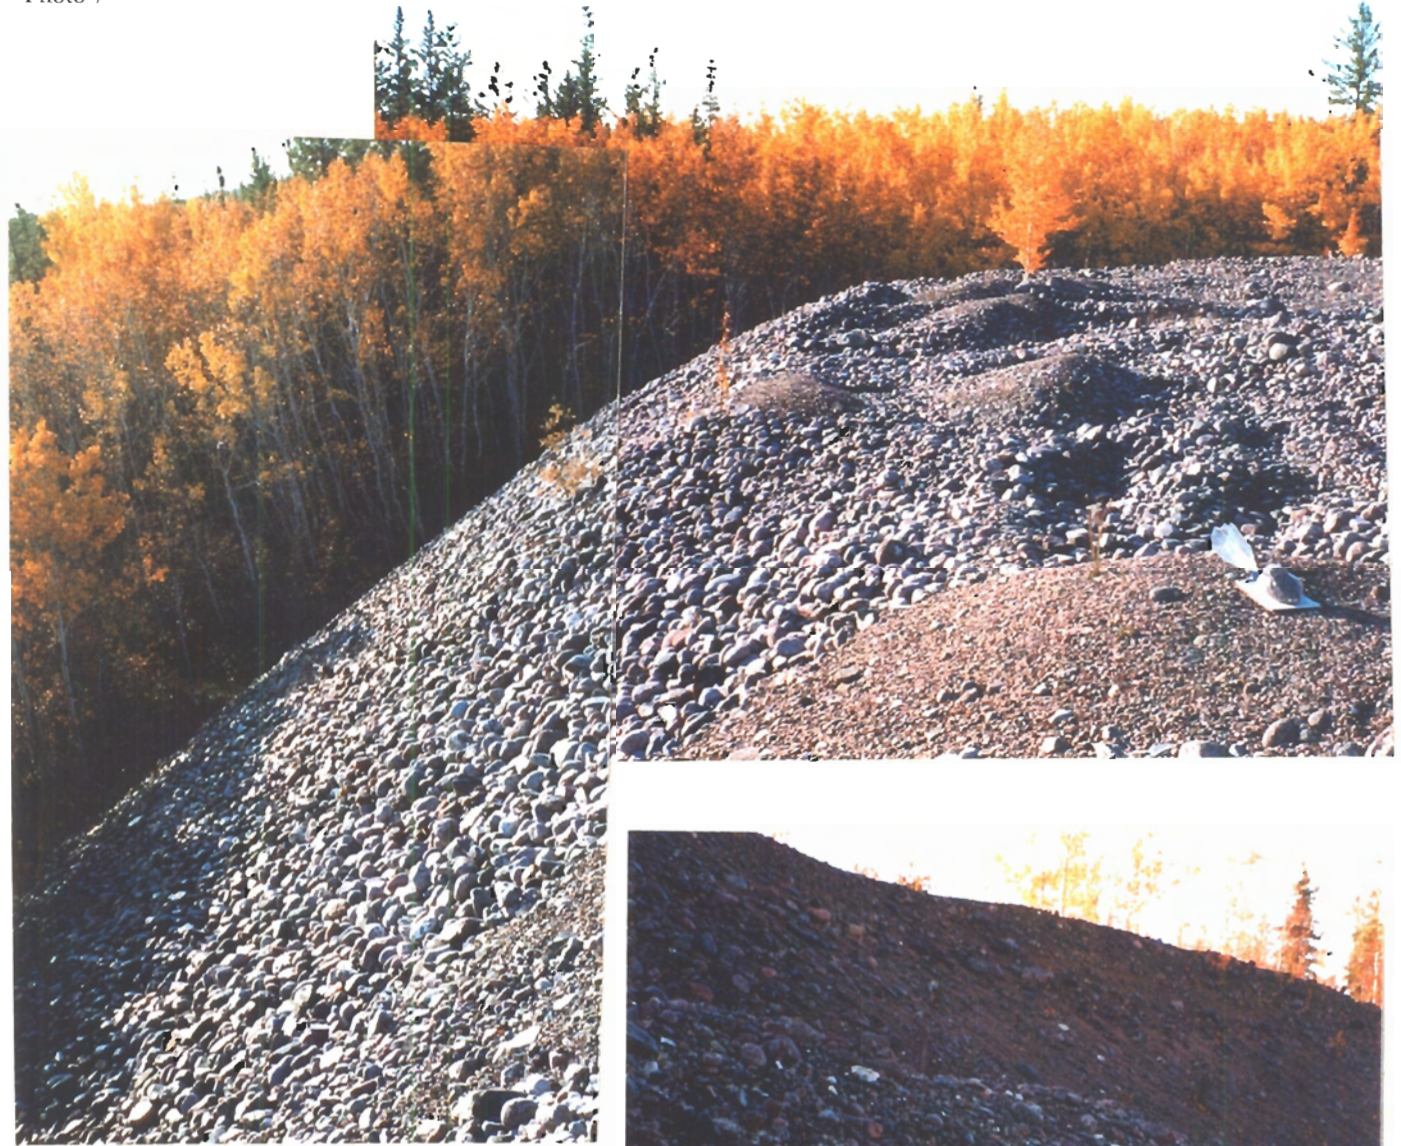
Photo 7

South edge of Pit Y looking
south west along cobble ridge.

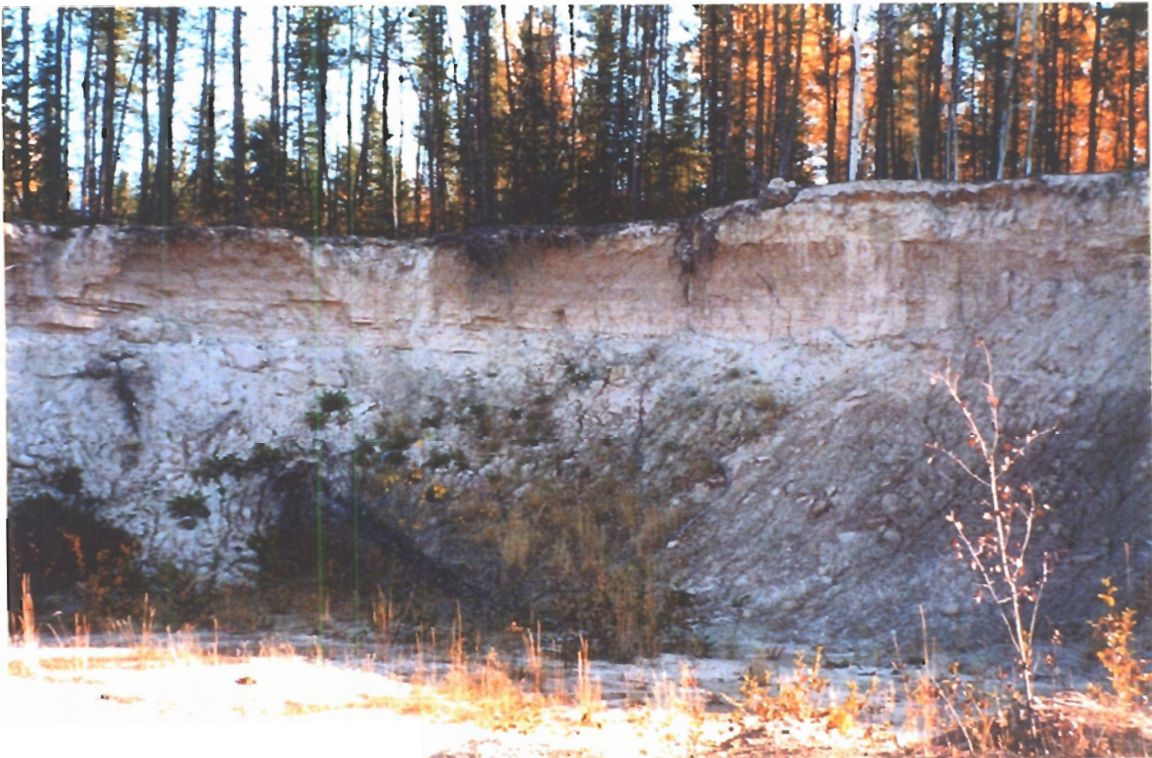
Photo 12

Horizontal stratification is clearly visible in the upper pit faces. This material is similar to the deposit of silt observed within Pit C. The results of gradation testing on one sample from each of the south and north extensions of the clay exposures indicate compositions of 0 % gravel, 4 to 18 % sand, 53 to 63 % silt and 19 to 43 % clay. The results of Atterberg tests indicate a Liquid Limit of from 19 to 31 % and a Plastic Limit of from 12 to 16 % for this fine grained soil. The clay has a low to medium plasticity based on these results.

South Clay Pit looking at east bank showing horizontal bedding at top of face.

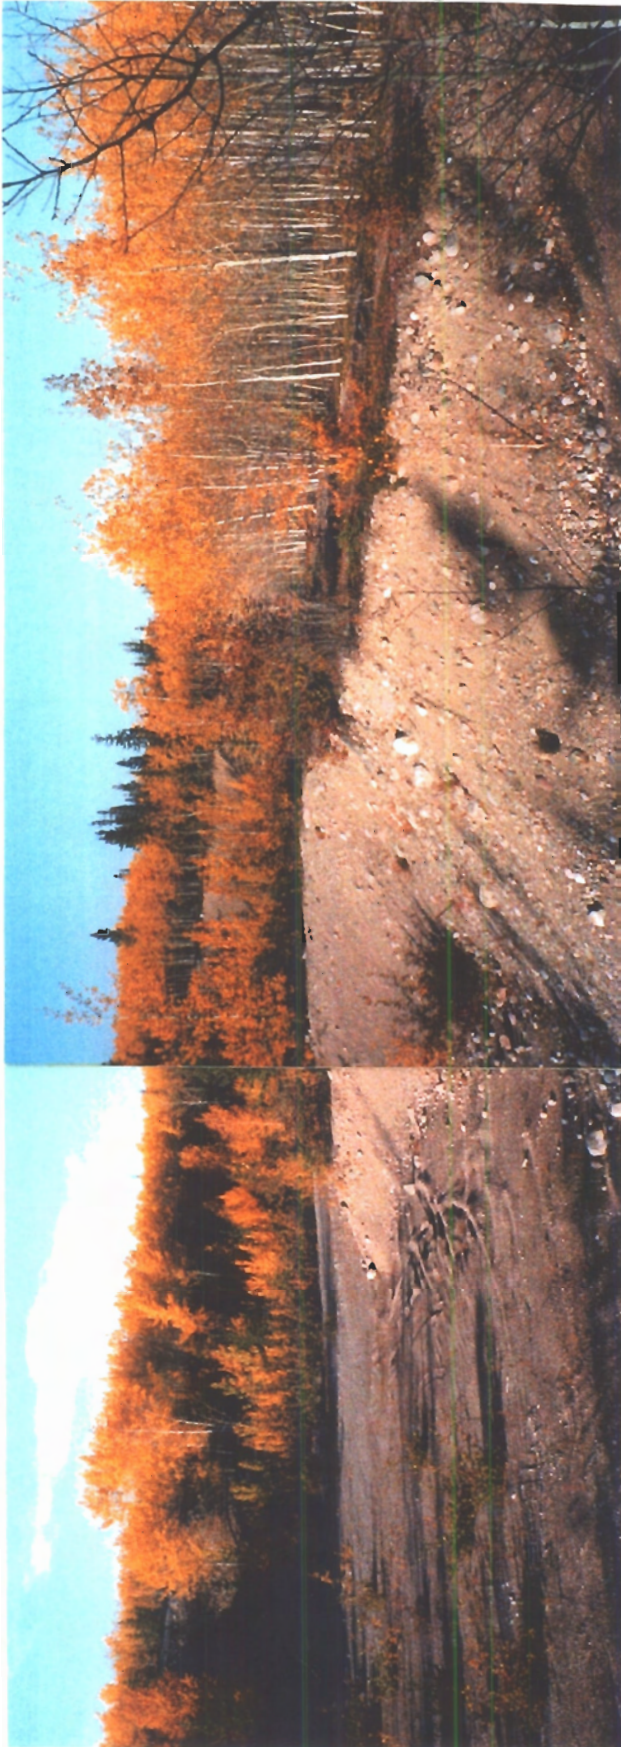
Photo 9 - Pit W looking east along south bank.

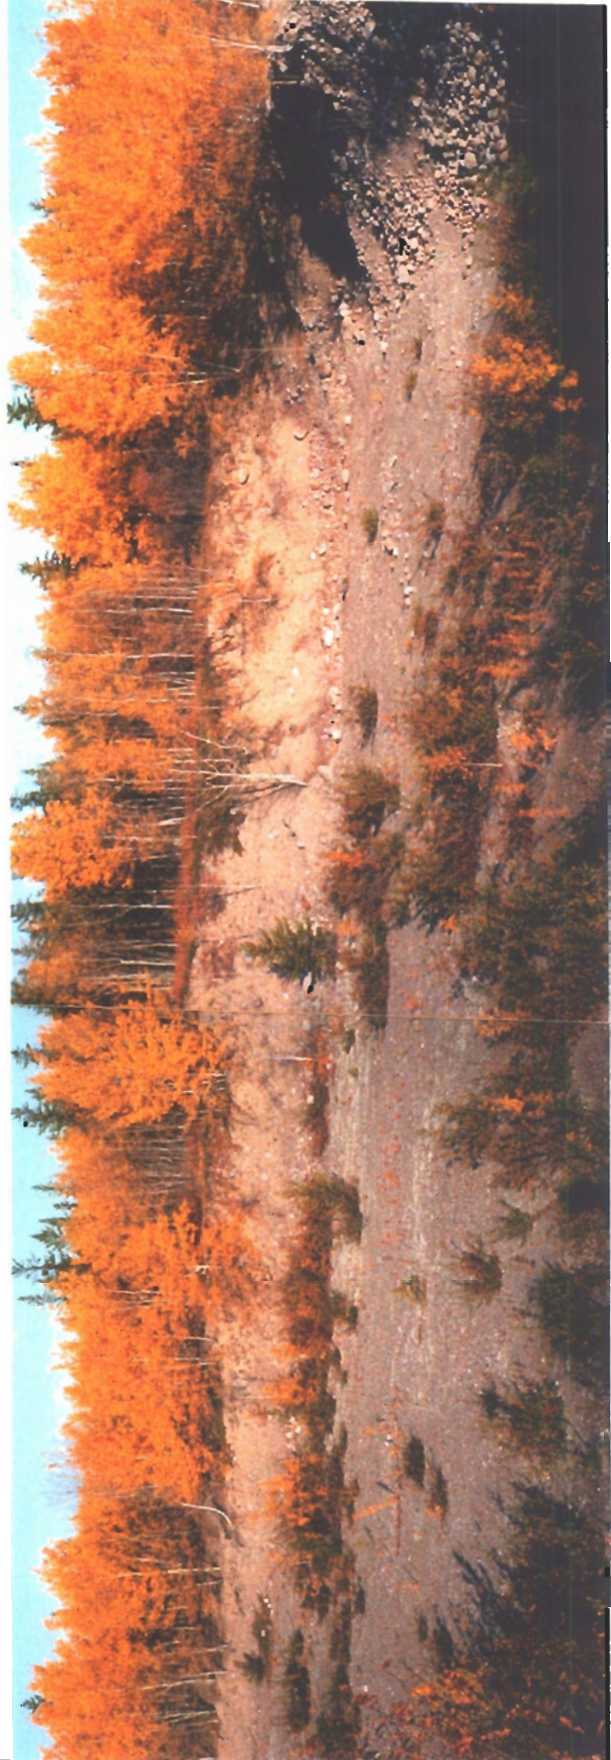
Photo 10 - Pit V looking north from airstrip.
