**GRANULAR BORROW INVESTIGATION
SNOWDRIFT AIRPORT
SNOWDRIFT, N.W.T.**

April, 1992

**GOVERNMENT OF THE NORTHWEST TERRITORIES
DEPARTMENT OF TRANSPORTATION
YELLOWKNIFE, N.W.T.**

**EBA ENGINEERING CONSULTANTS LTD.
YELLOWKNIFE, N.W.T.**

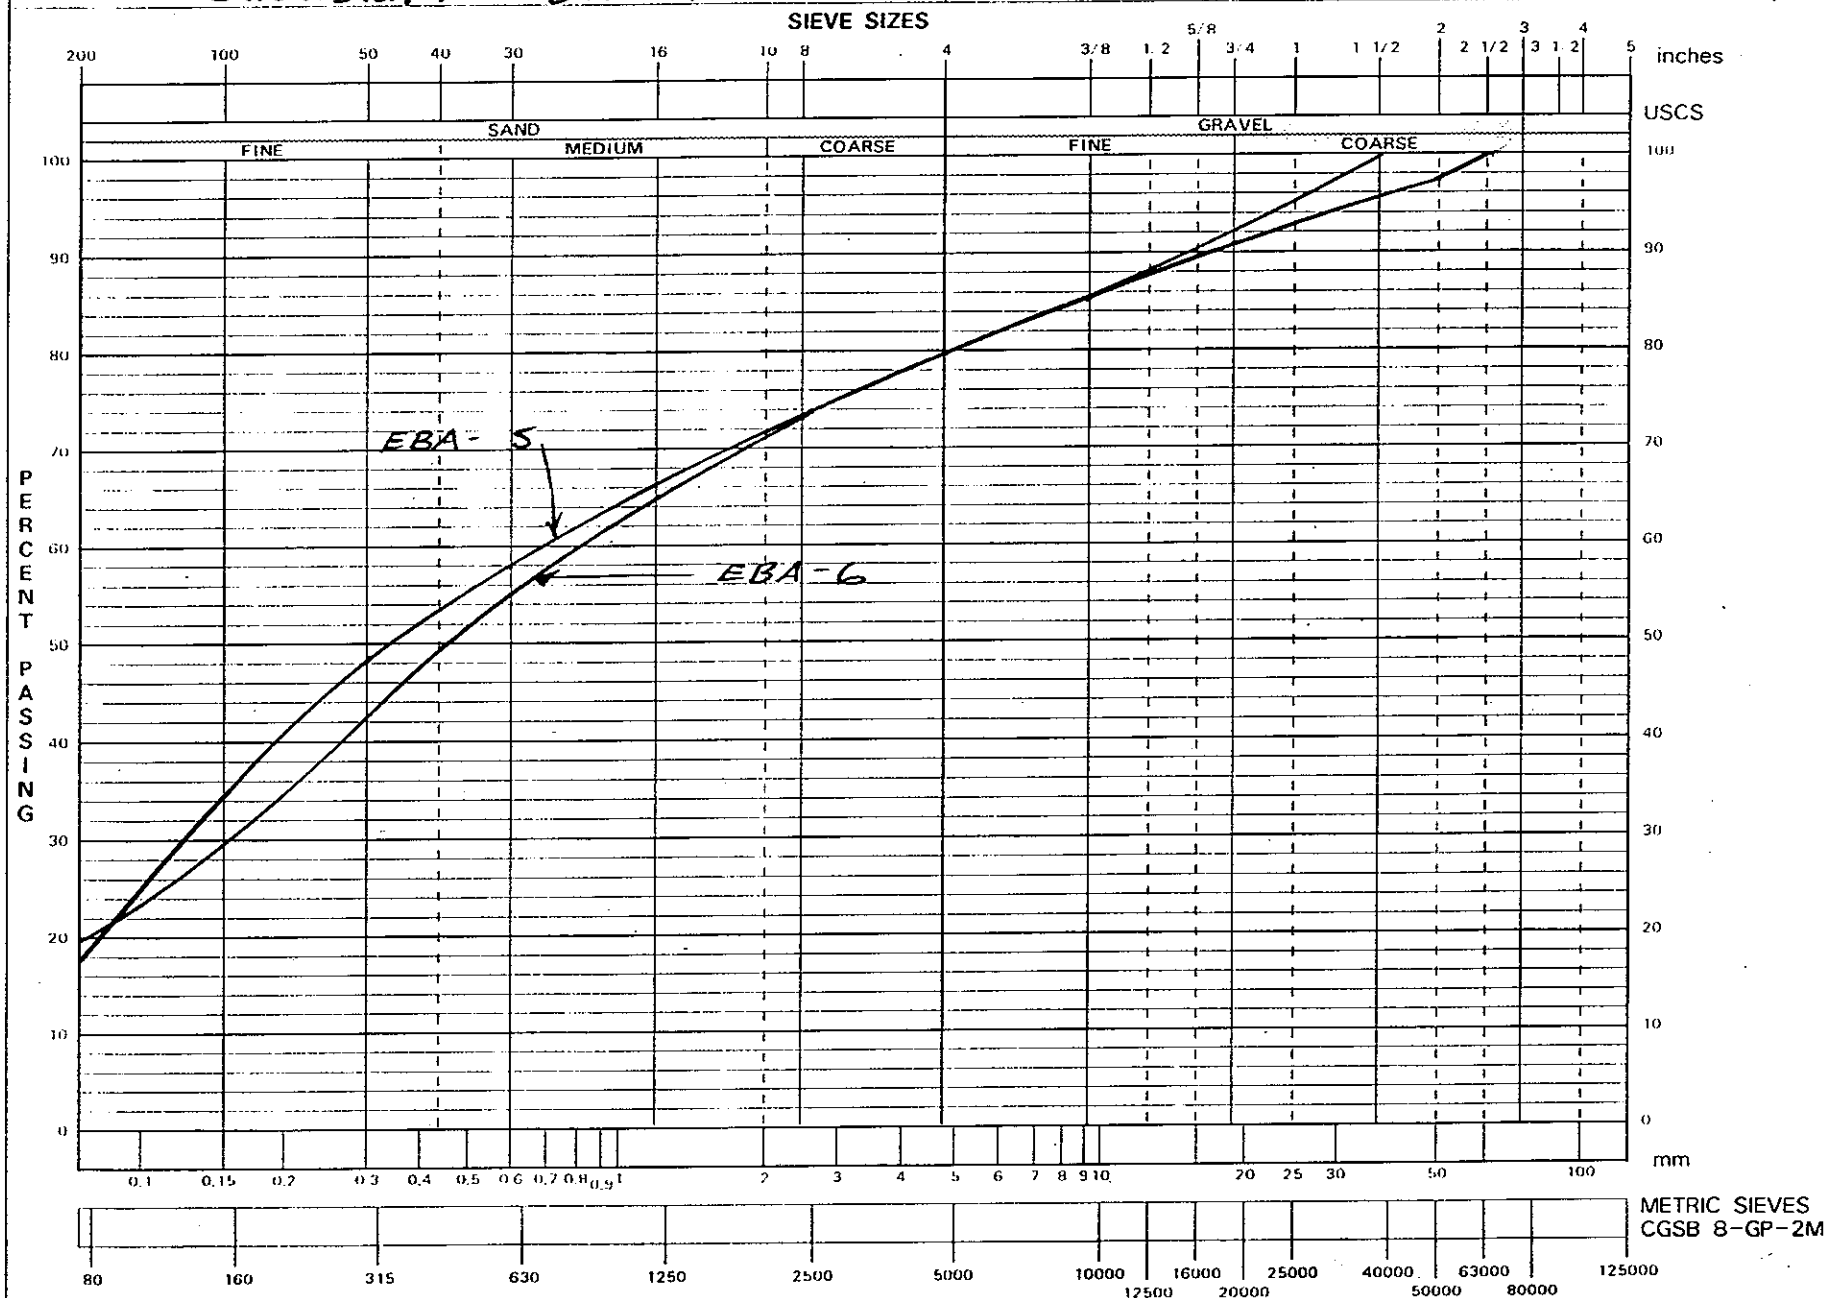
SNOWDRIFT SITE 4

GRAIN SIZE CURVES

From the limited information acquired at Site 4, it appears probable that sufficient blend material does exist. Results of gradation tests on samples from locations EBA-5 and EBA-6 indicate that the material is suitable for blending with crushed rock to produce a suitable surface material. However both test pits contained about 20% of gravel, to a maximum size of 60 mm.

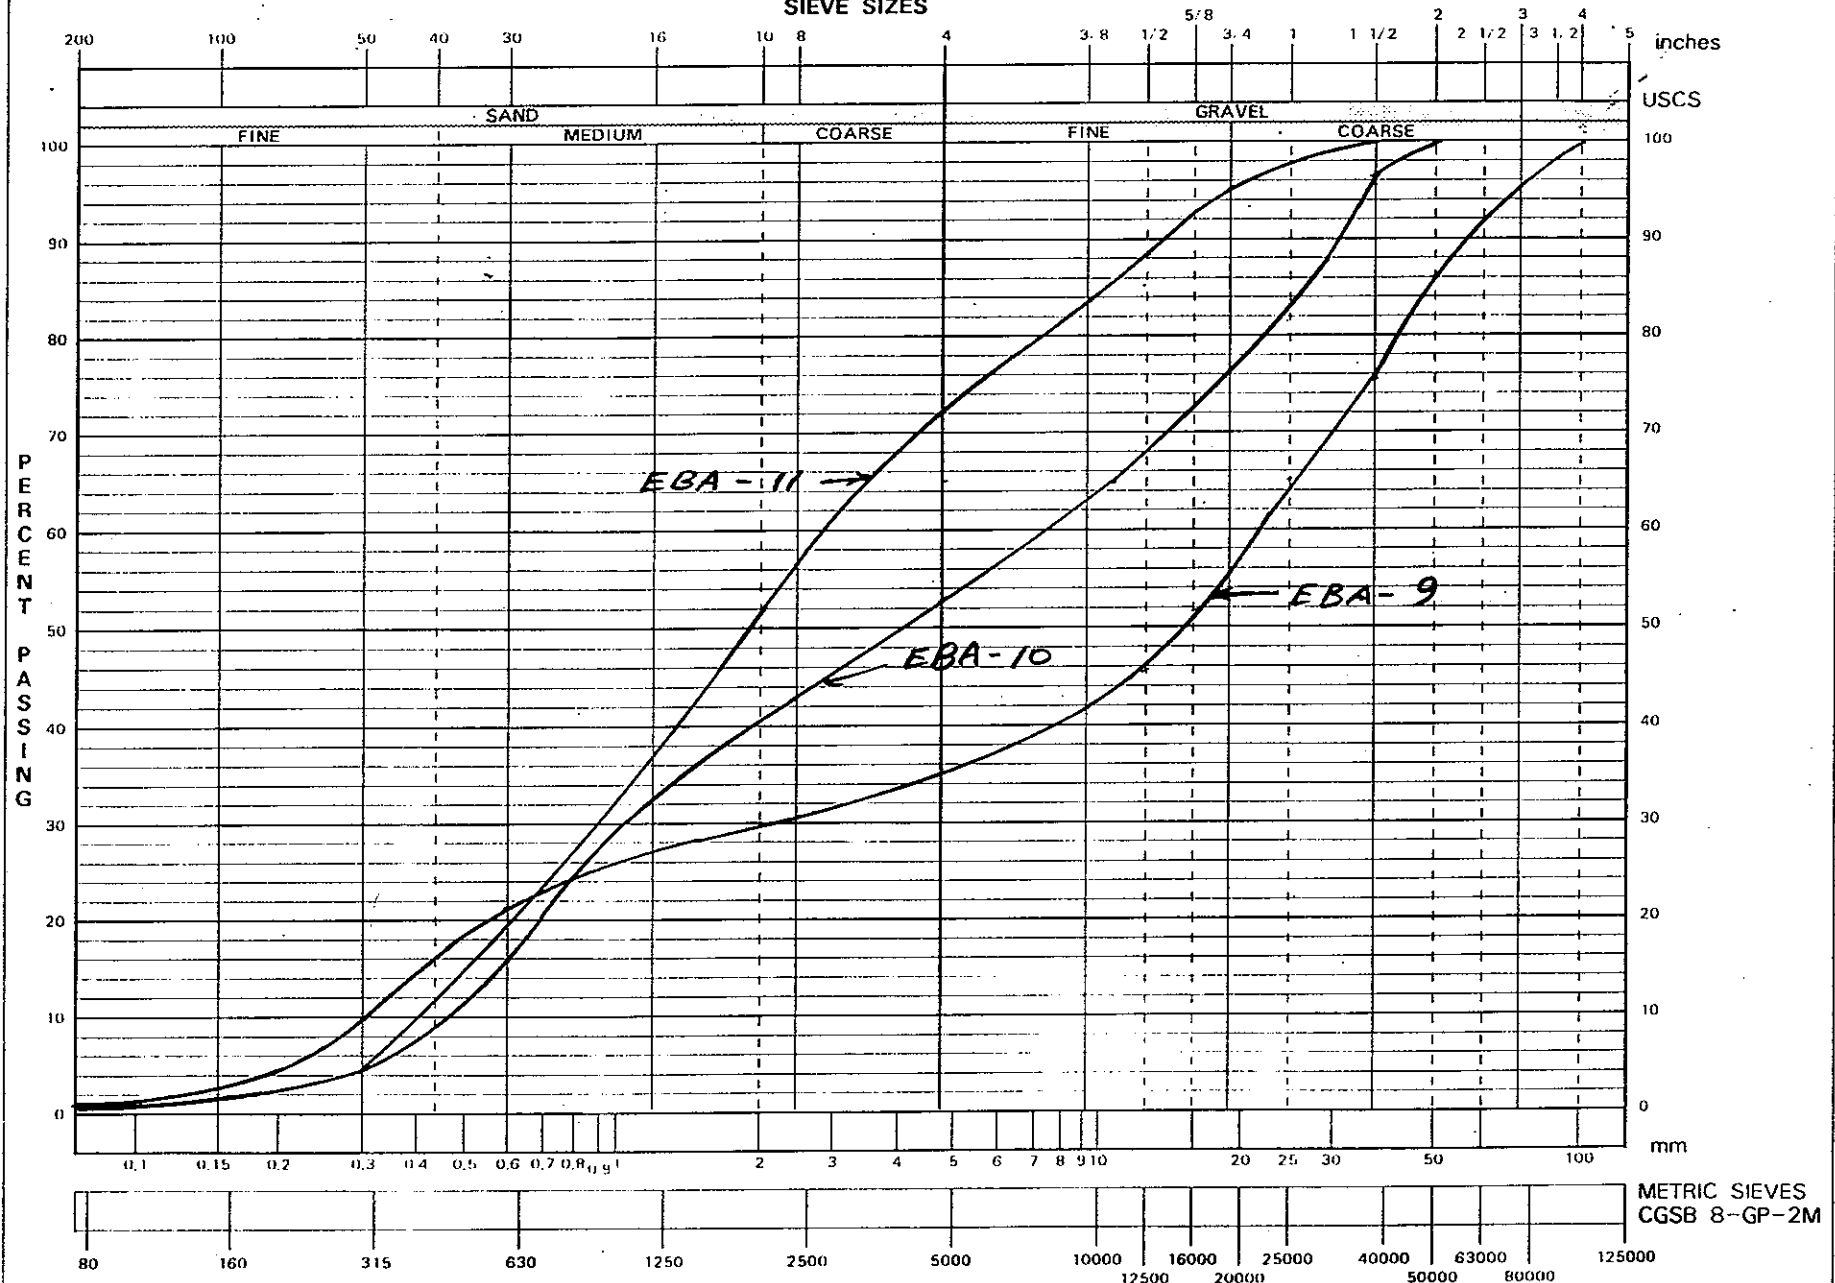
SNOWDRIFT SITE 6

GRAIN SIZE CURVES

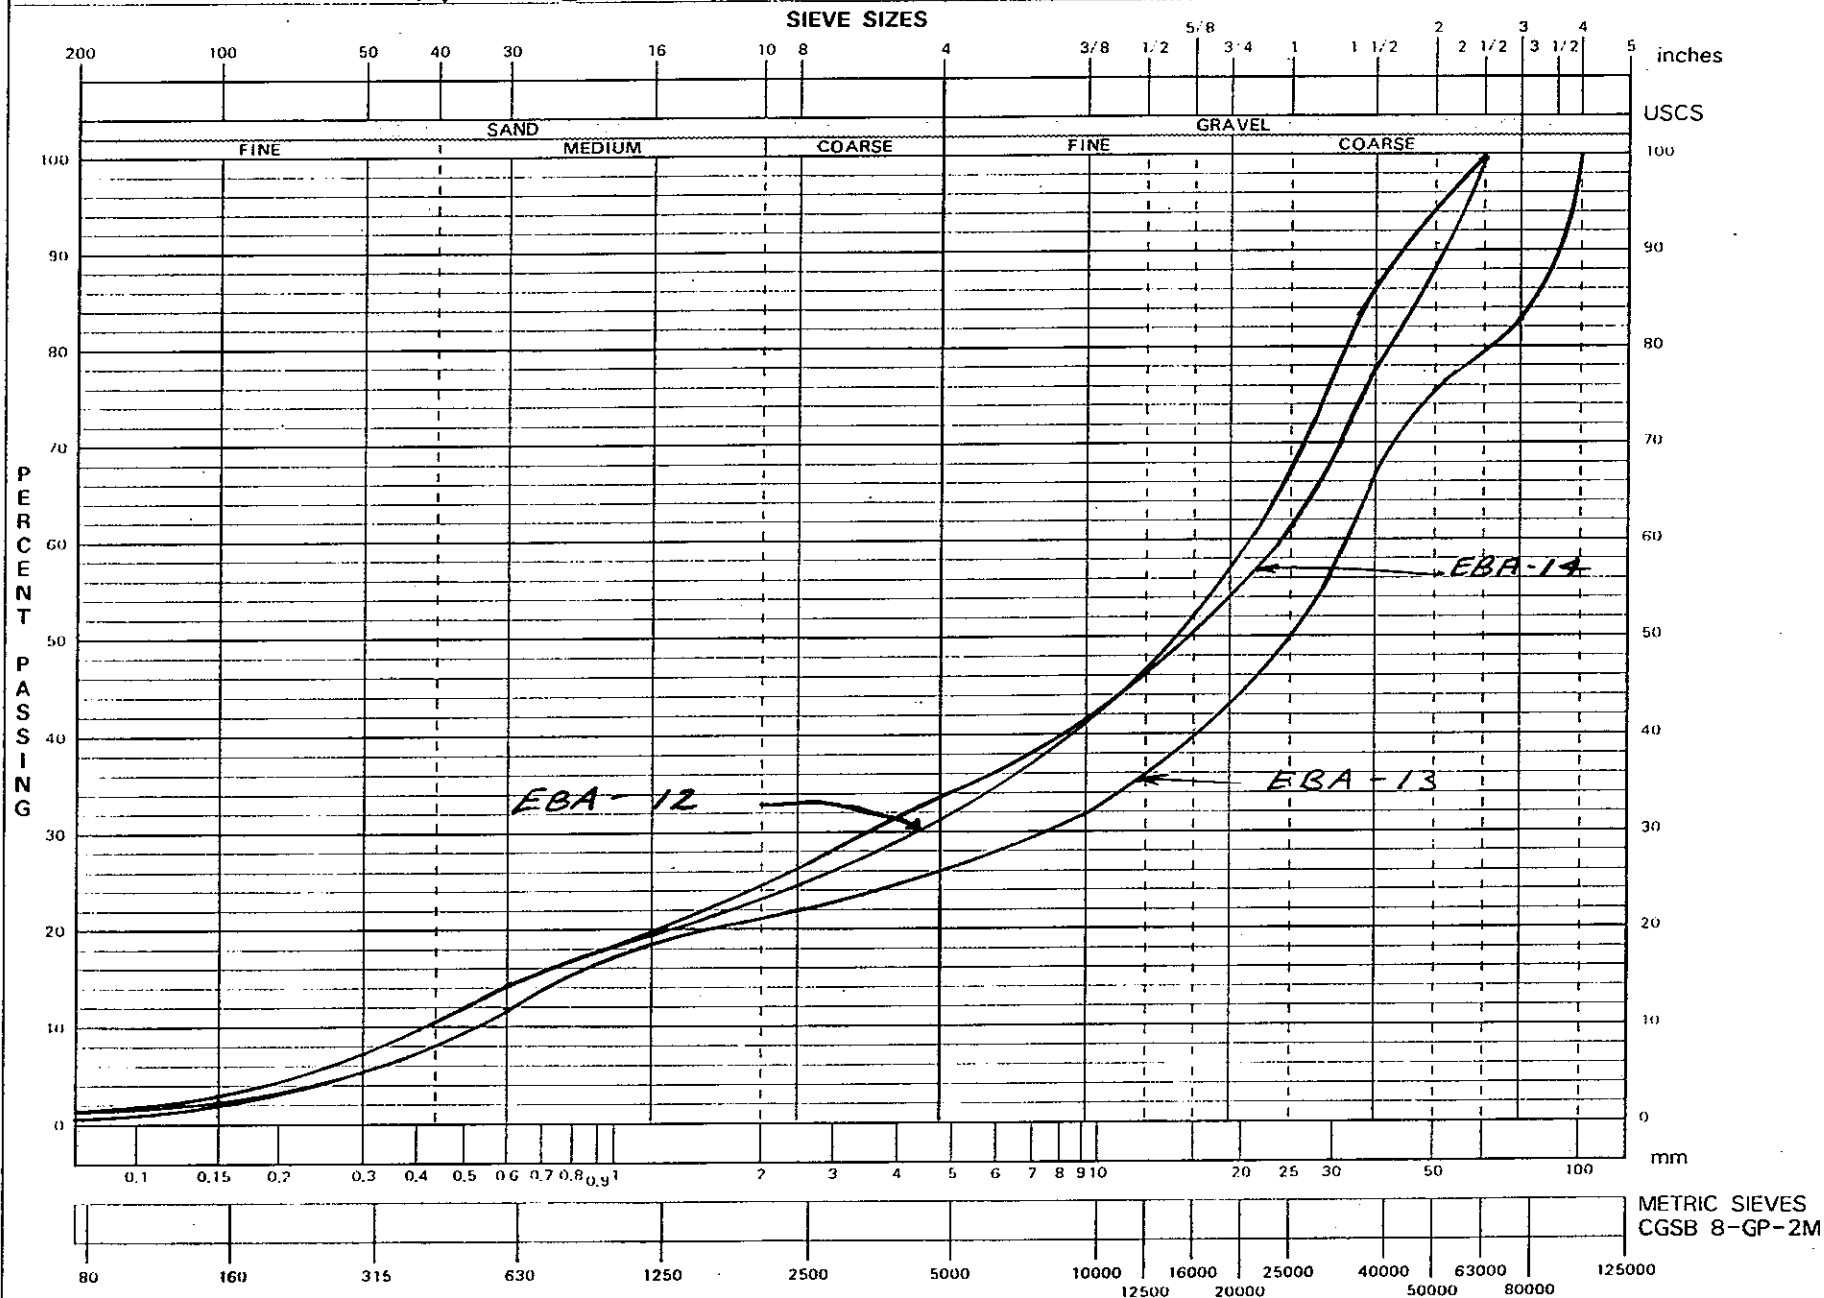
SNOWDRIFT SITE 7

GRAIN SIZE CURVES

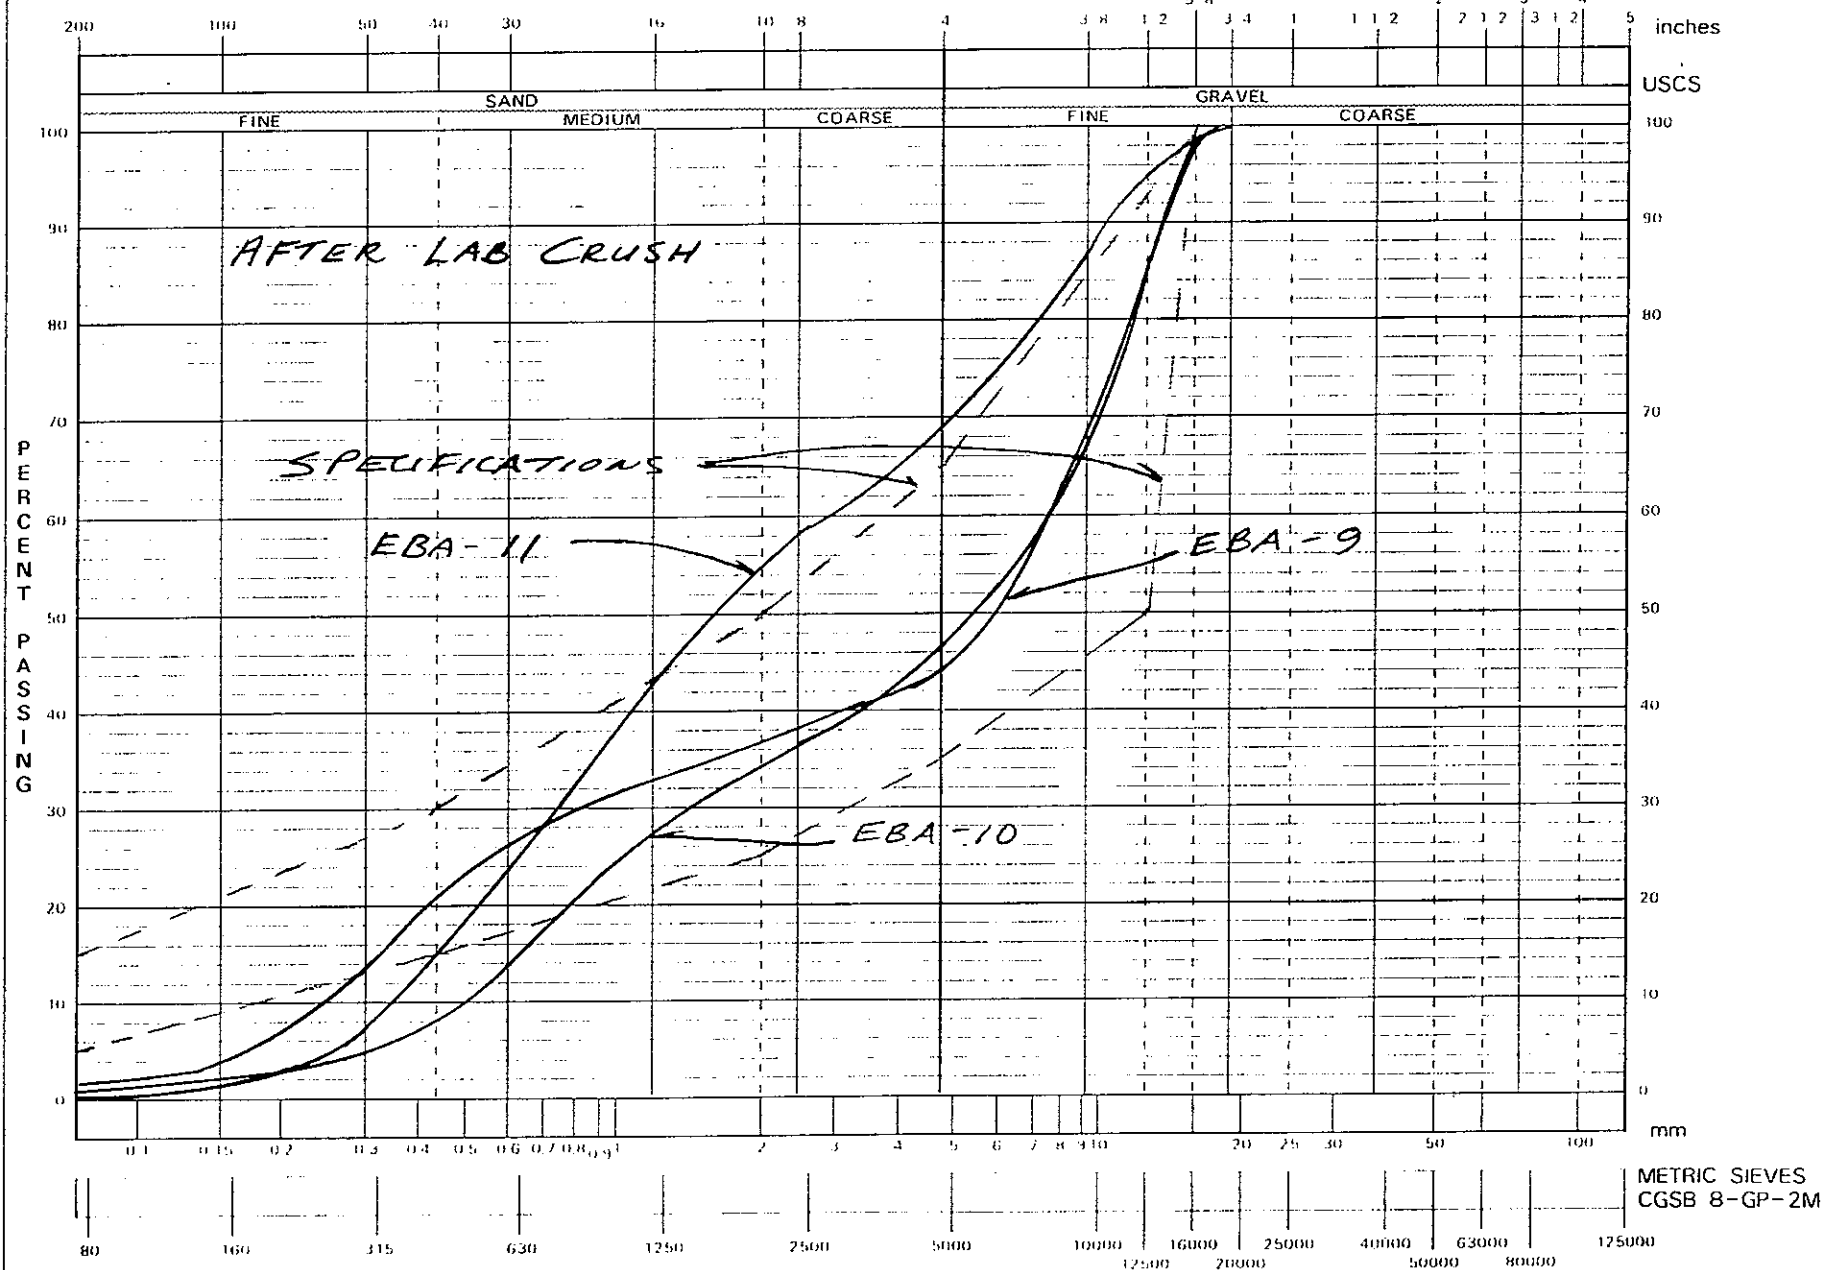
SNOWDRIFT SITE 6

GRAIN SIZE CURVES

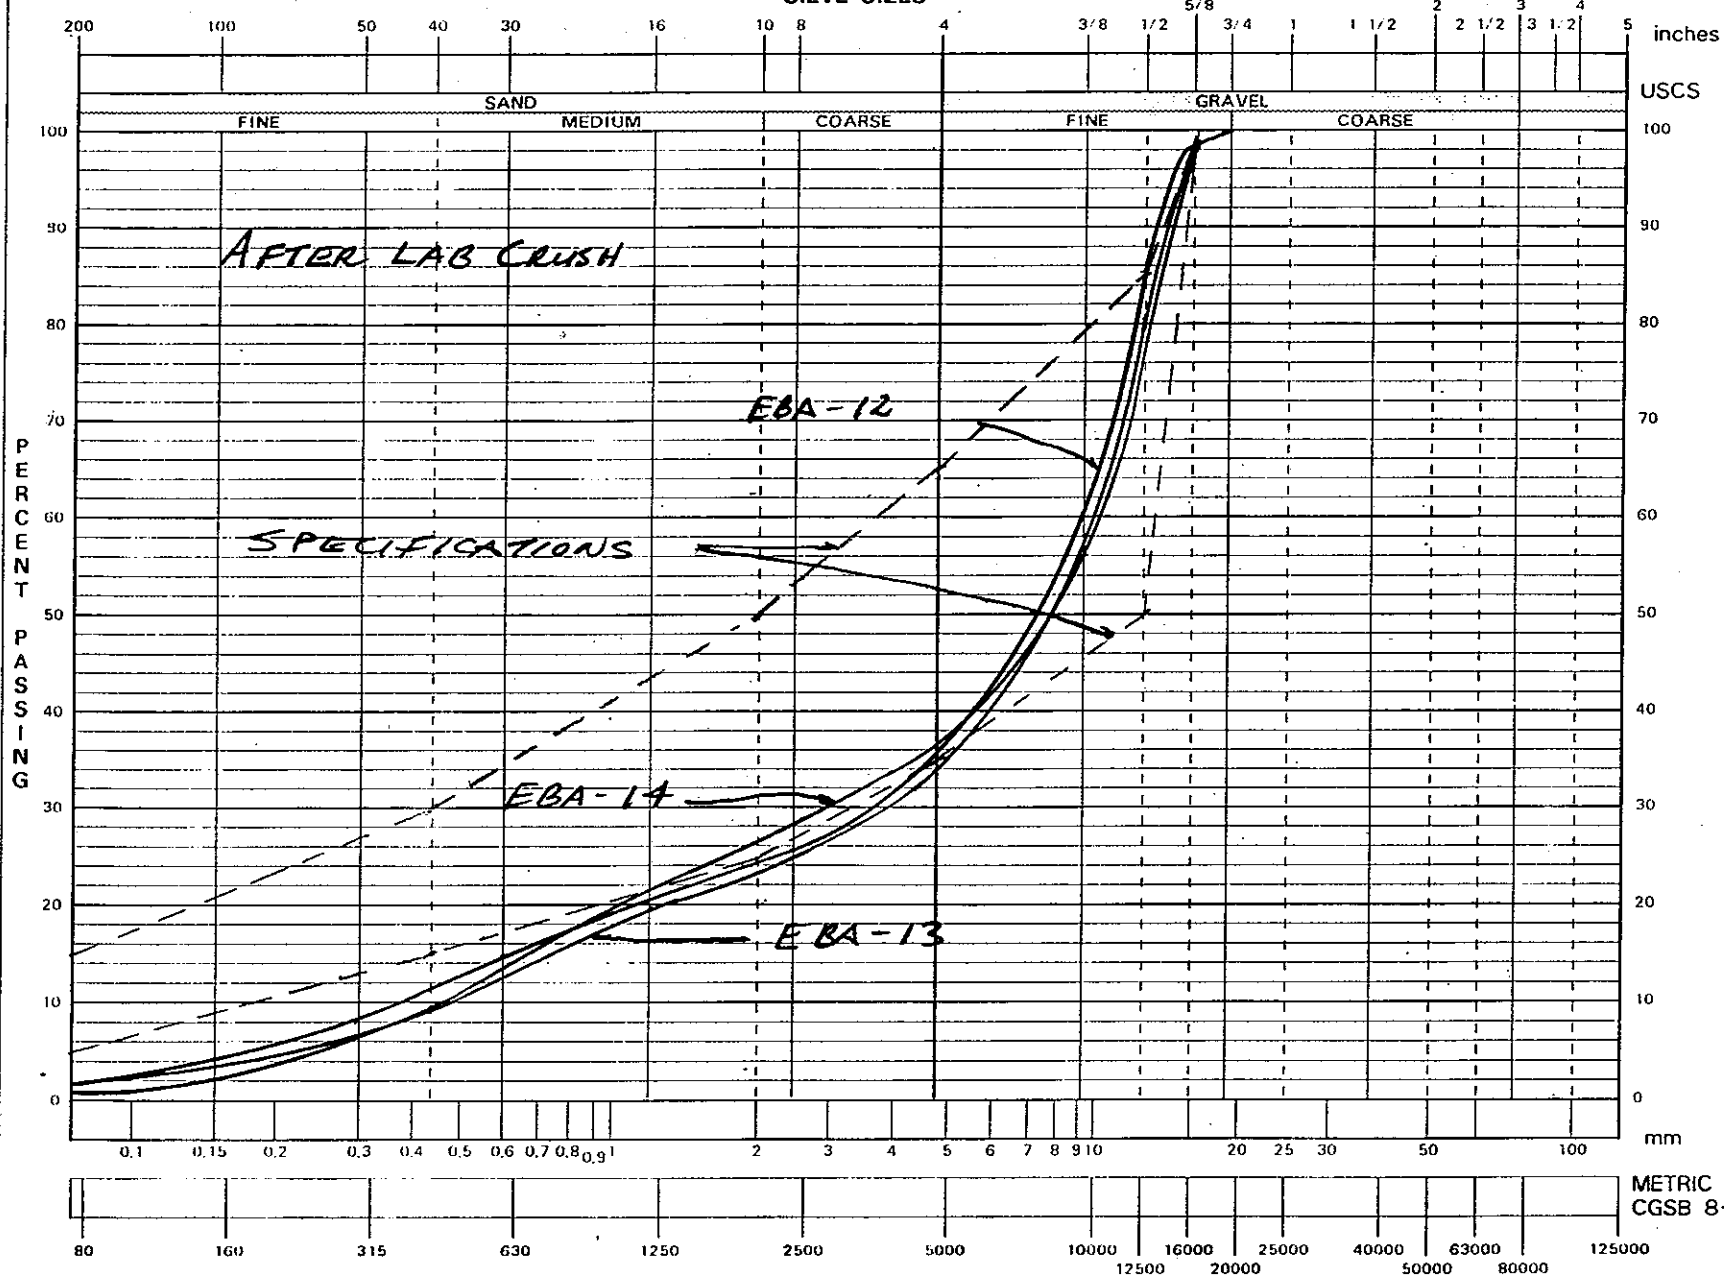
SNOWDRIFT SITE 7

GRAIN SIZE CURVES

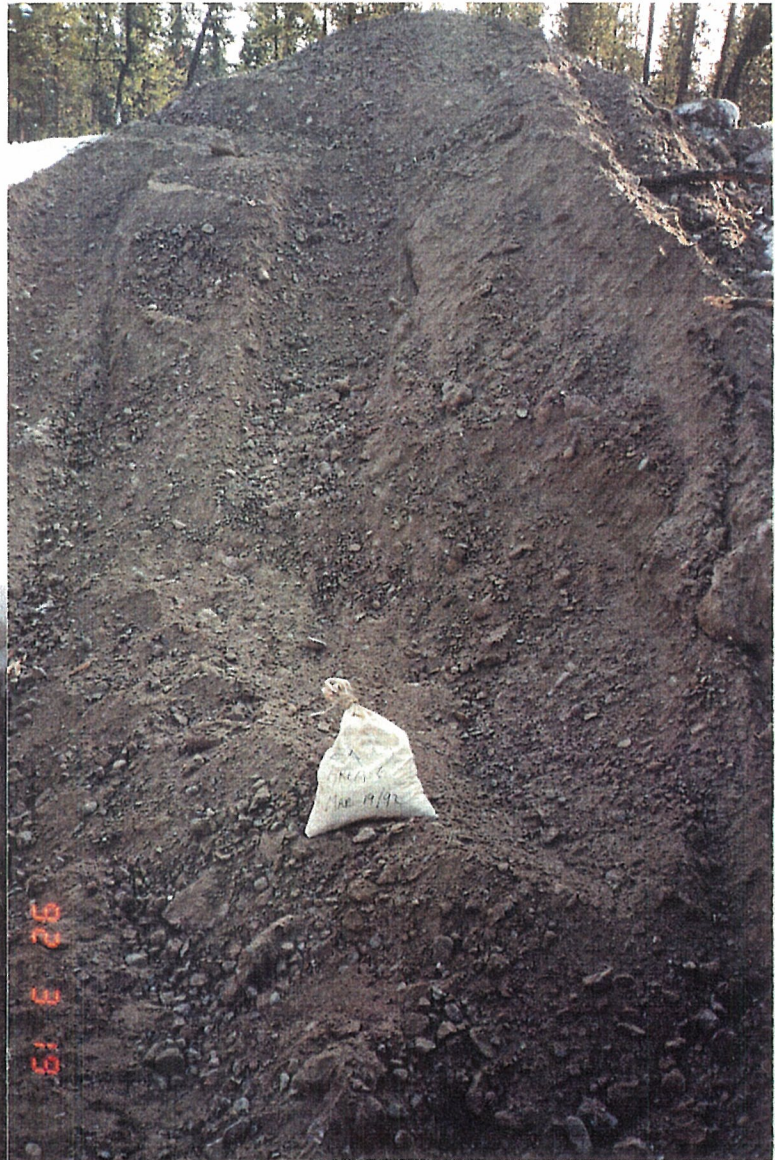
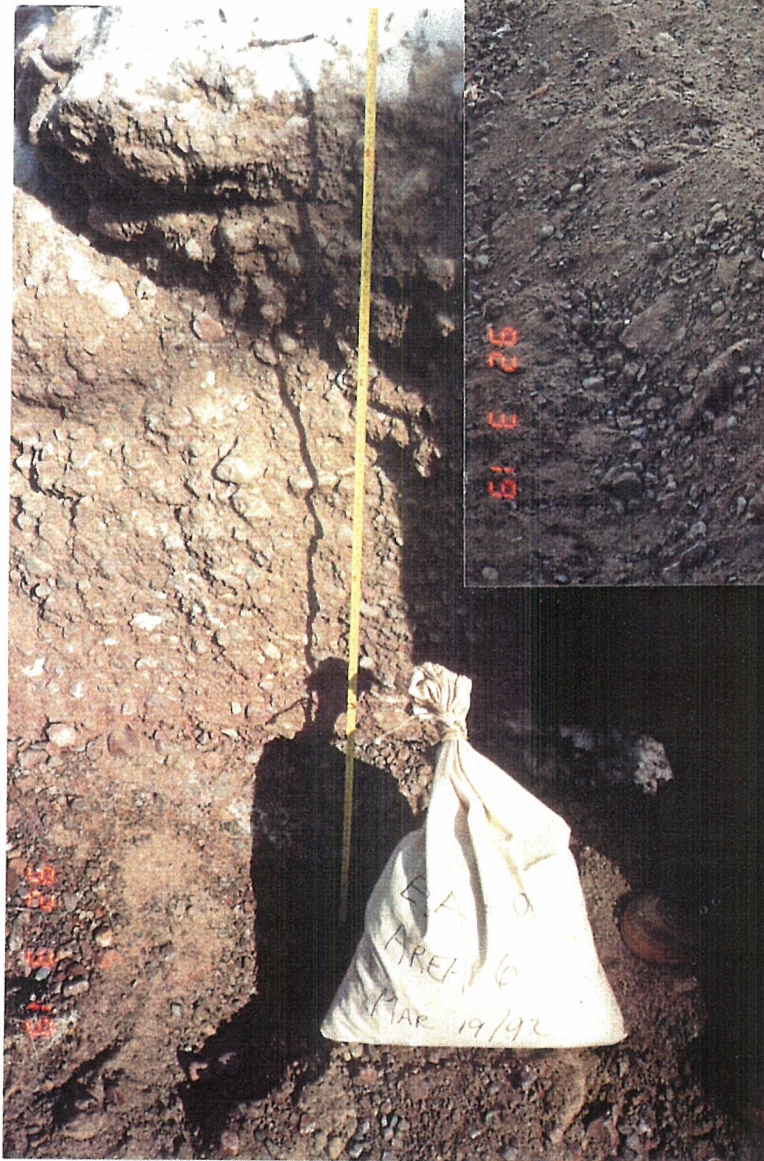
Test pit EBA 9
Site 6
(Neg # 14A)

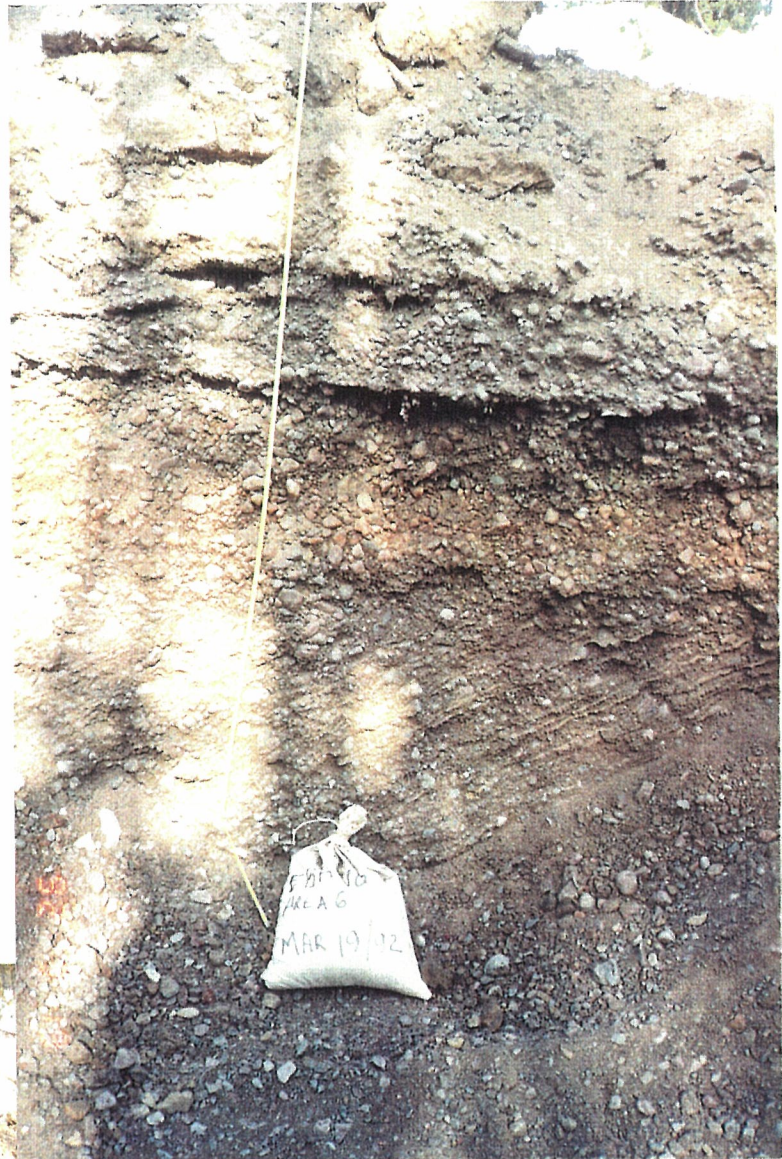
Test pit EBA 10
Site 6
(Neg #18A)

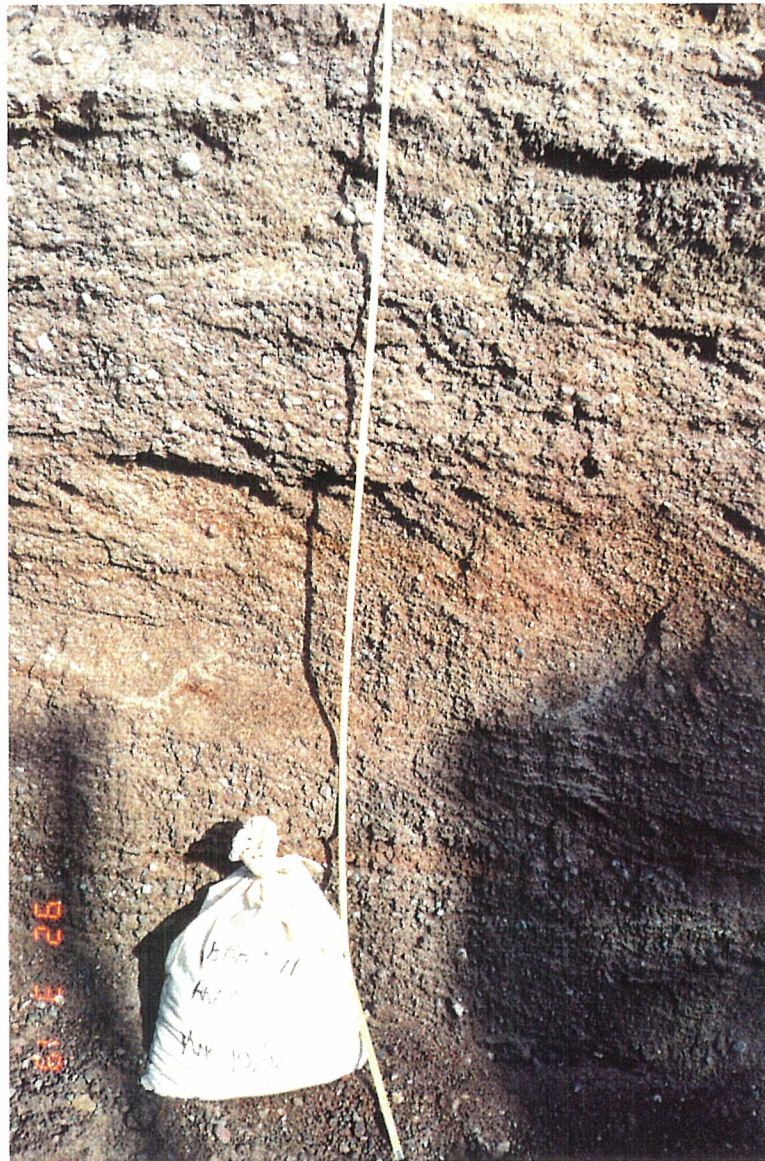
Test Pit EBA 11, Site 6. (Neg #20A)

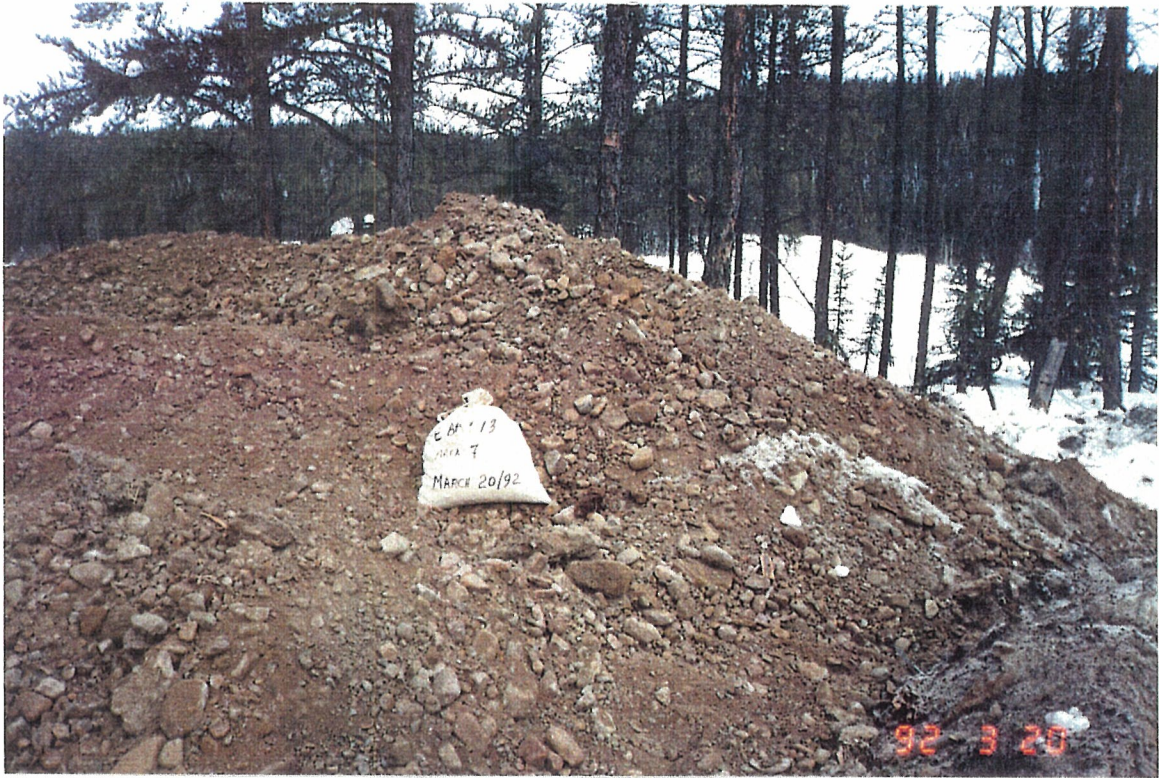
Test Pit EBA 13, Site 7. (Neg #00)

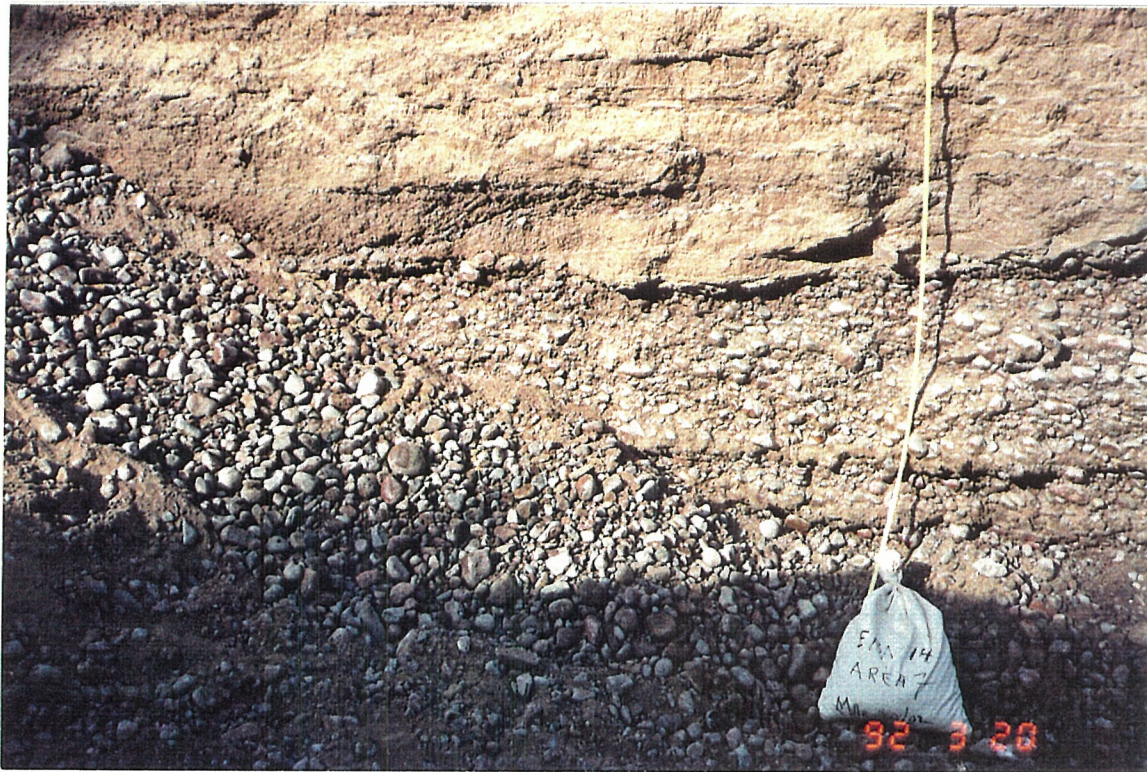
Test Pit EBA 14, Site 7. (Neg #1)
