PRELIMINARY
BASIC ENVIRONMENTAL DATA

RAINBOW CREEK
BRIDGE

REFERENCE MILE 471 MACKENZIE HIGHWAY

DEPARTMENT OF PUBLIC WORKS
EDMONTON, CANADA

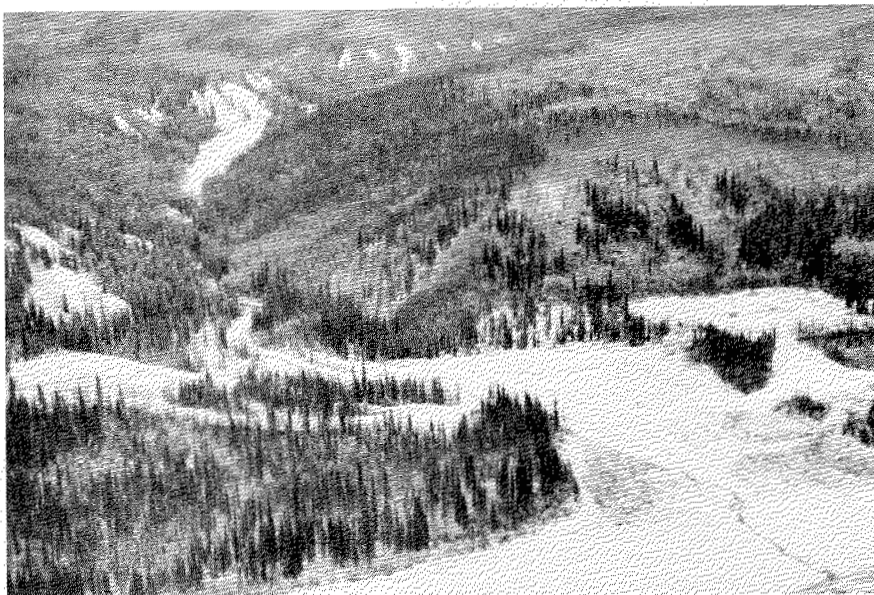
26.10.72. Rainbow Creek bridge crossing. Located on abandoned alluvial terrace. Both bridge design alternates encroach upon active channel and allow little room for movement of log debris. A single span would be more harmonious with physical conditions.

The fill for both bridge design alternates encroaches upon an active alluvial channel, and design allows minimum room for free passage of log debris. A single span would be more harmonious with expected conditions.

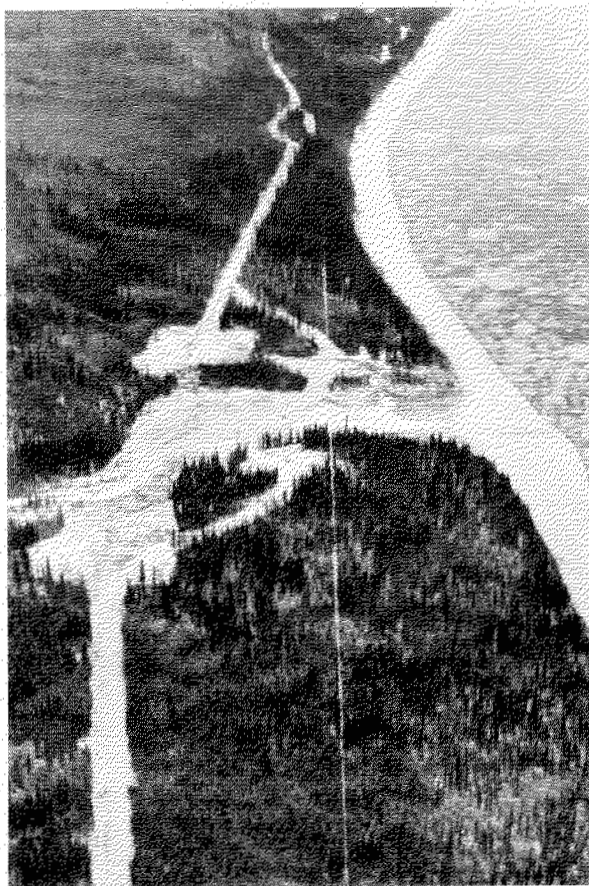
26.10.72. Rainbow Creek. Note location centerline in this photo. If the crossing has to be moved upstream against toe of scarp or onto scarp it will probably create siltation from unstable slopes. Existing cleared areas should be revegetated at the earliest possible date to minimize siltation from runoff; the stream is probably utilized by grayling and other species as spawning and rearing habitat. Vegetation is black and white spruce with some aspen. Soils are peaty gleysols and regosols.
