PRELIMINARY  
BASIC ENVIRONMENTAL DATA

OCHRE RIVER  
BRIDGE

REFERENCE MILE 455 MACKENZIE HIGHWAY

DEPARTMENT OF PUBLIC WORKS  
EDMONTON, CANADA

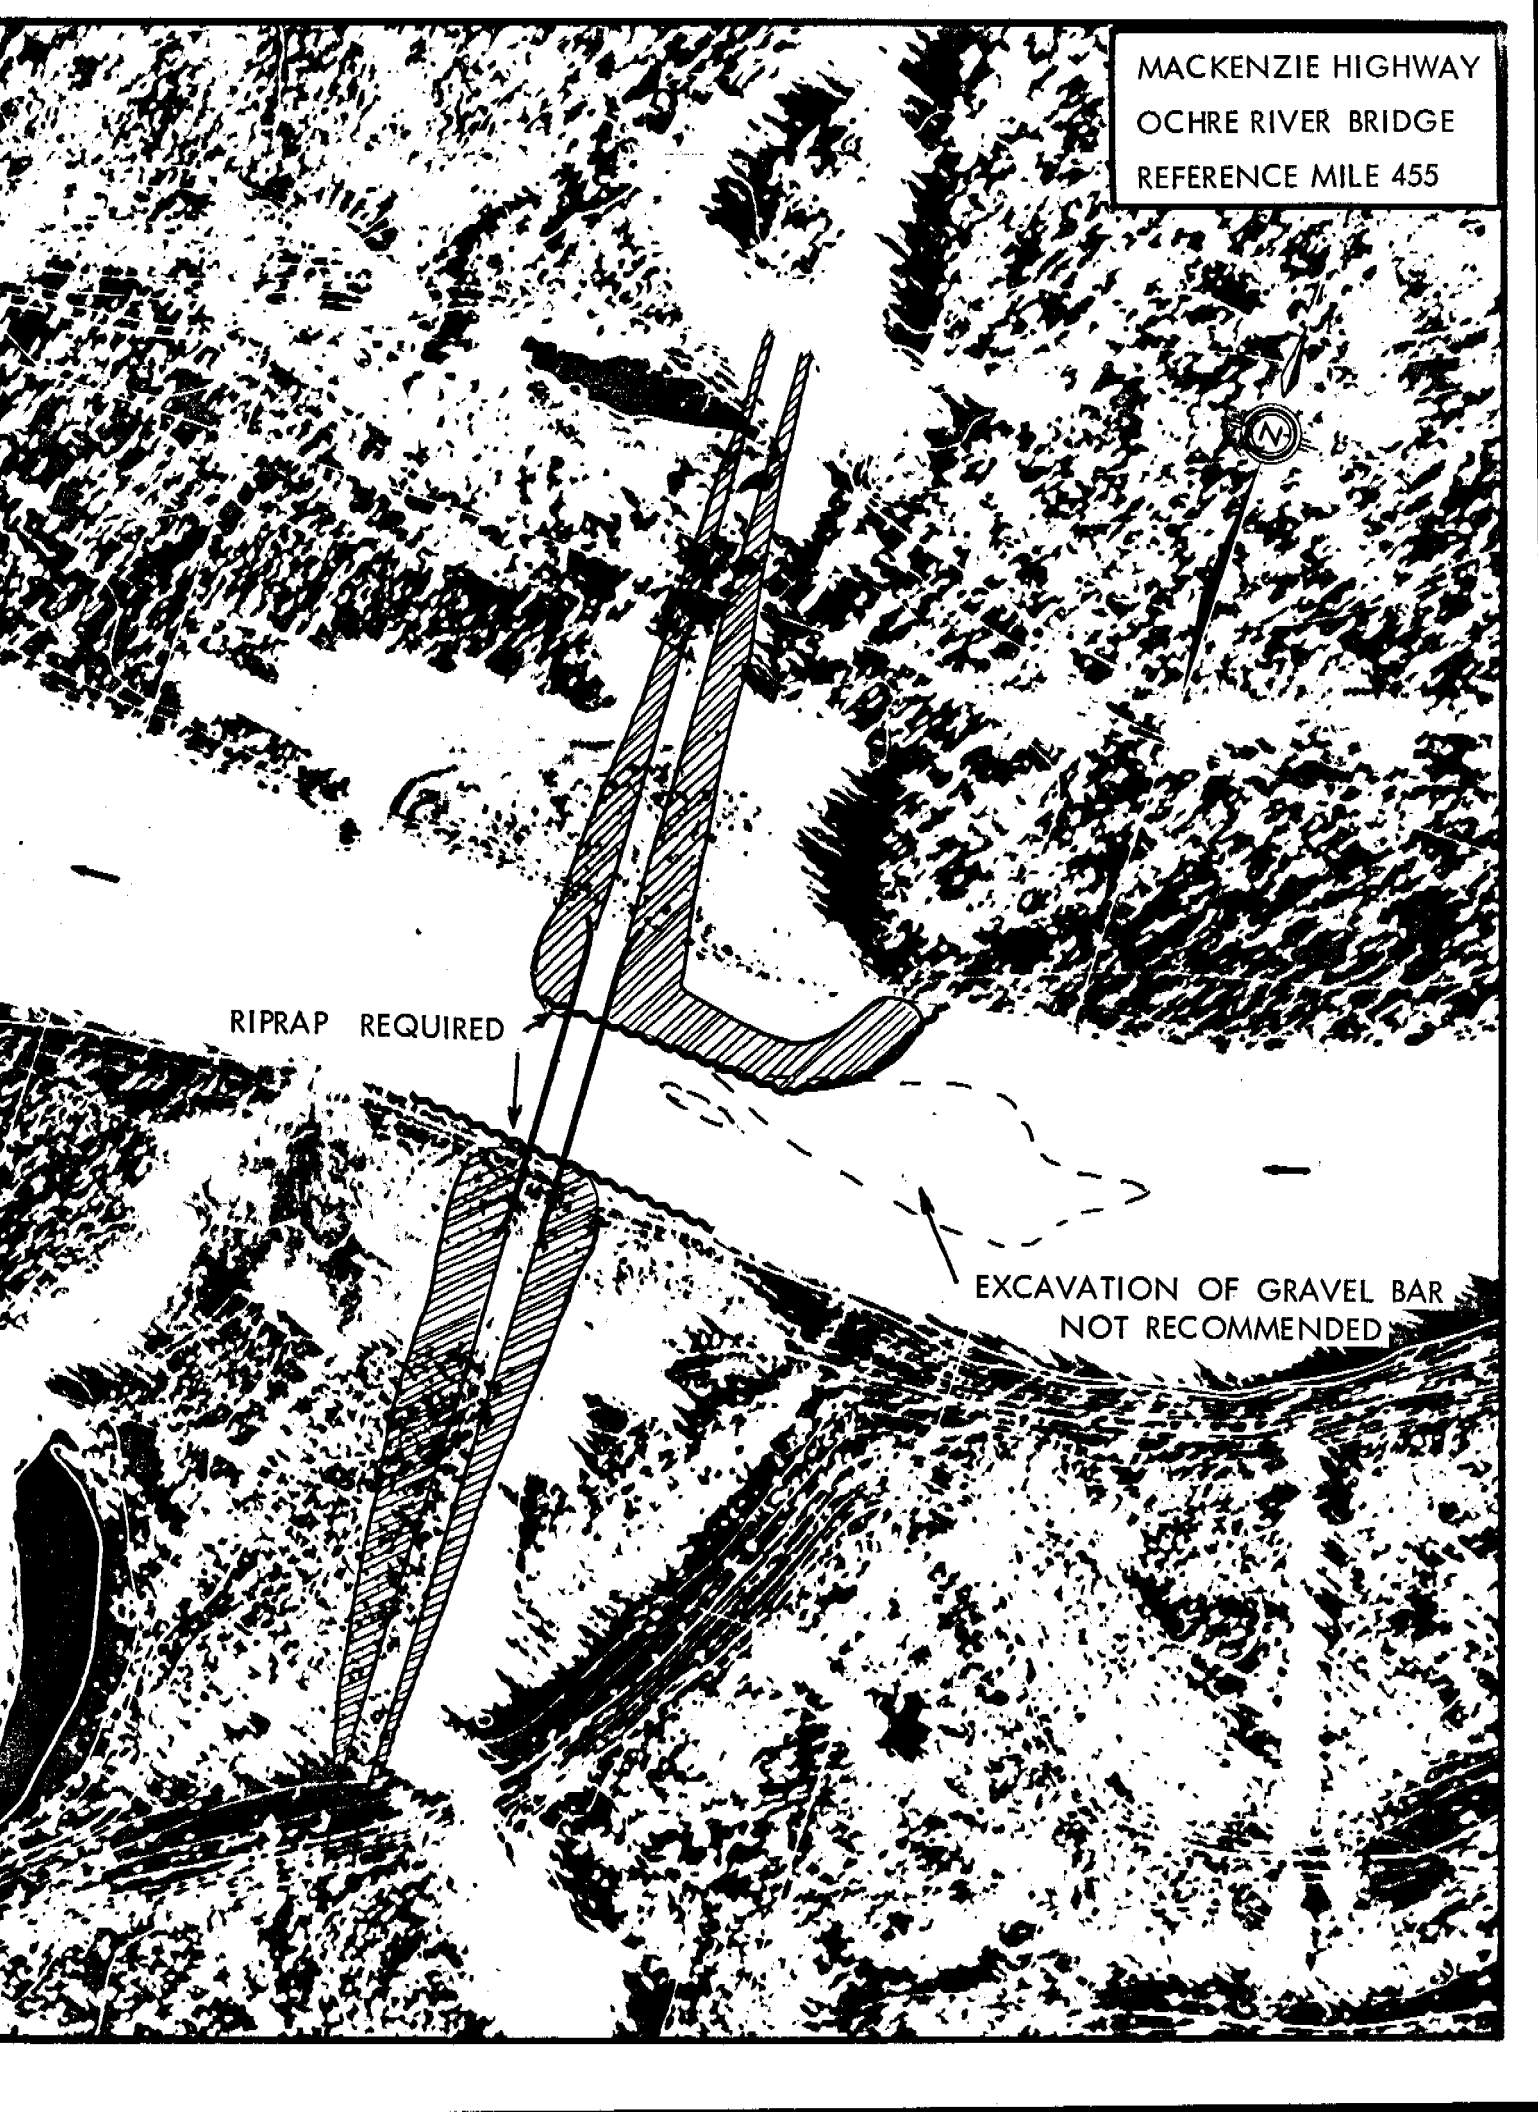
MACKENZIE HIGHWAY  
OCHRE RIVER BRIDGE  
REFERENCE MILE 455

RIPRAP REQUIRED

EXCAVATION OF GRAVEL BAR  
NOT RECOMMENDED

The bridge design planned for the Ochre River appears undesirable from the fisheries standpoint for several reasons. Most important of these is the removal of a large gravel bar upstream of the bridge site. Removal of gravel from the stream bed could be hazardous to the aquatic environment upstream and downstream.

Extensive riprapping of the proposed fills would be a major requirement.

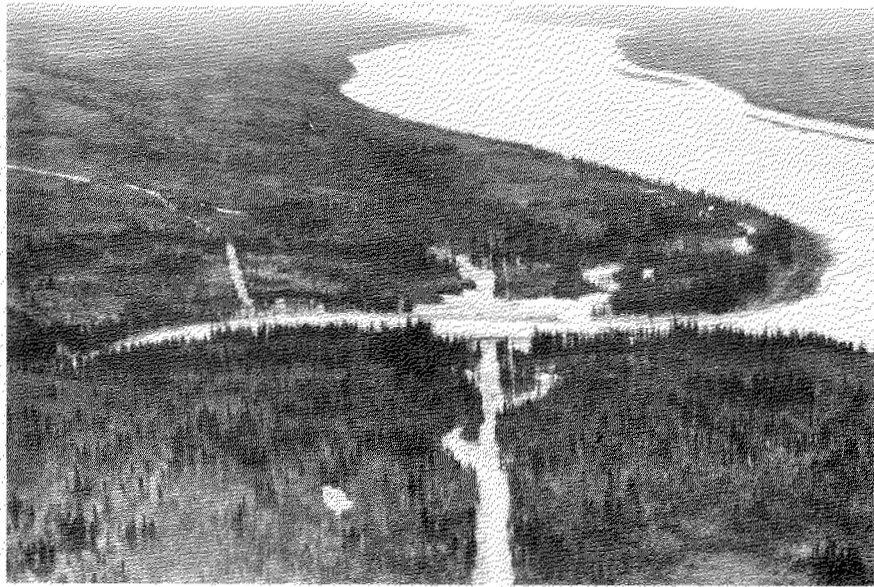
26.10.72. Ochre River. Looking south, winter road, centerline and road centerline visible. Vegetation is aspen, white and black spruce. Soils are peaty gleysols, luvisols and brunisols.

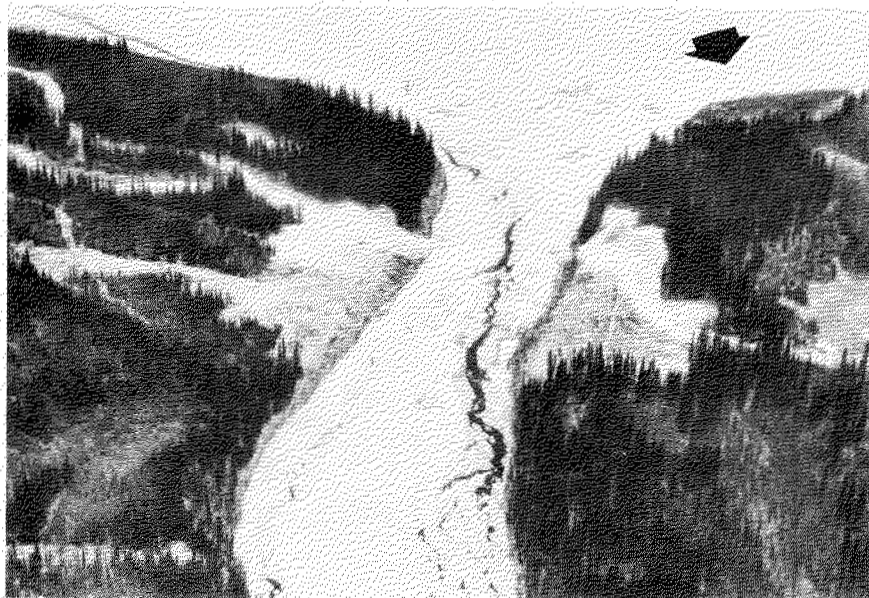
26.10.72. Ochre River. Known prehistoric site on downstream site of river mouth. Notice curve of thalweg; erosion most severe on southern side not on northern side as inferred in bridge report. Bridge footings should be on abandoned alluvial terraces, thereby eliminating special erosion prevention techniques.

The bridge site is flanked by abandoned alluvial terraces. Most severe erosion will be on southern side, not the northern side as inferred in bridge report. Footings and fill should be on terraces eliminating necessity of special erosion prevention structures.

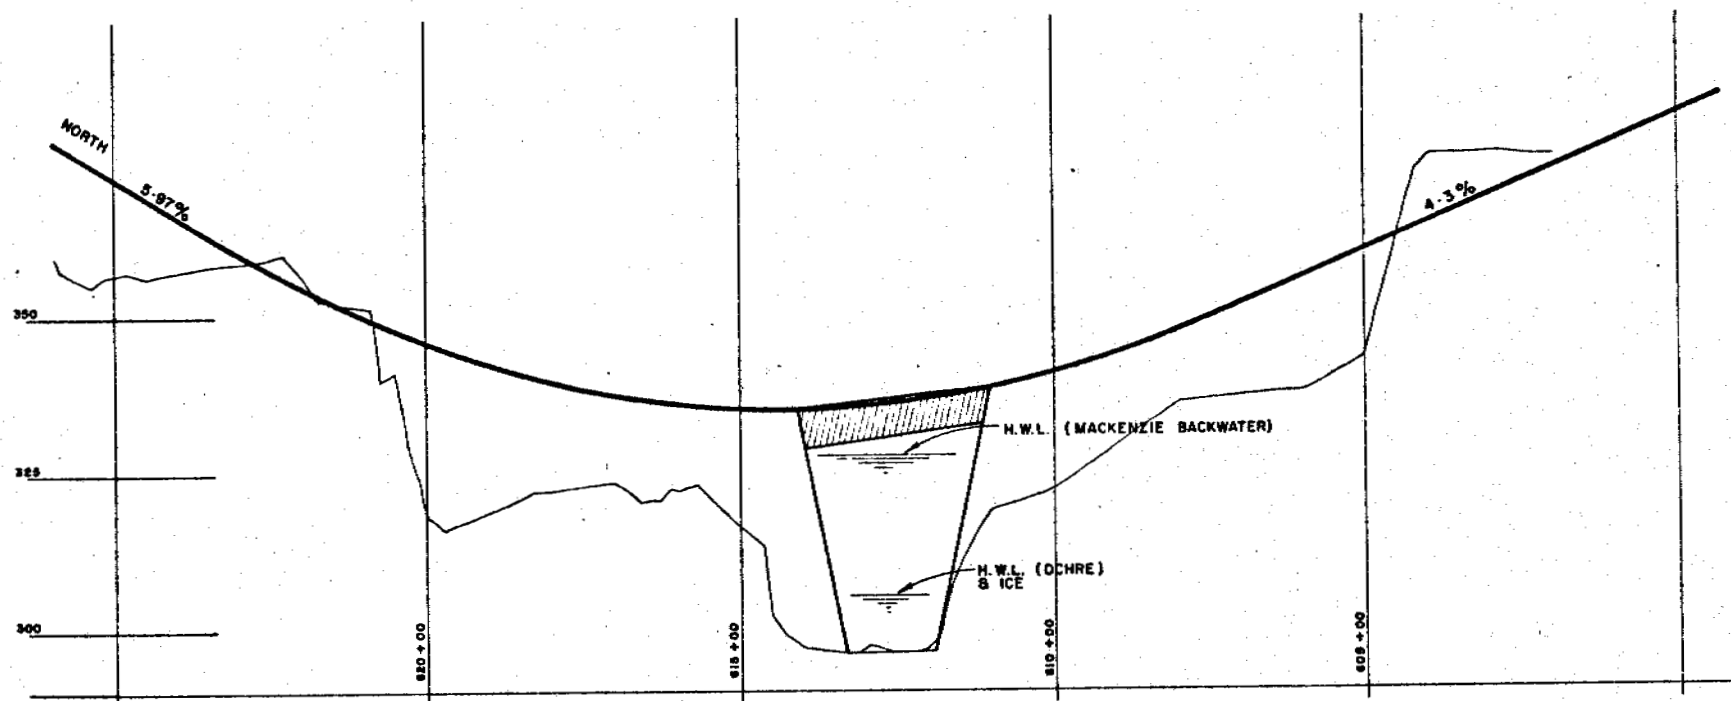
PROFILE  
 VERT. 1" = 20'  
 HORIZ. 1" = 200'

NOTE:  
 ELEVATIONS ARE TO GEODETIC DATUM.  
 CHAINAGE REFER TO FIELD SURVEY.

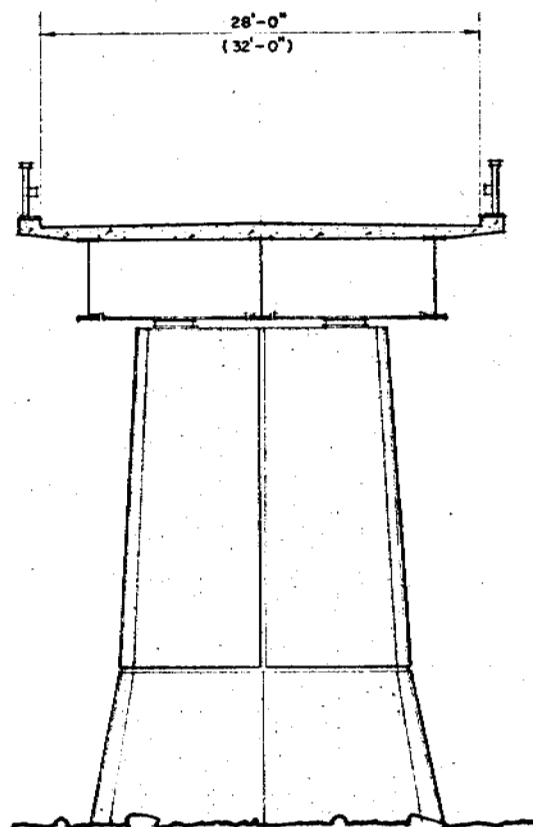
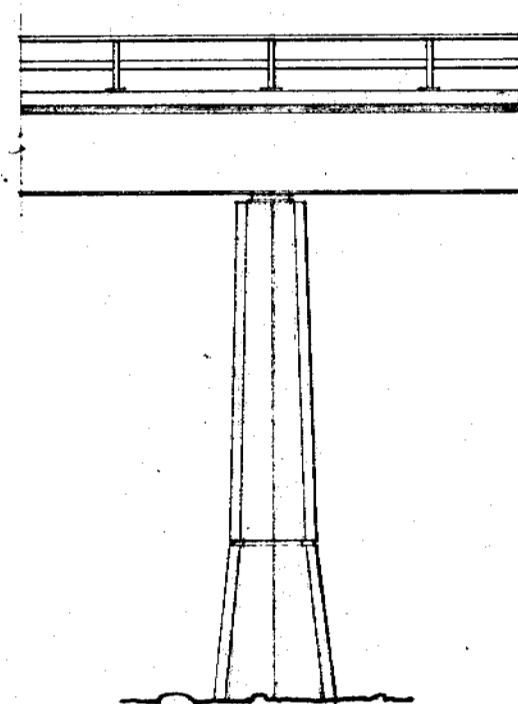
TYPICAL SECTION  
&  
PIER

SCALE:  $\frac{1}{8}" = 1'$
