HODGSON CREEK
BRIDGE

**BASIC ENVIRONMENTAL DATA
HODGSON CREEK BRIDGE
REFERENCE MILE 436**

**MACKENZIE HIGHWAY
NORTHWEST TERRITORIES**

**DEPARTMENT OF PUBLIC WORKS
EDMONTON, CANADA**

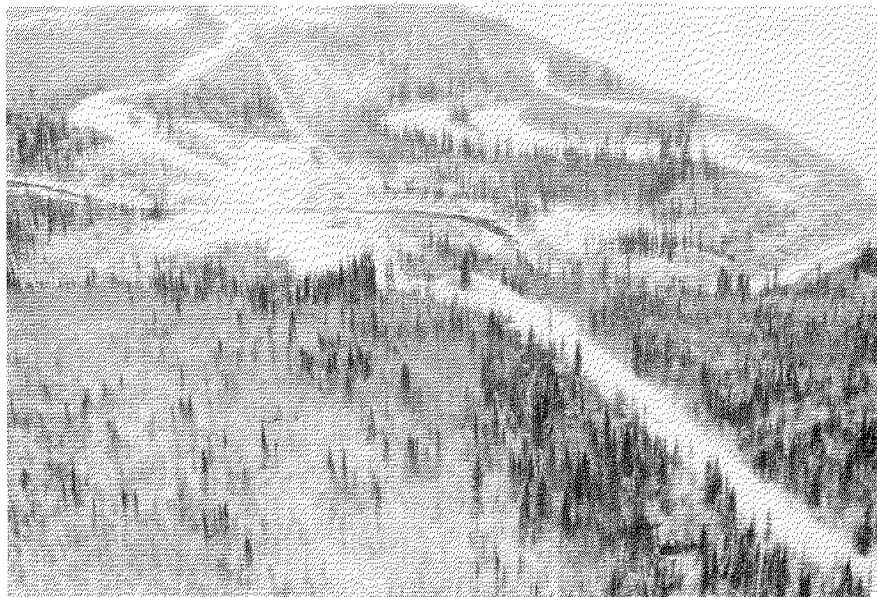
26.10.72. Hodgson Creek. Bridge site (to left in photo) abuts abandoned alluvial terrace on each side. Gradual erosion of western bank will occur. Erosion on eastern side not as severe. Rip-rap required. Vegetation is aspen, white spruce and black spruce.

The channel at the bridge site is a sharply curved part of a thalweg. Erosion on the western side is expected to be severe. Also, fill on the western side appears to encroach on the active stream channel. This may cause deposition upstream from fill and erosion downstream during certain flow periods. Further study is required.

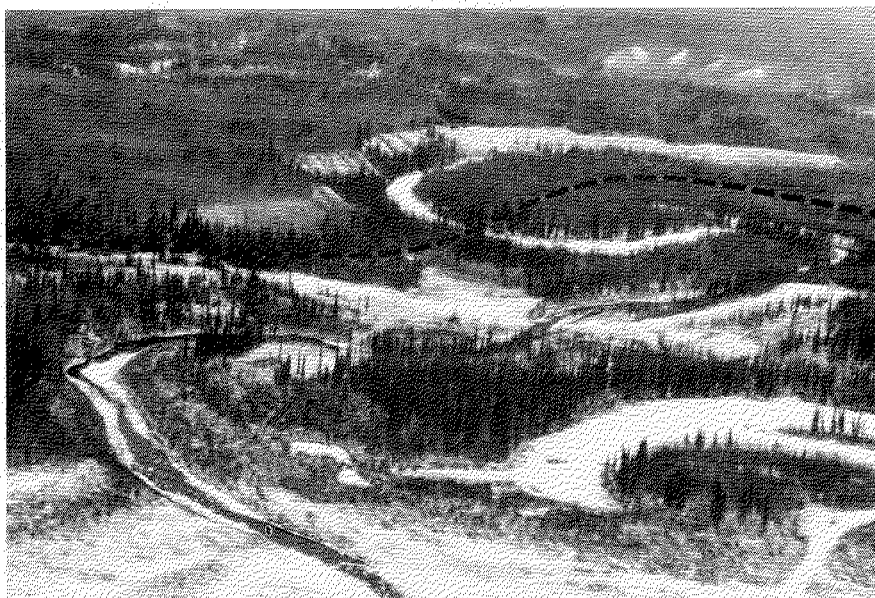
26.10.72. Looking upstream at Hodgson Creek. Highway location is just upstream of CNT landline (across center of photo). Top of south bank composed of sand and gravel of an abandoned alluvial terrace. Top of north bank is silt and sand of glaciofluvial or glaciolacustrine origin which appears well drained. The fishery resource in Hodgson Creek is probably utilized by residents of Wrigley. Precautions should be taken to prevent erosion and siltation, as well as migration blockage.

Silty soils along the north bank of the river become unstable when saturated. Precautions should be made to prevent such material from draining into the creek. Soils of the terrace are gravelly.

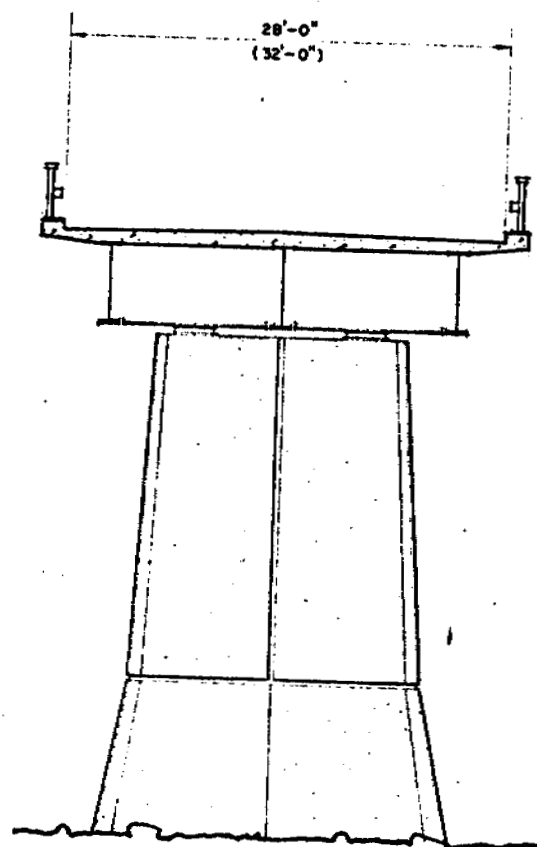
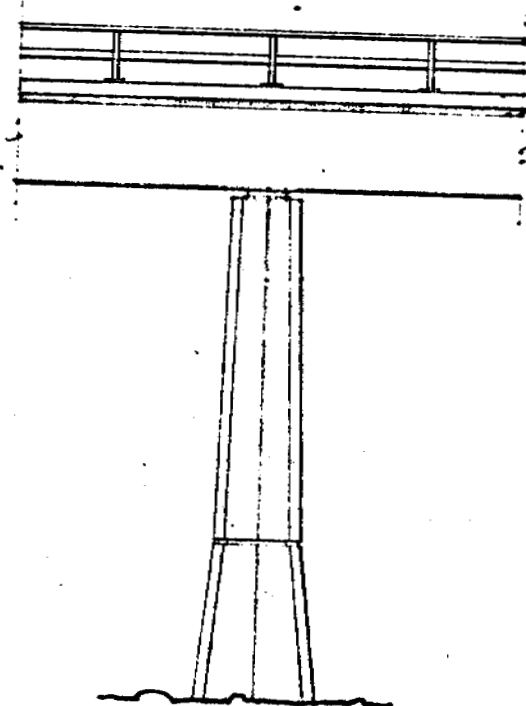
TYPICAL SECTION
&
PIER

SCALE: $\frac{1}{8}" = 1'$
