PRELIMINARY BASIC ENVIRONMENTAL DATA

BIG SMITH CREEK BRIDGE

REFERENCE MILE 546 MACKENZIE HIGHWAY

DEPARTMENT OF PUBLIC WORKS EDMONTON, CANADA

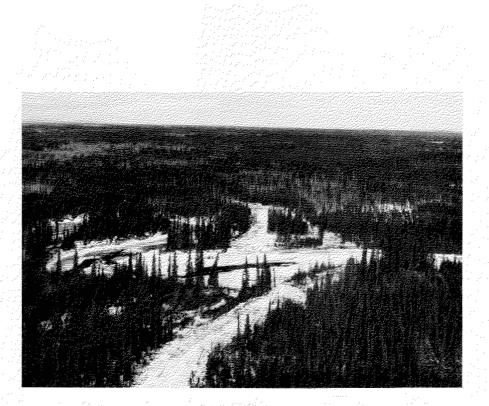
29.10.72. Big Smith Creek looking north. Road centerline is located at the extreme right of the photo. Banks appear stable; single span bridge appears suitable. Erosion on bends of thalwegs can be expected.

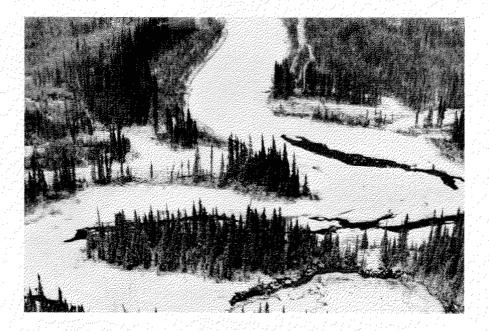
24.10.72. Looking easterly up Big Smith Creek. Waterfall is on lower edge of photo. CNT landline and winter road are across the center. The highway is located adjacent to and upstream of CNT landline. The crossing appears stable but may have flood hazard; will have low impact on fish is siltation prevented.
