ROLLIGON TUNDRA DISTURBANCE TESTS

TUKTOYAKTUK AUGUST 1970

REPORT

THE MUSKEG RESEARCH INSTITUTE

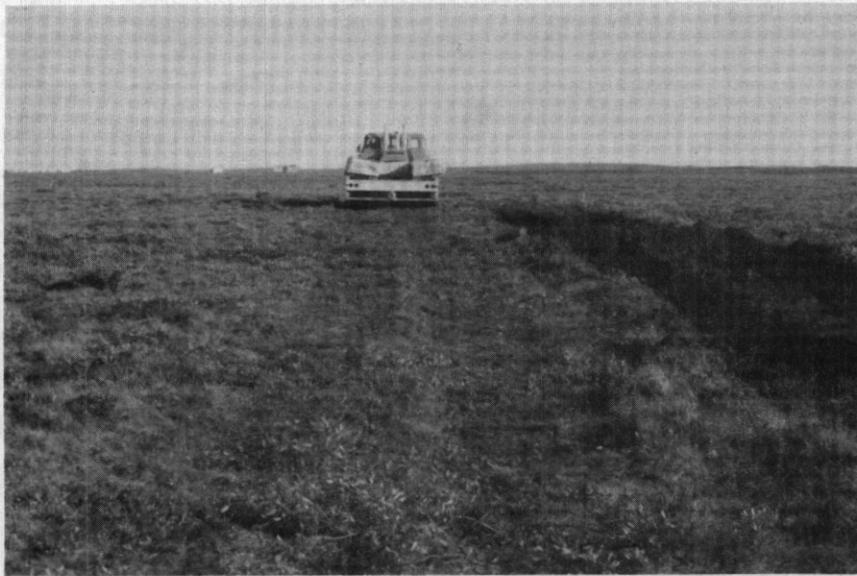
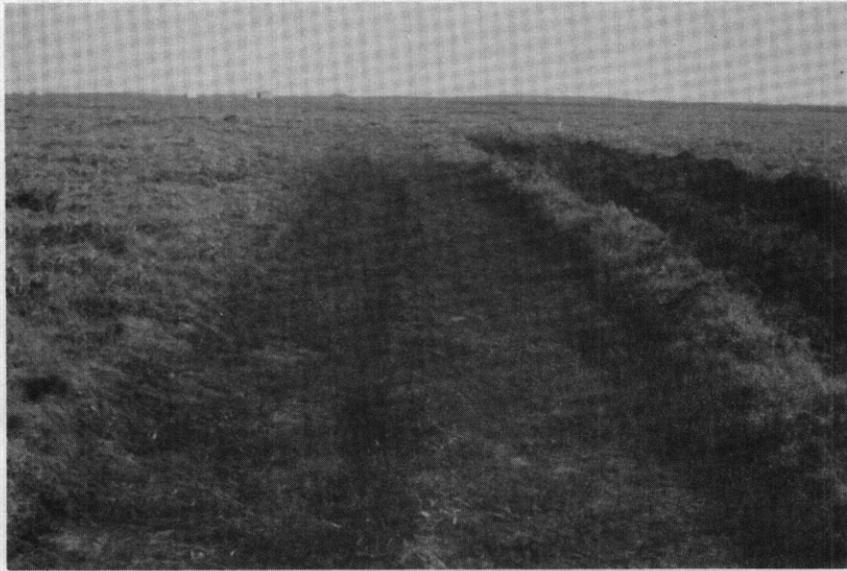
A second test was run on the same site with the modified loading, and the results of the two tests are compared in figures 3 to 16. In all subsequent tests the vehicle path was shifted

The degree to which these forms of disturbance progress depends on several factors including vehicle weight, ground pressure, vegetation composition, and ground moisture content. The decrease in vehicle weight and ground pressure has a profound effect on reducing surface disturbance as can be seen in figures 3 to 16.

It is evident, that as the number of passes increases the vegetation in every case gradually becomes flattened, shrubs have their leaves knocked off and many of the most brittle branches become broken. Eventually some soil is displaced by repeated application of the vehicle weight and shallow ruts develop. Small mounds become flattened to some extent.

No. of Passes	Site 1 Light Load	Site 2 Light Load	Site 3 Light Load	Site 3 Heavy Load
1	1-1	1-1	1-1	1-1
5	3-3	1-2	1-2	2-2
10	4-3	2-2	1-3	4-3
20	4-3	2-3	4-3	4-3
40	4-4	3-3	4-3	5-4
60	5-4	4-4	5-4	6-3
80	5-5	5-5	6-4	6-3
100	6-6	6-6	6-5	6-4

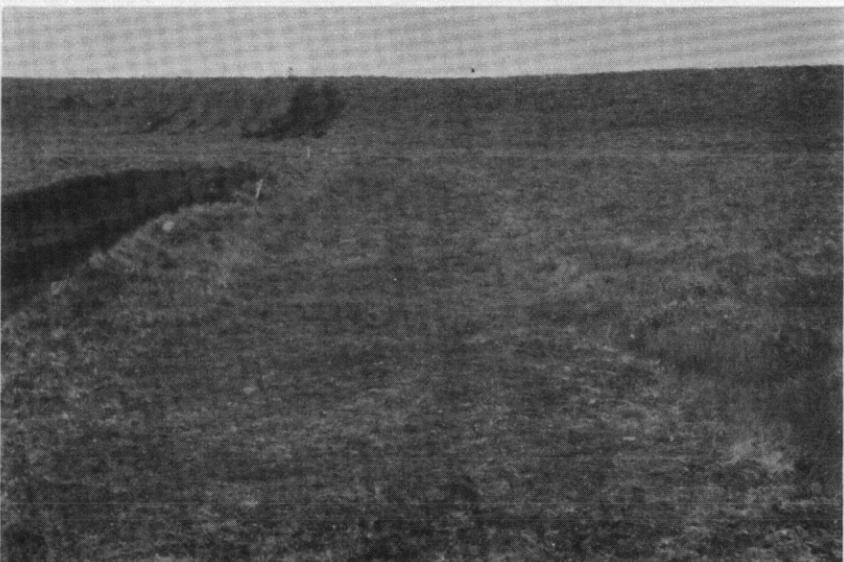
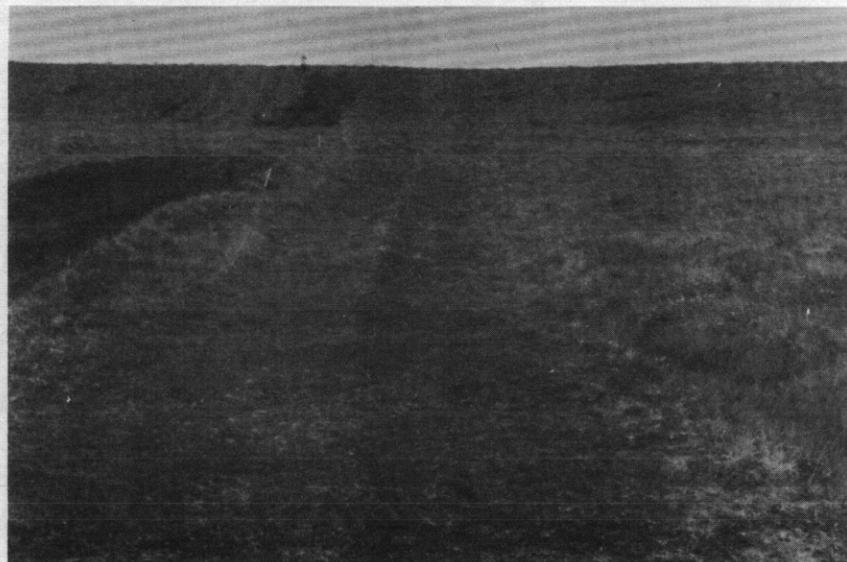
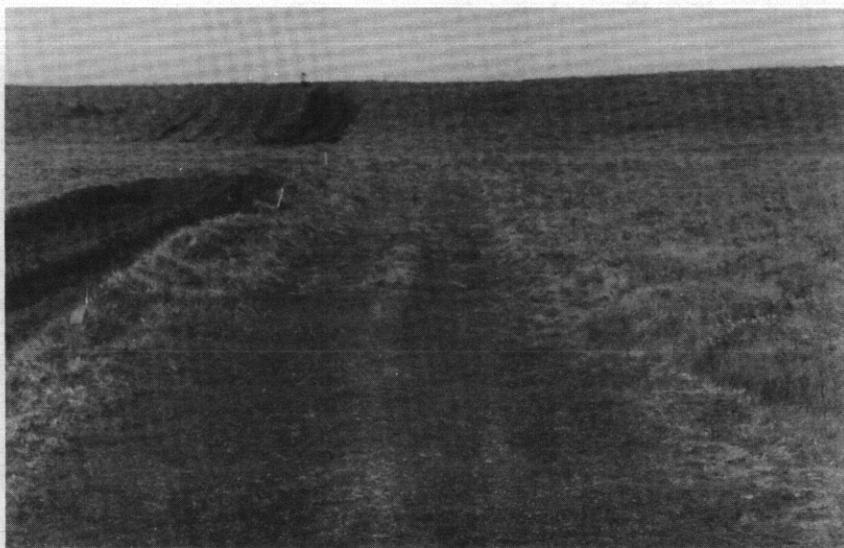
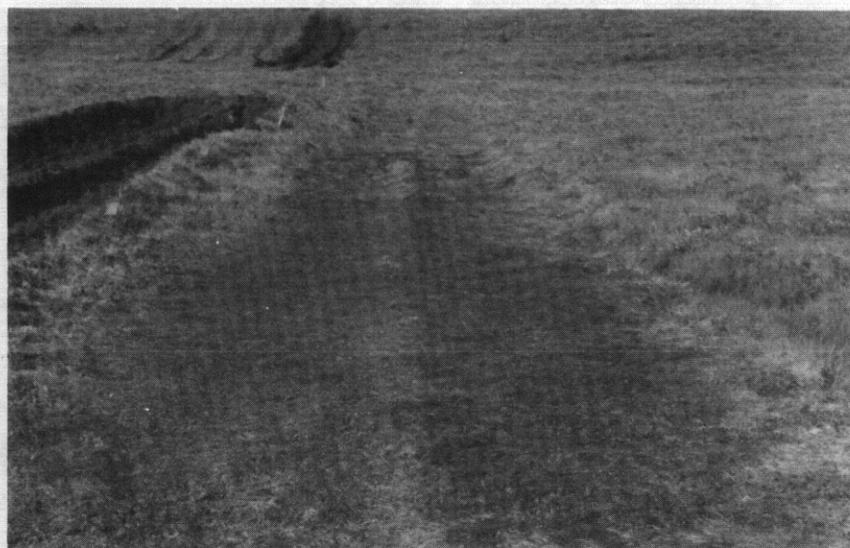
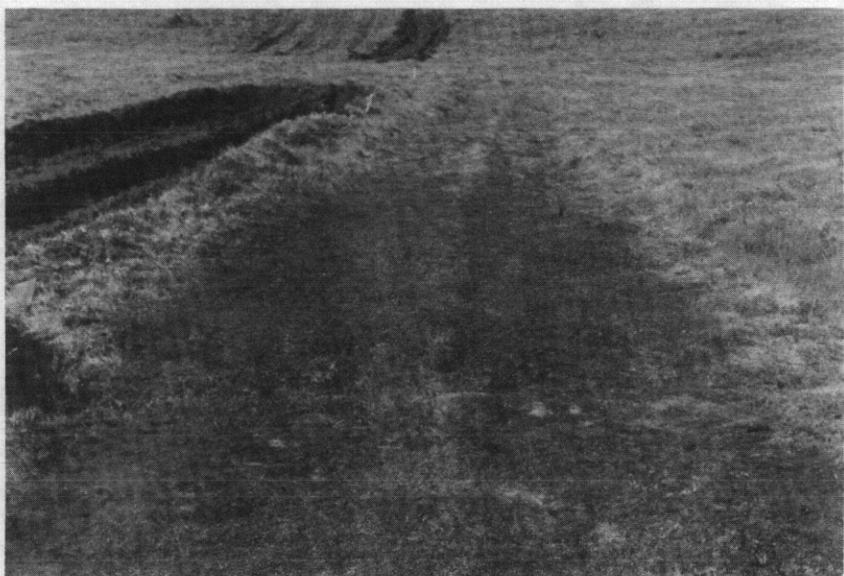
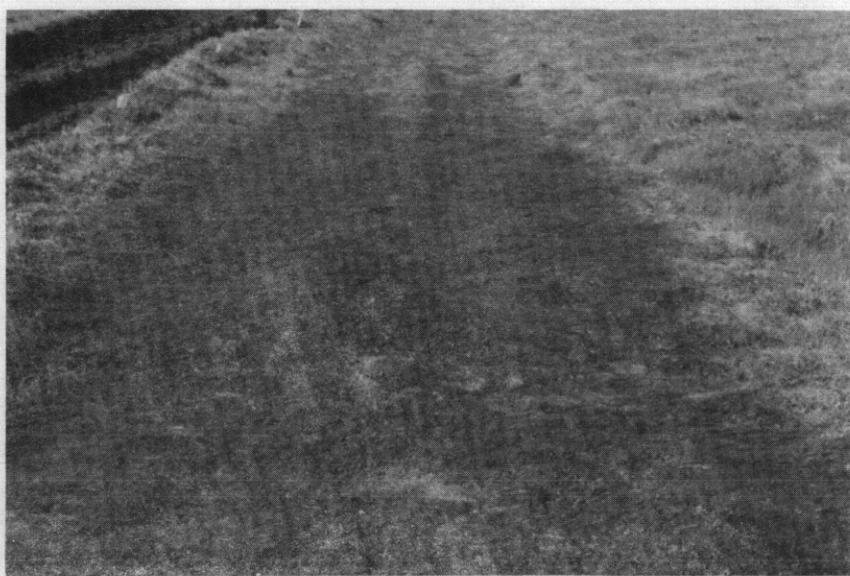
Similar tests were also run with the light loading conditions in Sites 1 and 2 with the results shown in figures 17 to 24 and 25 to 32 respectively.

Three test sites were used and were located within a few hundred yards of each other on a tundra peninsula adjacent to the Tuktoyaktuk harbour. Site 1 was in a low lying level area almost at sea level. The topography was characterised by depressed centre polygons typical of the region, and vegetation consisted of sedges, mosses and small shrubs in that order of predominance (FIE in the Radforth classification system - see Appendix I). Scattered patches of lichen were found, especially on the raised polygon borders. The site was moist near the surface, and the depth to permafrost averaged 11 in.

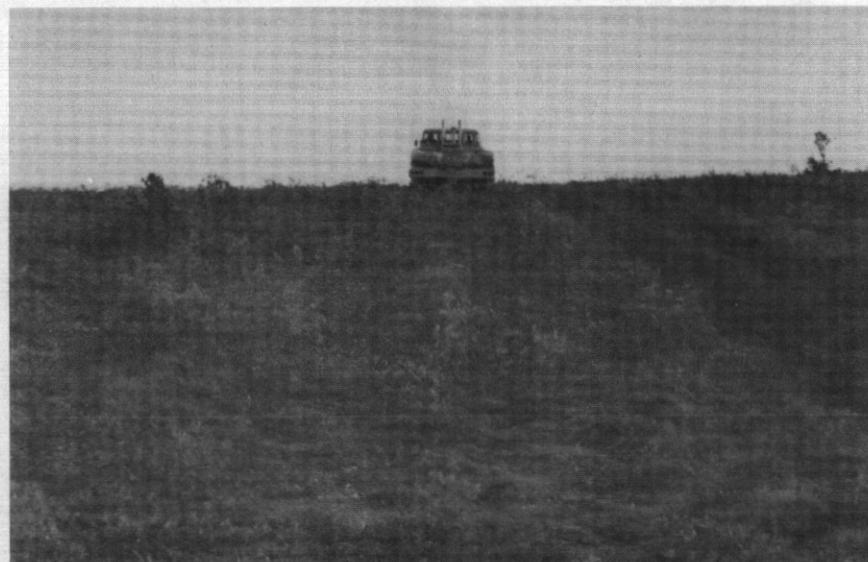
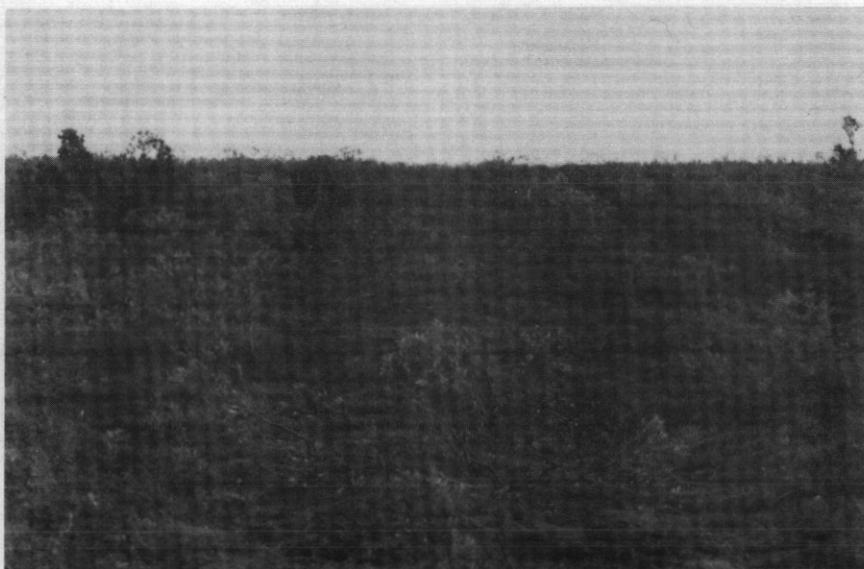
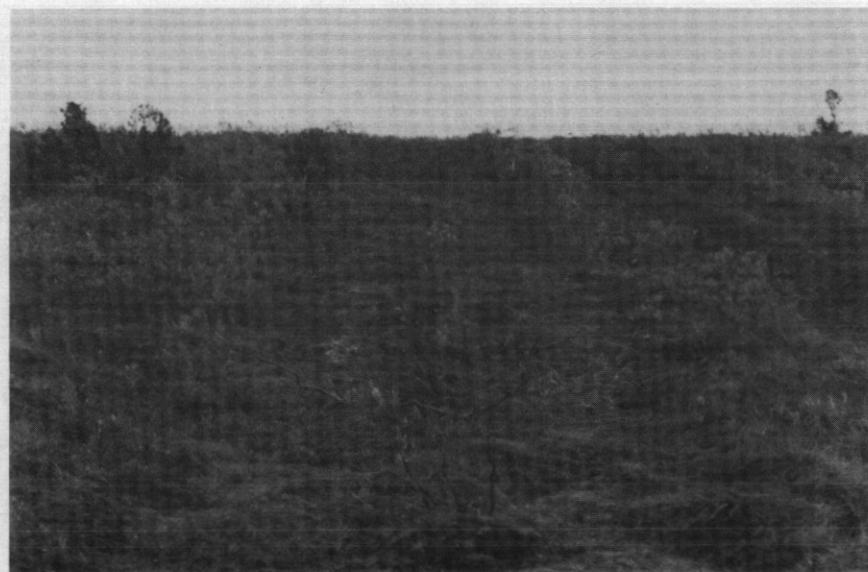
The vegetation in Site 2 appeared to be damaged more rapidly than in Sites 1 and 3 probably because of the higher proportion of brittle, fragile woody plants in Site 2.

Good drainage in Site 2 provided a lower soil moisture content and a firmer ground surface.

Preservation of the microtopography at high numbers of passes resulted and ruts were slow to develop. This is especially important on slopes where ruts can act as drainage channels and promote erosion.

Site 2 was on a well drained slope having a gradient of approximately 10 per cent. The ground surface was very firm and rough. Vegetal cover included heavier woody shrubs than those found in Site 1, mosses, and a few sedges (EIF - Radforth). Permafrost was present about 21 in. below the surface.
